Property Inspection Report

20 Elm St.
Arlington MA

Morgan K. Cohen Home Inspection LLC

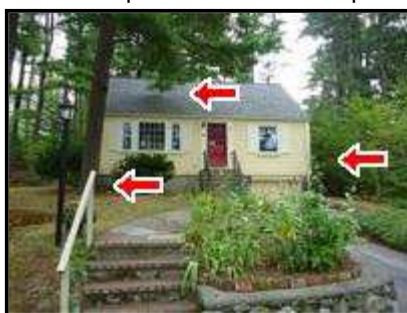
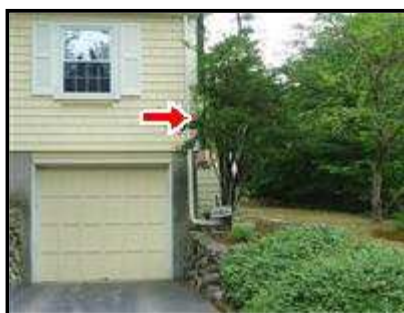
(1) **RR:** Trees and/or shrubs are planted too close or are growing too close to the building. Vegetation can damage the siding, the trim and the roof, and it can clog the gutters. Overhanging tree limbs can allow animals and insects onto the roof or can cause damage to the roof. Roots from trees planted too close to the building can cause damage to the foundation and sewer lines. Areas that are too shady do not allow the siding to dry out and mold, moss, and deterioration can occur. Prune trees and shrubs away from the building. Shrubs should be trimmed at least 18 inches away from the building and trees should be pruned 10 feet from the building. You should seriously consider removal of the large pine tree at the front left corner of the home. Consult a landscape contractor for repair.

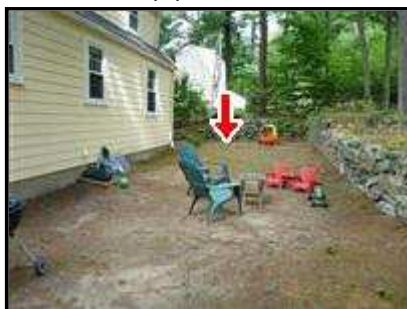
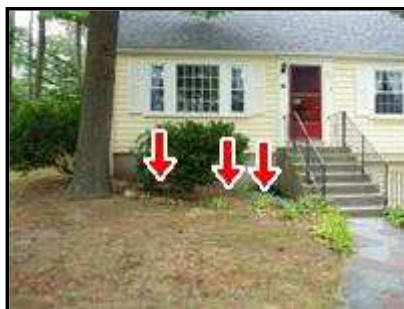
(2) **RR:** There are areas on the left rear corner and next to the front stairs of the home that are level or do not slope away from the building. Improvements to the grading to slope away from the building are recommended. Add a clay type soil surrounding the structure wherever possible on the perimeter up to 2 ft away from the foundation to help prevent moisture infiltration into the foundation.

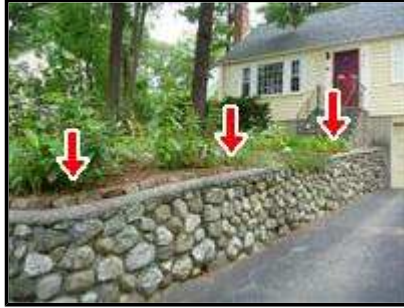
3.0 Picture 5

(4) **RR:** The retaining wall on the side of the driveway has no guardrails in place. This condition is a safety

hazard because someone could fall from this area into the driveway. Installation of guardrails is recommended in these areas.

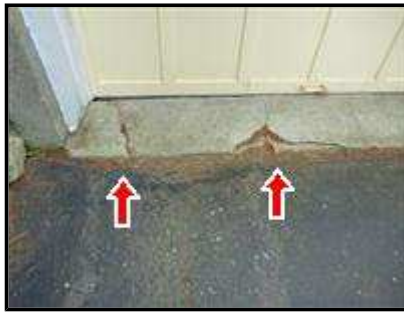
3.0 Picture 6

(5) **RR:** There are cracks in the concrete portion of the driveway near the door. When water penetrates these cracks it can cause them to worsen, and weed growth can cause damage, and moisture accumulation can cause heaving. It is recommended that this section of the driveway be patched (temporary repair) or replaced (preferred repair).

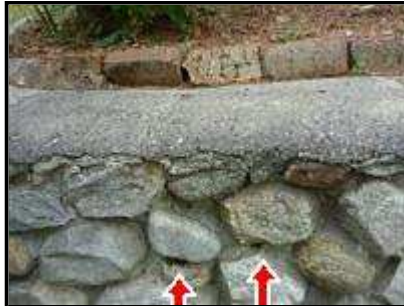
3.0 Picture 7

(6) **FR:** There are minor areas of mortar cracking. Expect to re-point these areas in the near to medium term.

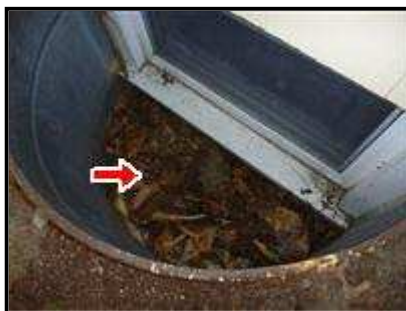
3.2 Picture 1

MR: There is dirt at the bottom of the window wells. This prevents drainage of the wells. Add gravel at the bottoms of the window wells to allow for drainage of the wells. Remove leaf debris and dig down to 6 inches below the bottoms of the sills. Add 2 inches of gravel on soil so that bottom of basement window sill is approx. 4-6 inches above gravel.

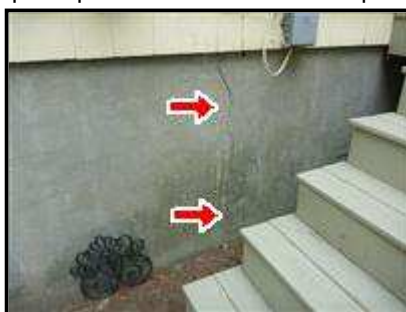
3.3 Picture 1

RR: There is a crack on the exterior of the foundation on the right side of the home. This condition can cause moisture or insect infiltration and may worsen over time. This crack should be sealed on the exterior and interior. Consult a foundation crack repair specialist or mason for repairs.

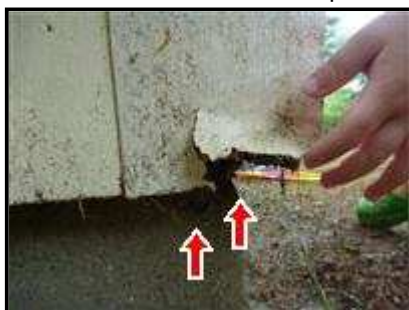
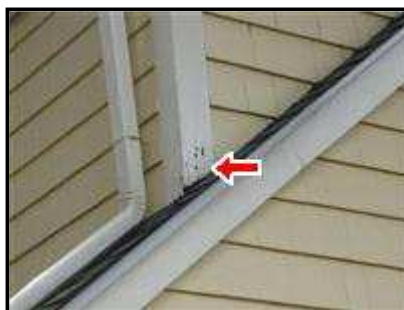
(1) **RR:** There is rot to the corner boards on the left rear of the home. These rotted sections of corner board should be replaced. Consult a contractor for repairs.

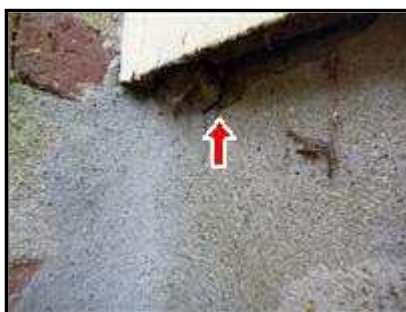
3.4 Picture 3

(2) **RR:** There is a gap in the siding at the bottom edge on the left side of the home next to the chimney. Sealing this hole is recommended.

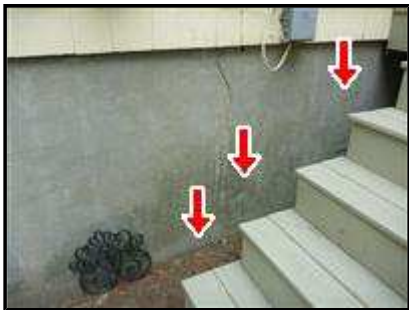
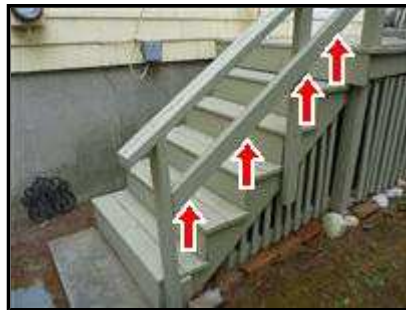
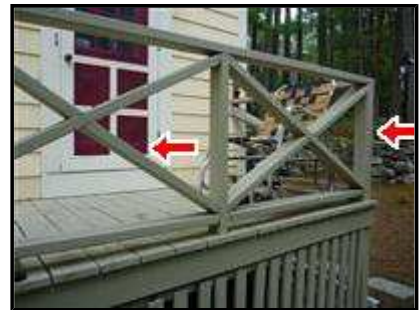
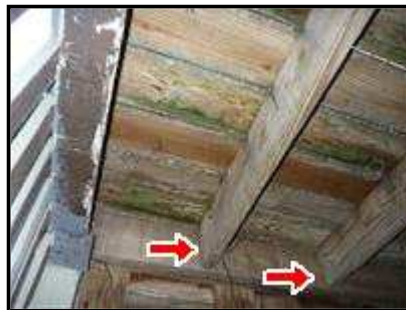
(1) **RR:** The handrail in place on the right side stairs has no baluster system. This condition can allow children to fall through the sides of the stairs. Replacement of the railings on the stairs with railings that have vertical balusters is recommended. Consult a contractor for repairs.

RR: The railings on the right side stair platform/deck do not have proper balusters. The guardrail and railing is constructed of horizontal components. This creates a ladder effect. Children can climb up the railing and fall. It is recommended that the railing be repaired or replaced with proper vertical balusters. The space between each baluster should be such that a sphere 4 inches in diameter cannot fit through.

RR: There is a space between the stairs to the right side entry and the foundation wall/siding on the home. This is a falling hazard. It is recommended that you install a handrail on this side of the stairs or replace stairs with stairs that are built to run up against the home.

RR: There are no joist hangers for the joists under the deck. Joist hangers are recommended to provide additional support for the decking. Without these, the joists may become loose and could fail. Installation of hangers is recommended.

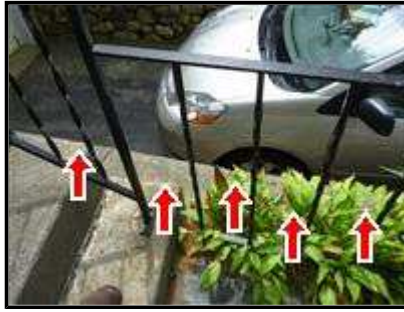
3.6 Picture 5

(2) **RR:** The spacing of the balusters for the front stair and path guardrail and handrail is too far apart. This may allow a child to climbing or fall through, or get their head stuck in the guardrail. Ideal spacing is such that a sphere 4 inches in diameter cannot fit through any gaps in the railing components. This condition should be corrected. Consult a contractor for repairs.

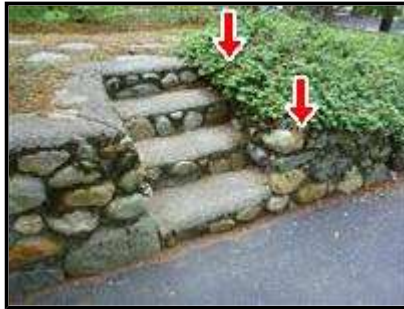
3.6 Picture 6

(4) **RR:** There are no handrails on the right side exterior steps. This condition can be a falling hazard. Installation of handrails is recommended.

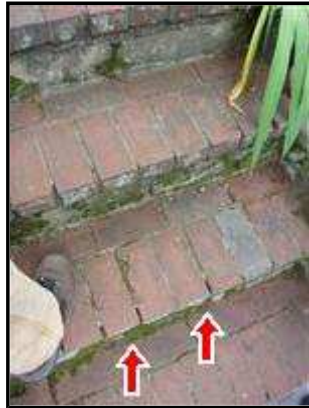
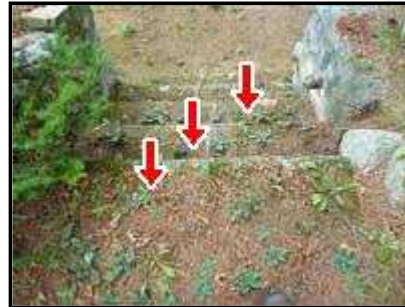
(5) **RR:** The front steps to the street have some open mortar joints, and the rear yard stairs have open tops to the treads, which are made of masonry block. This condition can lead to further moisture damage, and is also a safety hazard because the stair treads are not smooth and even. Repairs are recommended. Pointing is recommended to the front steps, and addition of treads on the rear steps is recommended. Consult a mason for repairs.

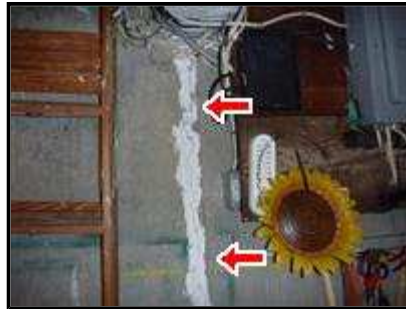
4.0 Picture 1

(1) **RR:** There is a vertical crack in the concrete on the right side of the foundation (in the garage area of the home). This type of crack is typical for a home of this type and age. The crack should be sealed to prevent moisture and insect infiltration. Consult a foundation crack specialist for repairs. Foundation cracks should also be monitored for further movement or opening. If any changes are noted, a licensed engineer should be consulted for further investigation.

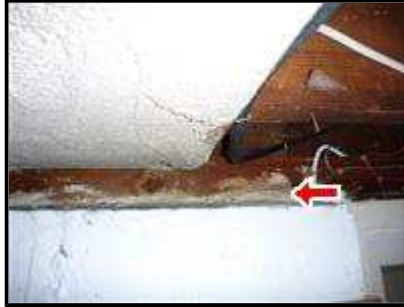
4.3 Picture 1

(1) **FI:** There is insect damage on the left side of the home in the sill. This damage appears old and the sill is hollow in the area of the damage. There is a concern that there could be additional damage to the sill in the areas to the front of the damage and potentially to the main beam. These areas were not able to be inspected because they were concealed by plaster. It is recommended that the concealed sections of sill and beam be uncovered and the structural components be inspected in these areas.

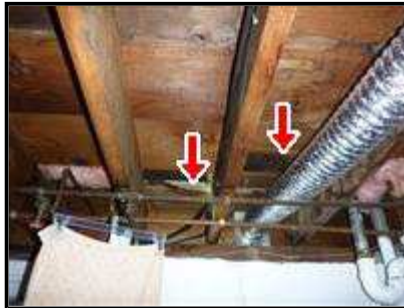
4.3 Picture 2

(2) **MR:** There are holes around pipes and wires and/or open gaps in the subfloor for the flooring in the first floor. Sealing these holes and patching these gaps is recommended to help prevent air, insect, and rodent infiltration up into the home. Consult a handyman or other qualified person to repair this condition.

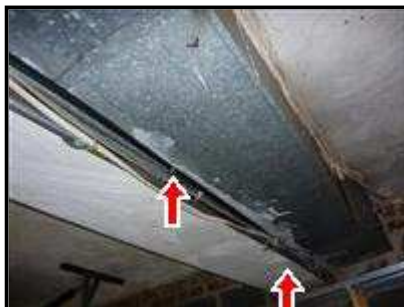
5.3 Picture 1

(2) **Energy Efficiency Upgrade:** There is no insulation on the supply ducting in the basement and the garage. This can make the heating system operate less efficiently than one with insulation on the supply ducting. Adding insulation is recommended.

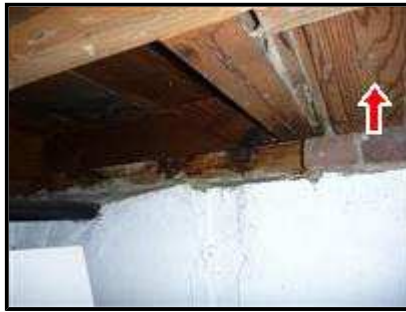
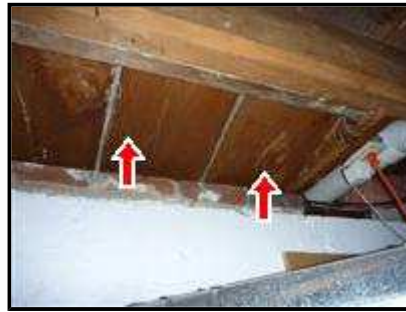
(1) **RR:** The form boards for the hearth extension are still in place under the fireplace chimney hearth extension in the basement. These form boards are meant to be removed after the hearth extension is built because they are a fire hazard in the case that embers fall through any cracks that may form in the hearth or hearth extension. Removal is recommended. Consult a chimney sweep for repairs.

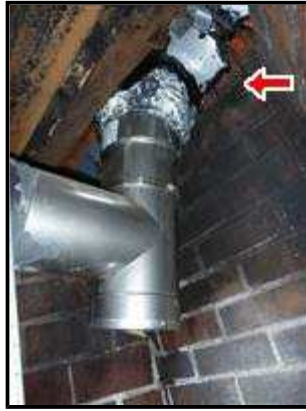
5.6 Picture 1

RR: There is a wood stove currently installed in the fireplace. This stove may or may not be staying. Verify if staying or not. Also, there is a direct connection between the stove and the fireplace flue. The damper has been modified for use with the wood stove. The interior of the flue was not visible for inspection due to this condition, and the damper will require rebuilding or replacement if the stove is removed. Consult a chimney sweep for repairs to be able to burn wood normally in the fireplace if stove is removed.

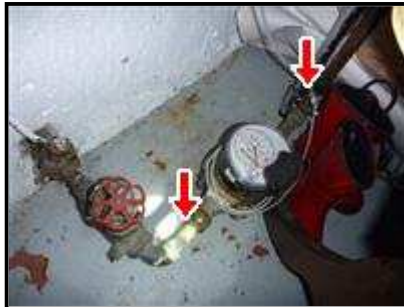
6.1 Picture 1

(1) **RR:** There is no bonding jumper wire over the water meter. This wire connects from the street side to the house side of the meter and connects the grounding system to the house side of the plumbing system. This wire is recommended. Consult licensed electrician for repair.

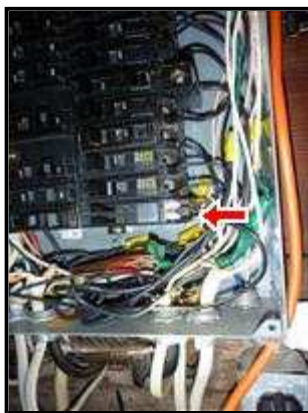
6.1 Picture 2

(2) **FI:** There are mini-breakers in use in the subpanel in the unit. The panel schematic does not indicate that the panel is designed for use with mini-breakers. Further investigation by an electrician is recommended, with correction as necessary.

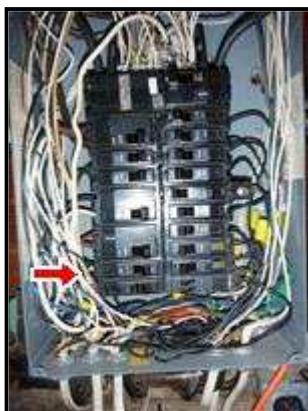
6.3 Picture 1

(1) **RR:** There are three circuits installed on one breaker in the main panel. This is a safety hazard and should be corrected. Circuit breakers may only have a maximum of two wires attached to the lugs if allowed by the manufacturer, and most are only rated for use with one circuit. Consult an electrician for repairs.

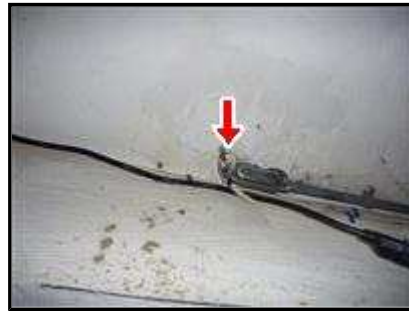
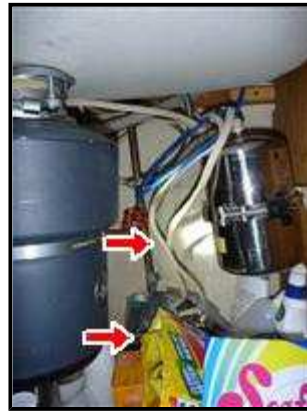
(2) **RR:** There is some wire sheathing that is taped with electrical tape on the outside of the wire. The extent of any damage to the wire is not known. remove tape in this area and replace feed wire if necessary. Consult an electrician for repairs.

RR: The wiring for the appliances under the sink is unprotected romex wiring, and the junction box is floating loose in the cabinet. This is a safety hazard. Properly mount junction box and replace exposed romex wiring with flexible armored wiring. Consult an electrician for repairs.

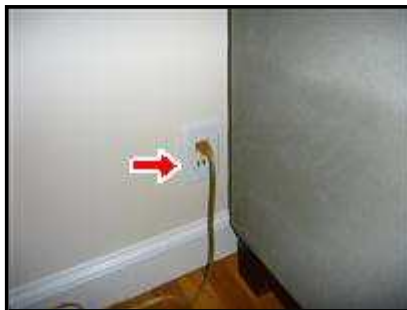
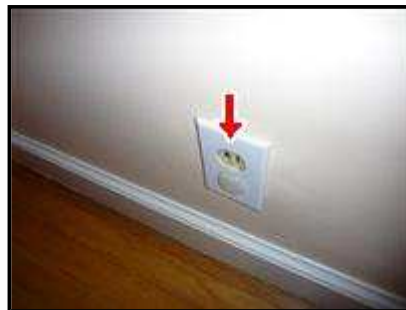
(1) **RR:** There are older two prong ungrounded receptacles in living room, dining room, and bedroom areas. Upgrade is recommended. Replacement with grounded wiring or replacement of aged two prong receptacles with GFCI receptacles is recommended. Upgrade to grounded circuits in rooms or areas where you intend to use appliances that require ground. Consult electrician for repairs.

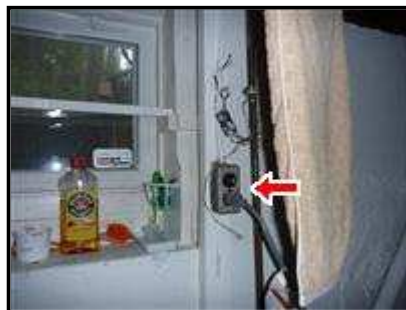
6.6 Picture 3

(3) **RR:** Upgrade unfinished basement and laundry area receptacles to GFCI is recommended. Consult electrician.

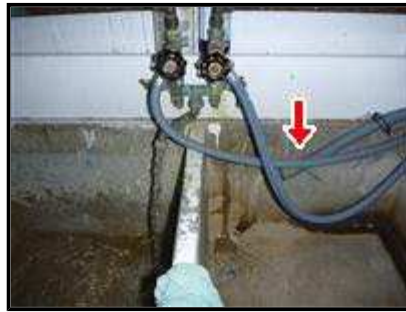
7.0 Picture 1

- (1) **FR:** The main waste piping is aged cast iron. This piping is at or very close to its average life expectancy. It is not possible to predict the remaining life of this piping. You should expect that you may have to make repairs or replacements in the near future. Monitor for deterioration and/or leakage and repair as necessary.
- (2) **RR:** The basement utility area for laundry is set up so that a washer will need to drain into the laundry sink. This is not recommended. It is recommended that a dedicated, properly plumbed standpipe be installed for washer drainage.

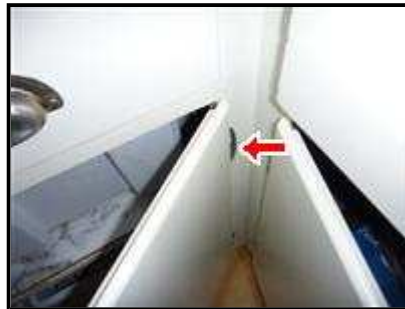
9.3 Picture 1

MR: Fill and seal holes around pipes under sink.

MR: Secure and adjust loose hinges on cabinet doors.

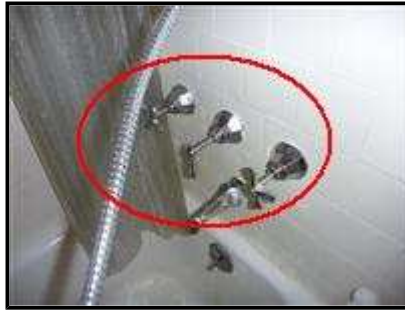
10.0.A Picture 1

(1) **RR:** Replacement of older hot and cold isolated shower/tub control valves with antiscald valve conversion kit is recommended. Consult plumber for repair/upgrade.

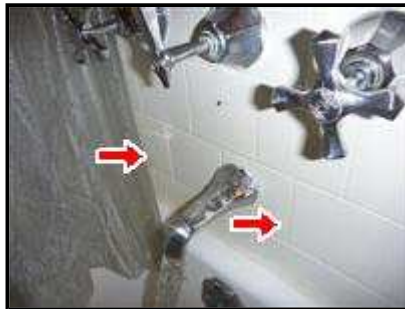
10.1.A Picture 1

RR: There was a hollow sound in places on the wall in the shower and the wall feels soft in places. There may be additional damage, mold, rot or deterioration to the framing and wall board behind the tile in this area. Repair is recommended. Keep in mind that if the damage is too extensive, then retiling the wall may be necessary. This is often the case when there is old deteriorated wallboard or plaster behind tile.

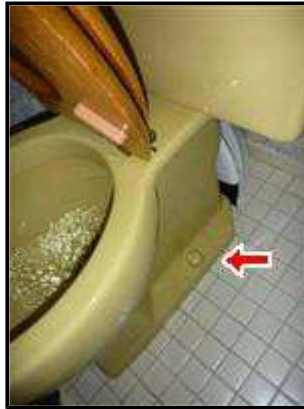
10.0.B Picture 1

(1) **RR:** The toilet is loose in the floor. Repairs may involve re-setting the toilet on a new wax seal or repairs to the flange. Consult a plumber for repairs.

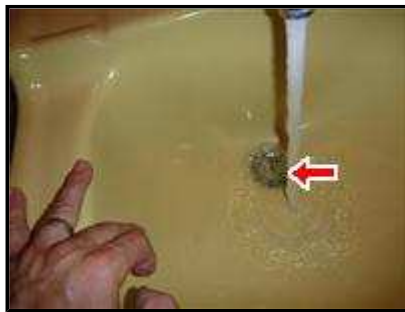
10.0.B Picture 2

(2) **RR:** The tub stopper valve did not operate. Repair recommended. Consult plumber.

(3) **RR:** The sink stopper did not operate properly when tested. Repair/adjust.

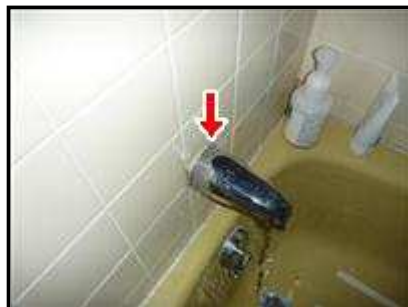
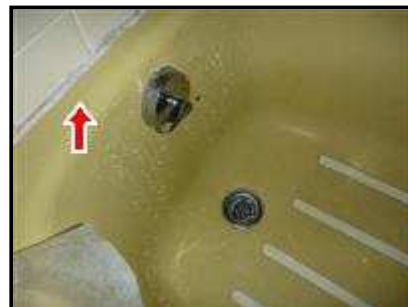
RR: Scrape and reseal caulking between tub and walls, and caulk the joint between the tub spigot and the wall.

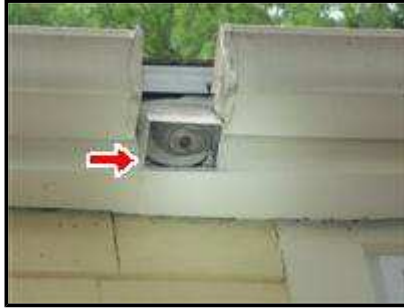
10.3.B Picture 1

RR: The bath exhaust vent fan outflow hood is blocked by a bees nest. This prevents the flap from opening and is a safety hazard. It is recommended that the bees nest be removed. It is not known whether or not this nest is active. No bees were observed in this nest or in the area of the nest (The nest may still be active, though). Consult a pest control operator for removal of the nest.

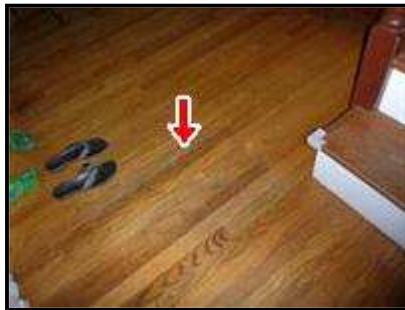
11.2 Picture 1

RR: There is surface damage, wear and cupping to wood floors in the home. Refinishing the floors is recommended.

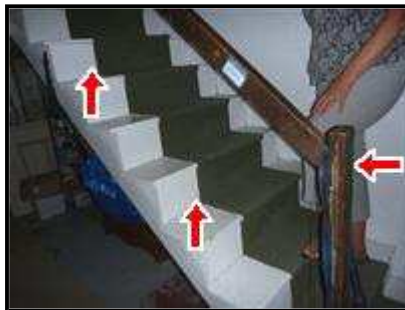
11.3 Picture 1

RR: It is recommended that you add vertical balusters to the stairs to the basement on the open side of the stairs, and secure the basement handrail. Consult a contractor for installation.

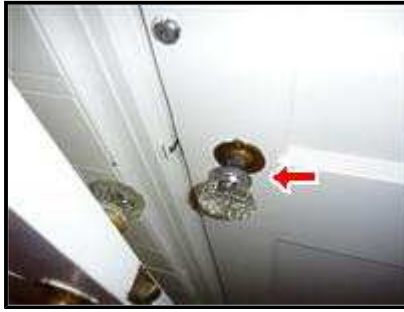
11.4 Picture 1

RR: There are older doors and door hardware throughout the building. Some latches do not line up and require adjustment. Some hardware is loose and requires repair or replacement. Consult a carpenter to repair and adjust doors in the home to operate properly.

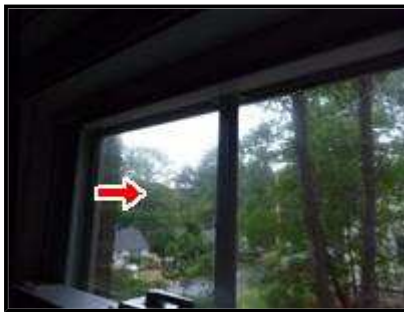
11.5 Picture 1

RR: The top sash on the left side second floor window has a thermal seal failure. This condition is evident due to condensation and staining between the panes of glass. This condition causes the window to become fogged. This sash should be reglazed or replaced.

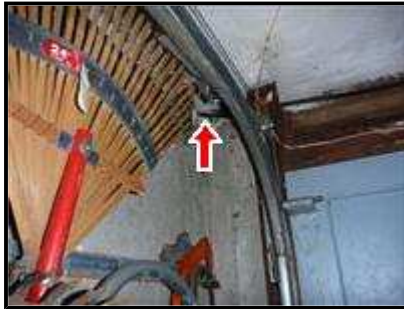
12.0 Picture 1

MR: There is a small hole in the ceiling in the garage above the door on the right side (right front corner). Fill and seal with a fire rated caulking.

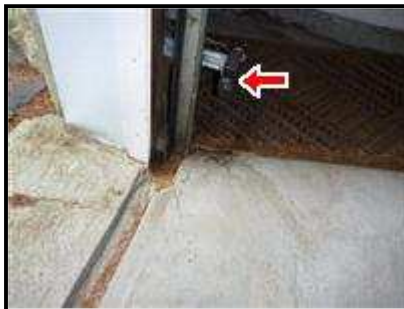
12.4 Picture 1

(1) **RR:** The opener has electronic sensors located higher than six inches off floor which may not be installed according to manufacturers specification. Most door manufacturers state that sensors should be mounted 6 inches or lower from the floor. This is unsafe and needs correcting.
