(Govt. of India)
(Ministry of Railways)

MAINTENANCE INSTRUCTIONS
FOR
UIC TYPE RUBBER VESTIBULE
OF B.G. MAIN LINE COACHES
(For official use only)

July , 2001

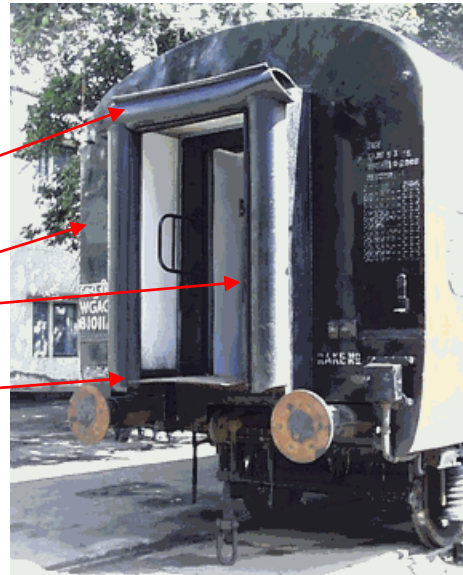
Figure 1.1

UIC type rubber vestibule arrangement on coach end wall.

- a) Upper flange
- b) Lateral side flange
- c) Foot plate arrangement

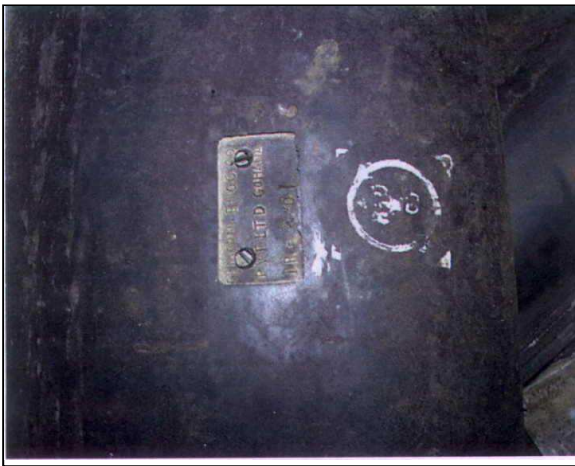
Figure 1.2

Embossed markings on rubber flange of one manufacturer
(not legible and on the rubbing surface)

Firm's stamps on rubber flanges should be located in such a way that the Firm's stamp should remain till the service life of the vestibule for which marking particulars will have to be suitably modified to last till the service life of vestibule. A sketch showing ideal location for the markings on side as well as upper flange is shown at figure 1.4.

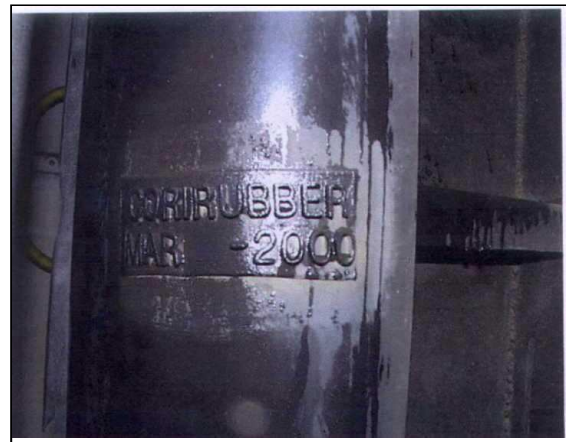
Figure 1.3

Embossed markings on rubber flange of another manufacturer
(more legible and away from rubbing surface)

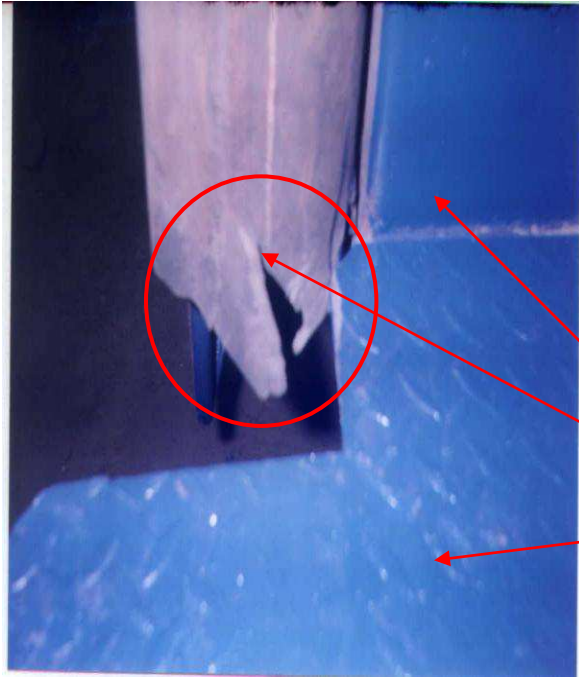
Figure - 1.5 Rubber flange torn by foot plate. and buffer to Drg. no. RDSO SKETCH -88050.

It is observed that the rubber flanges (see **Figure - 1.5**) to old drawings were cut or torn at bottom by buffer plungers and foot plate, whereas the rubber flanges of latest drawings RDSO sketch 99056 (see **Figure - 1.6**) are not cut by buffer plungers or foot plates.

At encircled area, it is seen clearly that the flange is fixed below the height of foot plate level.

Torn Lateral side flange with missing drainage channel

Drainage flange is detached and missing on the lateral flange

Old stock of rubber flanges can be modified as per the latest drawing.

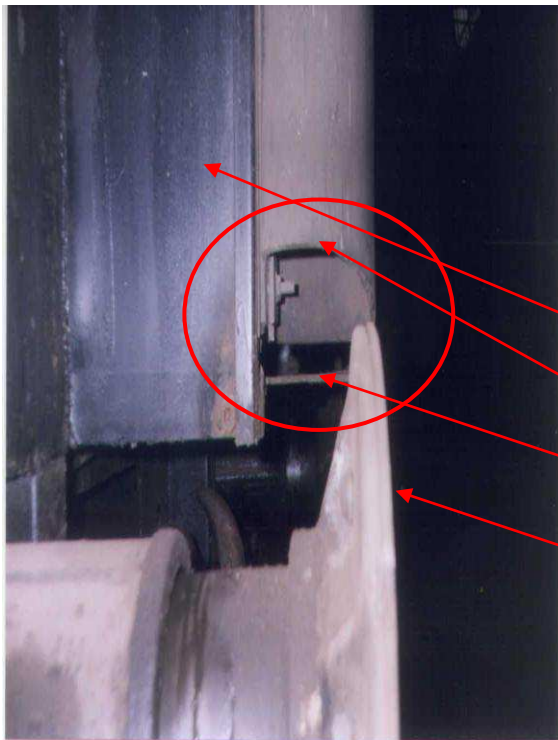
Figure - 1.6 Rubber flange clear of buffer and foot plate as per drg. no. RDSO SKETCH - 99056.

At encircled area, the lateral side flange is fixed above the buffer plunger and foot plate.

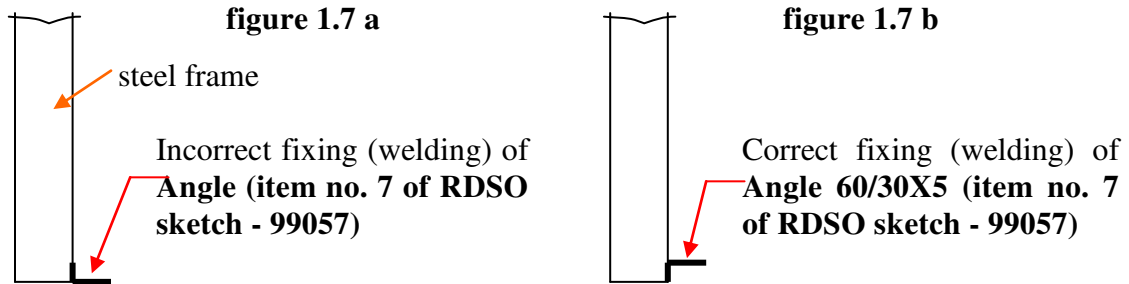
It is observed that in some of ICF coaches the Support bracket (angle) for foot plate are not fitted as per drawing. Due to this when a ICF coach is coupled with RCF coach in the rake /train, there is a gap of about 40 mm between the foot plates. During POH in such ICF coaches the support brackets should be replaced in correct position. (Ref. **Figure - 1.7a & b**)

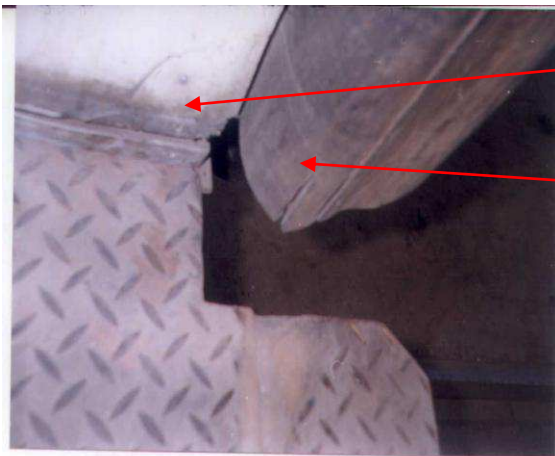
Figure - 2.1

- a) Steel frame bent out side
(Foot plate is not resting completely on support bracket)
- b) Torn flange at bottom.

- i) Check the steel frame for deformation and welding crack or corrosion. Deformed frame should be straightened by heating. (Ref. Figure - 2.1)

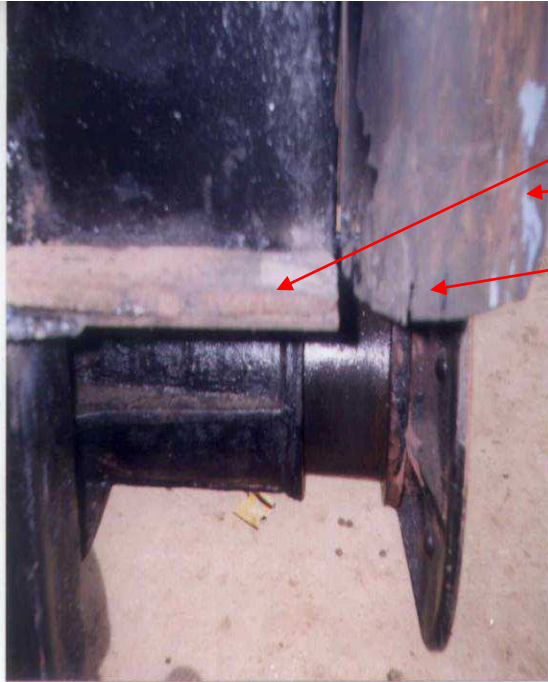
Figure - 2.2

- a) Support bracket (Angle) without rubber sheet.
- b) Worn out drainage channel
- c) Damaged rubber flange at bottom

- v) Refix the loose rubber seat 10X60X460 with neoprene adhesive Dunlop S 758 or Fevicol SR-998 on the support brackets. If the rubber seat is missing or perished, prepare new rubber seat 10X60X460 from condemned rubber vestibule and fix on support brackets with neoprene adhesive Dunlop S 758 or Fevicol SR-998.
- vi) After attending all the repairs apply two coats of anti-corrosive paint.

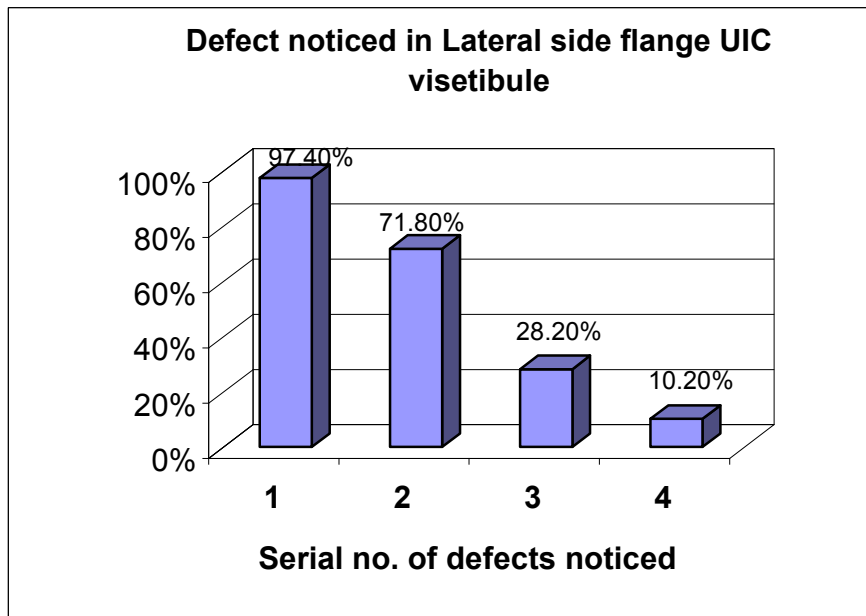
Figure - 2.3

Percentage of defects noticed in Lateral side flange				
Coaches inspected	Rubber drainage channel disjointed, worn, missing (1)	Rubber cracked at bottom (2)	Rubber worn, pitting, cracked at other areas (3)	Rubber perished (4)
39	38	28	11	4
	97.40%	71.70%	28.20%	10.20%

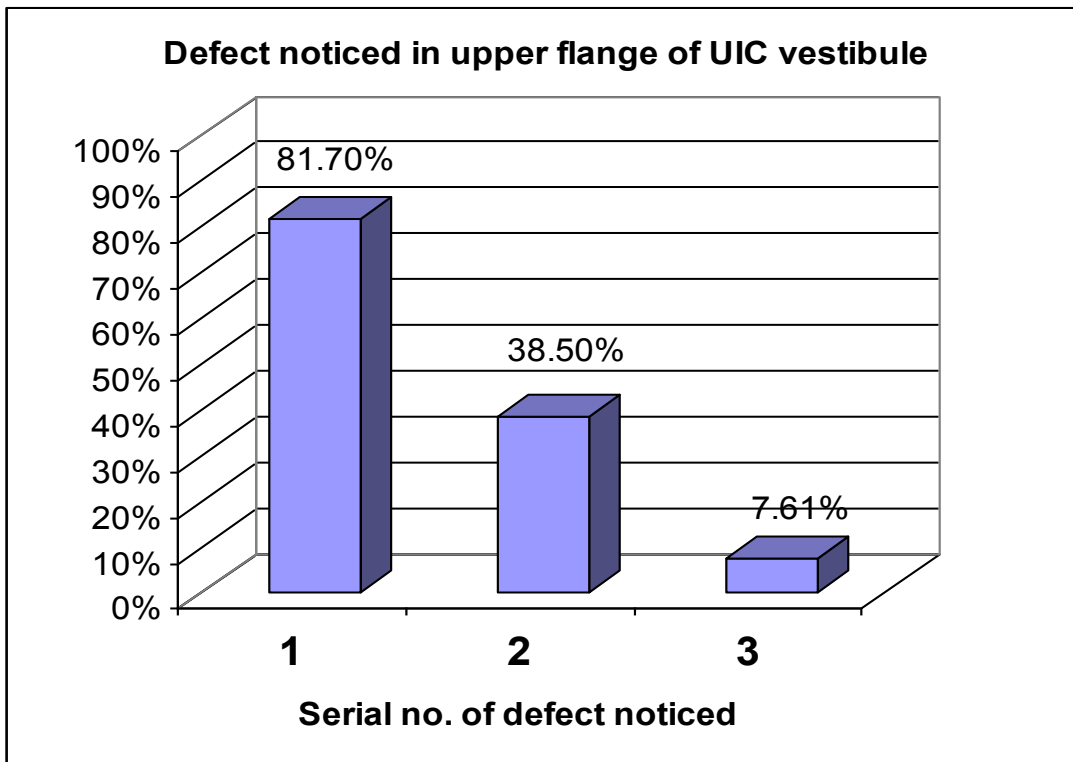
Figure - 2.4

Percentage of defects noticed in Upper flange			
Coaches inspected	Rubber drainage channel disjointed, worn, missing (1)	Rubber worn, pitting, cracked at other areas (2)	Rubber perished (3)
39	35	15	3
	81.70%	38.50%	7.61%

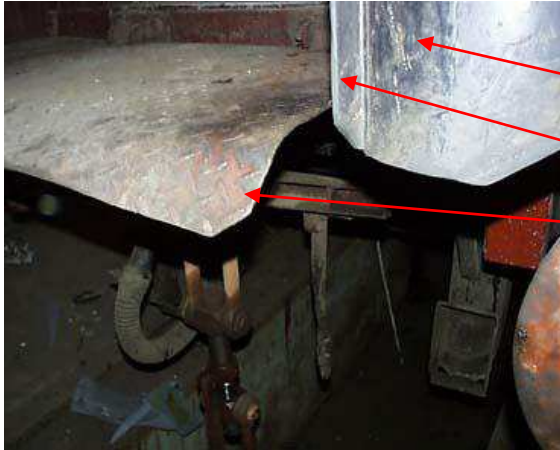
Figure - 2.5

- Worn lateral side flange
- Drainage channel is good condition
- Bent foot plate

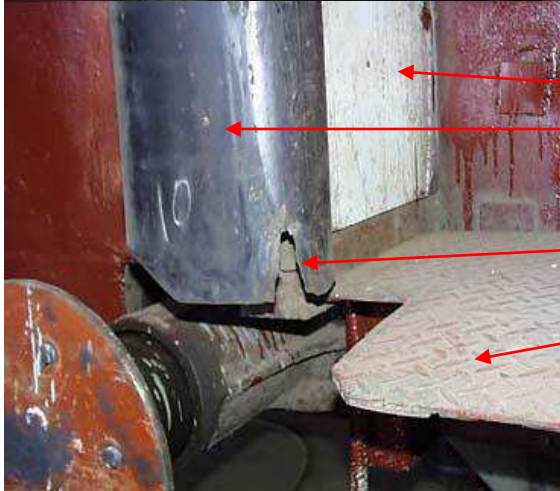
- LP sheet to be cleaned
- Drainage flange is missing from lateral flange
- Lateral flange cut at bottom
- New Foot plate

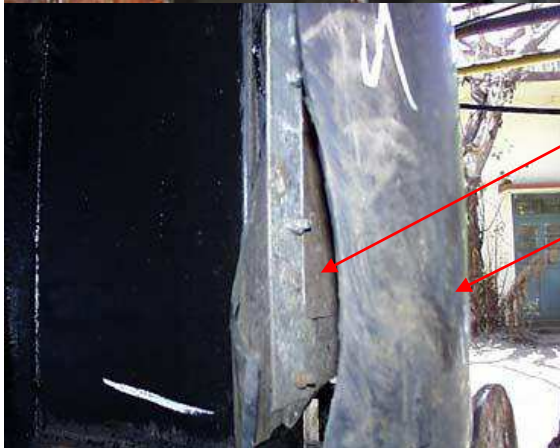
- Torn lateral flange
- Drainage channel is also missing

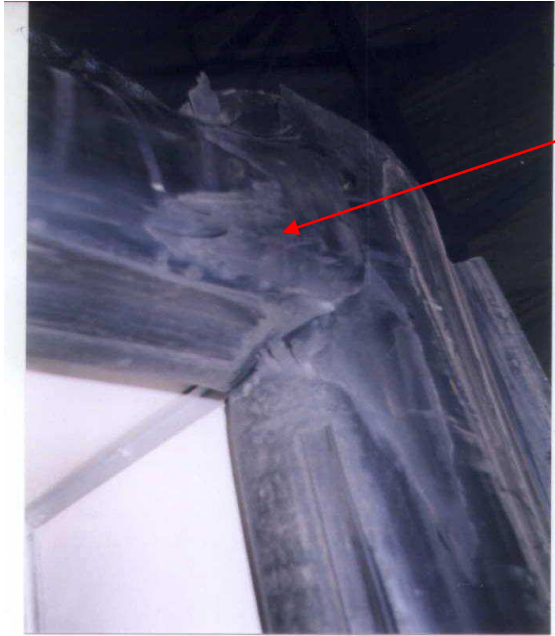
Figure - 2.6

a) Peeled rubber flange - defective rubber

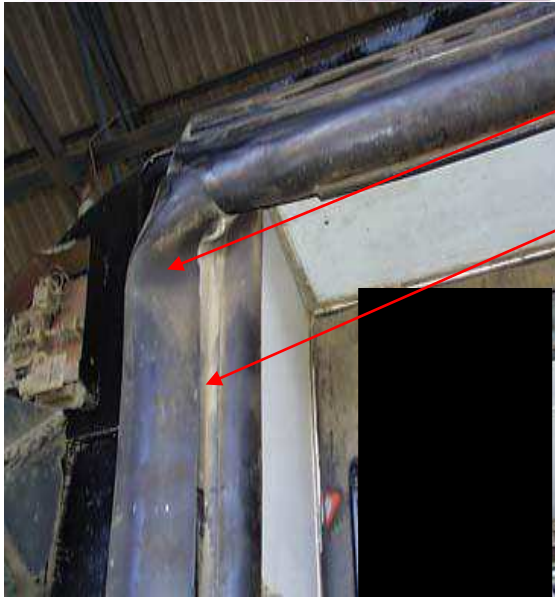
Compressed lateral side flange

Drainage channel in good condition

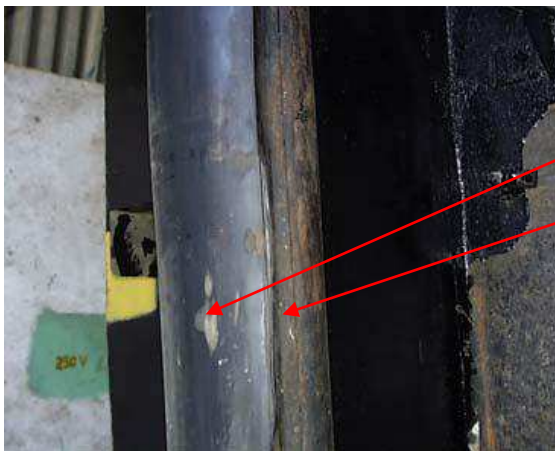
Worn out lateral flange

Worn out drainage channel

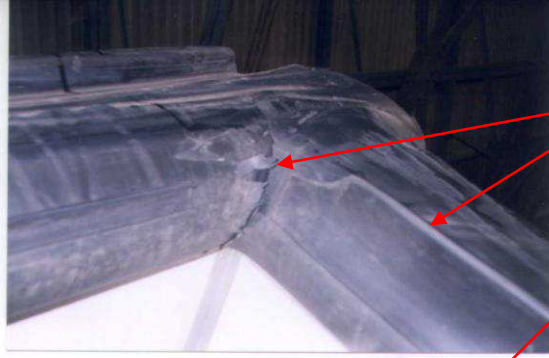
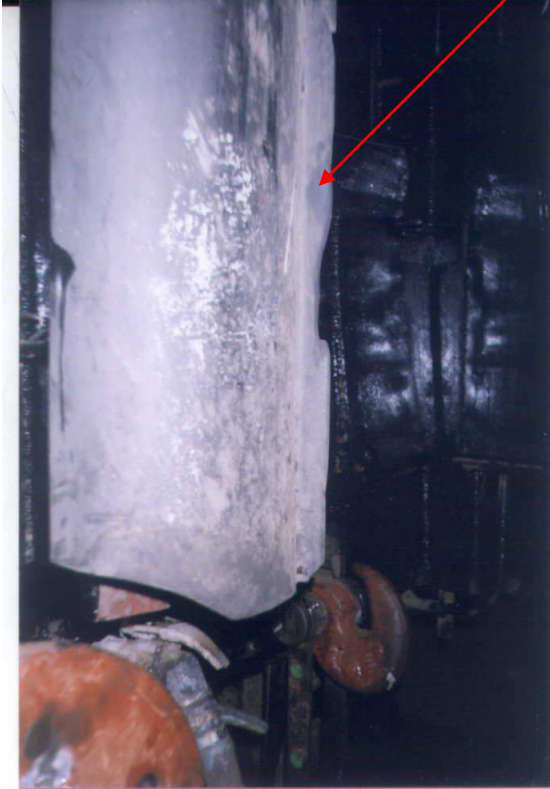
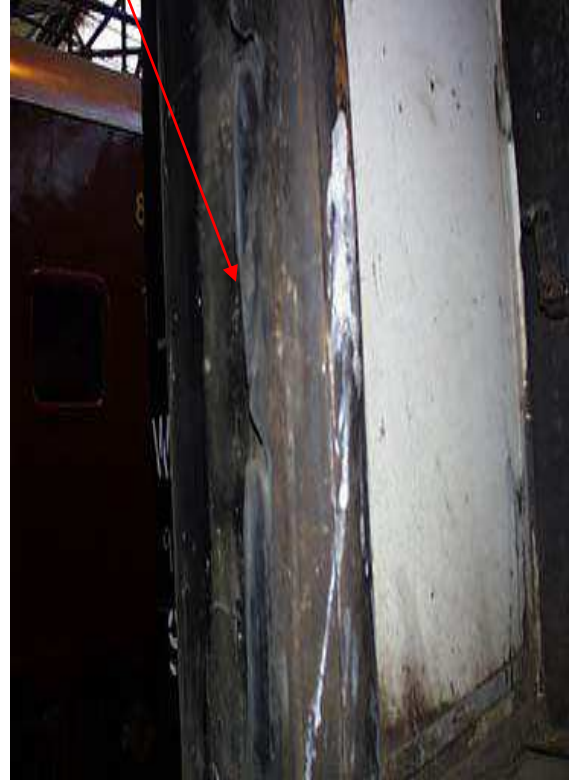
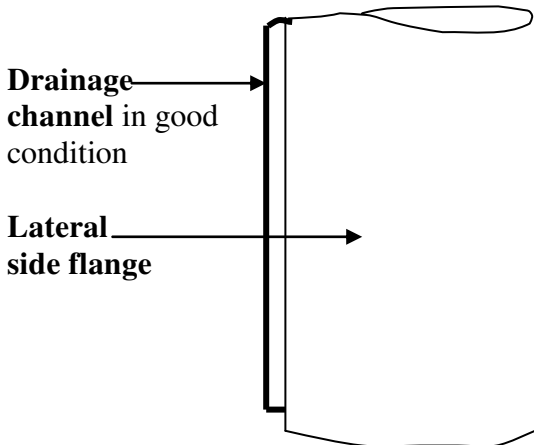
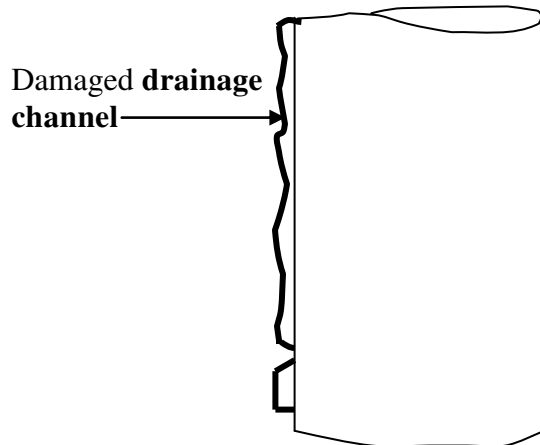
Figure - 2.7

- a) Peeled rubber flange - defective rubber
- b) Displaced drainage channel

Worn out drainage channel

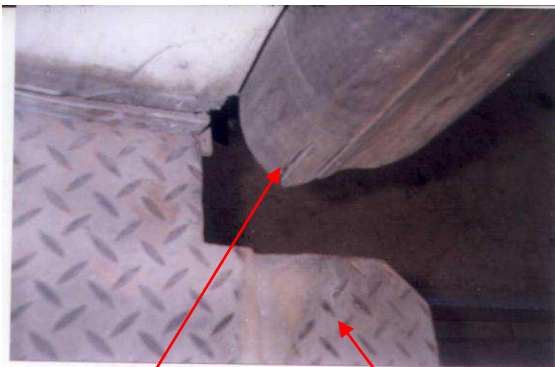
Figure - 2.8a
a) Torn flange

- iii) If the rubber flanges are found torn or cracked up to 300 mm the following repair method should be employed to prevent further propagation of the cut.

- Clean the torn or cracked spot/area on rubber flanges with an emery paper.
- Prepare a rubber patch from the condemned UIC vestibule according to size of the damage spot/area.
- Apply rubber solution ("Dunlop S-758 or Fevicol SR-998) on the cleaned surfaces. Do not allow the adhesive to form small deposits. These will trap solvent and cause pockets during adhesion.
- Allow the solution to become touch dry before fixing together.
- Fix the rubber patch on the damaged spot/area using back support and wooden mallet to prevent entrapment of air between mating surfaces. Allow complete dry before use.

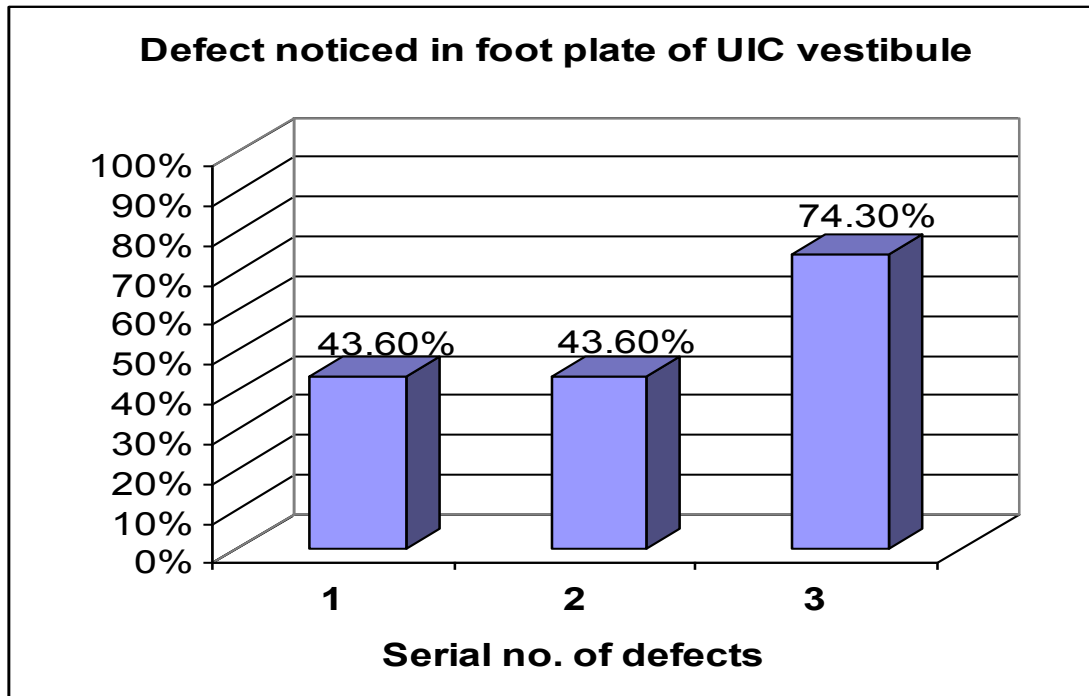
Figure - 2.9

Percentage of defects noticed in Foot plate			
Coaches inspected	Foot plate bend (1)	Wearing piece worn, missing (2)	Rubber packing missing (3)
39	17 coaches	17 coaches	29 coaches
	43.60%	43.60%	74.30%
