Real Estate Inspection, Inc
2705 Carleton Avenue
Reading, PA 23309
332-555-2461 332-555-6818 Fax

PROPERTY INSPECTION REPORT

Concerning: 2108 North 77th St, Millwood, PA 23884
(Address or Other Identification of Inspected Property)

By: Joe Inspector December 22, 2005
(Name of Inspector) (Date)

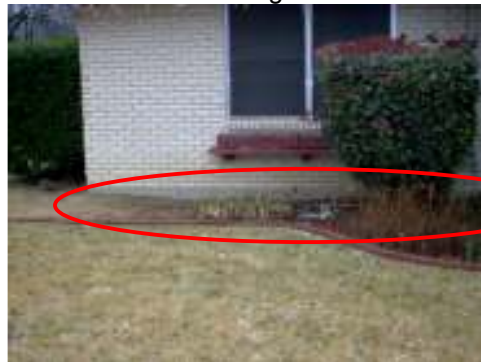
- Exterior: Area around patio in rear of house appears to be capable of pooling water. Though drainage appears to be sufficient on the day of the inspection, this location should be monitored and grading lowered to achieve flow away from the house.
- Exterior: Poor drainage on the front left side of the house. Water will pool here.

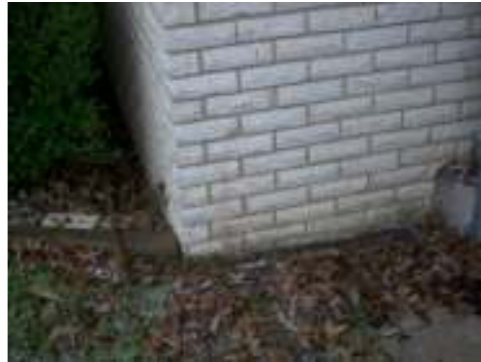
- Exterior: The soil line is high on the back side of the garage, conducive to termites.

Soil should be a minimum of 4" below foundation all around house to prevent water intrusion and insect infestation.

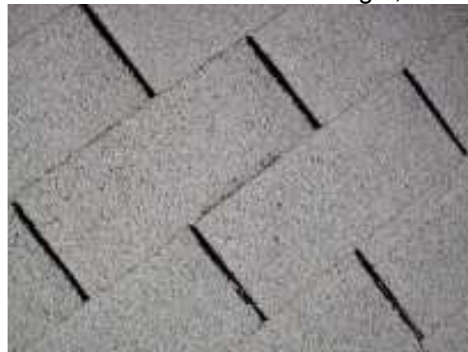
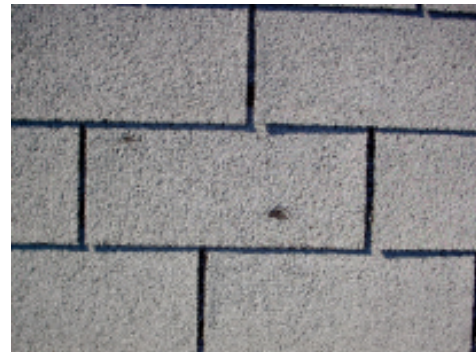
- Roof: Roof slope over front porch is too shallow for the covering materials used. No leaks apparent presently, but Inspector recommends monitoring this area periodically for leaks.
- Roof: Fasteners (nail heads) are exposed in several locations.
- Roof: Shingles are scuffed and/or damaged in several locations. Though damage is not extensive, Client should recognize that any damage decreases the effectiveness of the shingle, and shortens the life of the roof.

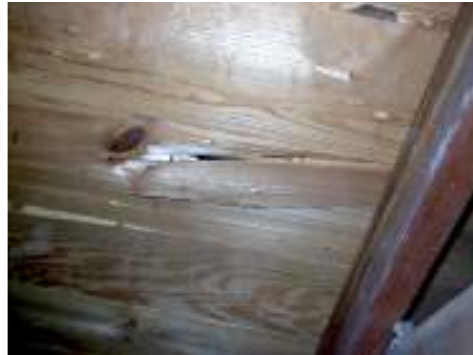
- Attic: Insulation has been torn away from duct above Kitchen ceiling.
- Attic: Observed broken decking board. See photo. No leaks observed at this location.

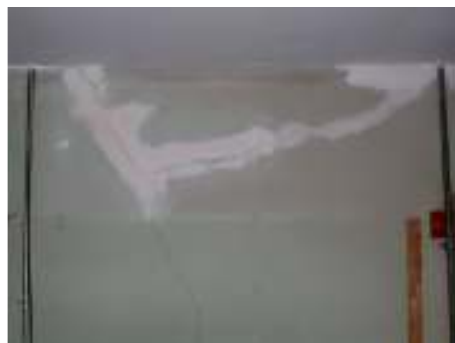
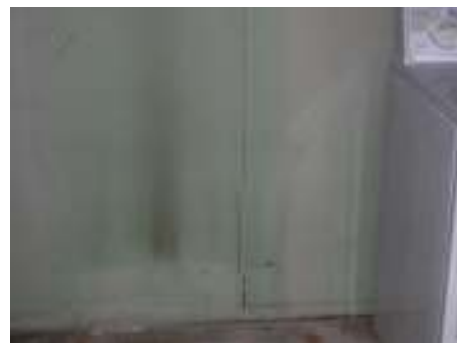
- Exterior: Observed stress cracks in brick and mortar at several locations (e.g., below and to the right of Dining Room window).
- Dining Room: Stress crack under window, roughly corresponds with location of crack in brick outside.
- Right Rear Bedroom: Drywall cracks are present in closet and above rear window.
- Garage: Drywall cracks are present on back wall and ceiling.

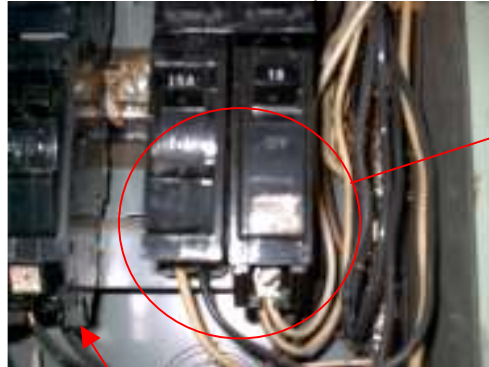
- Garage: Could not locate/confirm the presence of a grounding electrode for the electrical panel.
- Garage: Two 15-amp breaker(s) in lower right position are double fed. Recommend electrical specialist to evaluate and repair as needed.

These 2 breakers are not designed for two wire usage. Only one screw is present on each breaker. Recommend electrical specialist to evaluate and repair as needed.

These breakers are designed to allow two wire connections. Two screws are present on each breaker

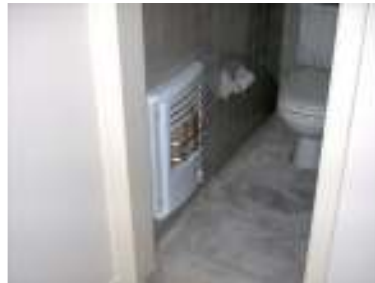
- Interior: The gas supply flex line is entering the furnace housing. Should be hard-metal pipe as it enters the furnace cabinet, in order to prevent rubbing and abrasion.
- Master Bathroom: Open-face (ventless) gas heater in use at this location.

Though these were in wide use when this house was built, current standards recognize inherent dangers from open flame, improper ventilation and carbon monoxide by-product. Inspector highly recommends removal of this unit and proper termination of the gas line BY A LICENSED PLUMBING SPECIALIST.
