# Mold Inspection Report (Initial Assessment)

**Inspection Date: Initial - October 6, 2009**

**Inspection Performed By: Richard Morse**

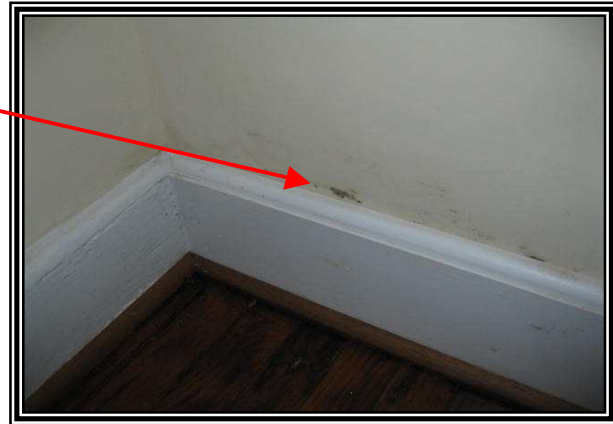
### Main Level Living Room -

Signs of mold was noted on the wall forward of the spiral staircase. Water is entering into the structure due to a leaking / filled gutter. Water overflows the gutter and enters into the wall cavity. It is first recommended that the gutters be cleaned to allow for proper water flow. It is also recommended that the mold be removed from the structure. To properly remove the mold, removal of the trim and sheet-rock will also be required.

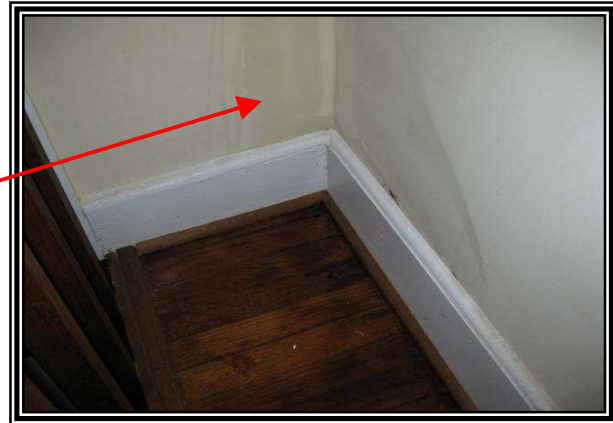
The same area as above, but the water stain is visible.

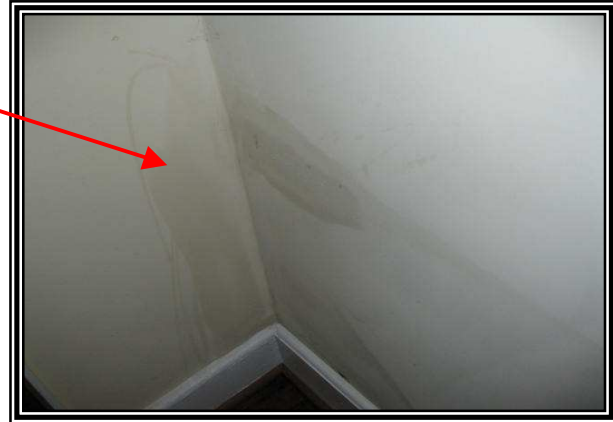
### Main Level Living Room -

The same area as above, but the water stain is visible.

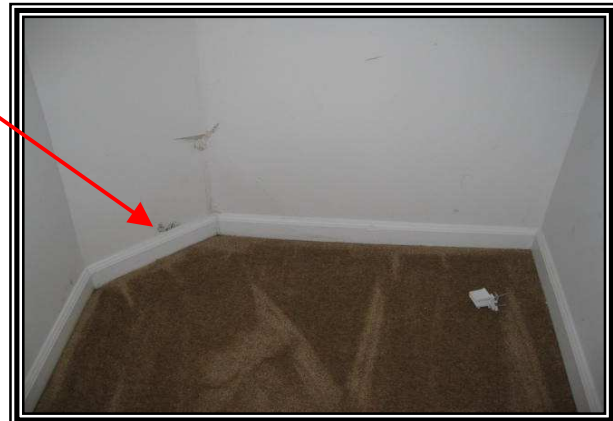
### Lower level, right hand Bedroom Closet -

The presence of mold was noted on the forward sheet-rock wall.

Removal and replacement of the affected materials will be required.

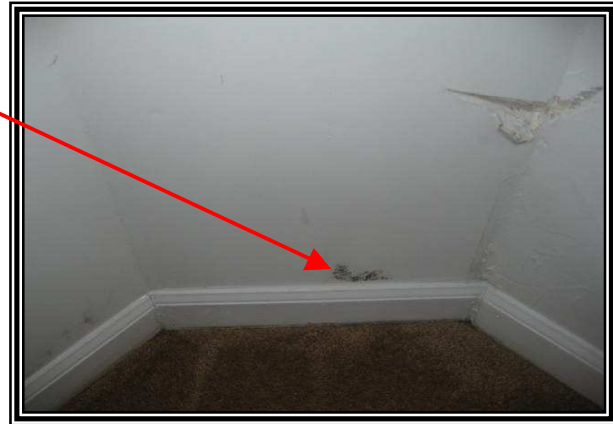
Lower level, right hand Bedroom -

The presence of mold was noted on the rear sheet-rock wall.

Removal and replacement of the affected materials will be required.

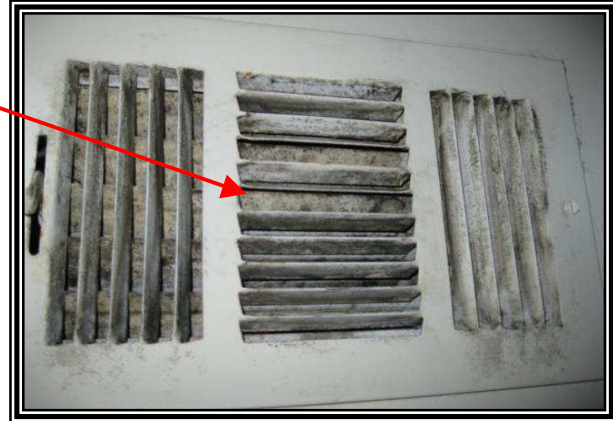
Lower level, right hand Bedroom -

Mold was noted on all of the HVAC vent covers. This being the case, it is highly recommended that the vent covers be cleaned or replaced and that the vent piping be cleaned.

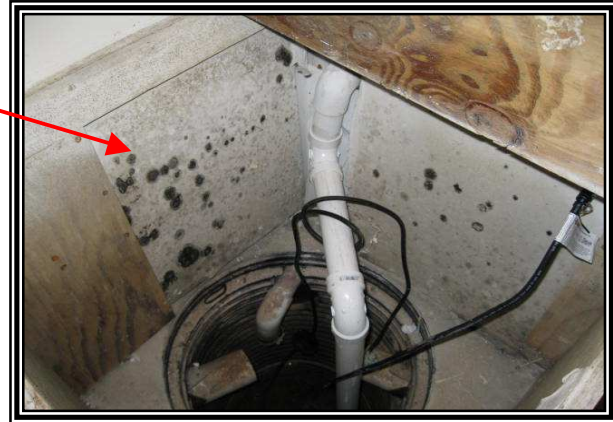
Lower level, left hand Bedroom Closet -

The sump pump well. Note the presence of mold on the sheet-rock walls. This affected material will require removal and replacement. It is also recommended that the sump have a cover installed to help prevent the moisture from evaporating into the living space. The cover will also help to lower the humidity level on the lower level.

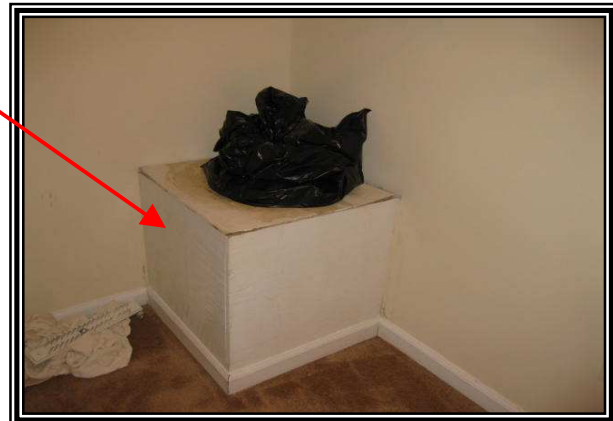
The sheet-rock sump pump cover.

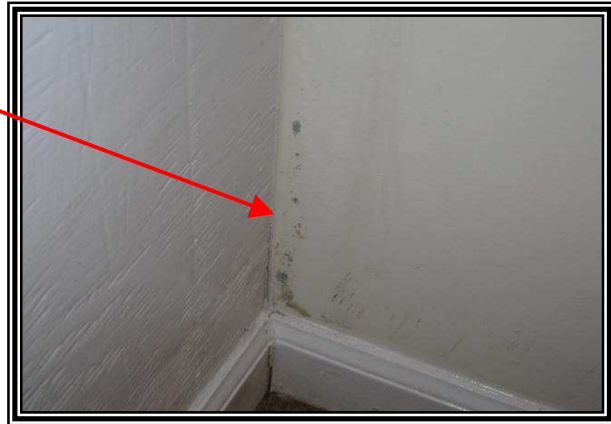
Lower level, left hand Bedroom Closet -

The presence of mold was noted on the sheet-rock wall to the right of the sump cover.

Removal and replacement of the affected materials will be required.

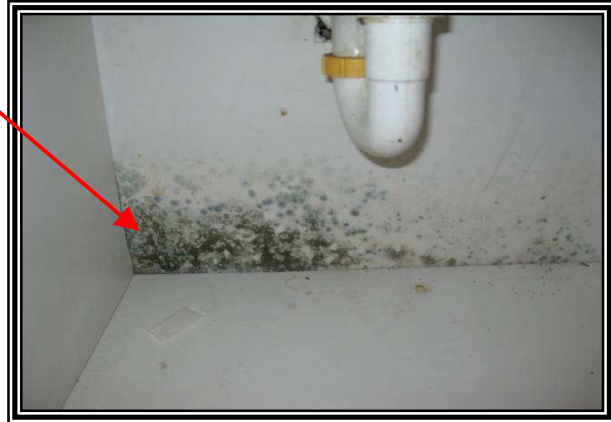
Lower level, left hand Bathroom -

The presence of mold was noted on the sheet-rock wall under the sink vanity.

Removal and replacement of the affected materials will be required.

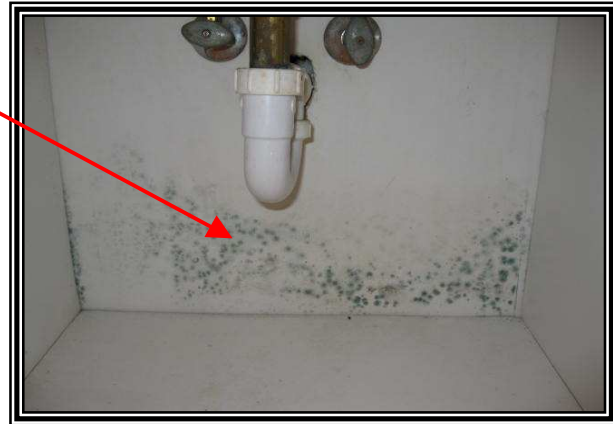
Lower level, right hand Bathroom -

The presence of mold was noted on the sheet-rock wall under the sink vanity.

Removal and replacement of the affected materials will be required.

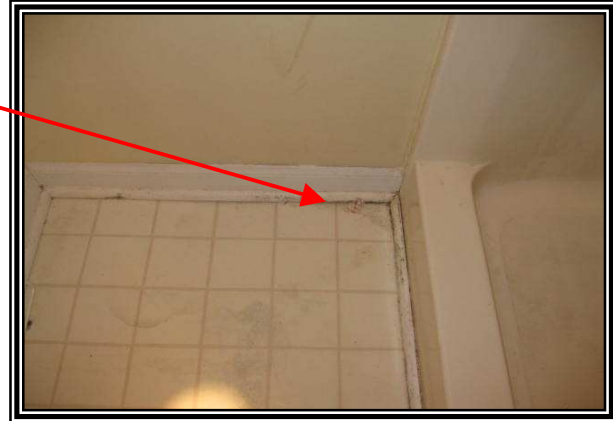
Lower level, right hand Bathroom -

The vinyl floor covering in the bathroom was also noted to be stained, indicating that water had come on contact with the floor. Water may have come from either the shower enclosure or from the forward portion of the structure. The actual source of the water could not be determined.

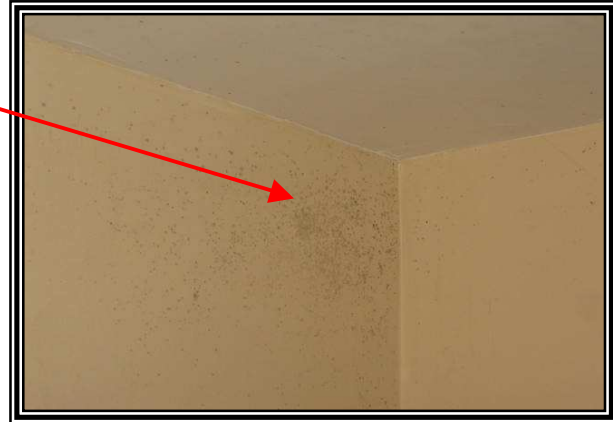
Lower level, right hand Bathroom -

The presence of mold was noted on the sheet-rock wall above the shower enclosure.

Proper cleaning of the affected materials will be required.

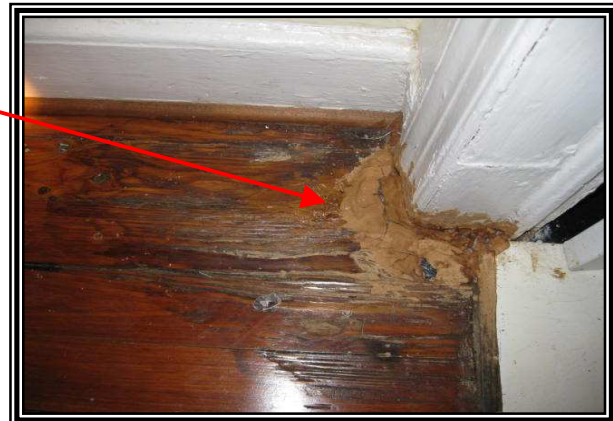
Main level, far left hand Bedroom -

A fungus was noted to be growing on the wood trim and flooring at the right hand rear corner of the bedroom, in the Kitchen entry-way. The wood flooring to the left of the fungus was noted to be damaged. It is recommended that the fungus be properly removed from the structure.

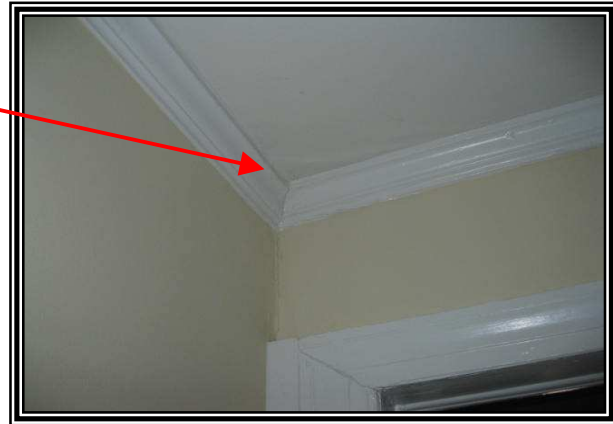
Main level, far left hand Bedroom -

Water stains were noted on the ceiling and wall just above the fungal growth. It appears that a water leak is present and requires repair to prevent further damage.

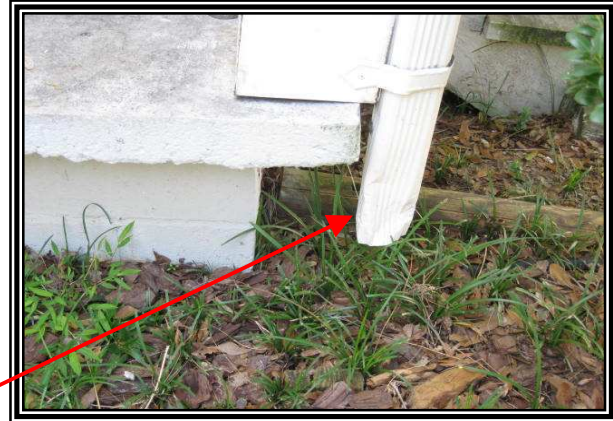
Exterior -

To help properly divert rain water away from the structure and foundation, it is recommended that extensions be installed at the end of the downspouts. The extensions will help to prevent earth erosion around the perimeter of the structure.

This is located at the right hand front corner of the structure.

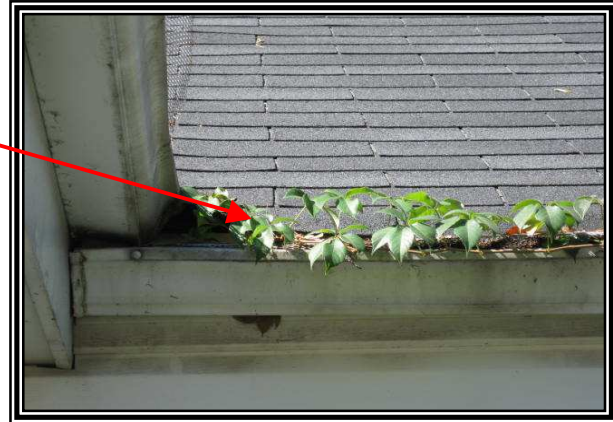
Exterior -

The gutters were found to be filled with leaves/debris and require cleaning to prevent overfilling. If the gutters are filled with leaves and debris, rain water can overflow the gutters due to poor drainage and spill into the soffit, which in turn could cause water staining and damage.

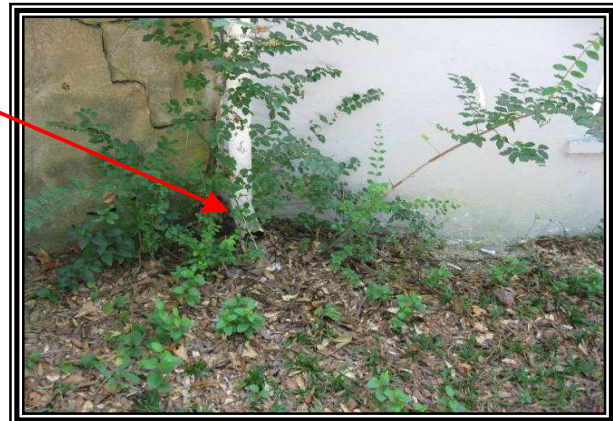
Exterior -

The gutter downspout that is located at the right hand rear corner of the structure. To properly divert water away from the structure, it is recommended that an extension be installed.

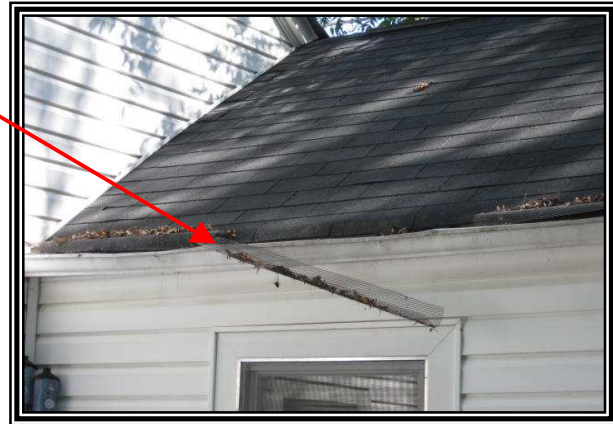
Exterior -

The structure was noted to have gutter screens installed. Several of the screens were noted be loose and damaged. It is recommended that the screen type of gutter guard be replaced with the solid sheet-metal type to prevent re-occurring damage and to prevent leaves from becoming stuck along the upper edge.

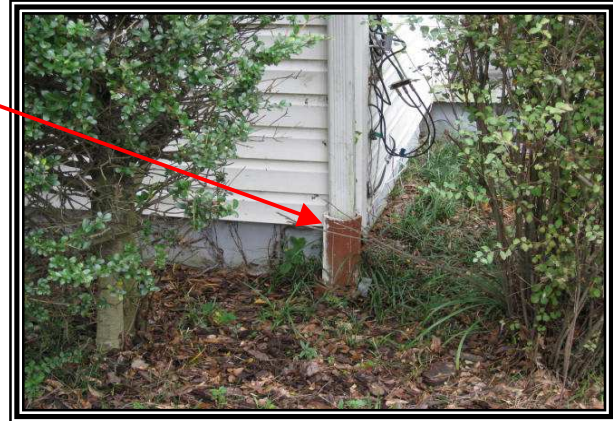
Exterior -

The front gutter downspouts are connected into the old, original clay-pipe extensions. It could not be determined if they operate properly. It is possible, due to their age and construction, that they leak. This could one of the water sources that allows for moisture to enter into the structure. The foundation is constructed of block and can allow for moisture to enter. Block is porous and can allow for moisture to enter if water is in contact with it.

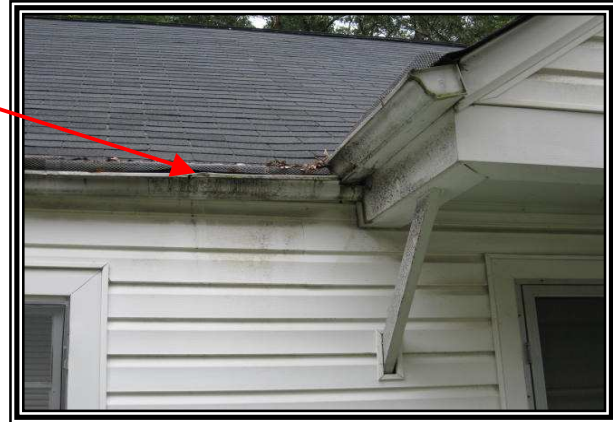
Exterior -

The gutter section that is located to the left of the front entry door. The water stain and mold in the Living Room is located directly below this area. Clearing the gutter is required to allow for proper water flow away from the structure.

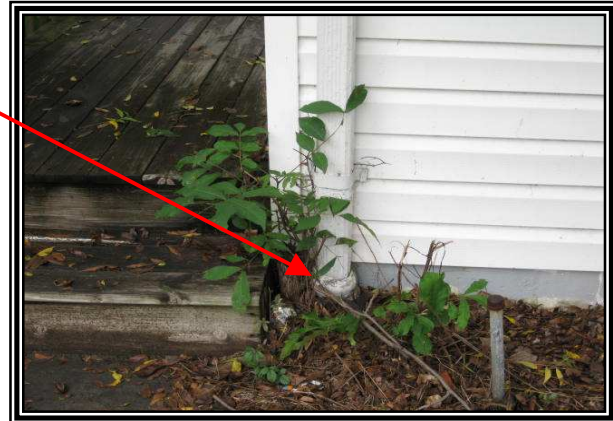
Exterior -

The left hand front gutter downspout. Note that this is also connected to an older clay-pipe extension. It is recommended that new plastic extensions be installed to ensure that water does not leak from the pipes.

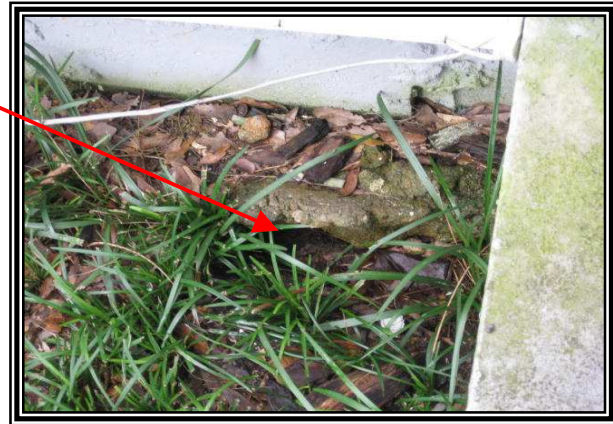
Exterior -

A void was noted under the concrete porch that is located at the right hand side of the structure. This is located next to a gutter downspout that is not connected to an extension. An extension is recommended to properly divert water away from the structure.

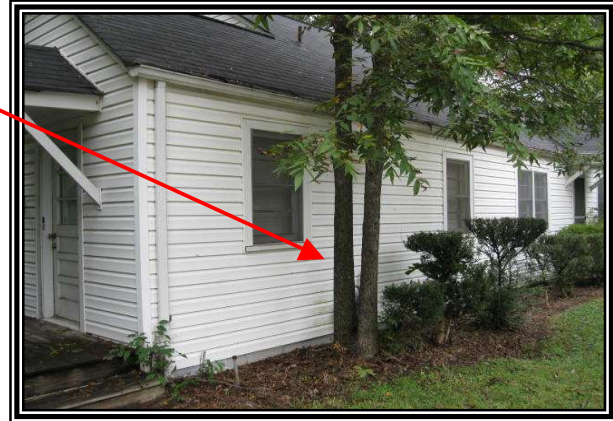
Exterior -

The left hand front corner of the structure. It is recommended that this tree be removed to help prevent it from damaging the block foundation, which could allow for water entry.
