Home Inspection Report

12345 New House St, New Home, MN 55000

KP Home Inspections LLC

1000001

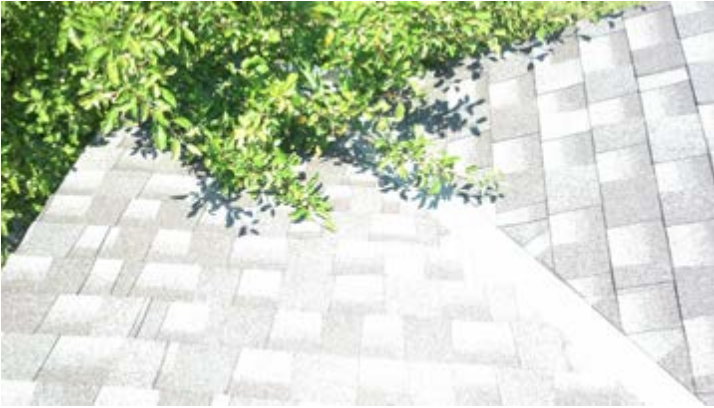
Trim back trees and shrubs away from home.

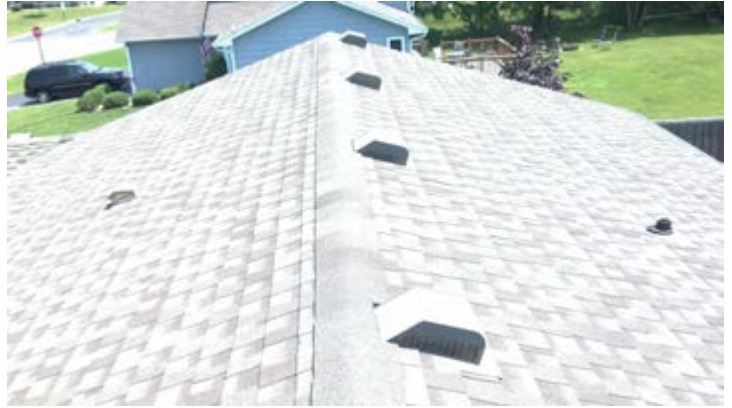
Recommend additional ventilation. Plumbing stacks do not extend far enough above roofline- recommend repair as necessary. Plumbing stack boots are not properly sealing around plumbing stacks making them vulnerable to exterior conditions- Recommend repair as necessary.

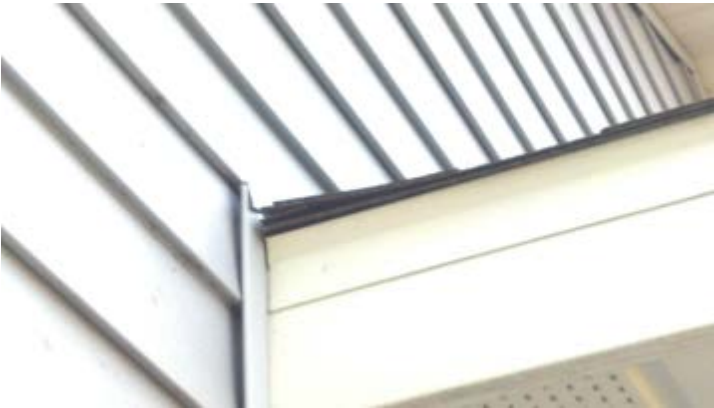
"Kick out" flashing should be at the bottom of all exterior roof to wall intersections to help divert water from entering behind siding.

Comments Kick-out flashing is recommended at roof to wall intersections

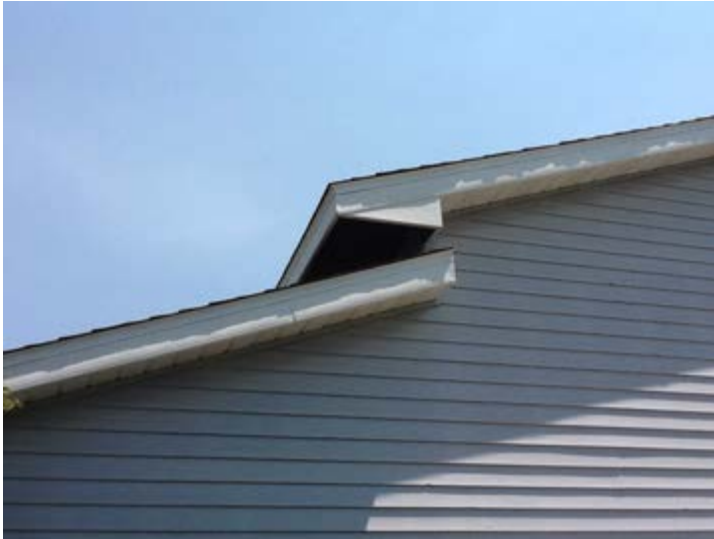
The soffit on above the North roof is missing, Recommend repair as necessary.

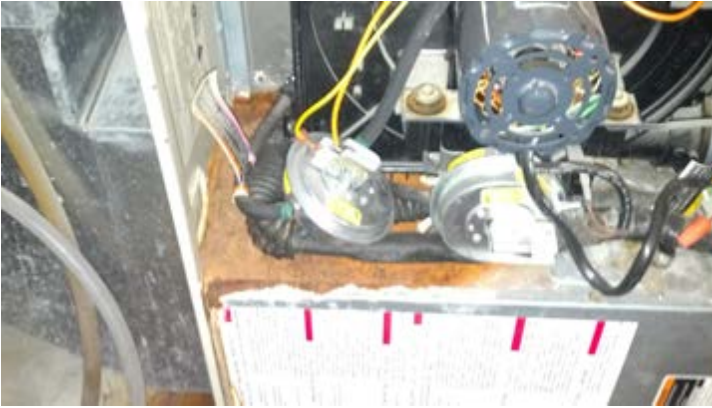
Heat pump N/A Supplemental electric Supplemental gas
Sub-slab ducts N/A Satisfactory Marginal Poor Water/Sand Observed: Yes No
#1 - System condition Satisfactory Marginal Poor Recommended HVAC technician examine
Comments Unit has excessive rust- recommend further monitoring

Furnace has significant rusting on the interior frame. Appears to be from a previous condensate line leak.
