## PROPERTY INSPECTION REPORT # Sample

**Concerning:** 258 Sample Drive, Your City, Texas 00000

**By:** Mark Lyle Brown - TREC License # 9762

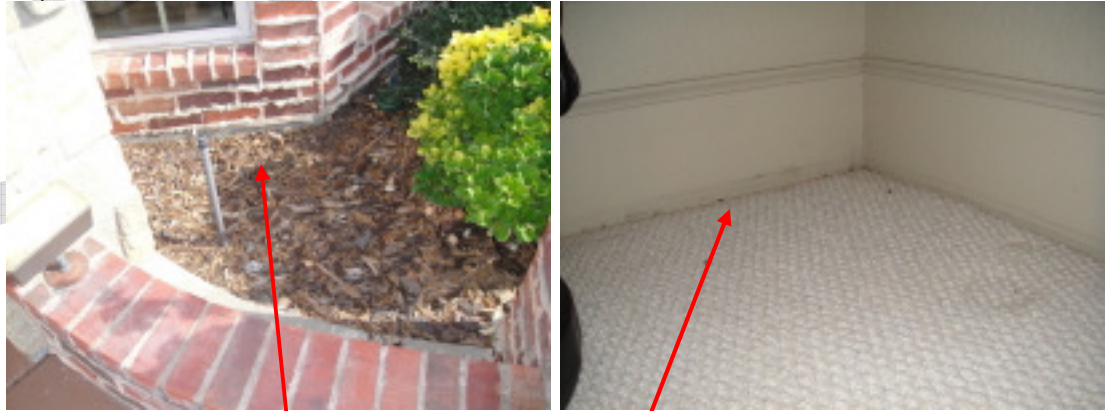
**The shrubbery bed to the right of the front entrance has high soil. Also, the drains appear to have been block by debris during heavy rains causing water to seep through the wall staining the baseboard in the office. Recommend adding a 'scupper' like drain / overflow that is lower than the bottom brick line that would allow water to escape the shrubbery bed should the existing in-ground drains stop up with 'floating wood mulch chips'.**

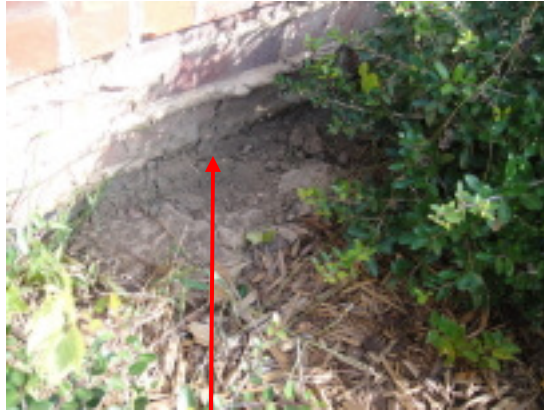
Some of the soil in the front shrubbery / flower beds is a little high.

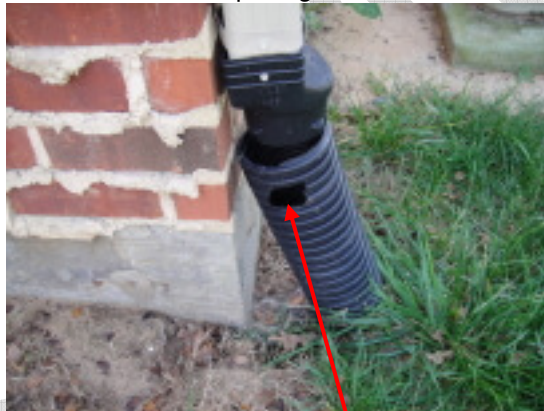
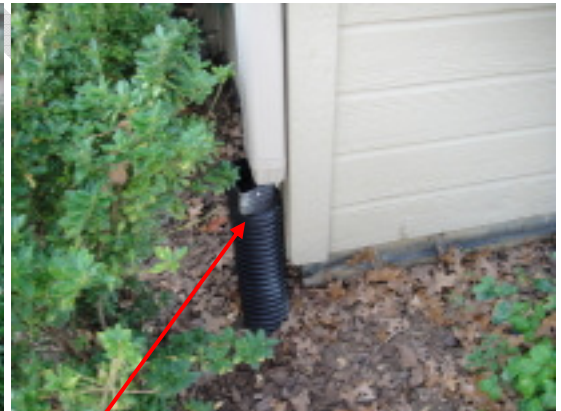
Some of the gutter downspouts have pulled loose from the underground drain pipes

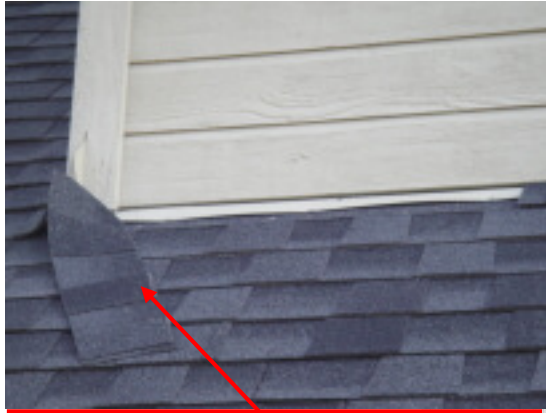
**Shingles blowing off on the west side of the home.**

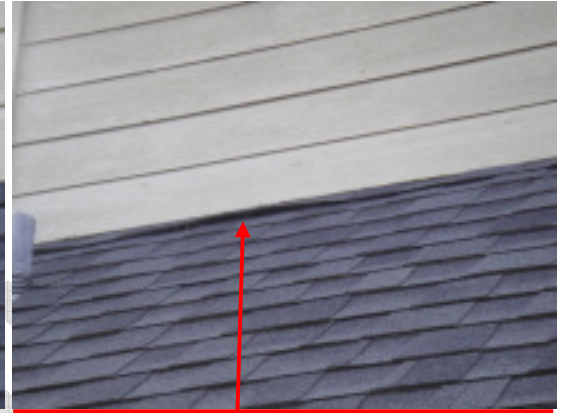
**Shingles not secured down properly on the north side of the home.**

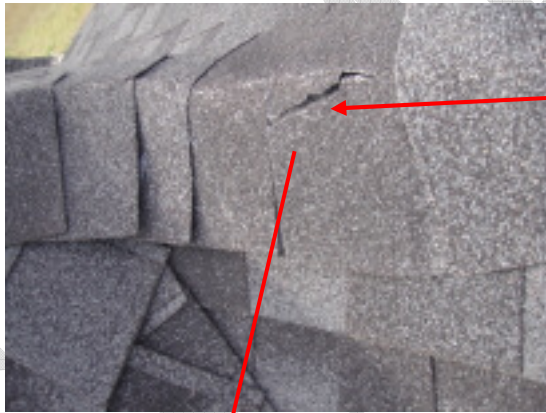
**This torn ridge shingle is allowing water to seep into the structure above the garage-to-home entrance door. The ceiling and walls have water damage. See wall**

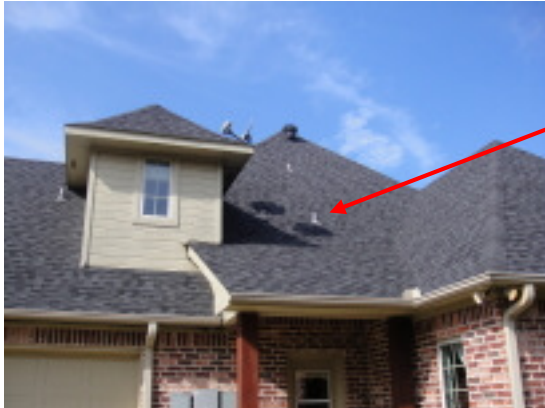
An old satellite dish was mounted here and then removed. The old cables are still protruding from under the shingles. **The cables at a minimum should be removed and proper repairs made to seal out moisture.**

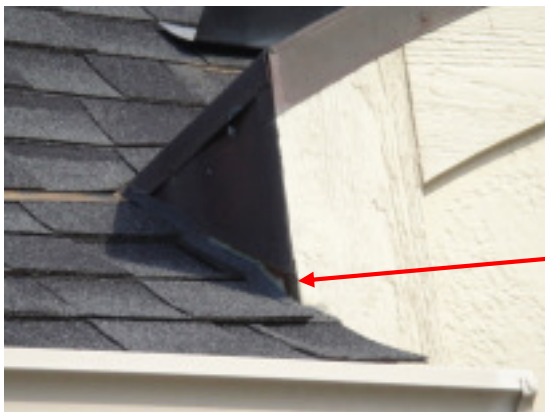
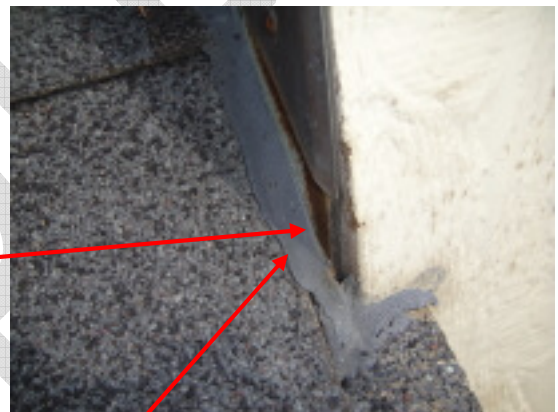
**This flashing above the south breakfast dining window is not sealed properly. Water is entering at this location as well as the outside window trim, and causing water damage on the interior window frame, sill, and baseboard / wall.**

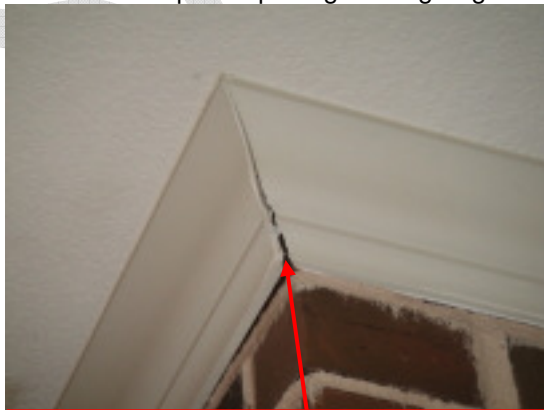
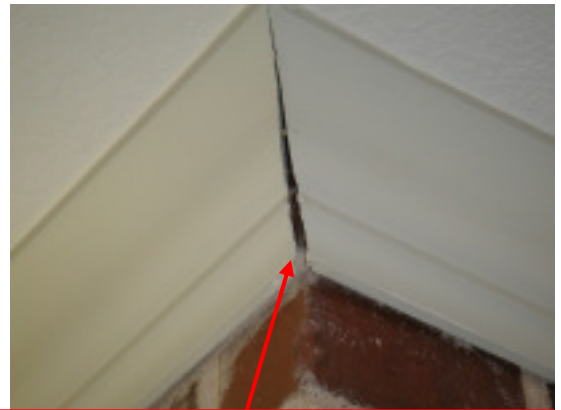
Some of the cove molding is separating in the kitchen ceiling. This trim separation is located around the brick columns on either side of the kitchen Cooktop. There is also some separation between the wall and the brick column. See photo below also.

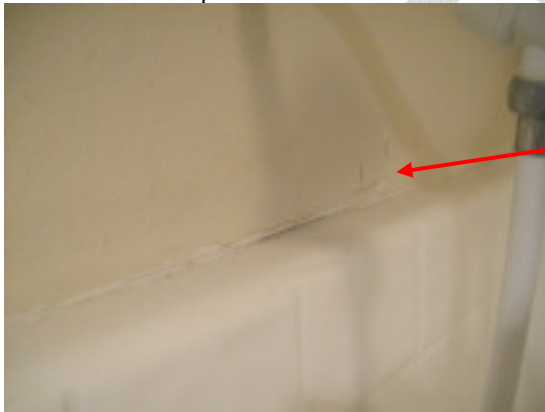
The wall above the upstairs southeast bath bathtub has some minor water damage / paint peel.

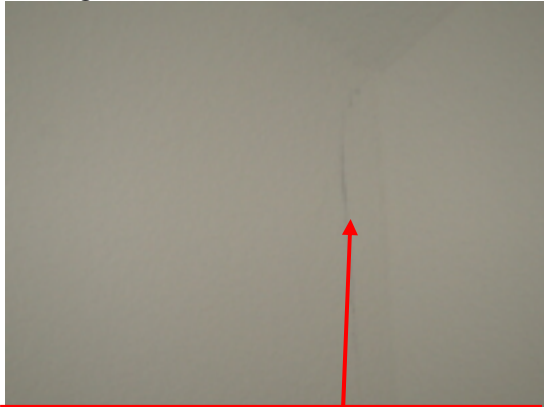
This crack is located in the ceiling of the breakfast dining area. This is a vaulted ceiling at this location. The indications are small enough that a coat of paint may seal. (These indications are common where a combination rafter / ceiling joist exists.)

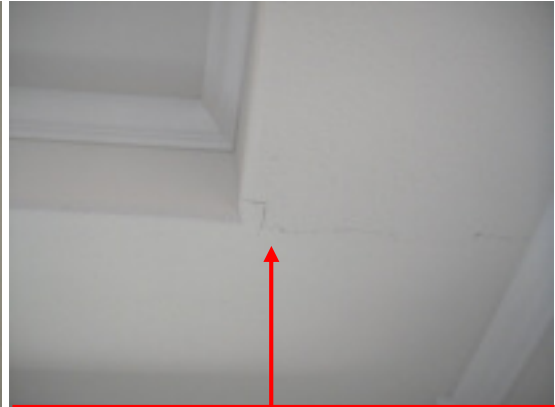
This crack is located in the master bedroom at the recessed ceiling area. This end of the home is located over 'backfill' and is a little more prone to movement. The geometry of a recessed ceiling tends to be more prone to cracking. (Ceiling joist that span the entire length of a ceiling tend to be more stable than designs that require intersecting members.)

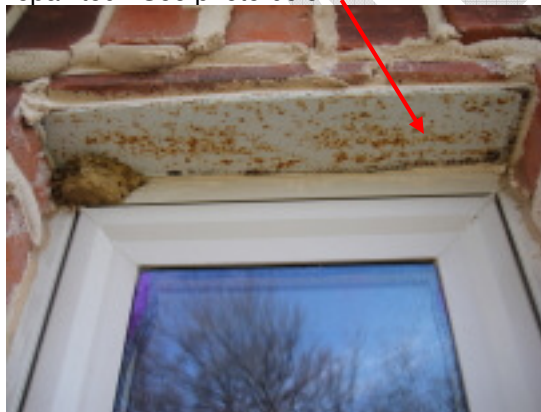
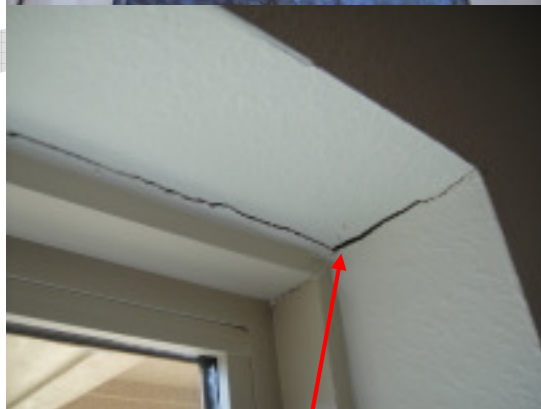
Movement cracks in the master bedroom south window.

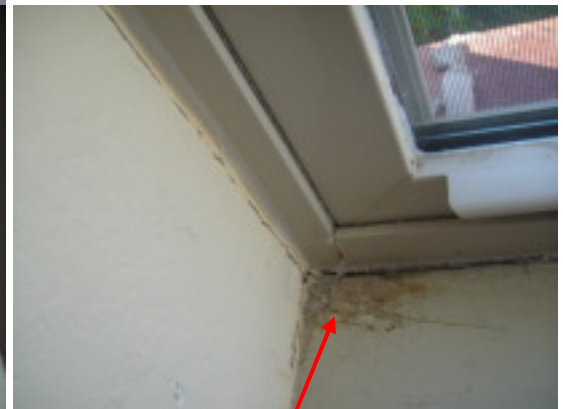
Water stain on window sill in upstairs south bedroom.

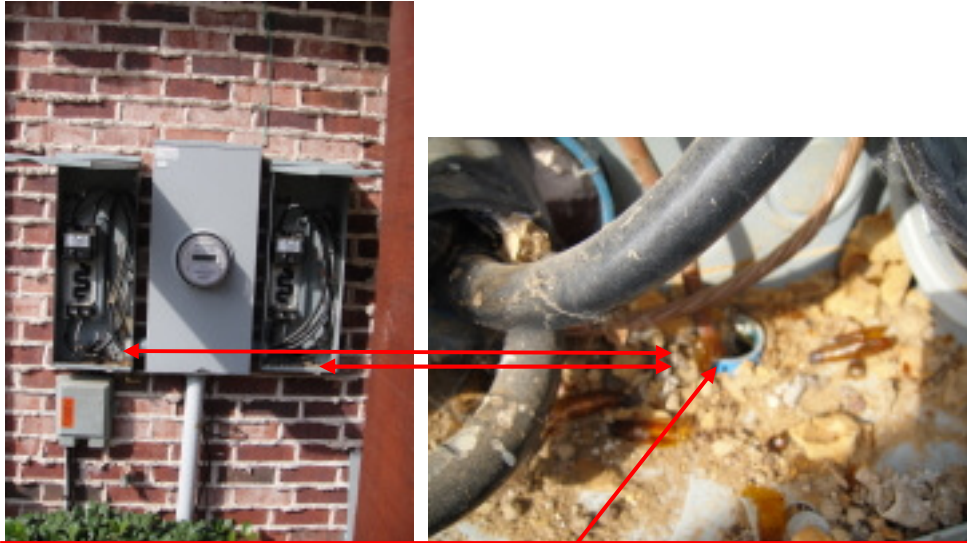
These panels are wired perfect. **The only issue is that there were a lot of large dirt dobber wasp nests inside the panels. These can create electrical shorts. The wasps are entering through the hole in the bottom of the panel where the equipment ground wires enter. These holes need to be sealed to prevent re-entry.**

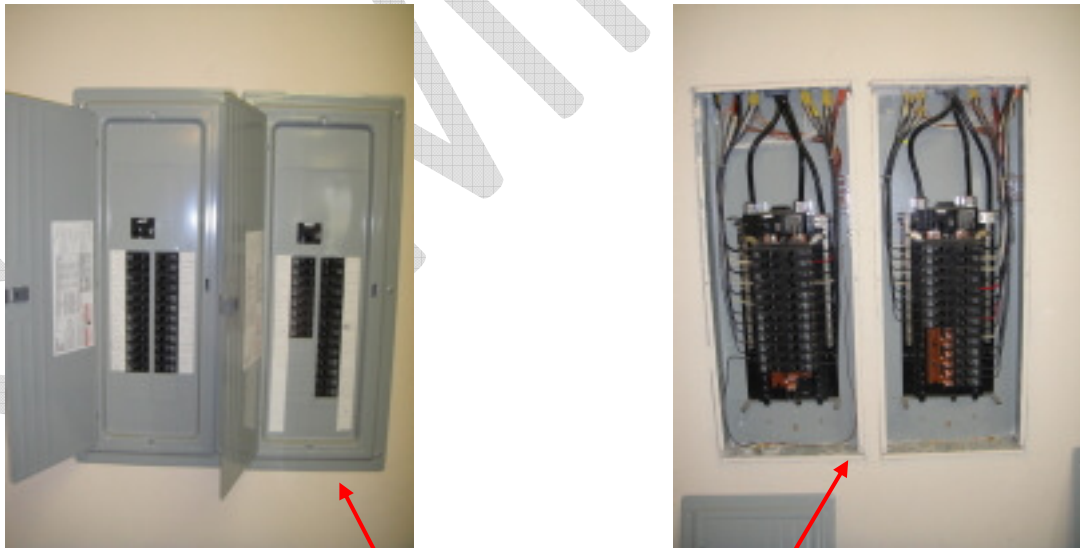
These sub-panels in the garage are wired perfectly. **One breaker was not labeled.**

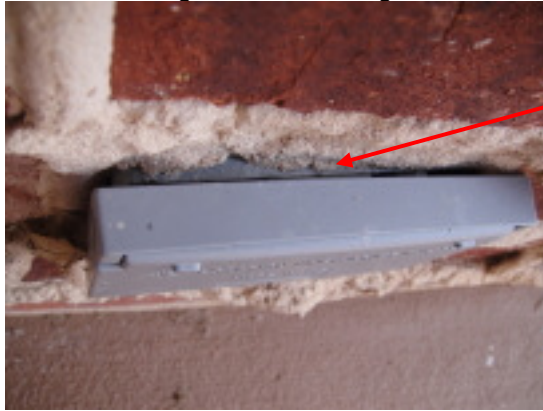
The receptacle on the front porch needs to be caulked on top of the box to prevent water entry onto the connections and into the wall.

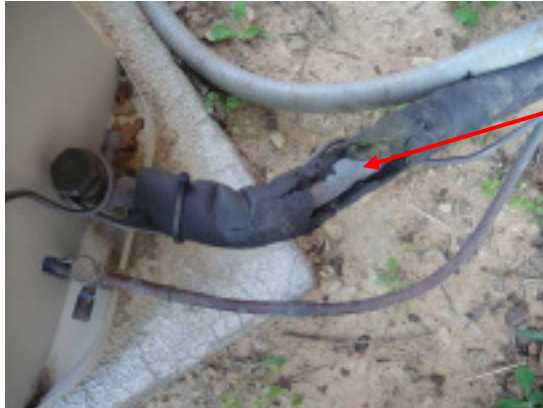
A few inches of insulation on the large outside condenser 'cool' line needs to be re-insulated to prevent energy loss.

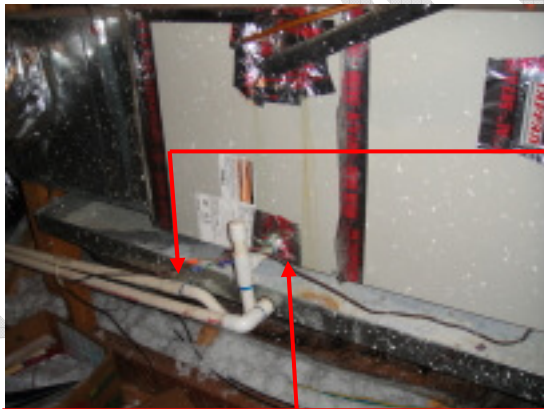
The secondary drain plug is still capped off. A secondary drain should be installed into the pan below.

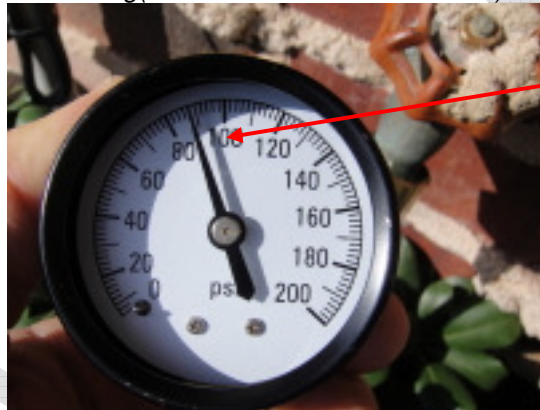
Gauge is 10 PSI off... your water pressure is 75 PSI.

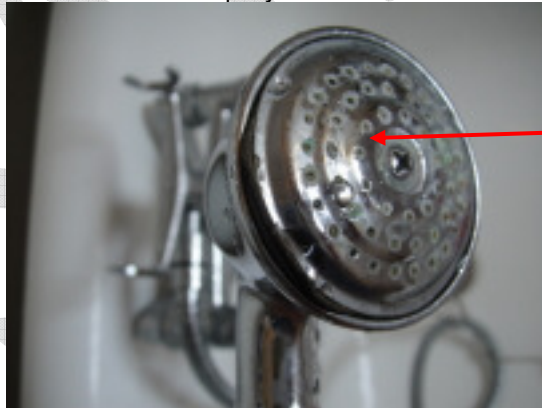
The master bath bathtub shower wand does not shut off completely and the head is stopped up with minerals.

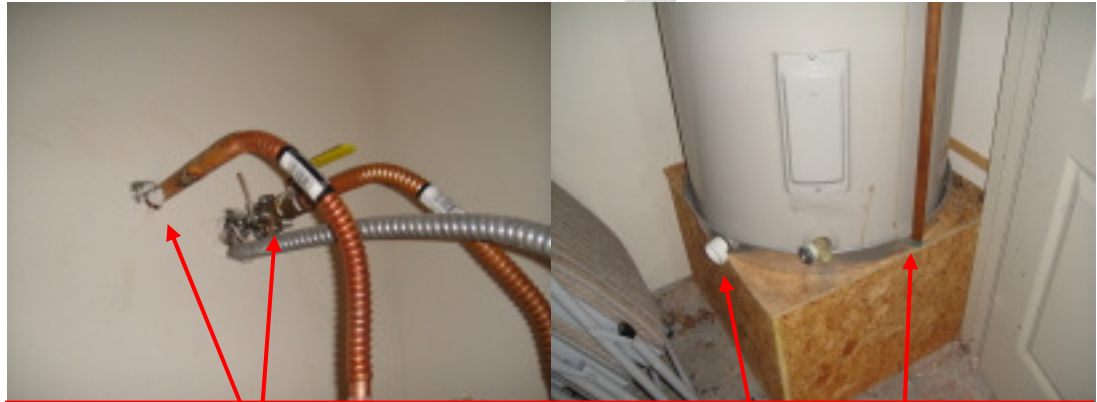
The equipment ground wires are installed on the 'cold side' per local jurisdiction. The state recommends the hot side be grounded also.

**The pan drain and temperature pressure relief valve piping should terminate outside the structure. The garage floor is on the same plane as the home. Water could seep under the wall and damage the interior of the home.**
