PROPERTY INSPECTION REPORT

123 Main St.
Anytown, CO

July 1, 2007

Tiger Home and Building Inspections Inc., Your Building Consultants For Life! 866-844-3726, Office e-mail: sales@tiger-home-inspections.com; www.tiger-home-inspections.com.

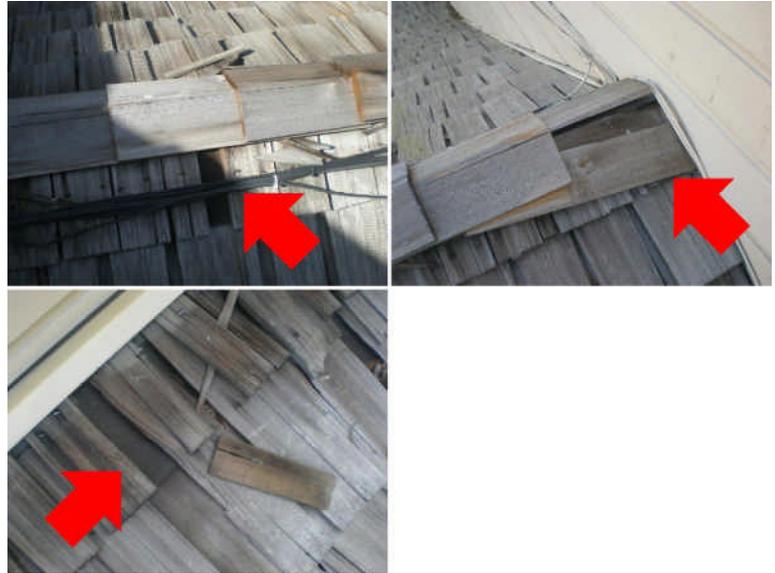
5.7 Condition of wood shakes/ shingles:

Attention: Cracking noted. Missing pieces and/or shingles noted. Splitting of shingles noted. Hip and ridge pieces falling apart noted.

1. **Attention:** Cracking noted. Missing pieces and/or shingles noted. Splitting of shingles noted. Hip and ridge pieces falling apart noted.

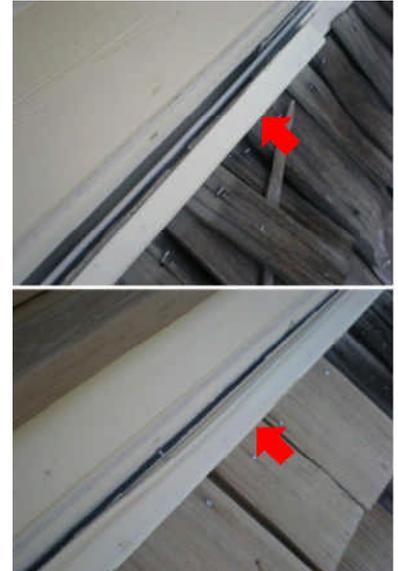
5.8 Flashing:

Attention: Re-secure wall roof flashing. Located at south side of roof.

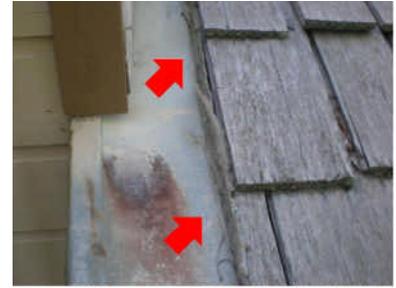
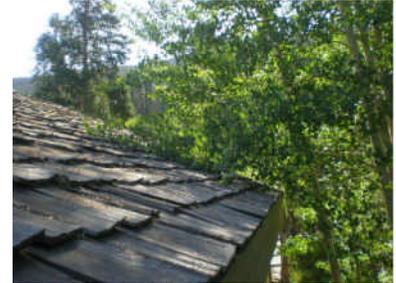
5.9 Overall condition of the roof:

Attention: Contact licensed qualified roofing contractor. Roof needs small repair. Also, areas of caulking need to be re-sealed.
Cut back trees so they are not in contact with the roof as they can cause damage.

3. **Attention:** Contact licensed qualified roofing contractor. Roof needs small repair. Also, areas of caulking need to be re-sealed.

Cut back trees so they are not in contact with the roof as they can cause damage.

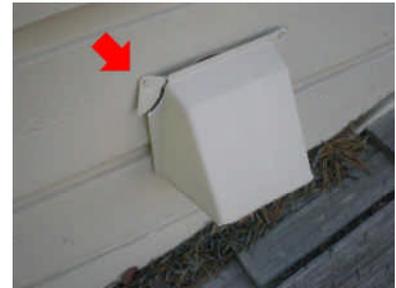
5.10 Additional Pictures:

Attention: Replace broken vent cover on exterior at north side roof.

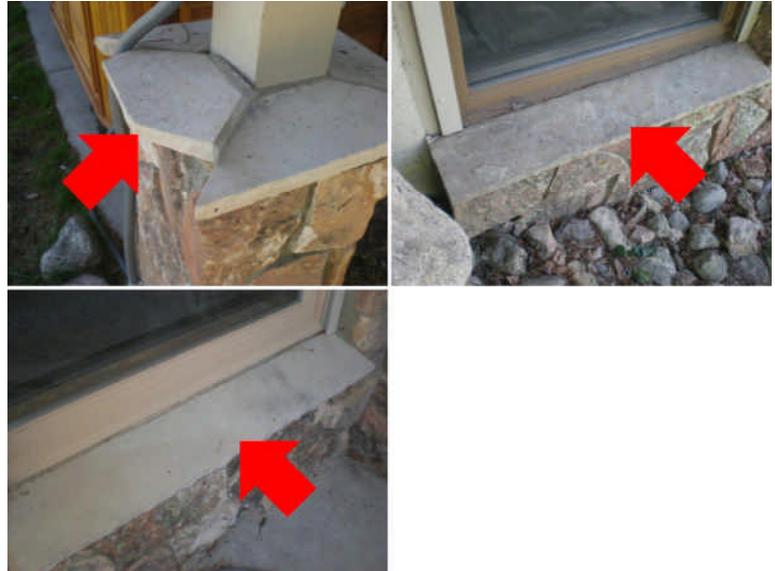
5.16 Condition of Stone:

Attention: At back patio. Broken and unsecured rock at deck post. Unsecured rock sill at window near back steps and on north side of the house.

4. **Attention:** At back patio. Broken and unsecured rock at deck post. Unsecured rock sill at window near back steps and on

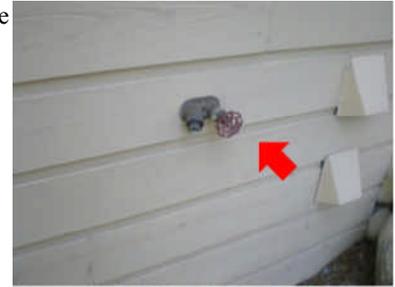
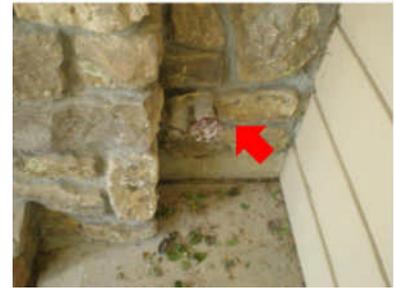
5.23 Condition of front faucet:

Attention: Could not get water to flow at faucet next to garage and on south side of the house.

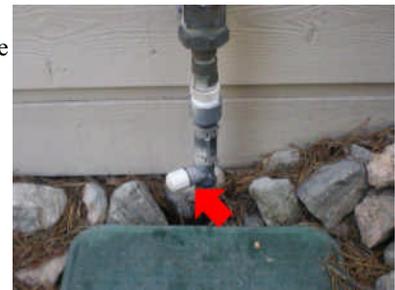
5.25 Lawn Sprinkler System:

Inspection of the installed lawn sprinkler is beyond the scope of this inspection. Hire lawn sprinkler company for inspection if concerned. **Attention:** Leaky pipe was noticed. Repair as necessary.

7. Inspection of the installed lawn sprinkler is beyond the scope of this inspection. Hire lawn sprinkler company for inspection if concerned. **Attention:** Leaky pipe was noticed. Repair as necessary.

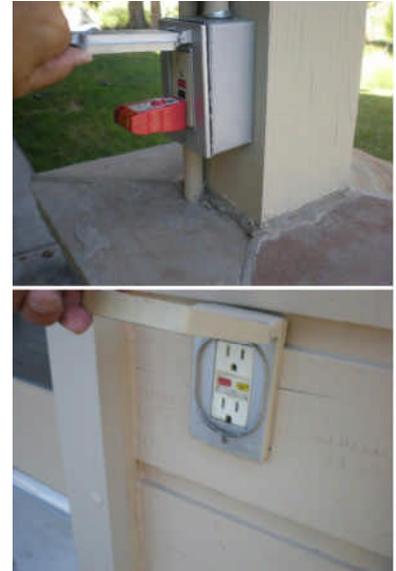
5.29 Rear Outlet(s)

Action: 2 GFCI outlets did not interrupt the circuit when tested.

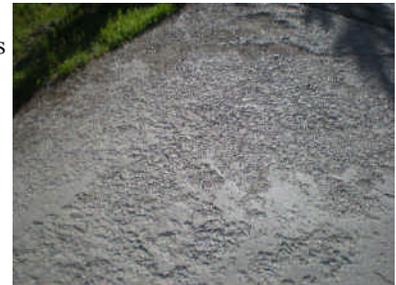
5.33 Driveway Condition:

Attention - The driveway needs attention and minor repair to prevent further deterioration. Spalling - Spalling is when the surface is flaking off. While this is not necessarily a fatal condition, it may worsen over time. At some point you may want to replace sections for aesthetic purposes. Doing a top coat sealer can help prevent further deterioration.

10. **Attention** - The driveway needs attention and minor repair to prevent further deterioration. Spalling - Spalling is when the surface is flaking off. While this is not necessarily a fatal condition, it may worsen over time. At some point you may want to replace sections for aesthetic purposes. Doing a top coat sealer can help prevent further deterioration.

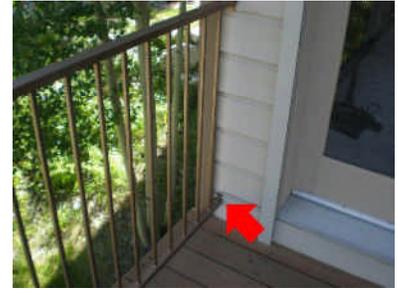
5.40 Deck Railings:

Attention - The railings are in place however some repair or upgrade is recommended. Re Secure all deck railings. Some are looser than others.

11. **Attention** - The railings are in place however some repair or upgrade is recommended. Re Secure all deck railings. Some are looser than others.

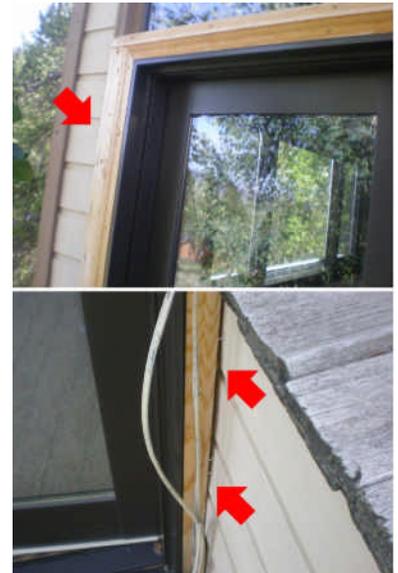
5.46 Comments:

Attention: The casing around the door on the exterior needs to be painted or stained. Right now, it is unfinished wood. Also, around the casing needs to be caulked and sealed.

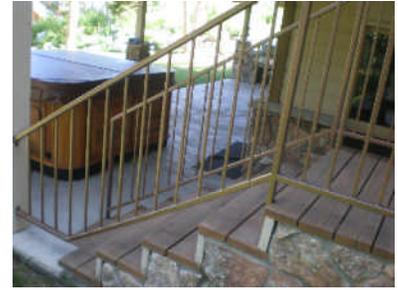
5.48 Deck Railings:

Attention - The railings are in place however some repair or upgrade is recommended. Handrails are loose. Re-secure.

12. **Attention** - The railings are in place however some repair or upgrade is recommended. Handrails are loose. Re-secure.

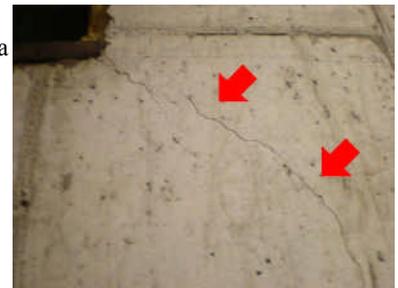
7.14 Conditions Noted in Exterior Walls, Interior View:

Shrinkage cracking was noted on at least one wall. Shrinkage cracking is the result of the evaporating of moisture in the concrete walls. This generally is not a cause for concern as all concrete shrinks. Should any of these cracks begin to grow, then further attention and evaluation would be recommended.

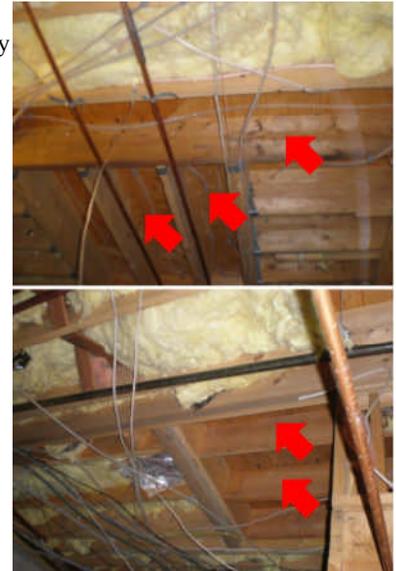
Attention: Some areas of the ceiling are not insulated. Crawlspace seemed fairly warm but adding some insulation will help with energy efficiency.

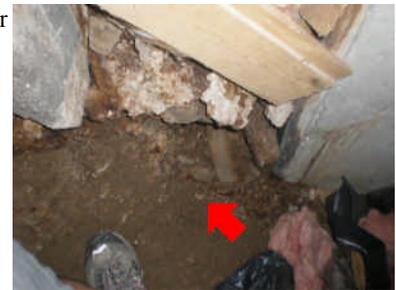
7.22 Evidence of Water Entry:

Attention: Small amount of ground water noticed under south side wall exterior wall. I would say it falls into the "acceptable" category for ground moisture. Monitor crawlspace during different times of the year to see if water becomes excessive.

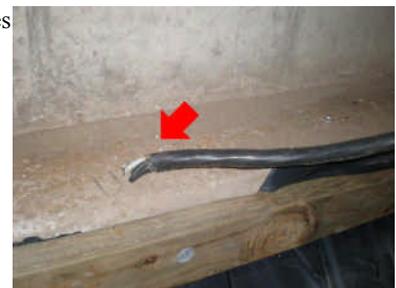
7.23 Lighting and Wiring:

Attention: There is some unterminated wiring on south end of crawlspace. Does not appear to be "hot", but have electrician properly terminate or remove wiring.

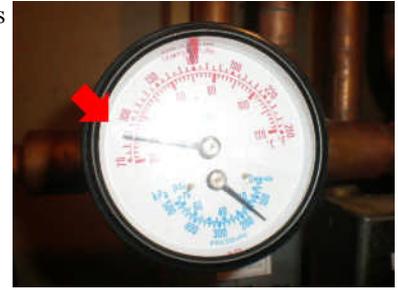
8.15 Temperature:

Attention: The temp gauge inside the cabinet read was at 180 degrees, which is where it should be. The temp gauge on the pipes near some of the zone valves was only reading about 85 degrees. This needs to be looked at.

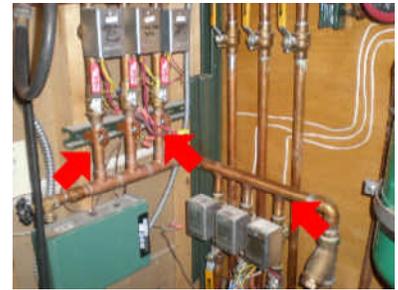
8.19 Circulating pump(s)

Attention: Some of the zones did not appear to be circulating. The pipes associated with that pump did not get hot indicating the hot water may not be circulating through the pump. Recommend having all circulating pumps checked by radiant heat specialist.

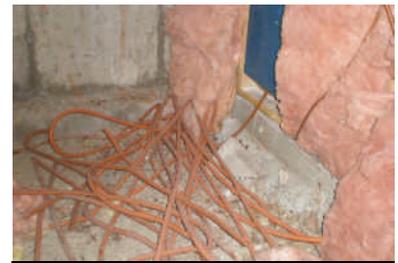
8.21 Radiant Heat Tubing:

Attention: The installed tubing is Wirsbo He Pex which is correct. In the crawlspace, there is some old Entran tubing which had major issues and was known for failure. It appears like the Entran tubing has been removed, but check with seller as to a complete history of the Entran tubing and make sure it was ALL replaced.

Old Entran tubing on ground in crawls

Recommend a full inspection and servicing of the heating system by a qualified radiant heat contractor.

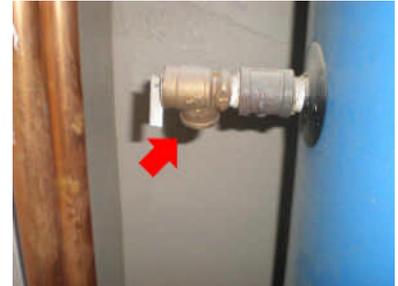
9.33 Safety Overflow Pipe:

Action: There is no overflow pipe installed. For safety reasons, immediate installation is needed to help minimize the possibility of serious injury.

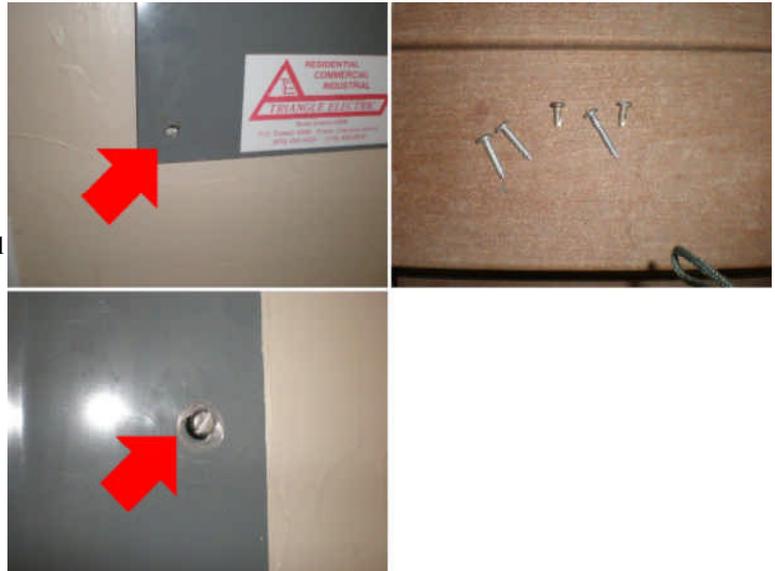
10.12 Panel Condition:

Action - The power panel, as a container for safely covering circuitry and components, requires immediate action to minimize the possibility of an electrical shock.

The panel cover is missing a screw and some of the other screws are the wrong size, not properly supporting the panel cover and one is a pointed tip screw. Panel screws should be flat tipped so that no wires get pierced when cover is removed and replaced. Recommend replacing all incorrect screws with proper panel screws.

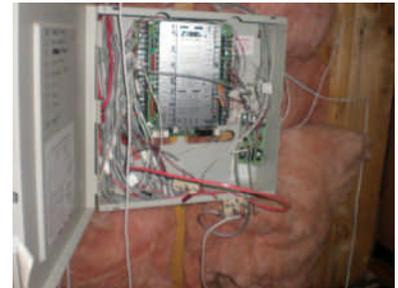
Attention: It does appear that the wiring may need attention. Panel door was open and loose wires and unterminated wires were noticed. Recommend contacting security company for full evaluation of the security system. Alarm company is Superior Alarm Summit 970-468-0276

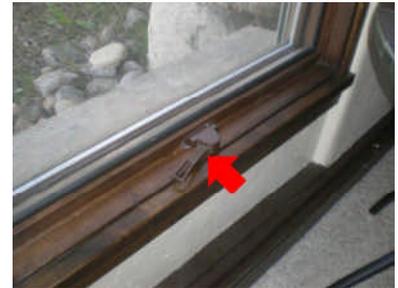
14.68 Windows:

Attention: Small window on the north wall was stuck shut. Could not get window to open.

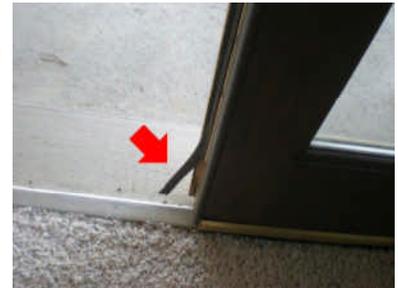
14.71 Exterior door(s)

Satisfactory - Door(s) to this room is satisfactory. **Attention** - The outside entry door to this room needs some minor adjustment or repair. Door on the right has a small piece of weather stripping that needs to be re-attached.

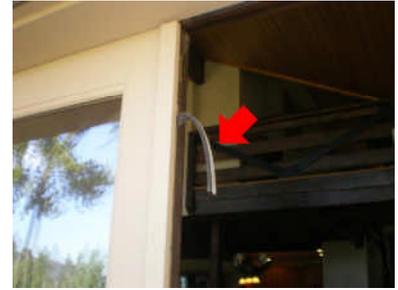
14.80 Exterior door(s)

Attention - The outside entry door to this room needs some minor adjustment or repair. Repair/replace weather stripping on left side door.
