Inspection Report

SAMPLE REPORT

Property Address:
YOUR HOUSE
YOUR TOWN, PA

Date: 2/4/2010	Time: 8:55 AM	Report ID: FILE NUMBER
Property: YOUR HOUSE YOUR TOWN, PA	Customer: SAMPLE REPORT	Real Estate Professional:

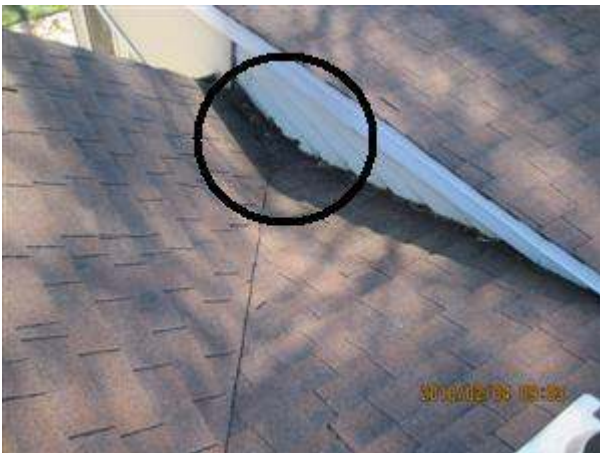
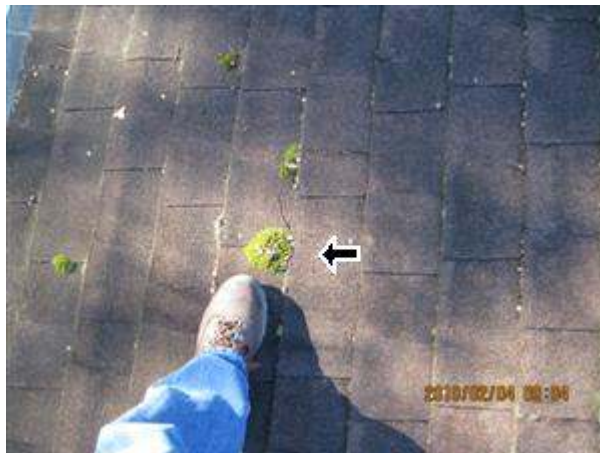
1.0 MULTIPLE LAYERS OF ROOFING NOTED.

HEAVY MOSS AND LICHEN GROWTH NOTED.

RESTRICTED VALLEY OUTLET NOTED: BETWEEN PORCH ADDITION AND GARAGE. CLEAN OUT FREQUENTLY TO PREVENT DEBRIS DAMS AND PLAN FOR EVENTUAL REBUILDING OF ROOF TO BROADEN OUTLET AREA.

PLAN FOR AGE-RELATED REPLACEMENT.

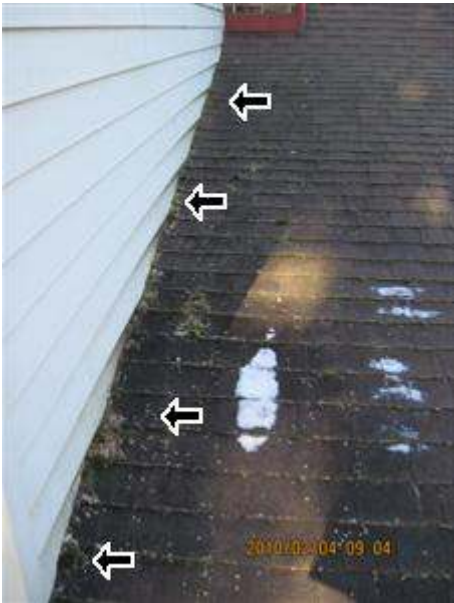
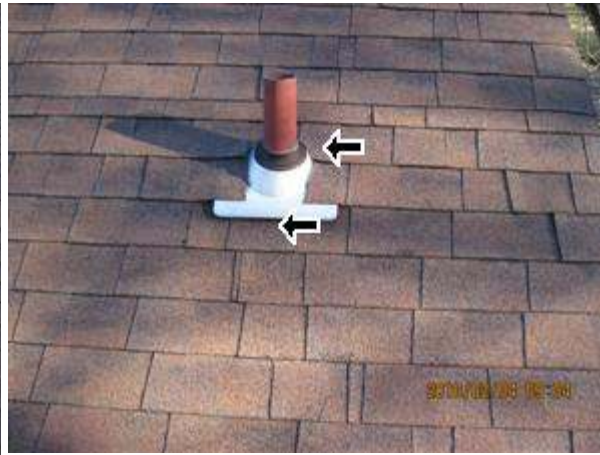
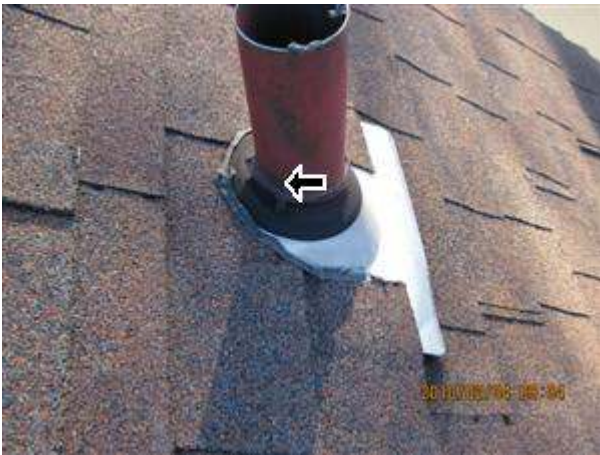
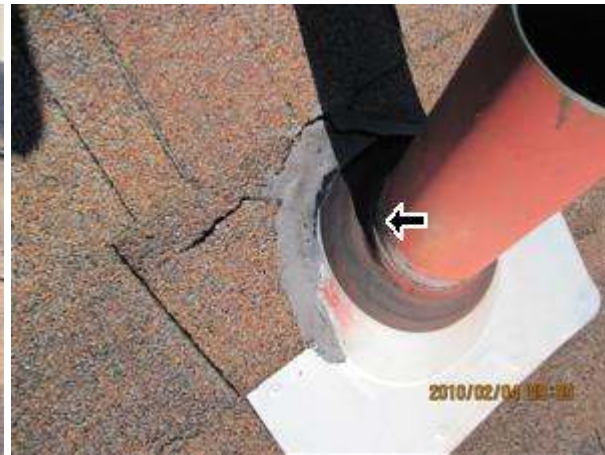
NOT REFLASHED WITH ROOF-OVER. RE-SEAL AT SIDING EDGES

SEAL OR REPLACE (3) TORN PLUMBING VENT COLLAR(S).

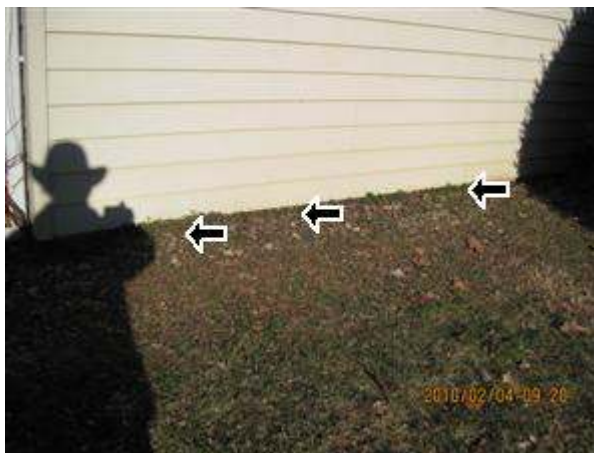
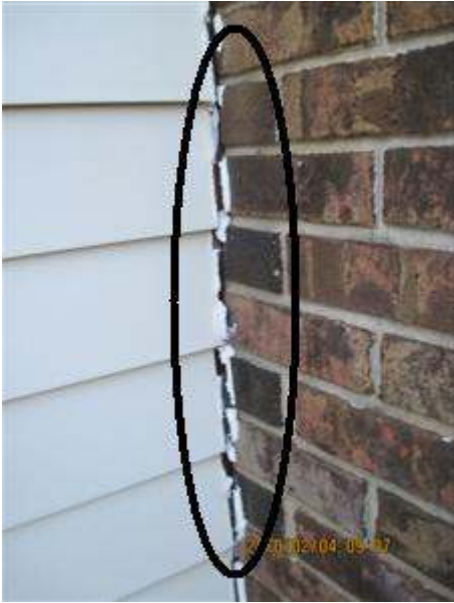
WOOD-SOIL CONTACT NOTED. LOWER MULCH/SOIL LEVELS.

THE BRICKWORK IS APPLIED WITHOUT BENEFIT OF WEEPHOLES OR VISIBLE FLASHING. THIS IS A COMMON DEFECT, AND USUALLY DOES NOT CAUSE PROBLEMS, BUT OCCASIONALLY CAN ALLOW A BUILD-UP OF MOISTURE BEHIND THE BRICK VENEER THAT CAN CAUSE HIDDEN DAMAGE/DETERIORATION TO DEVELOP.

2.0 CAULK/SEAL GAPS AT CHIMNEY-SIDING JOINTS NOW.

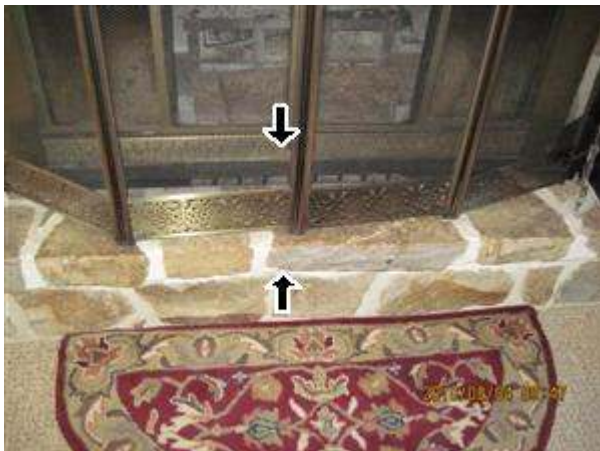
5.7 Picture 1

5.7 HAVE FIREPLACE EVALUATED BY CERTIFIED CHIMNEY SWEEP FOR SAFETY. SOOT AND CREOSOTE BUILD-UP NOTED.

SHALLOW HEARTH NOTED. EXTEND HEARTH OR USE FIRE-RETARDANT HEARTH MAT TO PROTECT FLOOR.

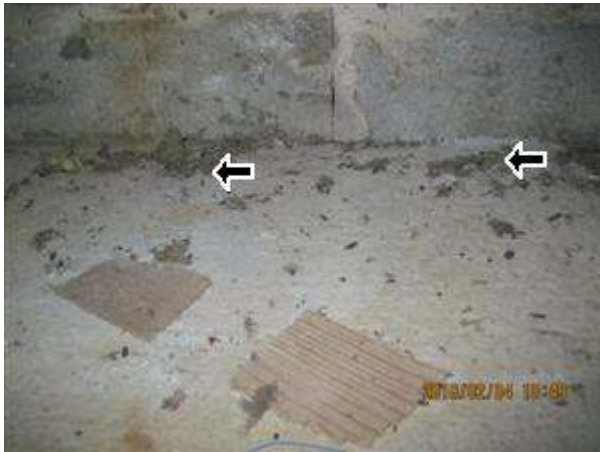
11.1 Picture 1

MINOR OLD INSECT DAMAGE NOTED: SILL PLATE AT REAR. NO APPARENT NEED FOR REPAIR IS NOTABLE.

PREVIOUS INSECT TREATMENT NOTED.

CONTACT SPECIALISTS FOR FURTHER EVALUATION AND TREATMENT AS NEEDED

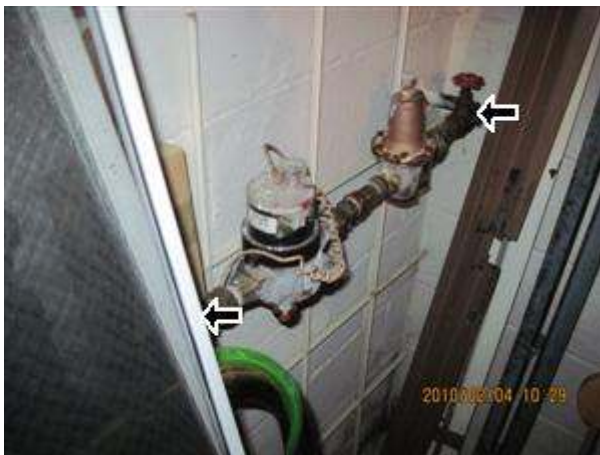
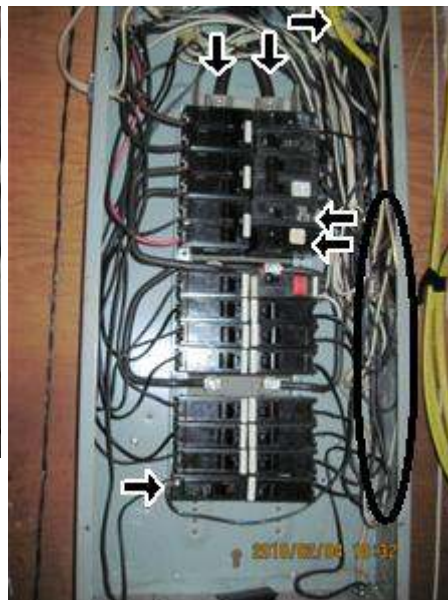
12.1 CORROSION NOTED IN PANEL. HAVE LICENSED ELECTRICIAN CLEAN ALL CORRODED CONTACTS AND CHECK BREAKERS. SEAL OR REPLACE EXTERIOR SERVICE ELEMENTS.

NO ANTI-OXIDANT NOTED AT MAIN ALUMINUM CONDUCTOR CONNECTIONS. HAVE A LICENSED ELECTRICIAN CLEAN AND PROTECT THESE CONNECTIONS.

DOUBLE-TAPPED CIRCUIT BREAKERS NOTED MAY CREATE A FIRE HAZARD. HAVE A LICENSED ELECTRICIAN SEPARATE THE CIRCUITS ONTO INDIVIDUAL BREAKERS.

DOUBLE-TAPPED NEUTRAL BUSSES NOTED MAY CREATE A FIRE HAZARD. HAVE A LICENSED ELECTRICIAN SEPARATE THE CIRCUITS ONTO INDIVIDUAL BUSS POSITIONS.

WIRES OVER- AND/OR UNDER-STRIPPED IN PANEL.

TOO MANY DEVICES NEEDED TO SHUT DOWN SYSTEM. HAVE A LICENSED ELECTRICIAN REWIRE/REPLACE PANEL TO ALLOW NO MORE THAN 6 DEVICES FOR COMPLETE SYSTEM SHUT-DOWN.

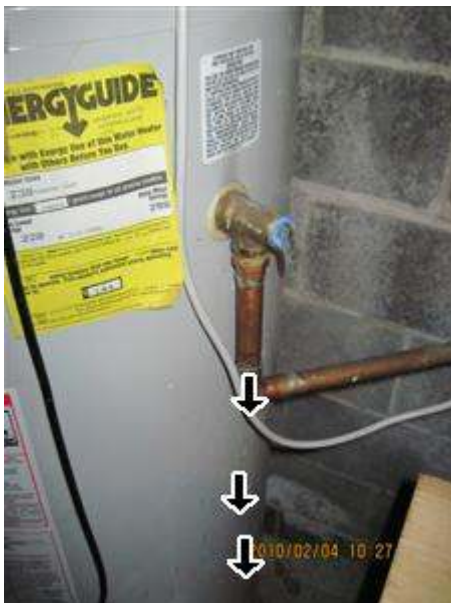
13.5 Picture 1

13.5 PIPE RELIEF VALVE WITHIN 6" OF FLOOR. PLAN FOR AGE-RELATED REPLACEMENT.

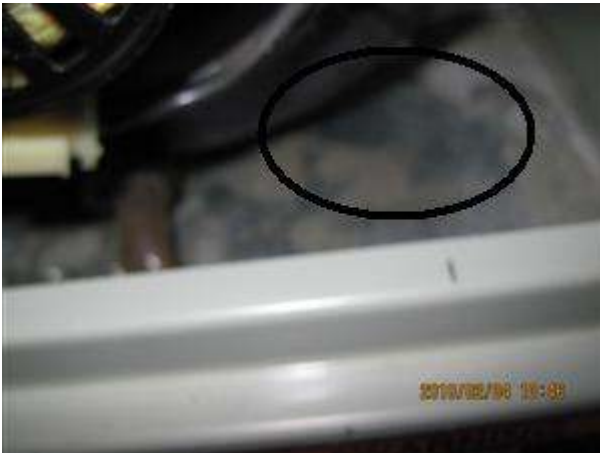
14.0 Picture 1

EVIDENCE OF CONDENSATE LEAKAGE NOTED IN HIGH-EFFICIENCY FURNACE.

-- HAVE SERVICE COMPANY CLEAN, ADJUST AND EVALUATE UNIT PRIOR TO SETTLEMENT.

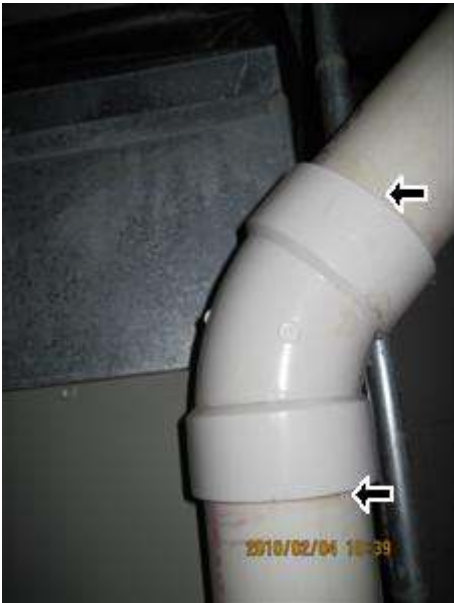
14.3 Picture 1

14.3 VENT PIPING WAS NOT PRIMED BEFORE GLUING PER MFR. SPECIFICATIONS. REPIPE AS NEEDED.
