Hurricane John / 4007-DR-ST/ 06-01-2006

Anytown Department of Public Works

Damage/Cost Report-Elevated Water Tower Damage from Hurricane John

Draft – 06/30/2006

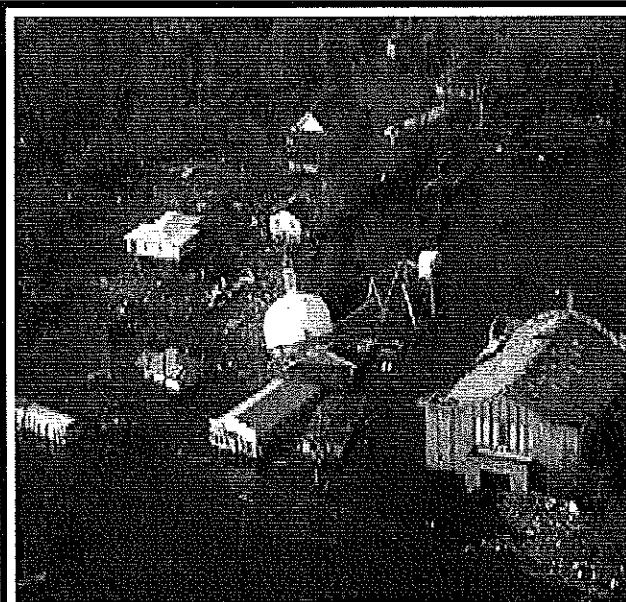
collapsed water tower, aerial view
Caption:

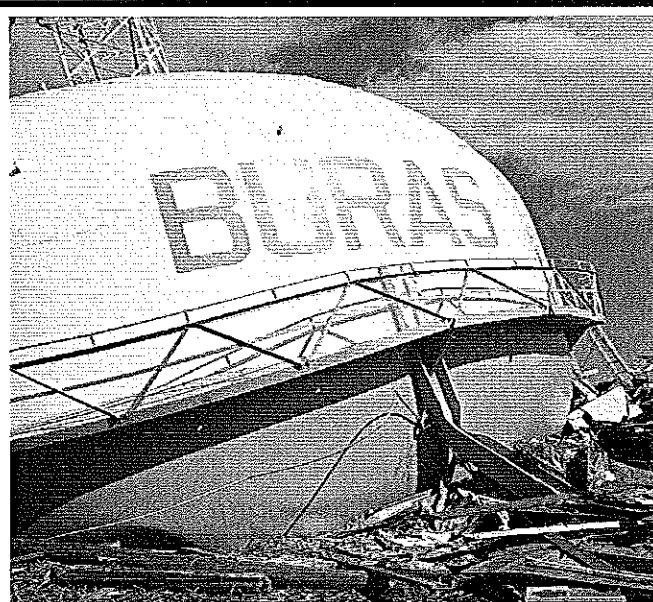
close up of collapsed water tower
Caption:

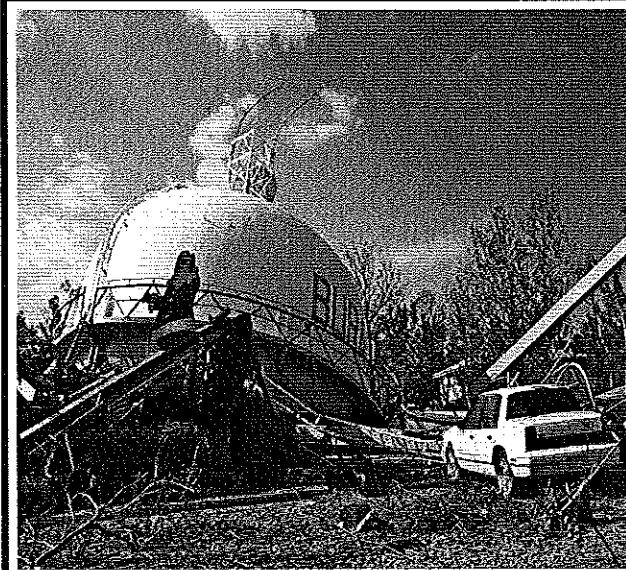
another view of collapsed water tower
Caption:
