## 7A FLIGHT READINESS REVIEW

OL/Alan Lindenmoyer  
Manager, Configuration Management

Date 06/26/01

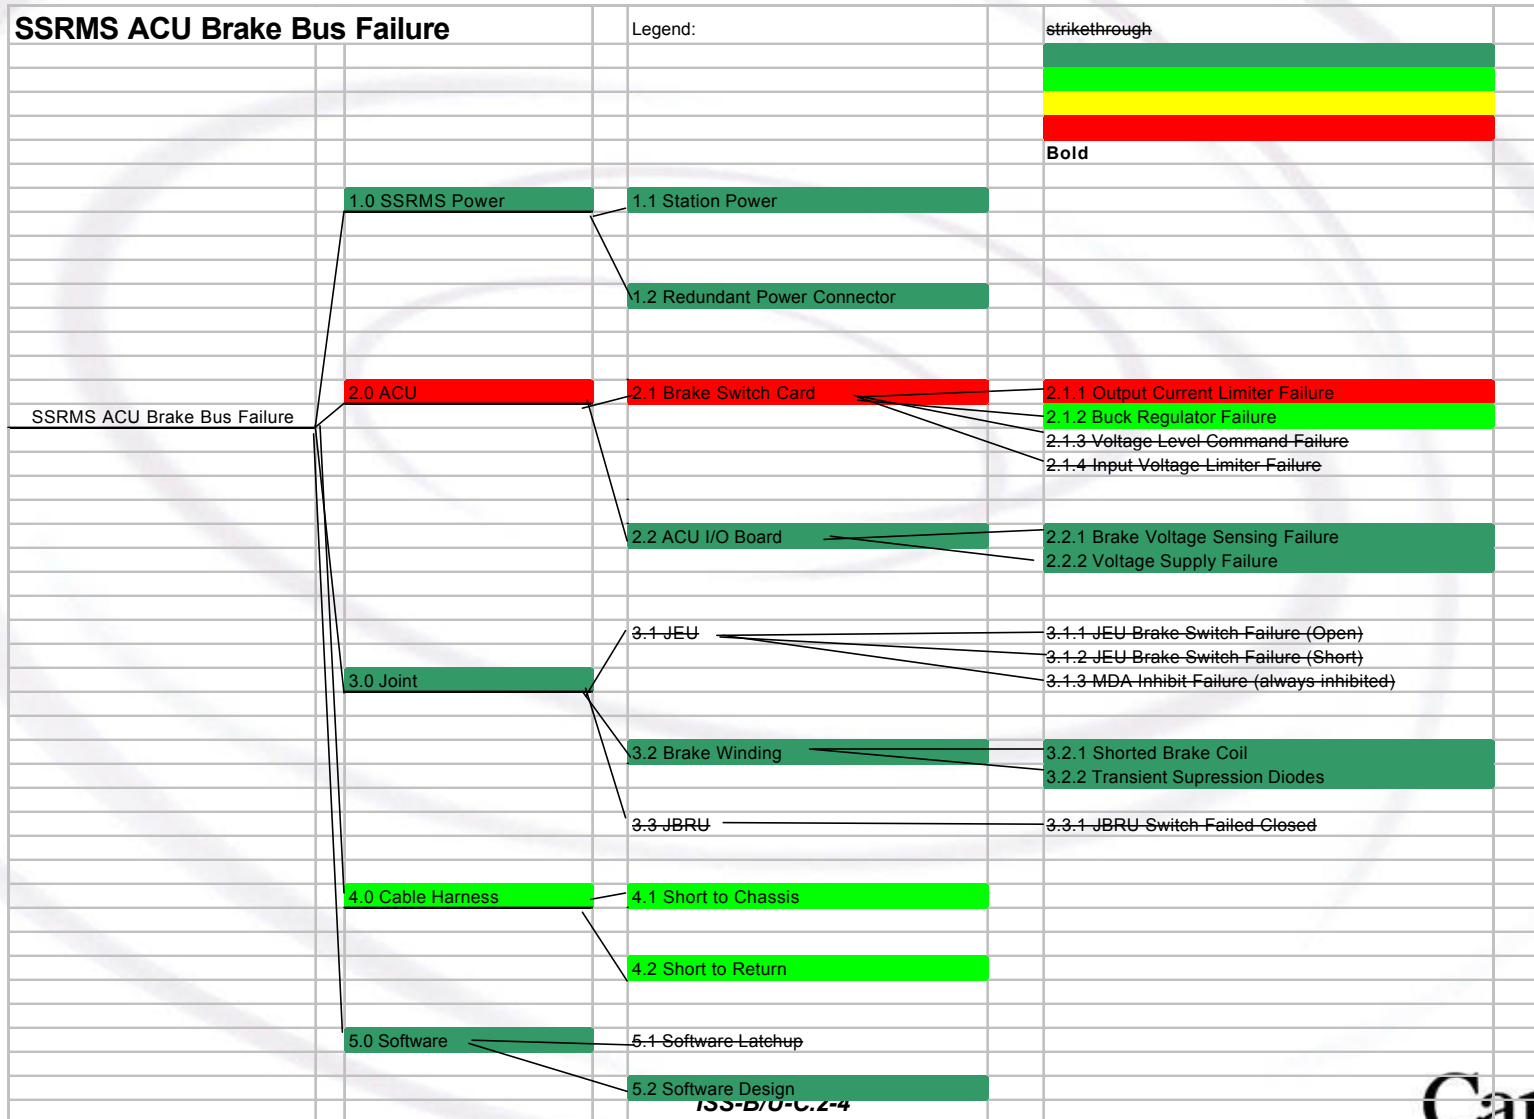
# ACU Brake Bus Failure Fault Tree:

SSRMS ACU Brake Bus Voltage Failure							
Branch Number	Branch Title	Action	Actionee	ECD	Related Task Ids	Result	Rationale
1.0	SSRMS Power						
1.1	Station Power					Highly unlikely	EPS group reported no anomalies on station power during failure events. SSRMS was only equipment on prime and redundant RPCMs during the failures. EMS testing determined that ACU can tolerate down to 96 V without losing brake voltage, and below this value

1.2	Redundant Power Connector					Highly unlikely	SSRMS power not successfully applied when connector mated during EVA. Connector had to be re-mated to successfully apply power. PDGF local bus switched to channel B to shake out any problems in the connector. No comm errors were found during this test.

2.0	ACU						
2.1	Brake Switch Card						
2.1.1	Output Current Limiter Failure					Likely	Output current limiter failure could result in erroneous limiting of brake bus current, which has the effect of reducing the brake bus voltage and would be present only when current is flowing on the bus (i.e. the bus is loaded). The failure could either

2.1.2	Buck Regulator Failure					Unlikely	Effect of buck regulator failure not expected to be dependent on brake bus loading. During diagnostic tests, failure annunciated only when bus was loaded.

2.1.3	Voltage Level Command Failure					Ruled Out	Voltage level command to buck regulator is independent of brake bus loading. During diagnostic tests, failure annunciated only when bus was loaded.

2.1.4	Input Voltage Limiter Failure					Ruled Out	Failure of voltage input limiter would result in ACU brake overcurrent trip messages. These messages were not seen.

2.2	ACU I/O Board						
2.2.1	Brake Voltage Sensing Failure					Highly unlikely	Effect of brake voltage sensing failure (the brake bus voltage is correct, but the ACU incorrectly detects the voltage level) would be independent of brake bus loading. During diagnostic tests, failure annunciated only when bus was loaded.
	Voltage Supply Failure					Highly unlikely	No unusual signatures seen in ACU voltages at the time of the failures, including the +12 V supply which is used to drive the ACU brake switch and brake voltage control.

3.0	Joint						
3.1	JEU						
3.1.1	JEU Brake Switch Failure (Open)					Ruled Out	JEU brake switch failure open would result in inability to remove brakes for a single joint only. Failure signature would be JEU brake status error (not seen). Would not result in loss of brake bus voltage.

3.1.2	JEU Brake Switch Failure (Short)					Ruled Out	Drain-to-gate short in JEU brake switch could not result in current draw on brake bus return path to activate output current limiter.

3.1.3	MDA Inhibit Failure (always inhibited)					Ruled Out	MDA always inhibited affects only one joint. Would not result in loss of brake voltage.
3.2	Brake Winding

3.2.1	3.2.1 Shorted Brake Coil					Highly unlikely	Short would have result in a narrow range of resistances to cause output current limiting. Physical configuration of coil (Class H triple insulation, designed for up to 200 C, vacuum impregnated) makes short highly unlikely.

3.2.2	3.2.2 Transient Supression Diodes					Highly unlikely	Both diodes would have to fail short in one brake coil, and resulting resitance of short would have to be in a narrow range to cause output current limiting.

3.3	JBRU						
3.3.1	JBRU Switch Failed Closed					Ruled Out	Review of design and test history revealed no failures that could cause this signature. Review of test records indicate no JBRU failures that could cause the brake bus undervoltage.

4.0	Cable Harness						
4.1	Short to Chassis					Unlikely	Short to chassis would not cause output current limiting, so would not cause drop in voltage by this mechanism. Short would require a minimum resistance of 7.3 ohm so as not to cause input current trip. Resistance through chassis is on order of 1 ohm or l

4.2	Short to Return					Unlikely	A short of this kind could cause output current limiting that would result in brake bus undervoltage. However, line to line short would be required, and short would have to lie in narrow range of resistances. No evidence of a short was found in the SSRMS

5.0	Software						
5.1	Software Latchup					Ruled Out	Software was rebooted on whole arm (power cycled to OFF and back) between occurrences of failure.
5.2	Software Design					Highly unlikely	Invesigation on-going. Preliminary indication based on historical info is that timing-related software failures are rare and random. This behaviour is inconsistent with observed failure signature.

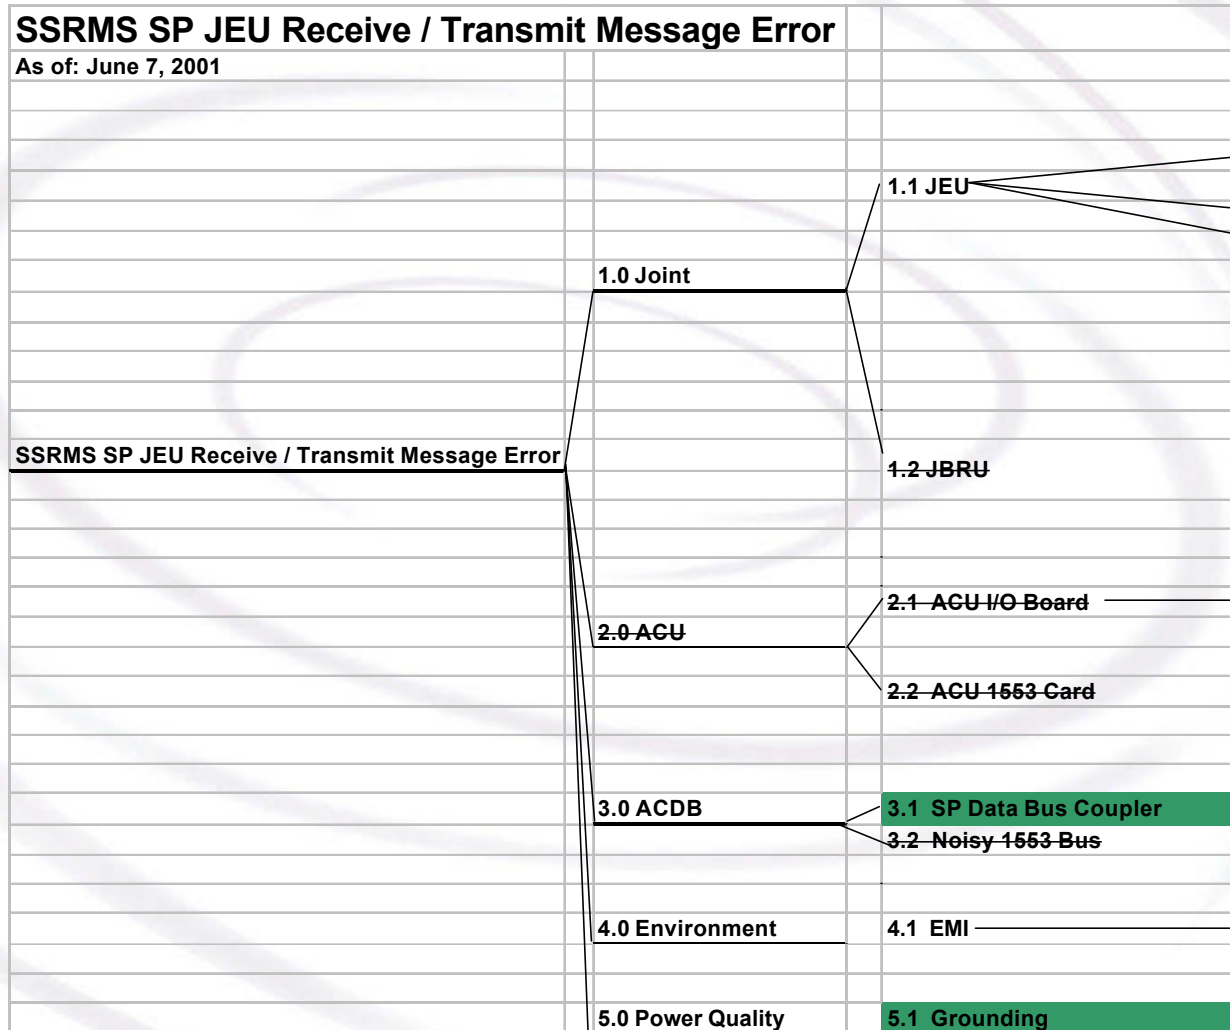
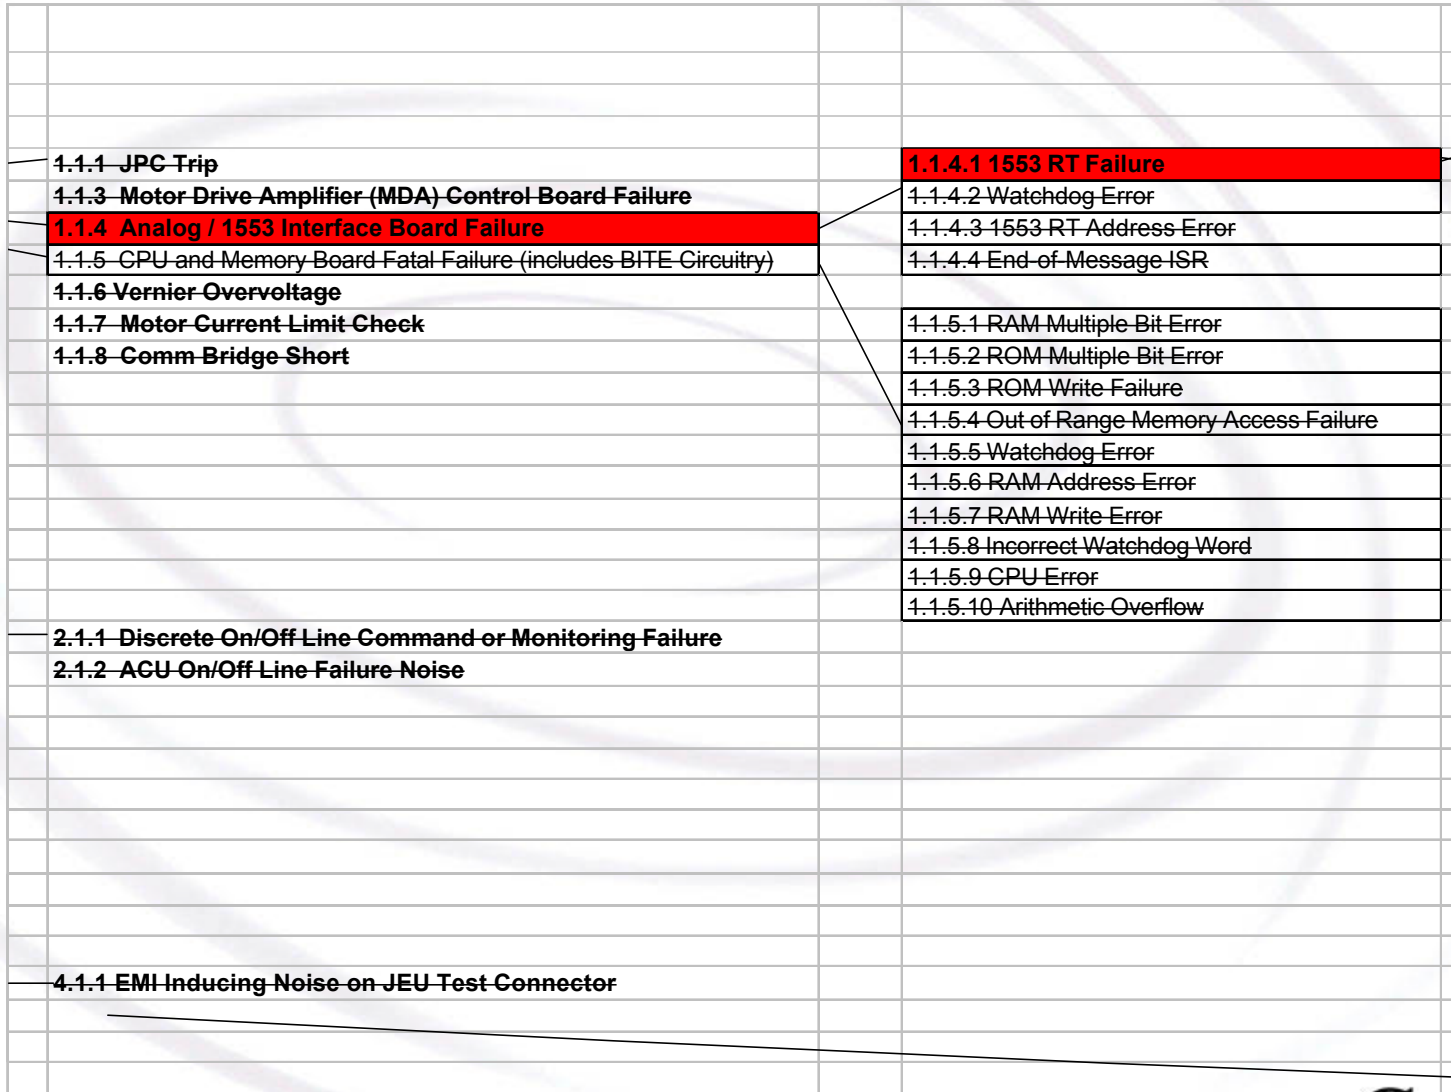
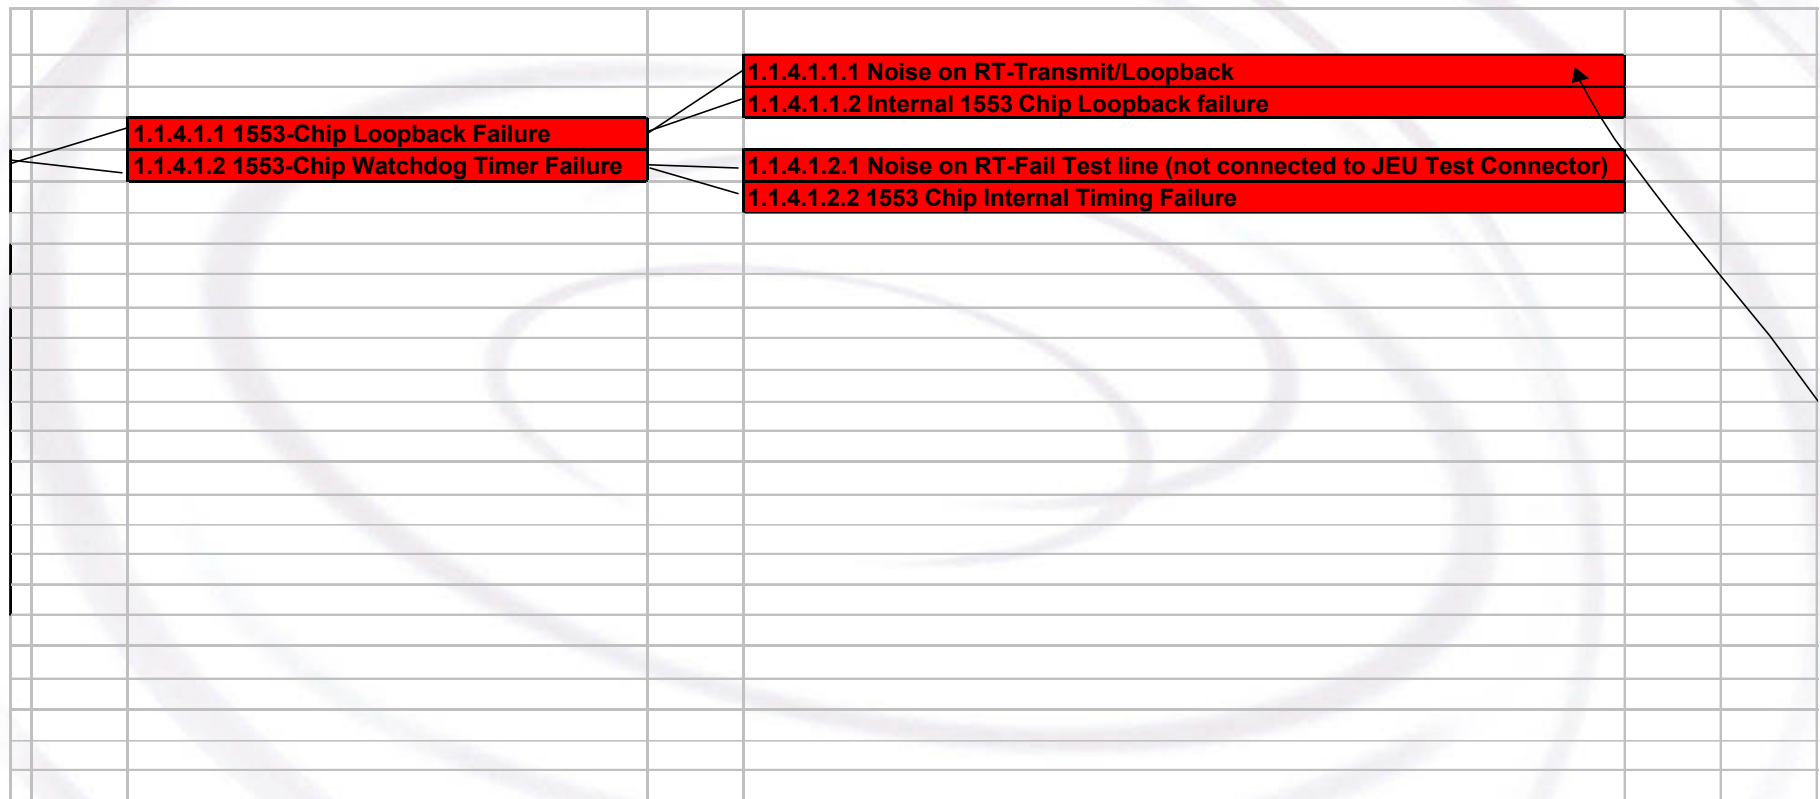
### SSRMS SP JEU Fault Tree:

SSRMS SP JEU Receive / Transmit Message Error							
As of: June 7, 2001							
Branch Number	Branch Title	Action	Actionee	ECD	Related Task Ids	Result	Rationale

1.0	JOINT						
1.1	JEU						
1.1.1	JPC Trip					Rule out.	JCS/AHS Patch ruled out the JPC as the cause of the failures.
1.1.2	Motor Drive Amplifier Control Board Failure					Ruled out.	During initialization and Standby state four hardware interlocks (MDA Inhibit, Buck Regulator Switch, Motor Drive Switches, and Commutation Bridge) are configured to prevent MDA from being capable of applying current to motor. Motor Over-current check is

1.1.3	Analog/1553 Interface Board Failure						
1.1.3.1	1553 RT Failure					Likely cause	JCS/AHS Patch implicated RT Failure in the single snap shot of data that was obtained.

1.1.3.2	Watchdog Error					Rule out.	JCS/AHS Patch #2 ruled out this cause. AHS Patch was executed which utilized a different 1553 RT Address. Since JEU was able to momentarily talk on the new RT address indicates that the address latch circuitry is functional.

1.1.3.3	1553 RT Address Failure					Ruled out.	JCS/AHS Patch #2 ruled out this cause.
1.1.3.4	End-of-Message ISR					Rule out.	JCS/AHS Patch #2 ruled out this cause.

1.1.4	CPU & Memory Board Failure						
1.1.4.1	RAM Multiple BIT Error					Rule out.	JCS/AHS Patch #2 ruled out this cause.
1.1.4.2	ROM Multiple BIT Error					Rule out.	JCS/AHS Patch #2 ruled out this cause.

1.1.4.3	ROM Write Error					Rule out.	JCS/AHS Patch #2 ruled out this cause.
1.1.4.4	Out of Range Memory Access Failure					Rule out.	JCS/AHS Patch #2 ruled out this cause.

1.1.4.5	Watchdog Error					Rule out.	JCS/AHS Patch #2 ruled out this cause.
1.1.4.6	RAM Address Error					Rule out.	JCS/AHS Patch #2 ruled out this cause.

1.1.4.7	RAM Write Failure					Rule out.	JCS/AHS Patch #2 ruled out this cause.
1.1.4.8	Incorrect Watchdog Check Word					Rule out.	JCS/AHS Patch #2 ruled out this cause.

1.1.4.9	CPU Error					Rule out.	JCS/AHS Patch #2 ruled out this cause.
1.1.4.10	Arithmetic Overflow					Rule out.	JCS/AHS Patch #2 ruled out this cause.

1.1.5	Vernier Overvoltage					Ruled out.	Vernier Over-Voltage check is not performed in initialization or Standby state and therefore is ruled out as the source of the loss of communication.

1.1.6	Motor Current Limit Check					Ruled out.	During initialization and Standby state four hardware interlocks (MDA Inhibit, Buck Regulator Switch, Motor Drive Switches, and Commutation Bridge) are configured to prevent MDA from being capable of applying current to motor. Motor Over-current check is

1.1.7	Comm Bridge Short					Ruled out.	During initialization and Standby state four hardware interlocks (MDA Inhibit, Buck Regulator Switch, Motor Drive Switches, and Commutation Bridge) are configured to prevent MDA from being capable of applying current to motor. Motor Over-current check is

1.2	JBRU					Ruled out.	JBRU was originally suspected since the brake bus and the resovler windings pass through Joint Back-Up Relay Unit (which could be related to the ACU Brake Bus failure observed and the WR RDC Bit failure). The watchdog timer has a 3kHz clock input which ha
<b>2.0</b>	<b>ACU</b>

2.1	ACU I/O Board					Ruled Out.	JCS/AHS Patch Ruled out ACU being cause of failure
2.2	ACU 1553 Card					Ruled Out.	No failure mode has been identified whereby the ACU 1553 card would be capable of consistently talking to the other 6 JEUs, tip LEU, and 4 VDUs, but not be capable of talking to the SP JEU. ACU 1553 card failure would affect communication with all units o
<b>3.0</b>	<b>ACDB</b>

3.1	SP 1553 Bus Coupler					Highly Unlikely	Failure has only been observed to appear at two discrete points in the state of the JEU: 1) when attempting to set its RT address, and 2) when transitioning to Standby state. Repeatability of failure in these two states and in no other states would requir

3.2	Noisy 1553 Bus					Ruled Out	No failure mode has been identified whereby the ACU would be capable of consistently talking to the other 6 JEUs, tip LEU, and 4 VDUs, but not be capable of talking to the SP JEU. 1553 bus failures would affect communication with all units on the bus.	
<b>4.0</b>	<b>ENVIRONMENT</b>

4.1	EMI		MDR			Ruled out.	MDR confirmed in MIS records that JEU test connector was installed. Also, JEU/AHS Patch #2 ruled out the JEU test connector as the cause of the RT-FAIL flag due to the fact that the 1553 Chip echoed back in it's status word that the RT-FAIL was set...thereb	
<b>5.0</b>	<b>POWER QUALITY</b>

5.1	Grounding					Unlikely Cause	Failure has only been observed to appear at two discrete points in the state of the JEU: 1) when attempting to set its RT address, and 2) when transitioning to Standby state. Repeatability of failure in these two states and in no other states would requir	
		JCS/AHS Patch will either eliminate this cause from the fault tree or leave it as a possible candidate.						
		JCS/AHS Patch will either point to this cause or eliminate this cause from fault tree
