Eugene Water & Electric Board

Generator Inspection and Testing

2014 Generator Testing and Inspection Report

Station	Carmen Power Plant	Engineer	Tyler Nice
Unit	1	Date	1/28/15

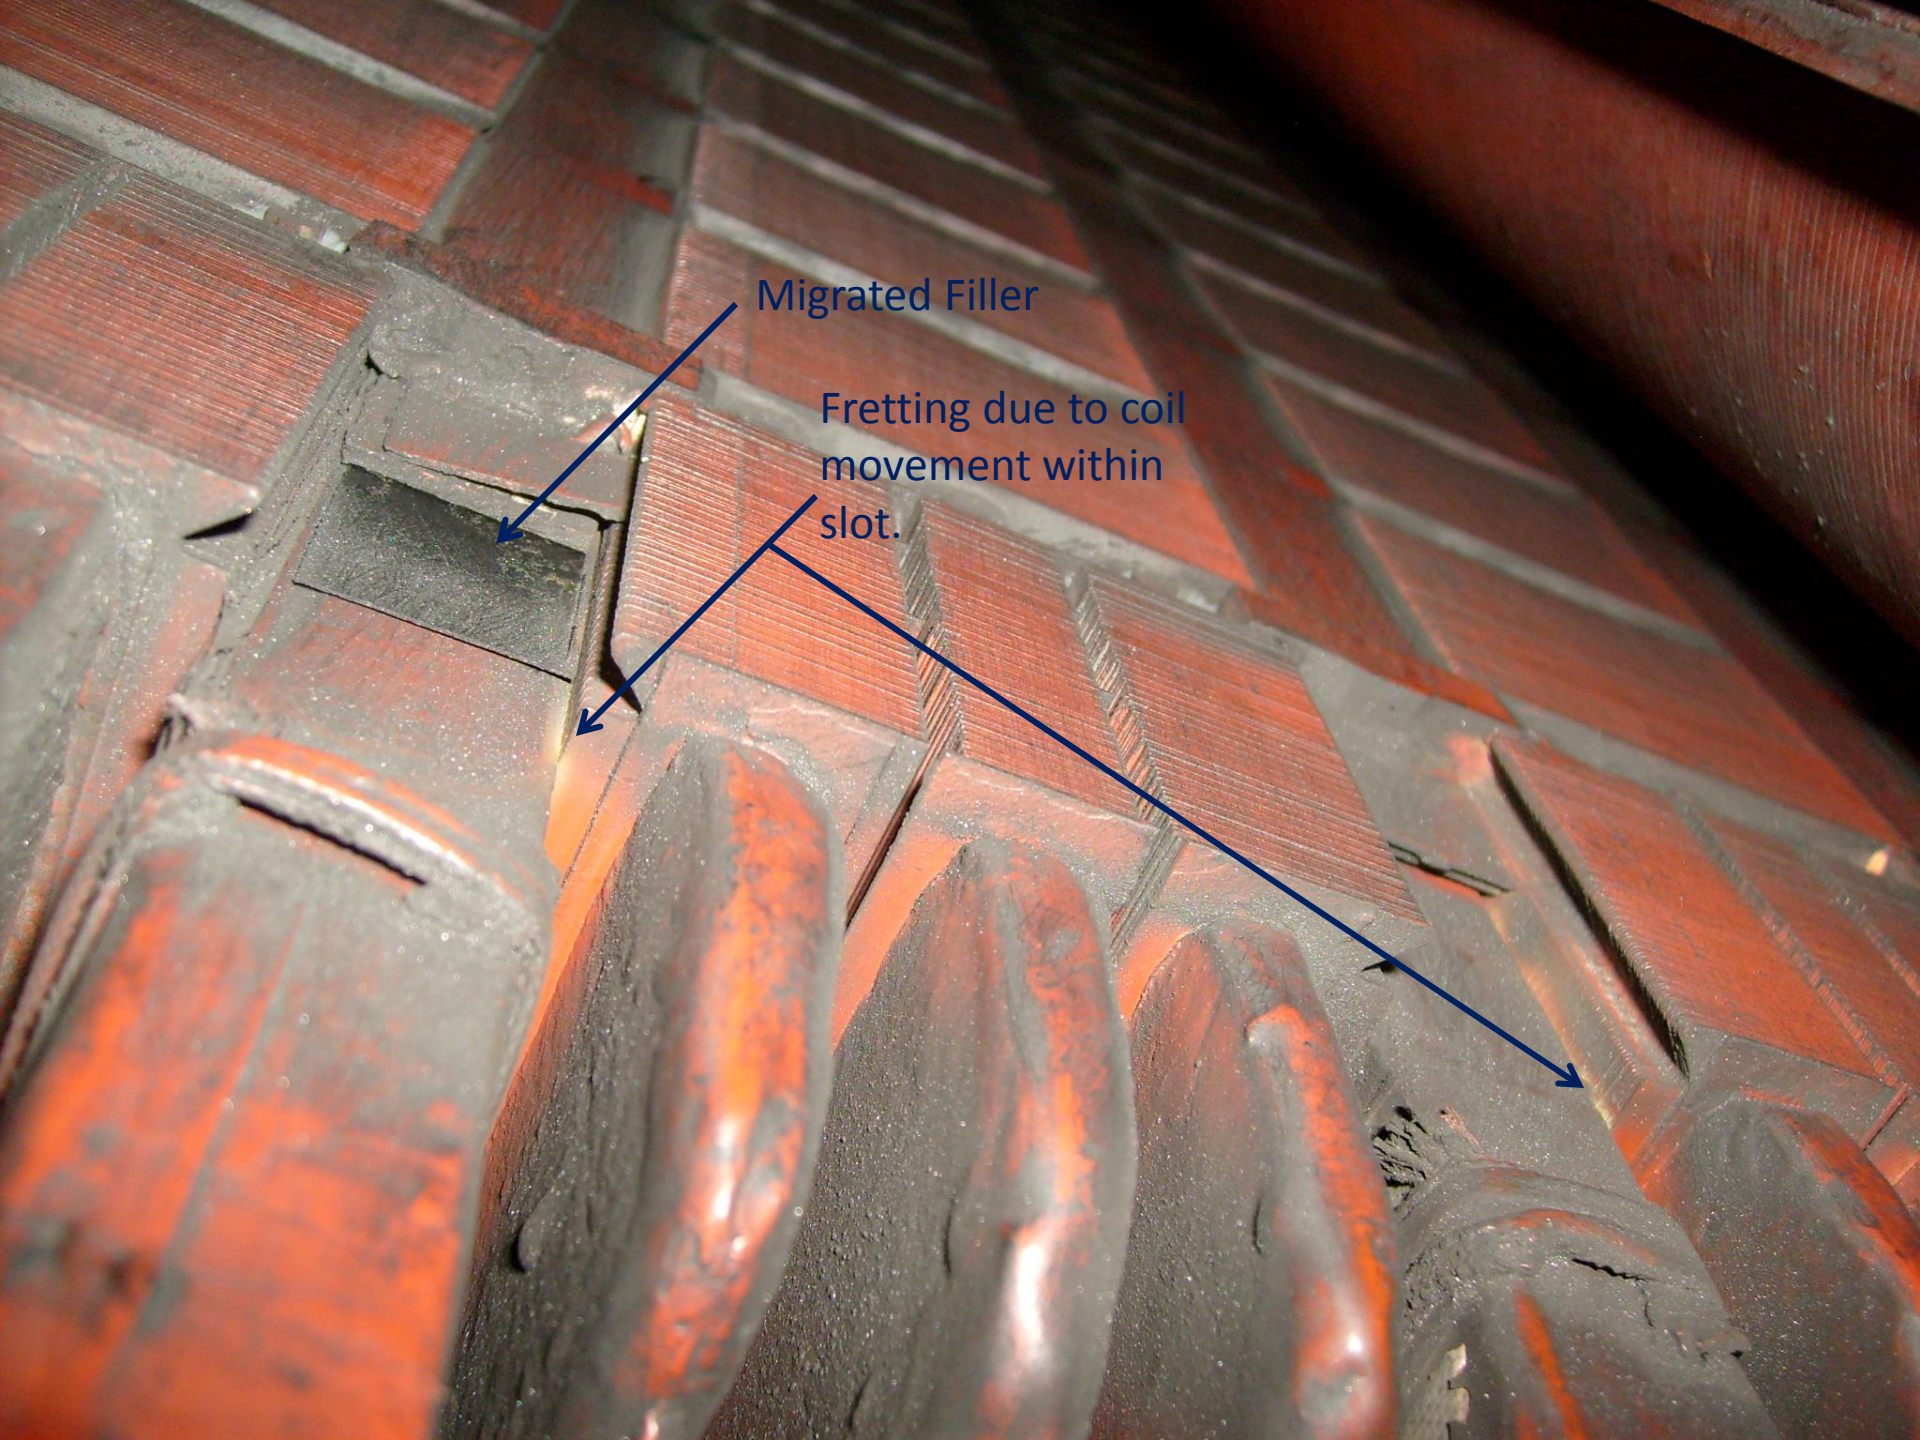
- Wedging system is showing signs of looseness; evident by slipping fillers and packing. No wedges have been found migrated.
- Coil to core fretting found in few locations on bottom side of core.
- All high voltage coils show signs of partial discharge at end winding.
- Contamination of oil and carbon dust prevalent in air gap and lower end winding.

Migrated Filler

Fretting due to coil
movement within
slot.

- End winding partial discharge damaged areas were painted over.
- Unit end winding was cleaned.
- Migrated fillers were repaired.

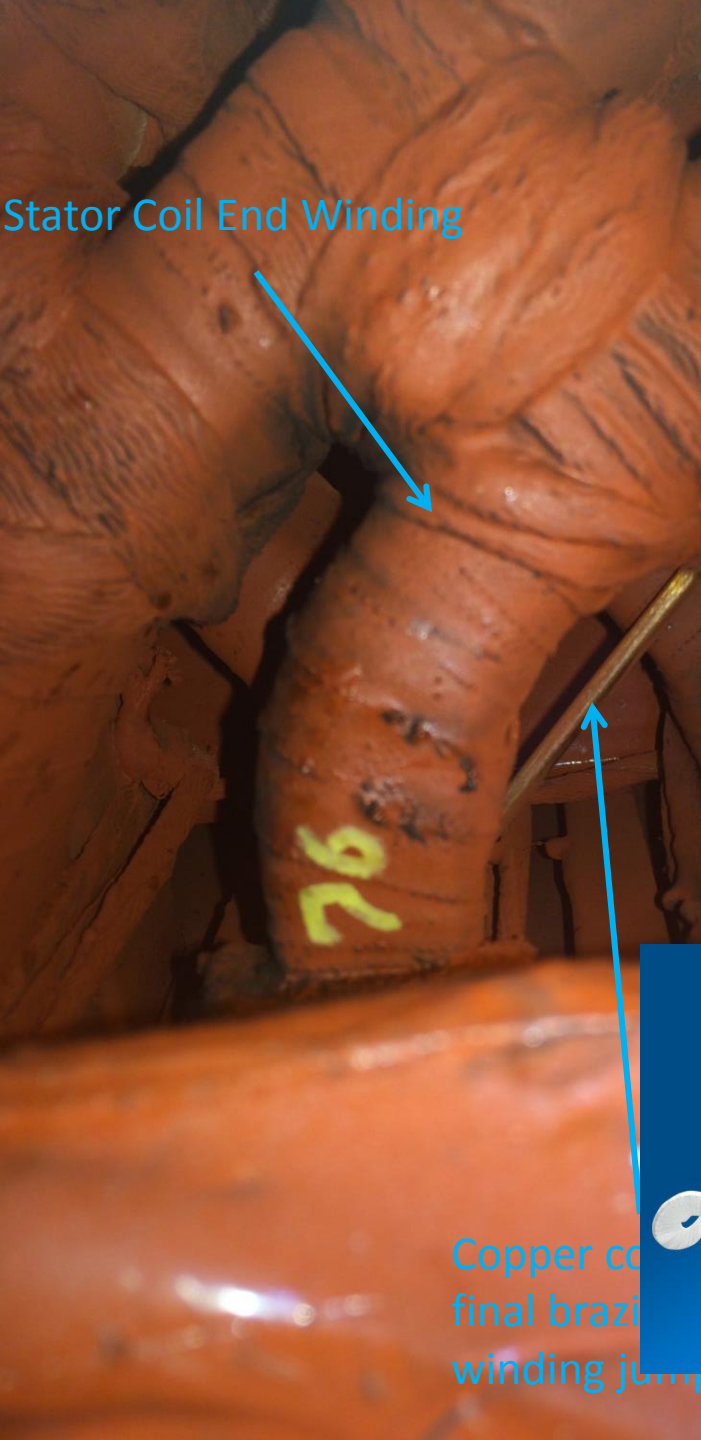
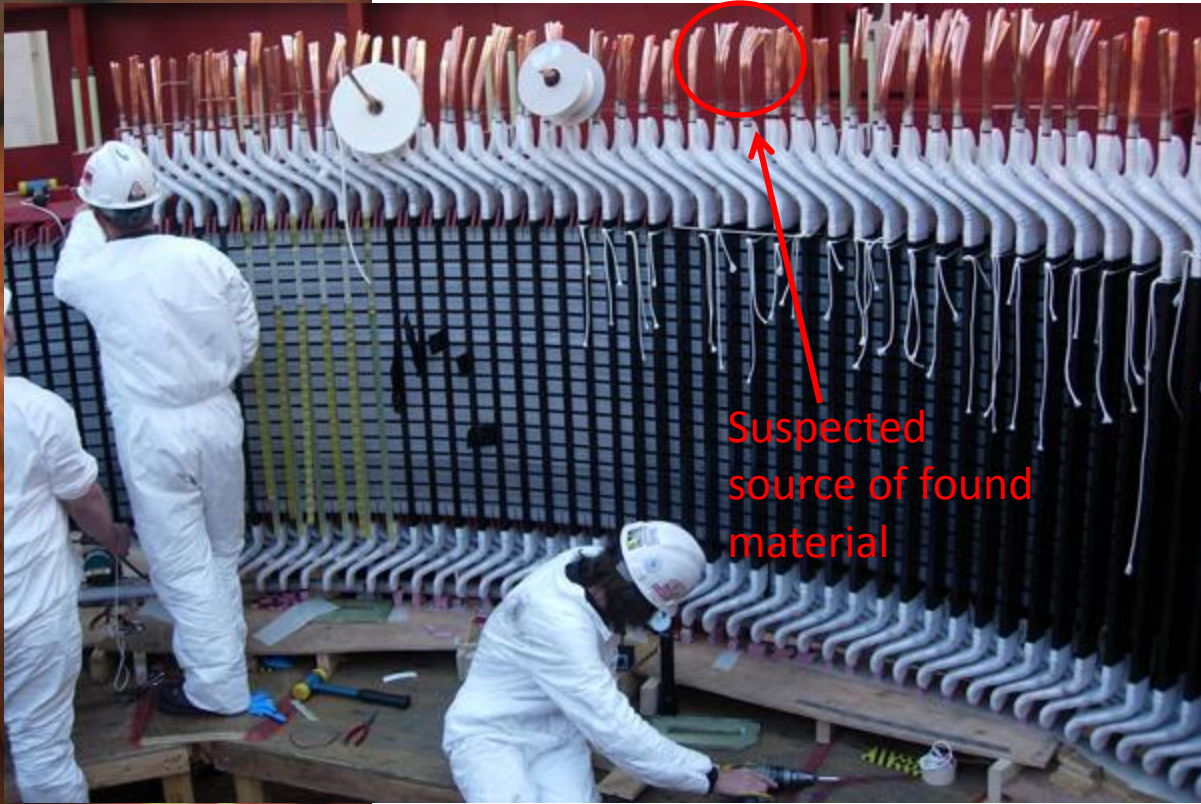
Stator Coil End Winding

Suspected source of found material

Copper coil
final braze
winding jumpers.

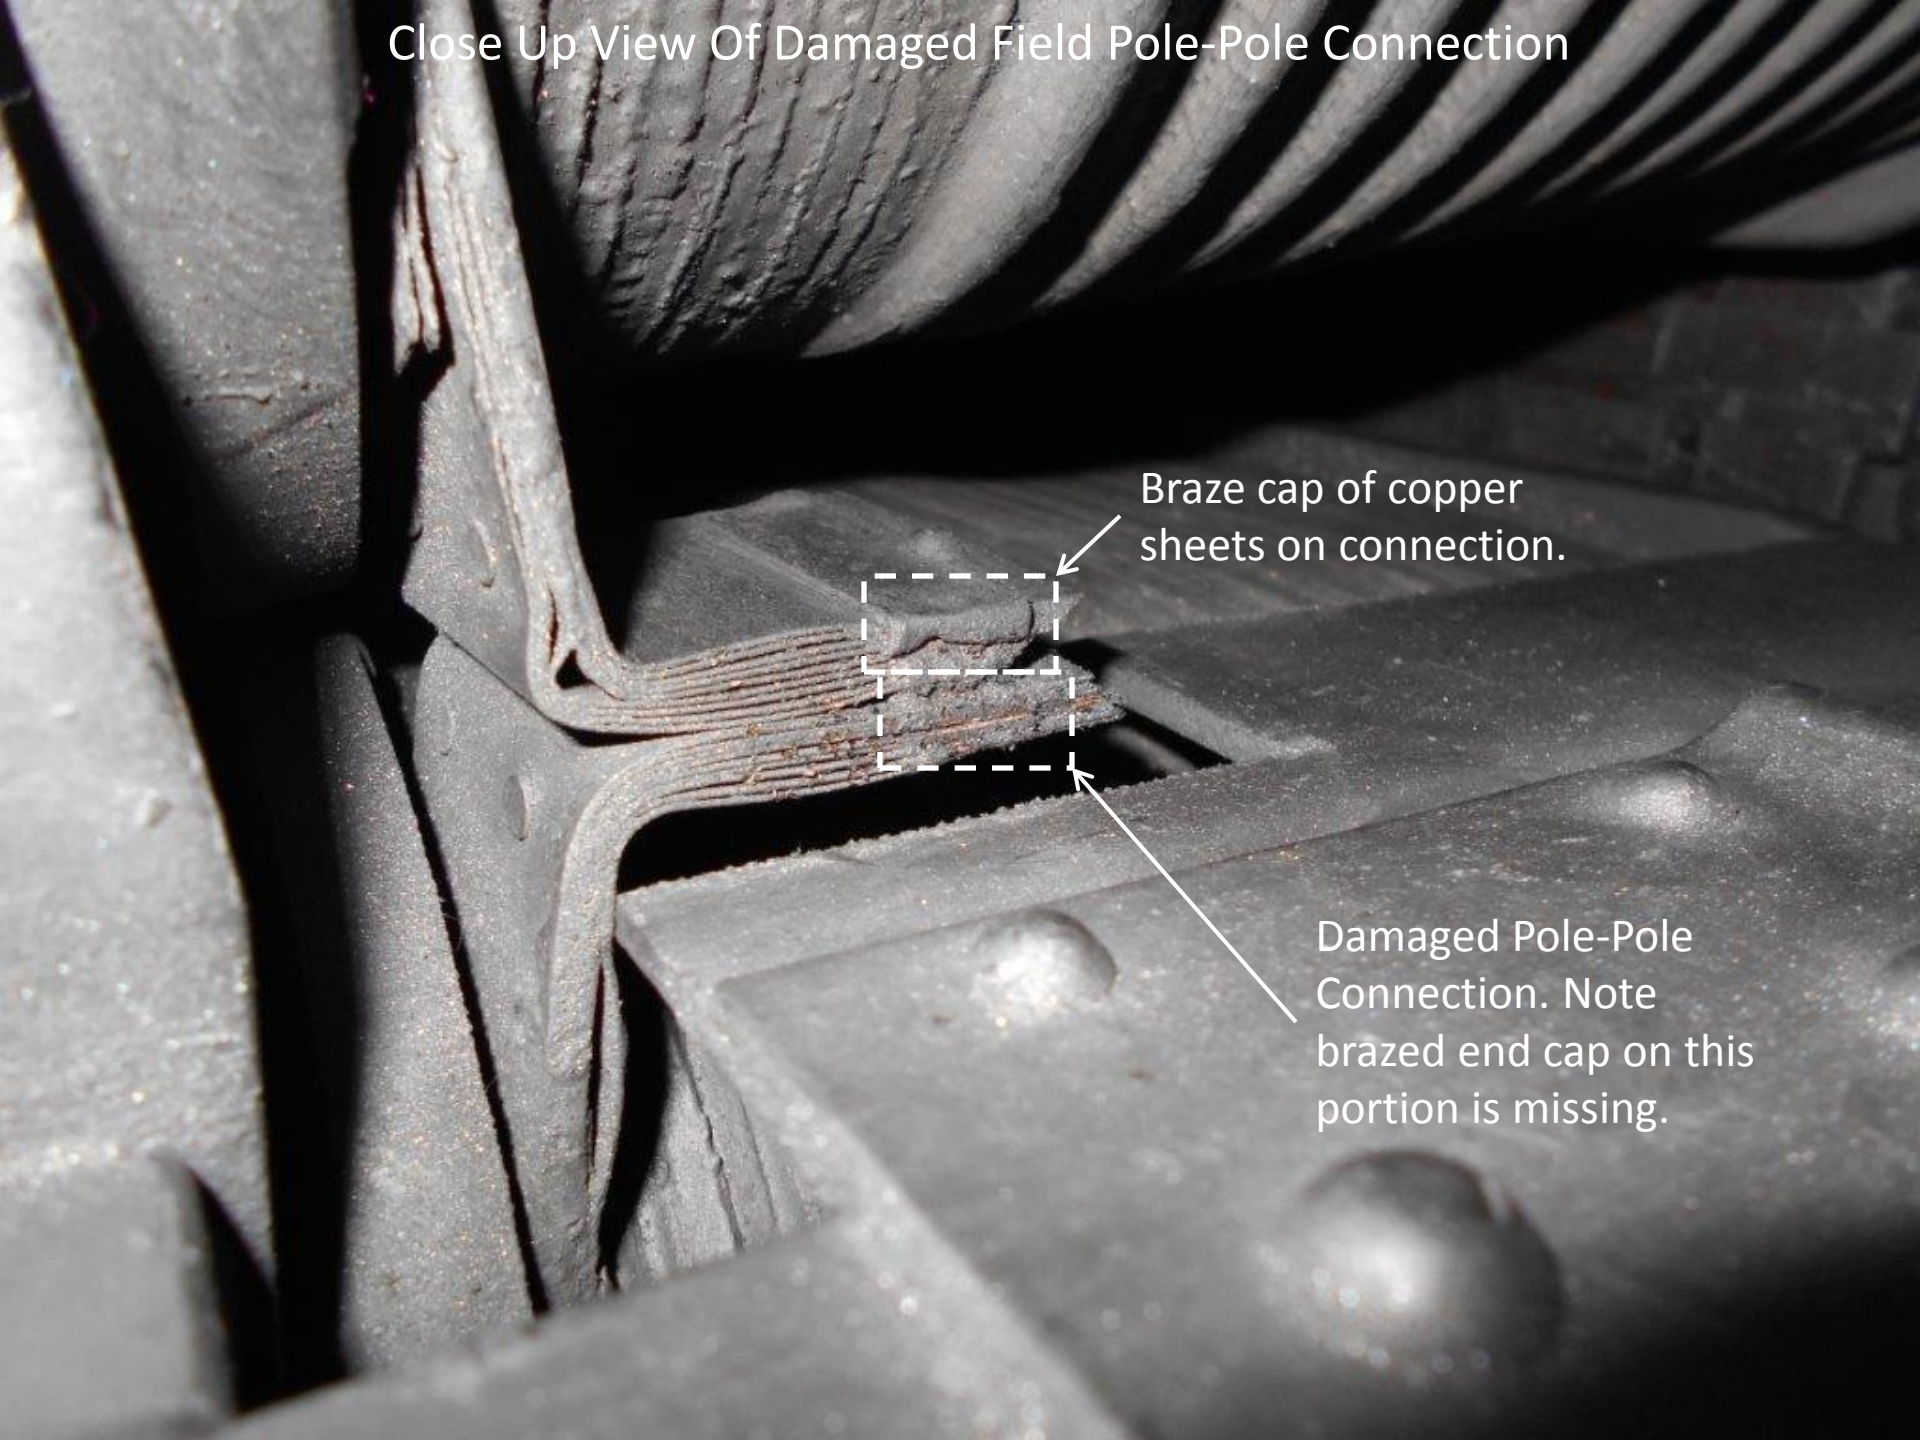
Damaged Pole-Pole Connection. Note brazed end cap on this portion is missing.

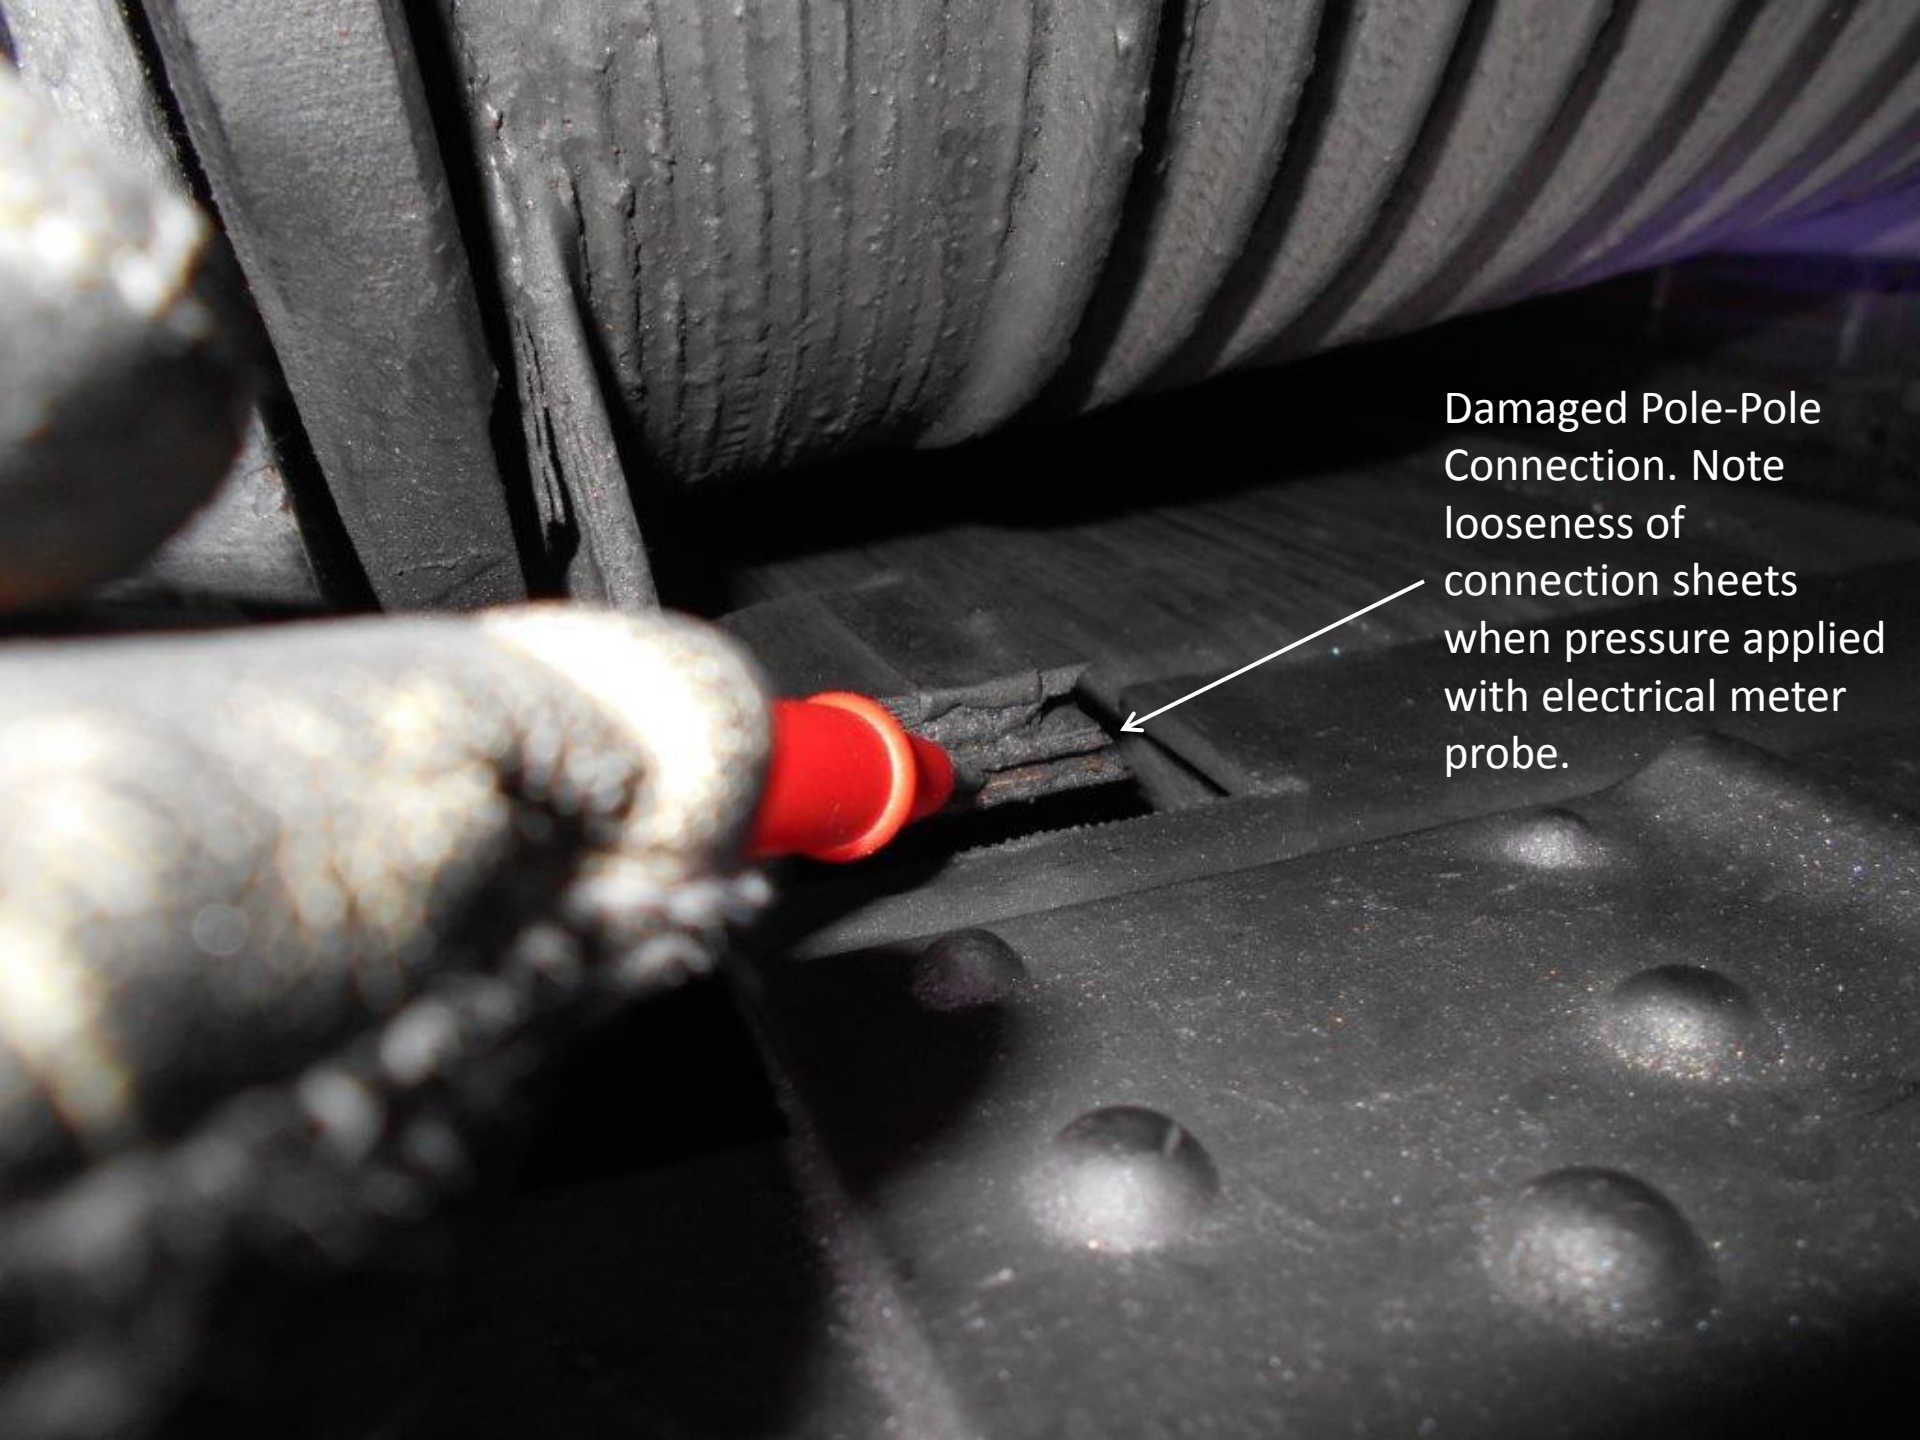
Damaged Pole-Pole Connection. Note looseness of connection sheets when pressure applied with electrical meter probe.

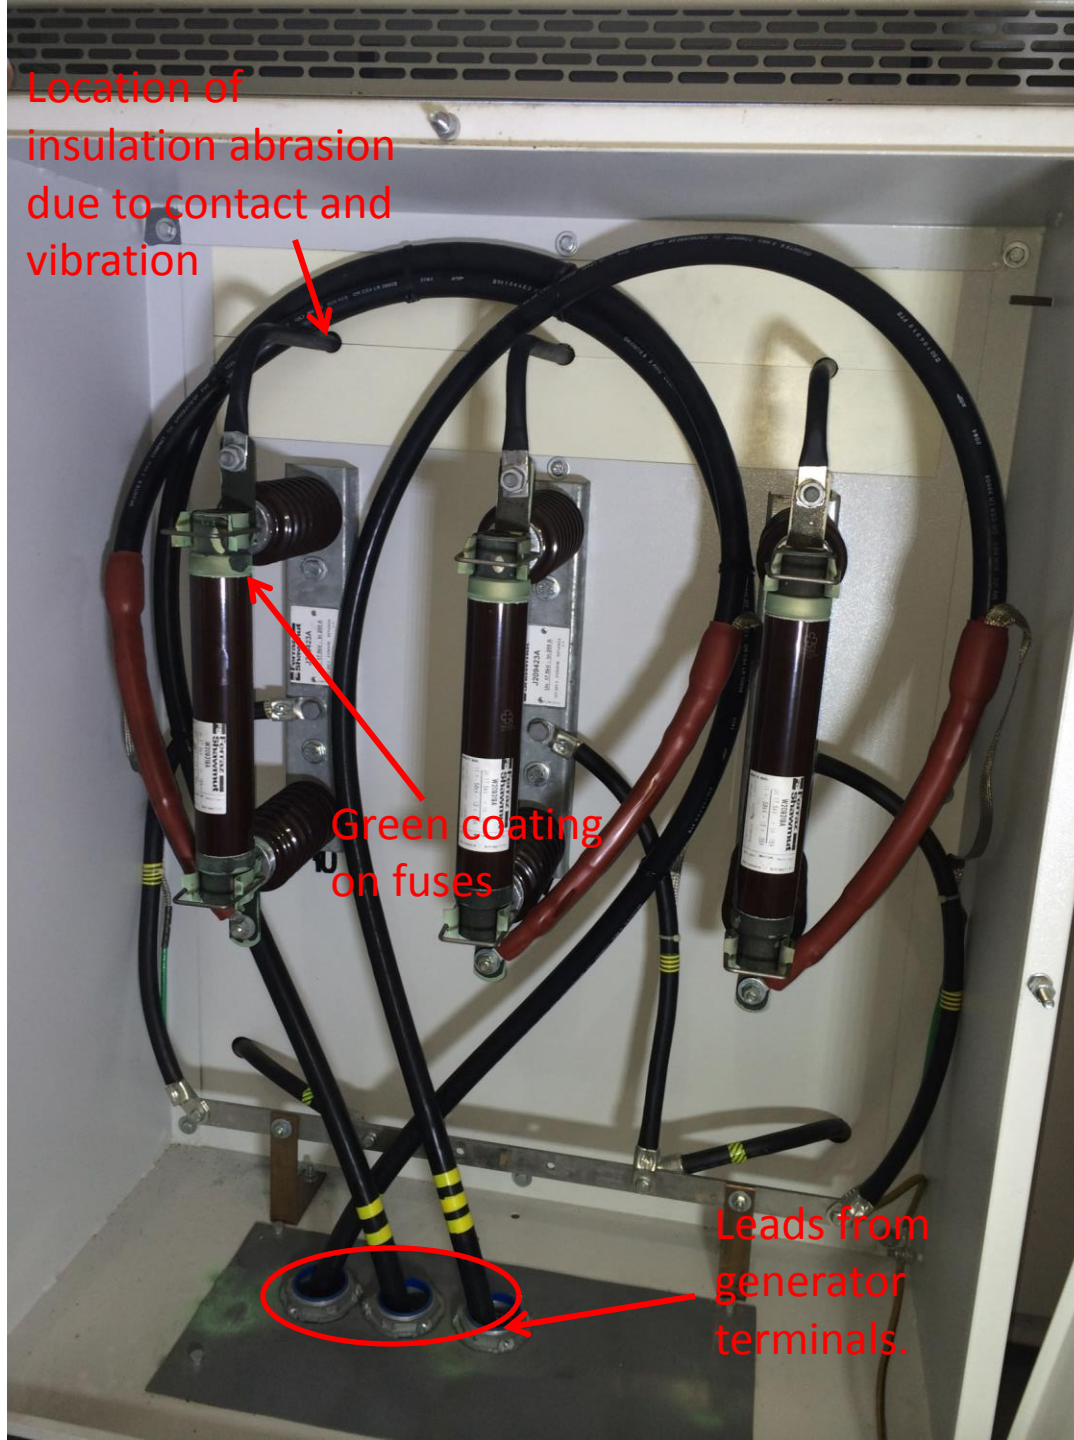
Location of
insulation abrasion
due to contact and
vibration

Green coating
on fuses

Leads from
generator
terminals.

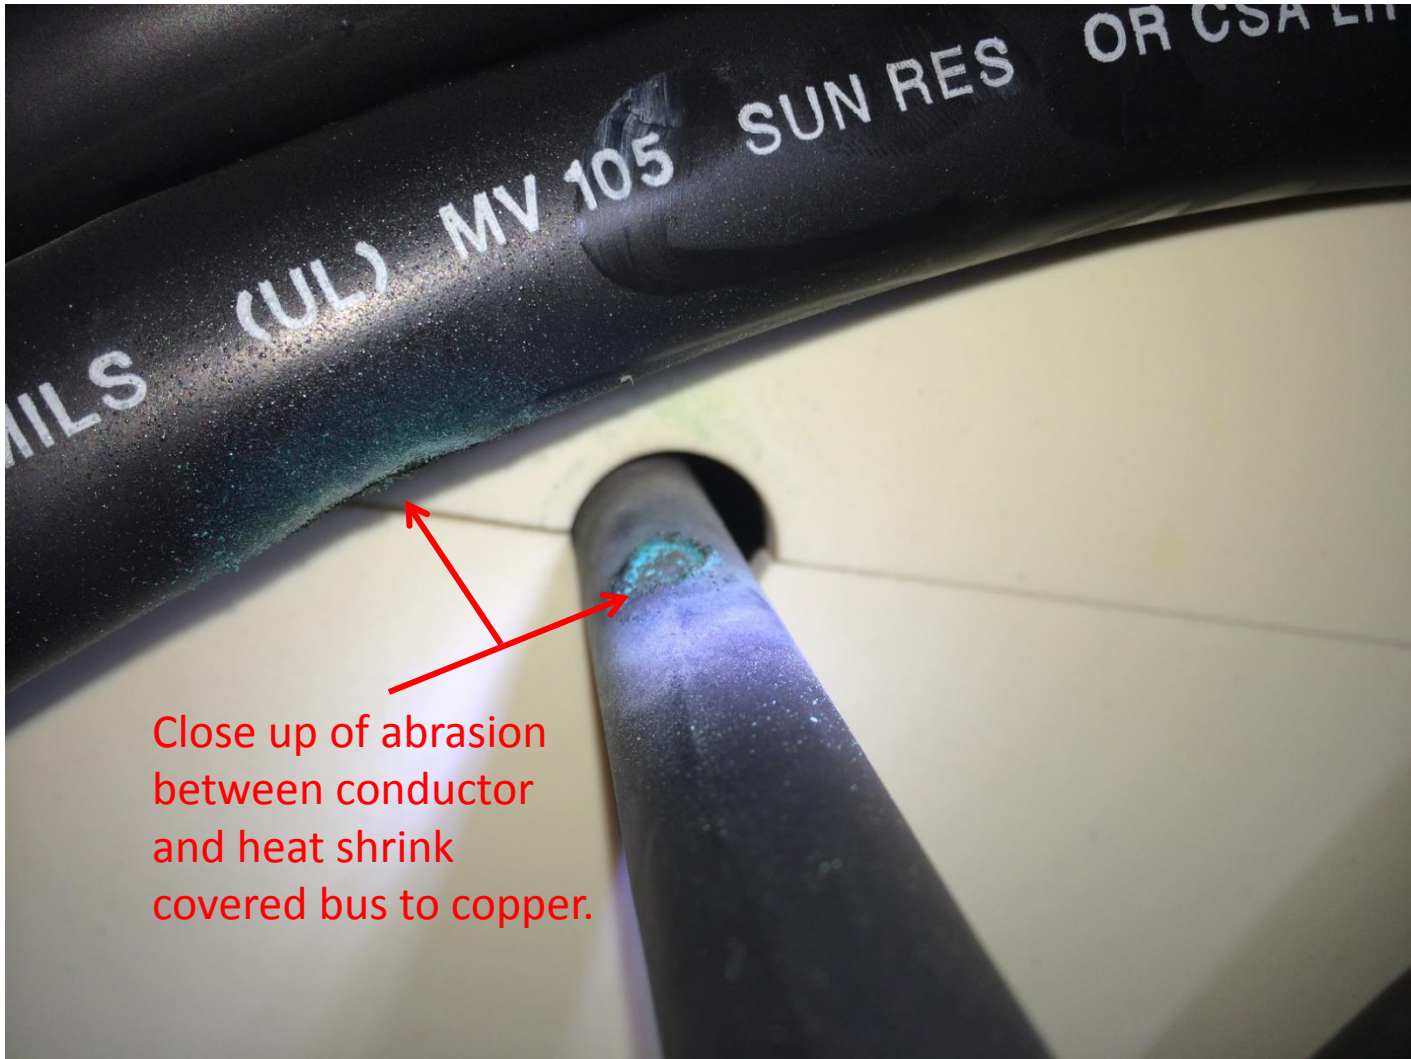
Close up of abrasion between conductor and heat shrink covered bus to copper.
