U.S. Department
of Transportation
**Federal Aviation
Administration**

General Aviation Airworthiness Alerts

AC No. 43-16

**ALERT NO. 218
SEPTEMBER 1996**

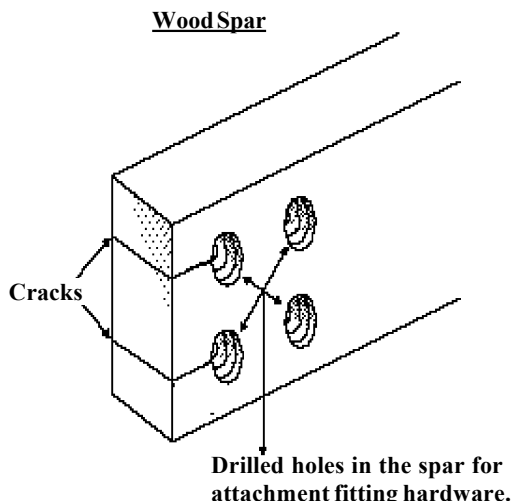
Aeronca Model 7AC Champ	Wing Spar Cracks 5740
--	----------------------------------

While dismantling the left and right wings for recovering, both wing spars were found cracked.

The cracks emanated from the two inboard attachment holes and ran through the end of the spars. (Refer to the following illustration.) This damage necessitated replacing the wing spars. It was recommended that, at every opportunity, close attention be given to all of

the spar attachment points, especially on older or high time aircraft.

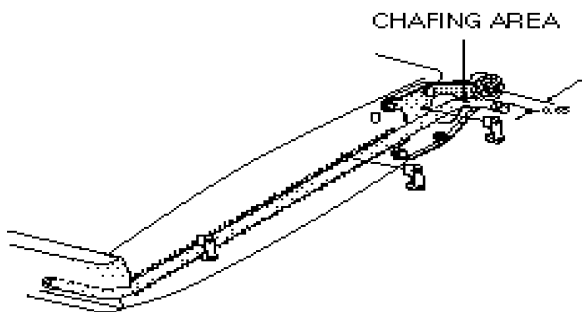
During an annual inspection, the air tube for the right elevator horn deice boot was found chafed through.

The deice tube (P/N T700A3031002101) was chafed at the point where it makes a 90 degree bend and enters the elevator tip. (Refer to the following illustration.) The tube had a small hole at the point of contact. This type defect degrades the operation of the deice system and leads to the possibility of the elevator jamming in icing conditions. Airworthiness Directive 95-11-16 and Service Bulletin 70-020-30 deal with this subject and should be consulted for requirements and applicability.

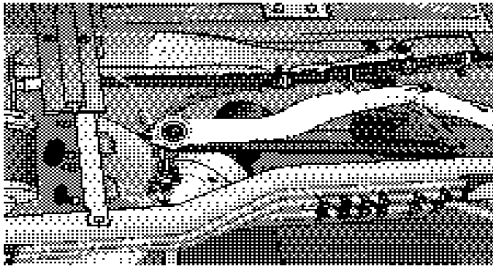
An operational test of the landing gear system was then conducted. The gear was manually operated through approximately eight cycles, and all of the rigging was checked and adjusted. The gear was then electrically operated through approximately 20 cycles. At that time, the gear failed to extend. The retraction rod was found bent and had been pushed into the rear spar web, which caused damage to the web. (Refer to the following illustration.)

Further investigation revealed the right landing gear leg (P/N 60-810103-1) was not the correct part for this application. The correct part for this aircraft is (P/N 60-810028-17). The gear leg had hung on a nut, used to secure the uplock stop, which was attached to the downlock support assembly. It was concluded that the downlock support assembly (P/N 60-810083-2) attachment point was worn. In conjunction with the incorrect part being installed, the support assembly was allowed to move laterally, during gear transit, and contact the gear leg (P/N 60-810103-1).

The submitter recommended the downlock support assembly be inspected for lateral movement, with the landing gear leg at a 45 degree angle. In addition, the manufacturer's technical data should be consulted for the correct "usable on code" for individual aircraft.

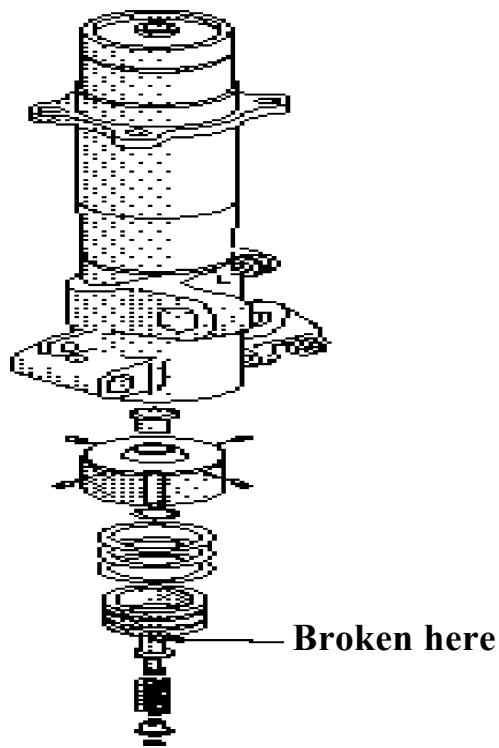
Cessna Model 500 Citation	Broken Landing Gear Piston 3222
--	--

When the left main landing gear was disassembled for an axle change, the isolation piston (P/N 6541000-200) was found broken.

This piston is surrounded by the dampening spring, and was broken at the top of the piston housing. (Refer to the following illustration.) It appeared the piston stem had been broken for some time. The submitter speculated this defect was caused by landing with the strut improperly serviced or by taxiing/towing with a flat strut.

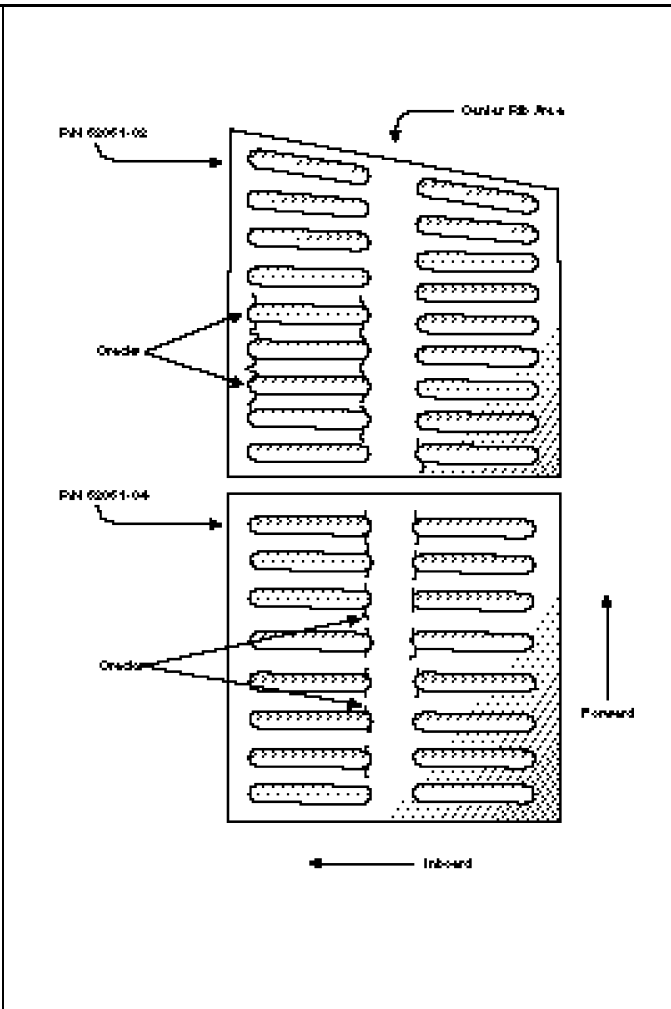
**Piper
Model PA 28-151
Warrior** **Wing Stiffener
Cracks
5730**

During an annual inspection, cracks were found in the stiffener corrugation ends of the doubler skin (underneath the wing walk-way area). (Refer to the following illustration.)

The aircraft had inspection holes below and outboard of the cracked area; however, most of the damage was inboard of a wing rib, which made finding the cracks very difficult. One indication of the existence of these defects was a "soft or spongy" feeling when weight was placed on the wing walk-way area.

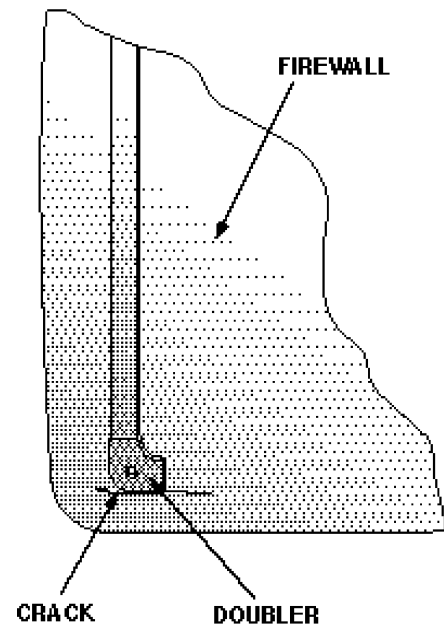
**Firewall Crack
5412**

During an annual inspection, the engine firewall was found cracked.

The crack was located between the lower right engine mount attachment point and the cowling flange. It was approximately 2.5 inches long and ran horizontal. (Refer to the following illustration.) The submitter speculated this defect was caused by metal fatigue (due to age). It was recommended that a close and detailed inspection be conducted, at frequent intervals, in the area of the firewall.

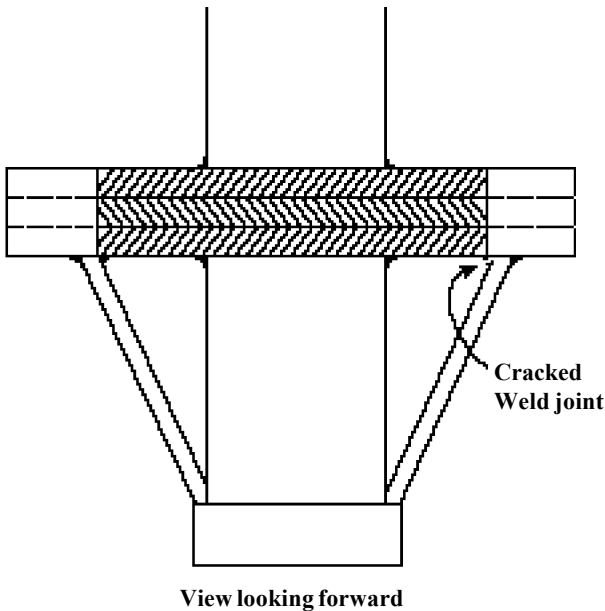
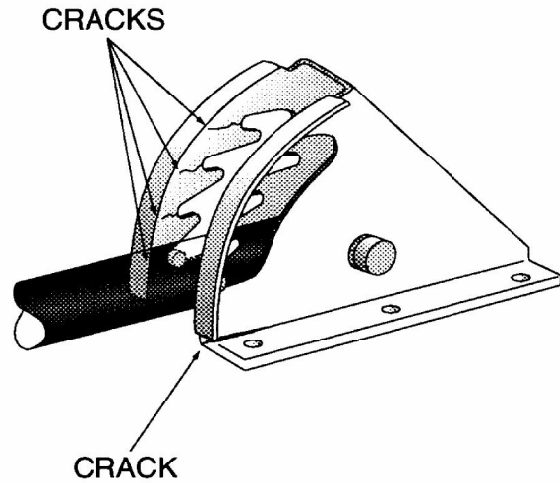
**Landing Gear
Crack
3222**

During an annual inspection, the nose landing gear trunnion was found cracked.

The crack was located on the right side of the nose gear trunnion (P/N 95723-00) "stay arm." (Refer to the following illustration.) The defect was adjacent to the weld joint and was approximately .25 inch long. This area should be closely checked during scheduled inspections and maintenance.

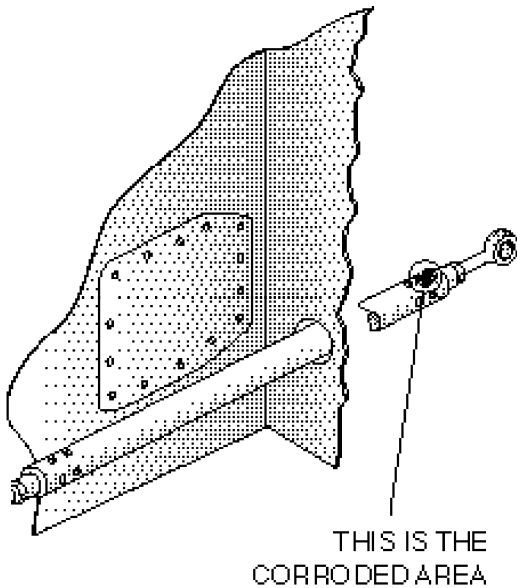
Sikorsky Model S-76A Mark II	Corroded Main Landing Gear Tube 3230
---	---

(P/N 1528-20), on the right-hand side of the damper tube (P/N 76250-02102-041), was sticking out approximately .0625 inch on both ends of the tube. (Refer to the following illustration.) The "HI-LOCK" fastener had corroded in the center and subsequently broke. The submitter recommended that a one-time inspection and replacement of all "HI-LOCK" fasteners on this tube be implemented. Additionally, an inspection was recommended every 3,000 hours, for corrosion and pitting, on the inside of the tube assembly.
