Pipeline Incident Report

005199

May 25, 2005

Animal Doctor Veterinary Clinic Explosion
902 State Highway 29 N.
Alexandria, MN

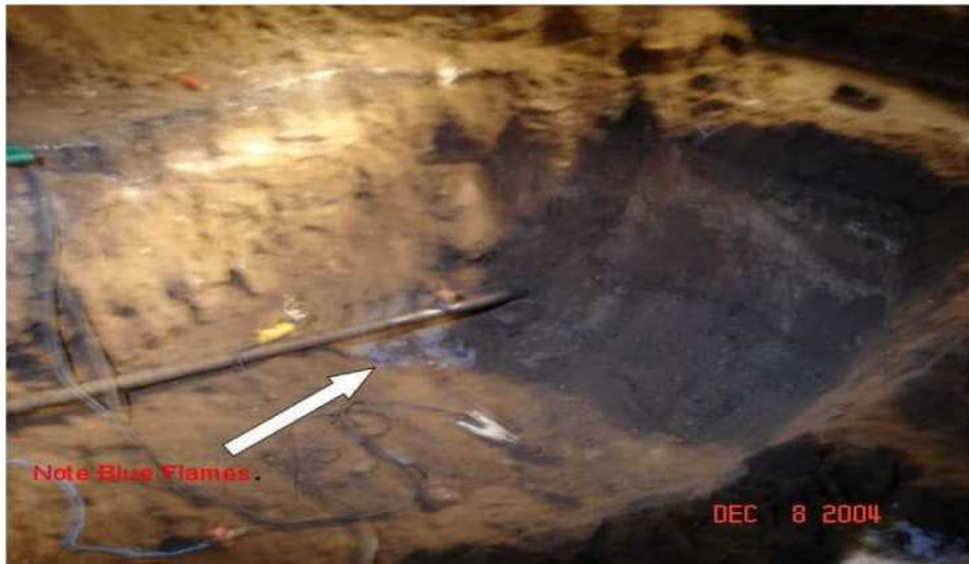
After the briefing, Haugrose witnessed CPE personnel taking gas detector readings at a water main shutoff valve located adjacent to the intersection of Sunnyside Drive and Robert Street at the SW corner and in cracks in the pavement along Robert Street to the west, where it intersects State Highway 29. All readings were at 90% gas in air. Haugrose observed CPE contract personnel (Ferguson Brothers) digging with a backhoe to expose the main that ran E/W under Robert Street between Sunnyside Drive and State Highway 29. CPE personnel picked this spot to excavate in search of the leak. After exposing approximately 20 feet of the main, CPE personnel decided to install stopple fittings at this location. When the CPE welder struck an arc, the soil caught on fire. The welder was able to extricate himself from the ditch without injury. The blue flames were not of a violent nature, burning at a consistent height of 6 – 12 inches, but rather extensively in the bellhole (see figure 1).

Figure 1 - Gas burning in bell hole

CPE personnel believed the flames would burn out in a few minutes as the saturation burned off. However, after a period of 30 – 45 minutes, the flames remained consistent, indicating the soil was continuously being fed natural gas. After this amount of time, CPE personnel decided to have Ferguson Brothers continue excavating upstream from this bell hole with the flames still emanating from the ground. At this point, Haugrose intervened and strongly suggested to Mr. Zilka and Mr. Headlee that CPE shut off all gas to this area prior to continuing any further excavating. He proposed two options to them; one - going upstream and shutting off the nearest mainline valve or bar holing upstream along the main until a point was reached where there was no indication of gas in the ground, and at that point excavating and installing stopple equipment to stop the flow of gas. CPE elected to install the stopple equipment upstream, as shutting off the nearest valve would interrupt service to a large number of customers in 29 degree weather.

Haugrose observed CPE personnel bar holing and taking gas detector readings upstream along the main, and within 200 feet, a point was selected that had no gas in air readings. At this point a bellhole was excavated, and by 4:00 a.m. a stopple valve was installed and closed. Almost immediately, the flames in the original bell hole extinguished. More bar hole readings were taken and the concentration dropped quickly.

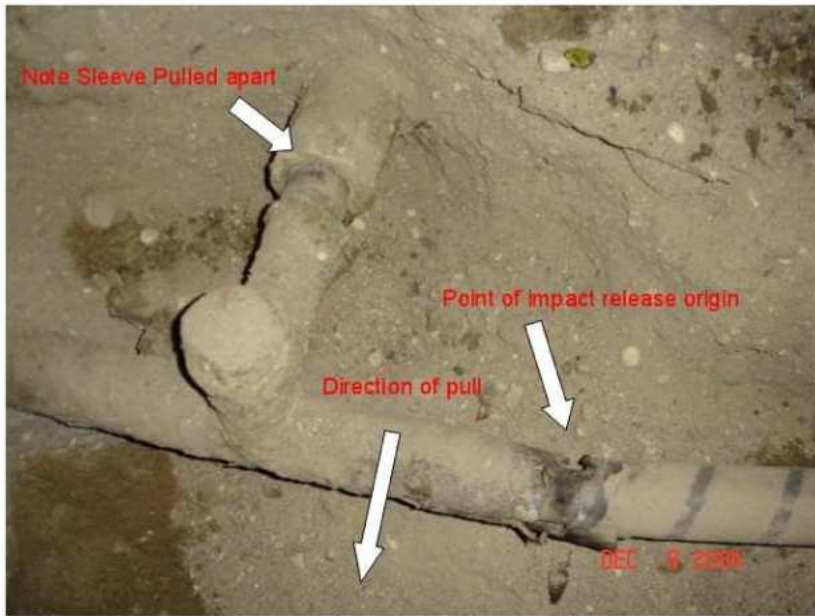
When it became apparent that the leak was contained, the search for the leak source began once again. The CPE personnel had knowledge of certain excavation work that was done in the summer of 2004 at the intersection of Sunnyside Drive and Robert Street, so they elected to excavate at this location. They soon uncovered a two inch Dresser Style Tee fitting that ran to the north under Sunnyside Drive from the E/W running main under Robert Street. The fitting had some deteriorated coating and CPE personnel decided that this was the leak site and prepared to cut out the fitting. Steinbach was observing this operation and couldn't determine if this fitting was leaking by looking at it. He challenged CPE's assessment and Haugrose had CPE crack open the stopple valve. It became apparent that although the coating had deteriorated, the fitting was not leaking. The excavation continued upstream and by 5:00 a.m. another compression was found that ran to the south under Sunnyside Drive, and about two feet upstream of this fitting, the leak source was identified. The two inch main had evidence of coating damage, and the pipe was kinked. A crack had developed beginning at 0 degrees to almost 180 degrees looking upstream at the main. The tee fitting had the sleeve pulled apart approximately 4 – 6 inches in a northerly direction. It was obvious that some mechanized equipment had hooked the main and pulled it in a northerly direction. CPE had never been informed of any damage to the main. (See figure 2.)

Figure 2 – Leaking natural gas main

CPE then cut away the affected area in three locations, including the Dresser style tee, bagged it, and took it into custody for storage and testing. New pipe and a new tee fitting were fabricated on site and tested to 100 psig with Haugrose observing the test. The fabrication was then installed in the cutout portion of the main (Figure 3). The new piping was properly coated and existing coating was repaired as necessary (Figure 4). The service line to the affected building was capped, and the repaired installation was pressure tested to 100 psig for one hour. After completion of the test, the service line was cut away and abandoned in place. The service tee was capped, the stopple valve was opened, and the line was purged of air and put back into service. The affected customers in the area were relit and the evacuees were allowed back into their homes. The traffic barriers were opened by

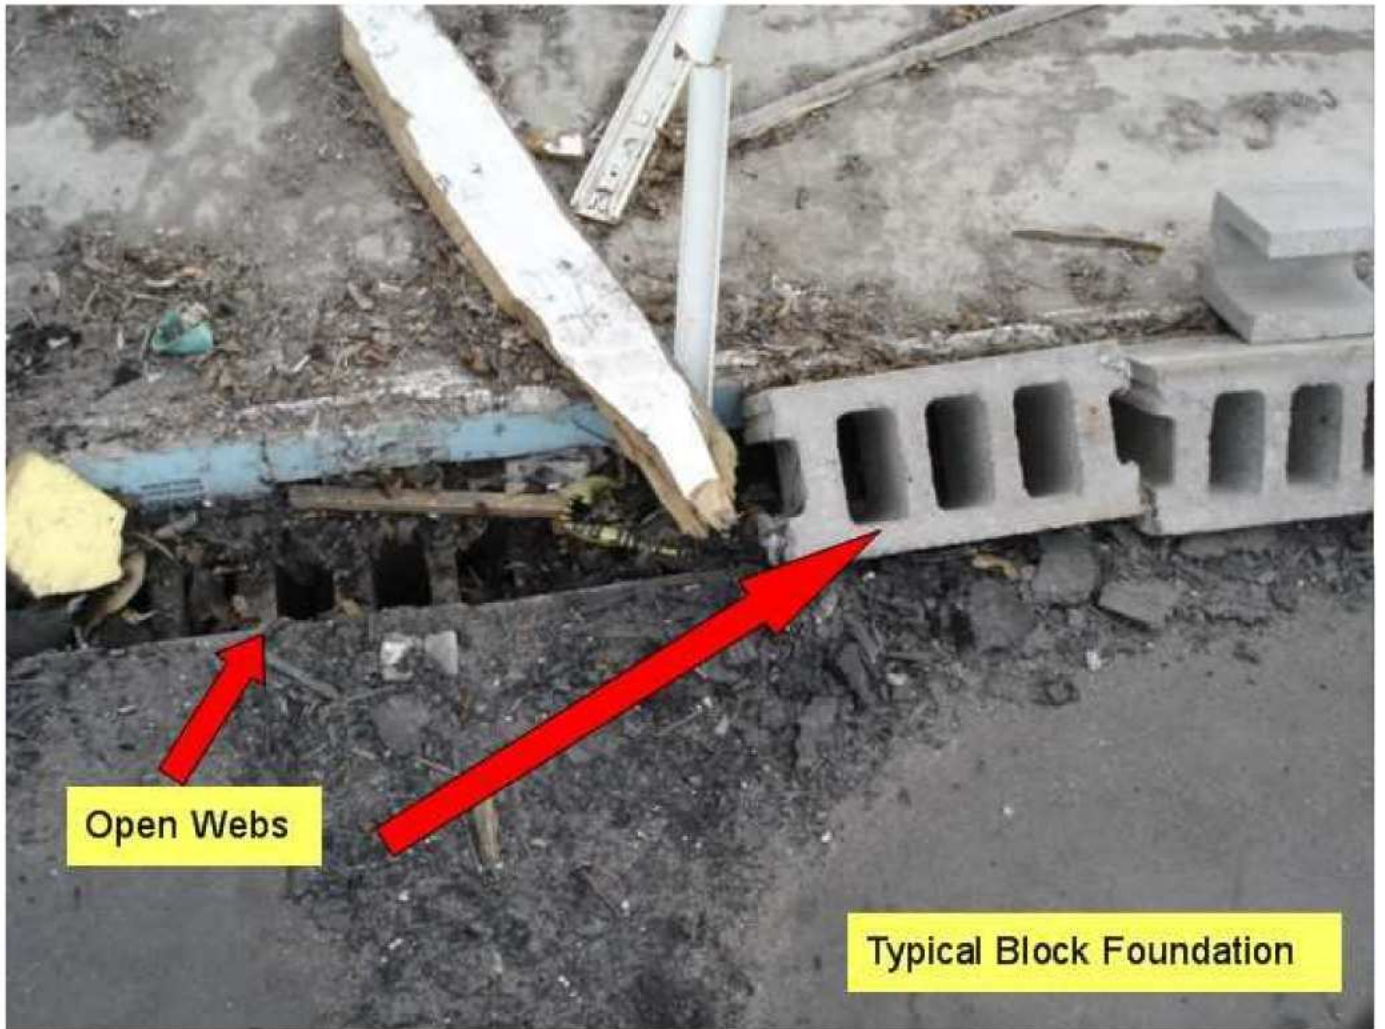
Figure 5

The fuel source was provided by the leaking natural gas main, and the gas migrated into the building through the foundation wall, where it was ultimately ignited by a piece of equipment, most likely a gas fired boiler, or water heater, in the utility room. This is supported by observations of the foundation and building wreckage, which indicate open webs in the concrete block, as well as abandoned tubing which provided a direct conduit from the soil through the foundation wall. Figures 5-8 illustrate open webs in the concrete block as well the abandoned PEX tubing.
