**ASPHALT CONCRETE  
PATCHING MATERIAL  
EVALUATION**

**Interim Report**

**SR 548**

1. Report No. OR-RD-01-19		2. Government Accession No.		3. Recipient's Catalog No.	
4. Title and Subtitle  Asphalt Concrete Patching Material Evaluation Interim Report				5. Report Date June 2001

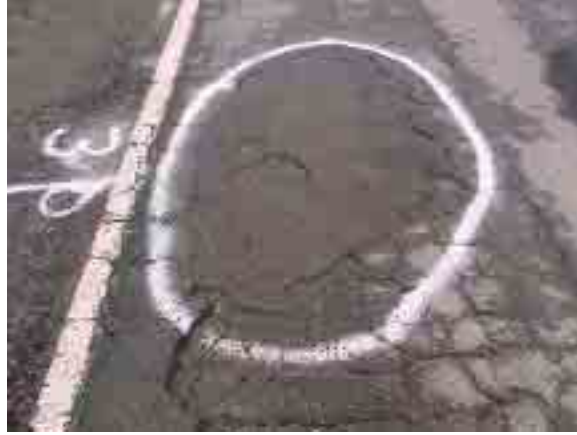
- One of the Albany mix potholes was a partial failure (Figure 4.9), which could have been caused by not rolling over the whole 457-mm (18-in) wide patch. This partial failure changed little over five months of monitoring. The other Albany mix patch was a complete failure (Figure 4.10).
- The Instant Road Repair patch failure resulted from the center portion wearing away (Figure 4.11).
- The King Patch product was a complete failure in less than a week.

Figure 4.11: Instant Road Repair failure after one week

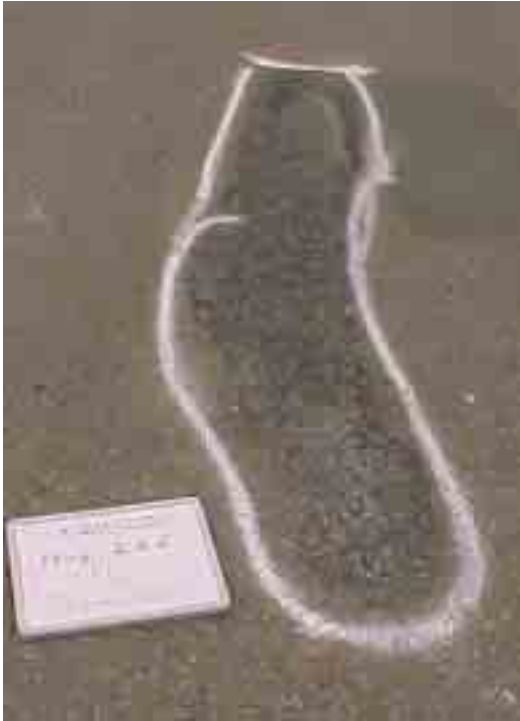
Figure B.3: Perma Patch failure on Hwy 226

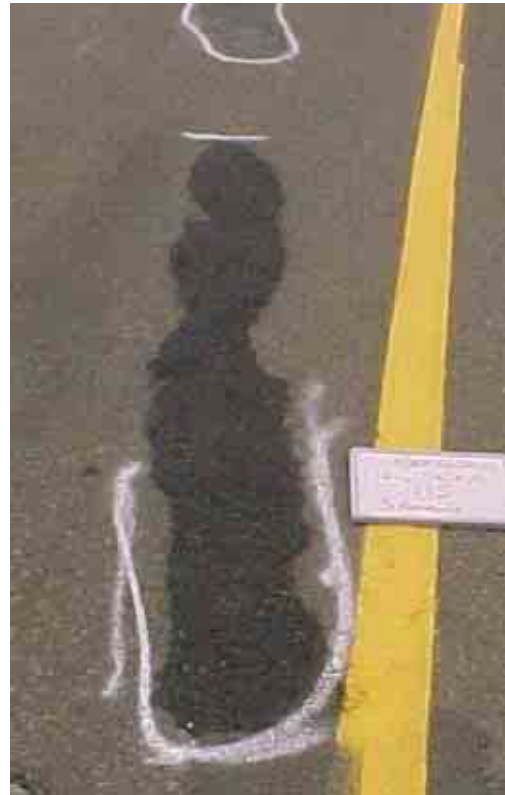
Figure B.5: Albany material performed well

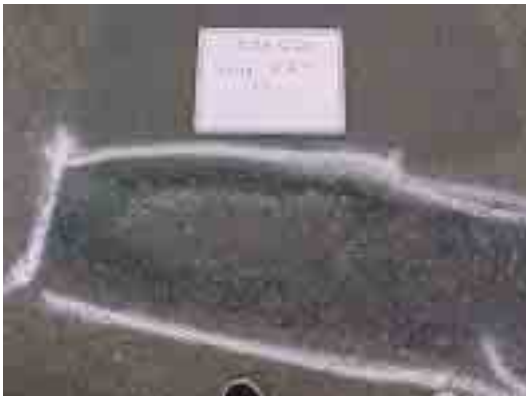
Figure B.4: Close-up of Perma Patch failure
