Signature Home Inspection

1234 School House Road
Yourtown, US 12345

Prepared for: Bob Smith

Prepared by: Signature Home Inspection
1008 Rose
Highland Heights, OH 44143

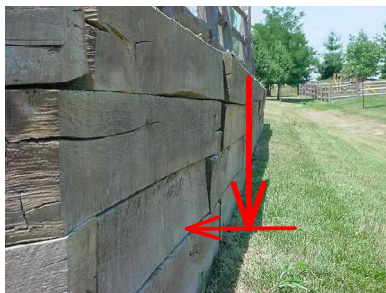
- 5. Balcony: Concrete
- 6. Porch: Concrete
- 7. Vegetation: Shrubs with some weeds
- 8. Retaining Walls: Railroad ties The wall is showing signs of movement, but appears to be stable at this time. A qualified contractor is recommended to evaluate and estimate repairs to maintain the wall.

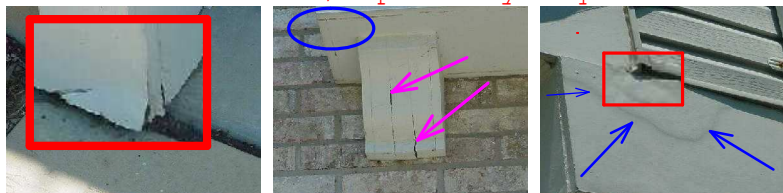
1. Water damage to trim wood at either side of garage door from moisture wicking into the finished particle board. The surface is starting to delaminate. Recommend repair/replacement of the trim boards and silicone seal wood that is in contact with concrete to prevent wicking.

2. The wood window boxes have water damage and will require repair/replacement. The wood has started to separate at the supports and at the corners of the window boxes.

3. The trim board at the southwest corner of the porch has water damage due to water penetration and will require repair/replacement of the wood. The trim board extends out creating a ledge allowing water to collect on the top edge of the board and cause the wood to rot.

Recommend estimate/repairs by a qualified contractor.

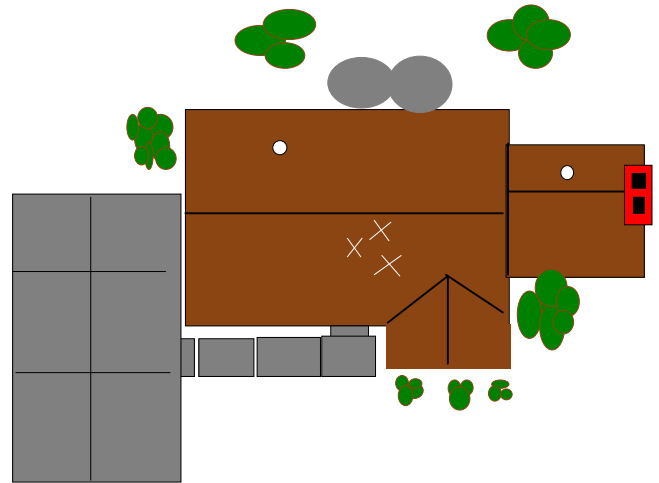
- Method of Inspection: On the roof
- Unable to Inspect: 30% Height of the roof
- Material: Fiberglass shingle Missing roof shingles from wind damage as marked "x" in diagram. Repairs are required.
- Type: Gable

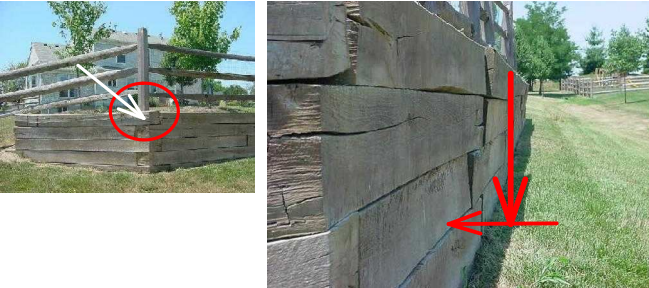
1. **Vegetation:** Shrubs with some weeds
2. **Retaining Walls:** Railroad ties The wall is showing signs of movement, but appears to be stable at this time. A qualified contractor is recommended to evaluate and estimate repairs to maintain the wall.

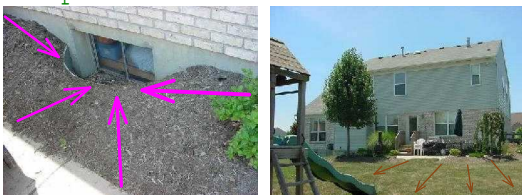
1. **Deck:** Treated wood The deck has been built below acceptable building standards and is not safe in its current state. Recommend further evaluation and estimate to bring deck up to an acceptable building standard.
2. **Grading:** Moderate slope The grade and landscaping materials are too high and extend above the window well at the Northeast rear of the home. Recommend that the grade be reduced or the metal window well soil retainer be replaced with a taller unit to keep the mulch and soil beds from washing into the well.

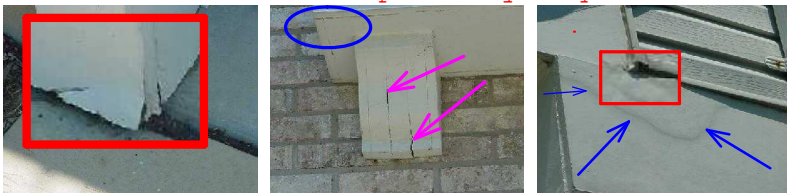
1. Water damage to trim wood at either side of garage door from moisture wicking into the finished particle board. The surface is starting to delaminate. Recommend repair/replacement of the trim boards and silicone seal wood that is in contact with concrete to prevent wicking.

2. The wood window boxes have water damage and will require repair/replacement. The wood has started to separate at the supports and at the corners of the window boxes.

3. The trim board at the southwest corner of the porch has water damage due to water penetration and will require repair/replacement of the wood. The trim board extends out creating a ledge allowing water to collect on the top edge of the board and cause the wood to rot.

Recommend estimate/repairs by a qualified contractor.
