Property Inspection

**41 Forest Drive
Parklands, Christchurch
STRUCTURAL REPORT**

July 2012

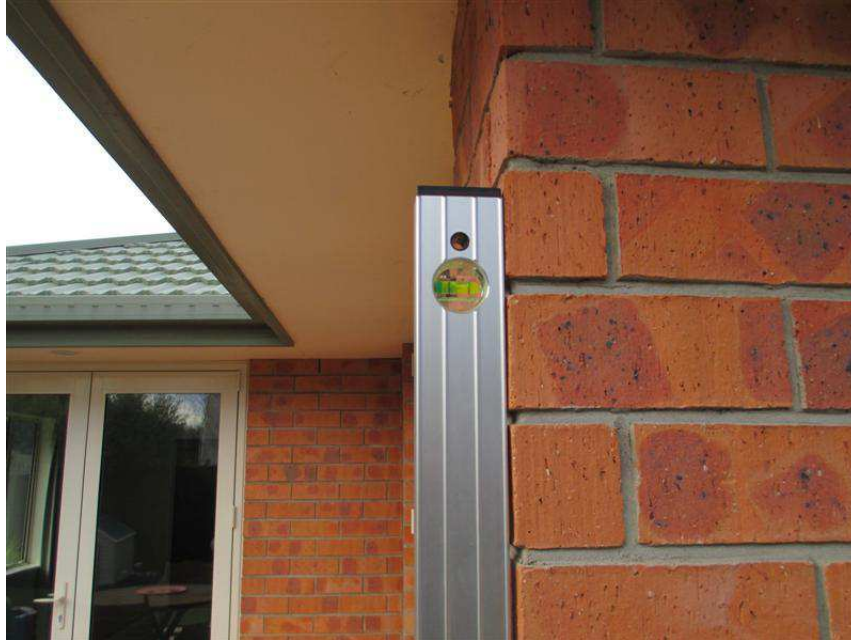
The external surfaces and walls were checked with a 1200mm digital level which revealed a slight lean on some walls to the north. This lean is insignificant and is likely to be remedied when the foundation and damaged floor slab is repaired.

Figure 3 - External wall checks revealed minor lean to the northeast

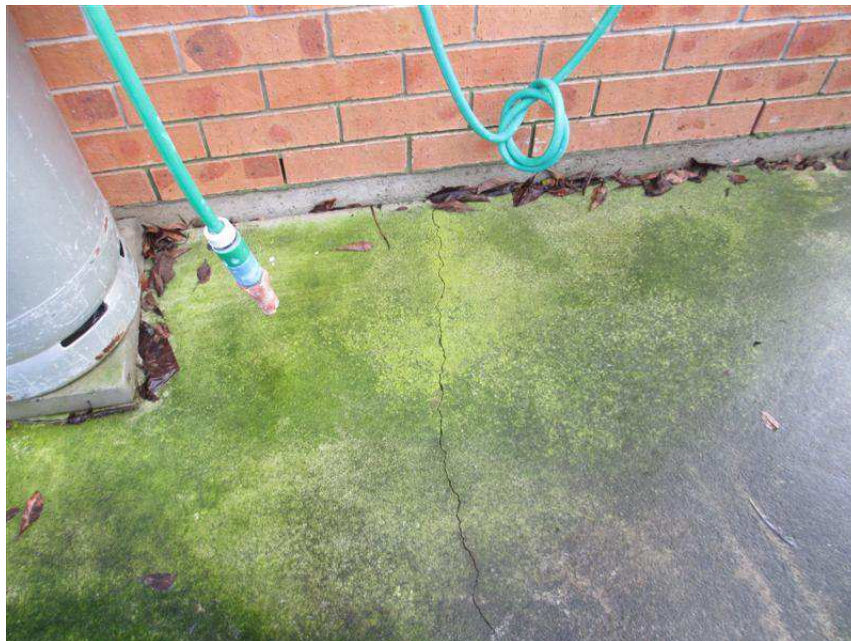
Figure 4 - Minor crack in pavement on southeast side

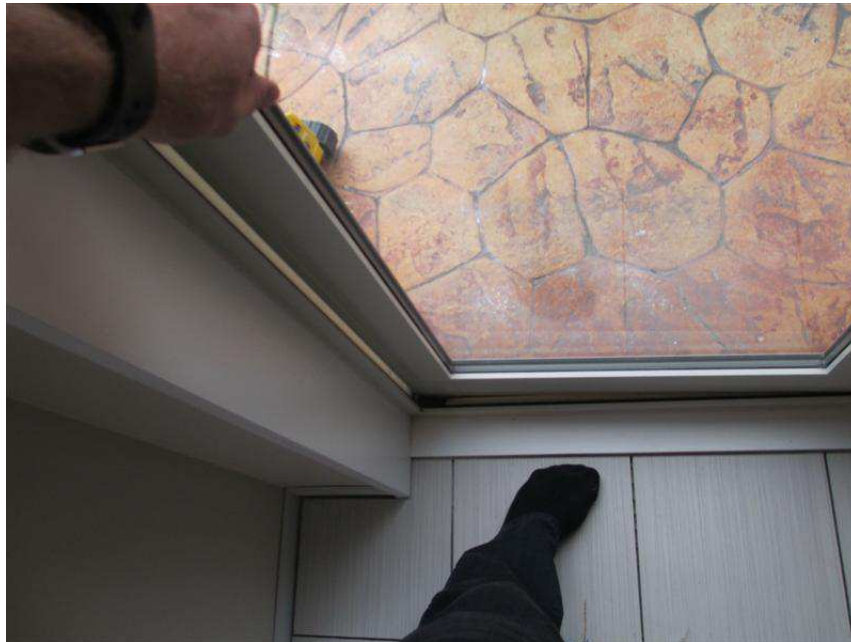
The lines of the roof, guttering, spouting and flashings were straight and there were no signs of damage or failure. The external joinery and doors appeared to be in good condition with only minor movement noted in the west facing lounge joinery.

Figure 5 – some evidence of movement in external lounge door

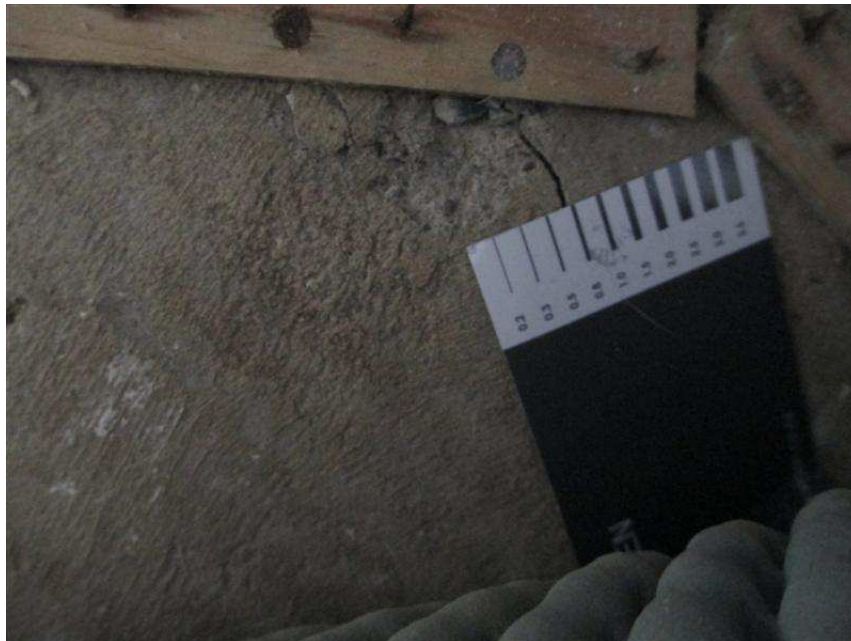
A small crack of approximately 0.8mm is evident in the concrete floor in the lounge. It is likely given the extent of settlement that more small cracks will be present once the floor linings are removed. These cracks should be repaired once the foundation and re-leveling work has been carried out.

Figure 6 - Crack in lounge floor slab (up to 0.6mm)

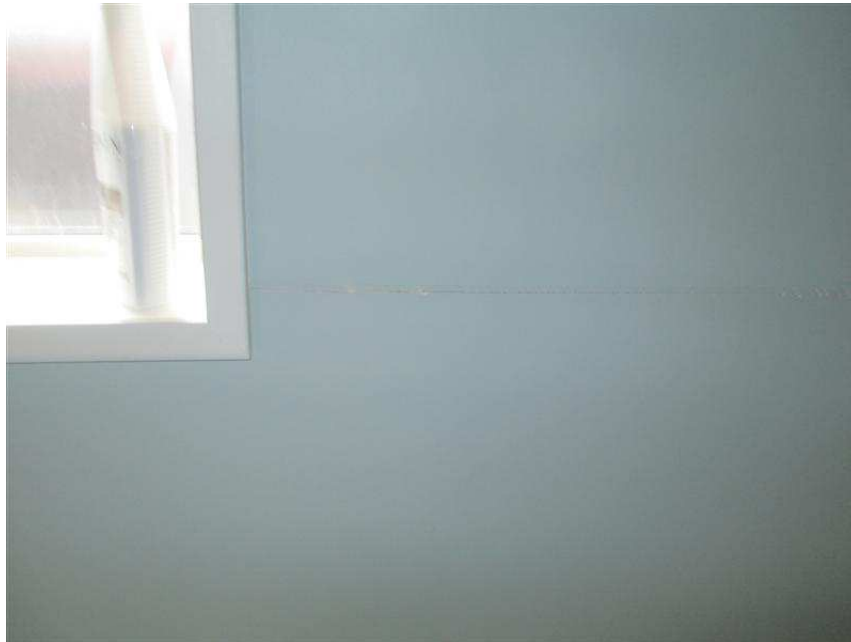
A visual inspection of the linings revealed evidence of minor damage as would be typical of a house that has undergone settlement. This damage is most significant in the ensuite of the master bedroom where a horizontal crack extends from the corner of a window opening. Cracking in linings generally propagate from point of high stresses such as the corners of penetrations in wall linings and can easily be repaired. The repair methodology depends on the extent and width of the crack.

Figure 7 - Horizontal crack in Gib lining in ensuite

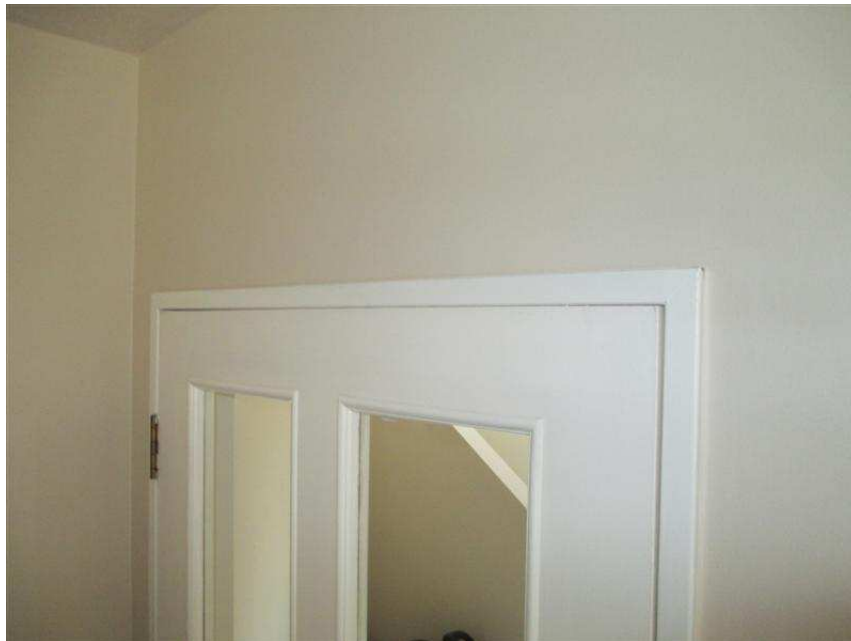
Figure 8 - Slight twist in internal door frame - door still opens and shuts

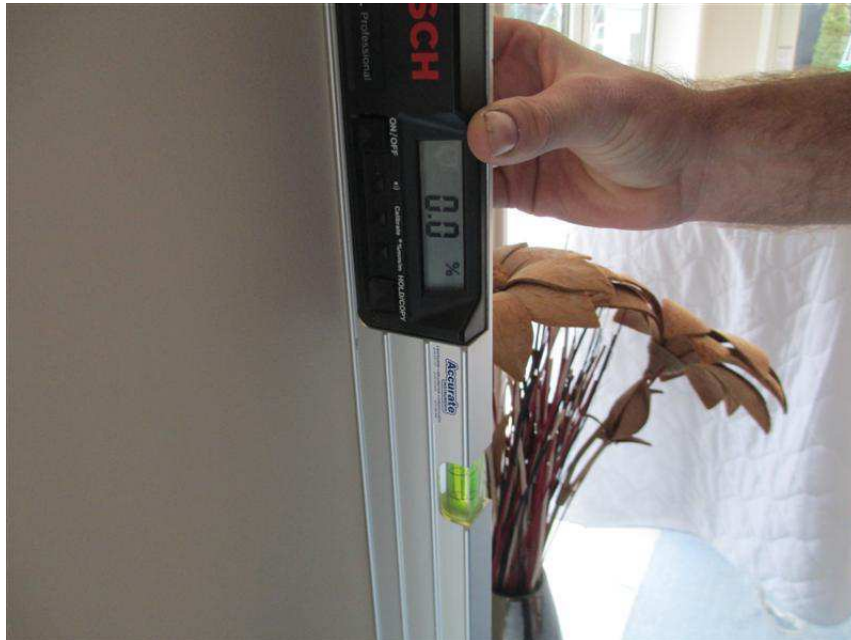
Level checks (with a digital level only) and lining inspections in the first floor rooms revealed no significant damage. The levels mirrored the ground floor, and there was very little damage to the linings. A sample of the doors and joinery were checked revealing no evidence of significant movement.

Figure 9 - Level checks on both ground and upper floor were generally good, minor lean to the northeast

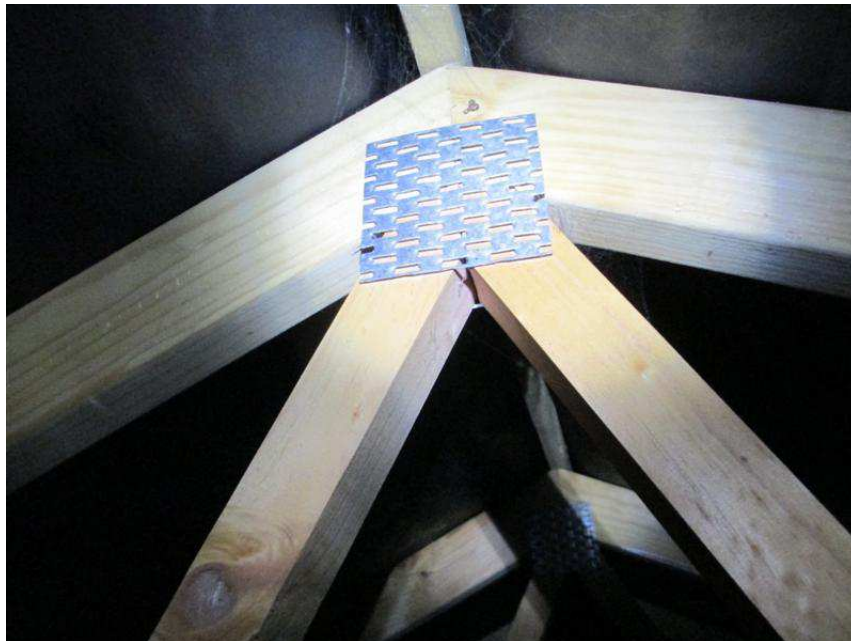
Figure 10 - Roof framing connections sound

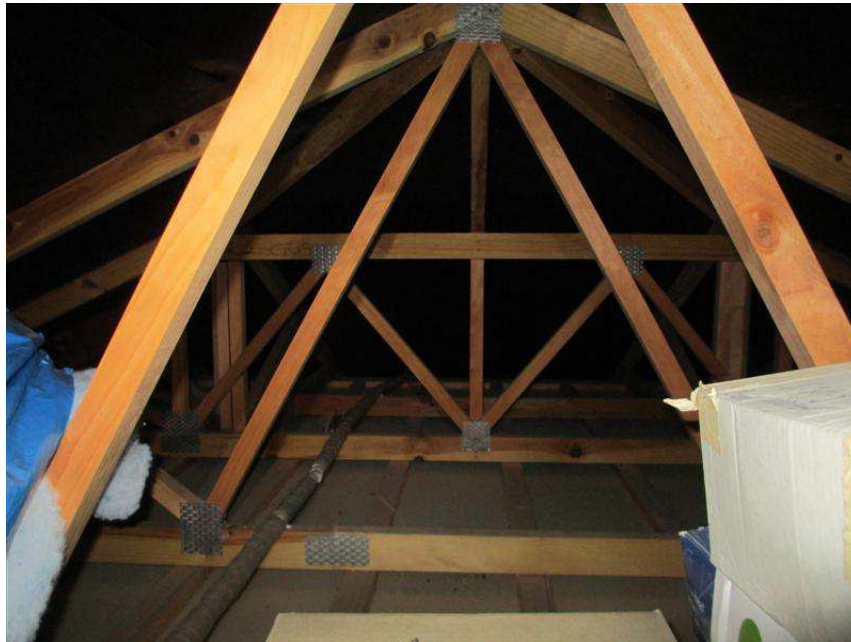
The timber roof framing was visually inspected from the access hatch. The framing is generally in good condition, with solid connections and straight framing.

Figure 11 - Roof framing in good condition
