Failure Investigation Report – Columbia Gas Transmission Rupture – Activity ID 122980

Principal Investigator Dave McMillan, PHMSA ER
Regional Director Byron Coy
Date of Report 2/18/2011
Subject Failure Investigation Report – Columbia Gas
Transmission Pipeline Rupture

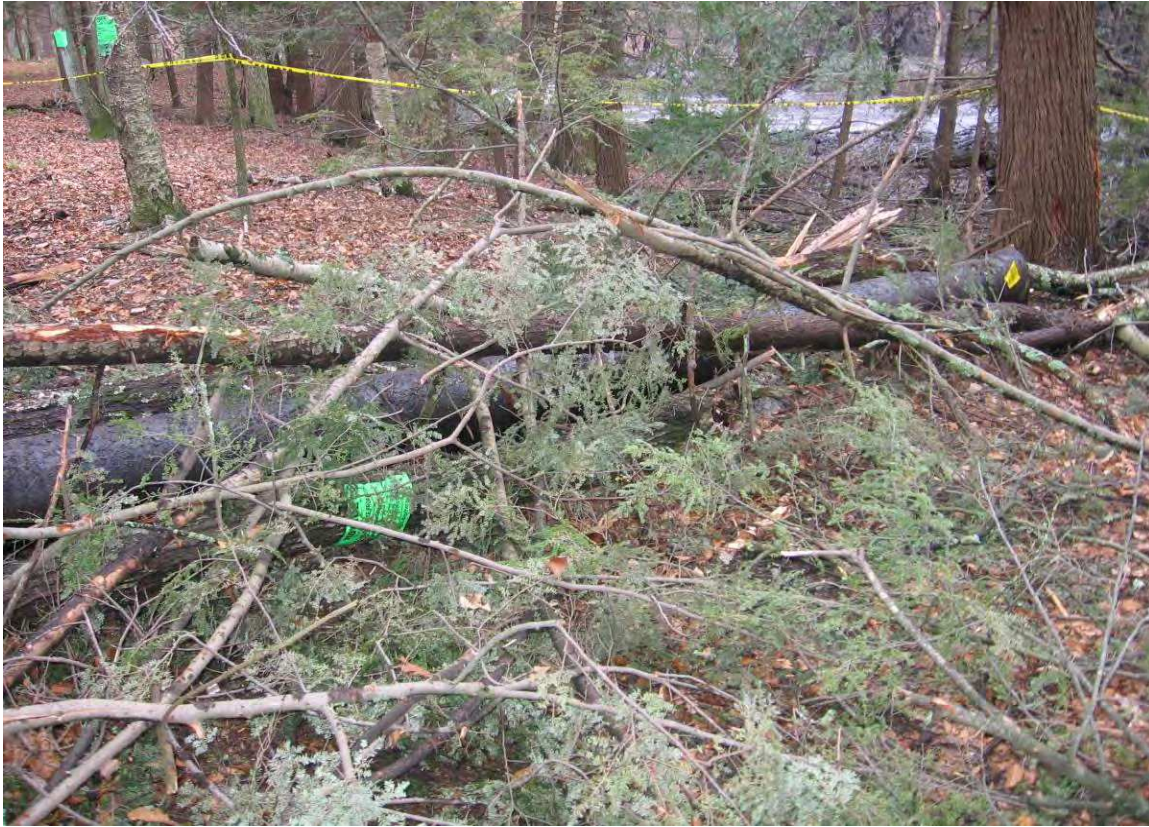
Figure 1: Severed 14.9 foot section of pipeline

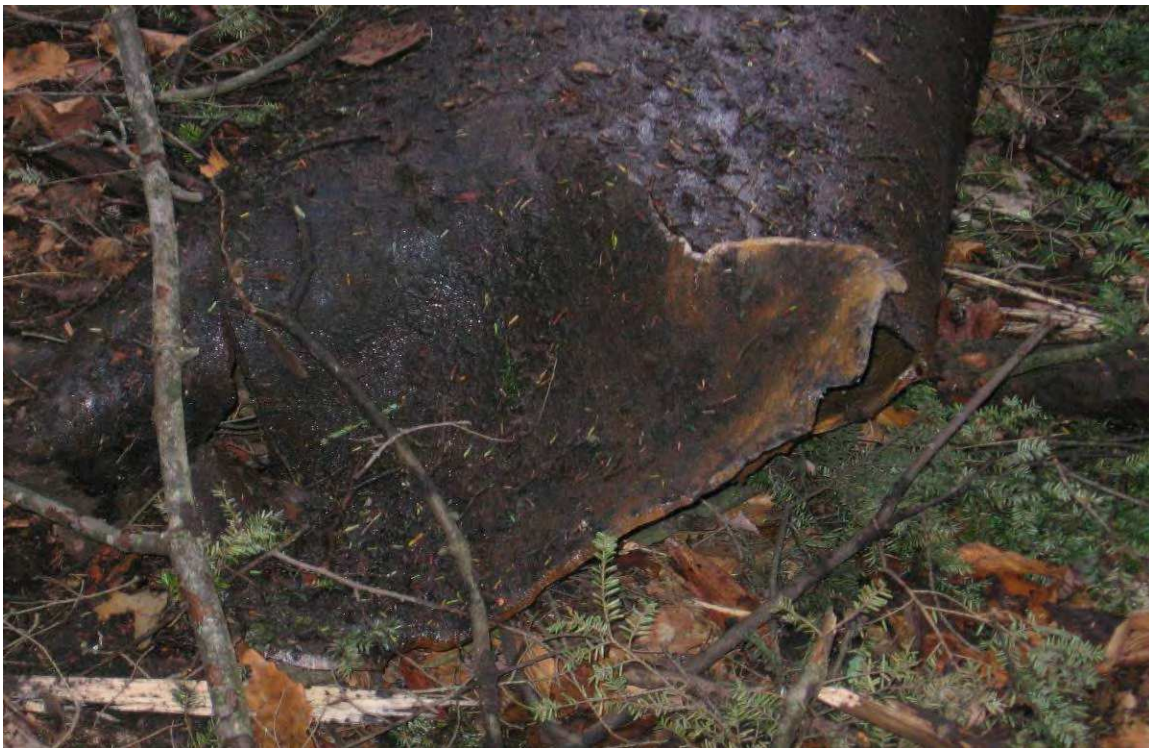
Figure 2: Severed 37.1 foot section of pipeline

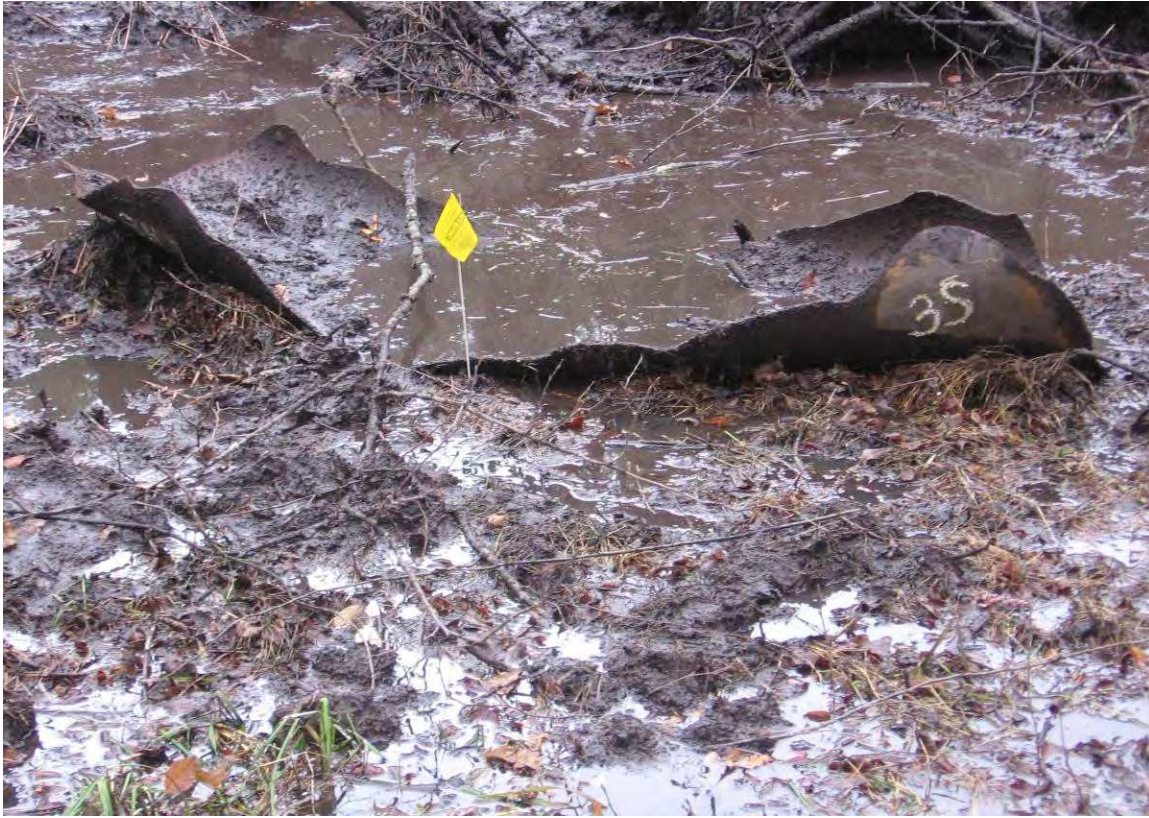
Figure 3: Severed 9 foot section of pipeline

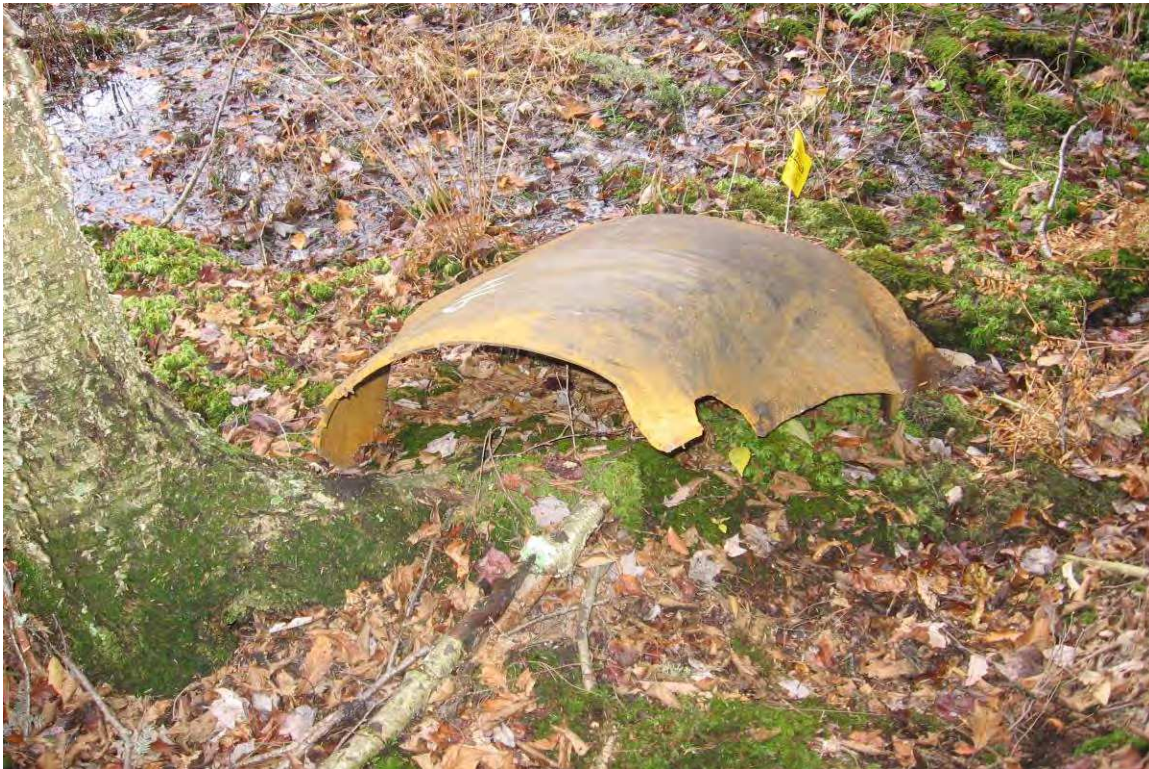
Figure 4: Severed 4.7 foot section of pipeline, piece 4

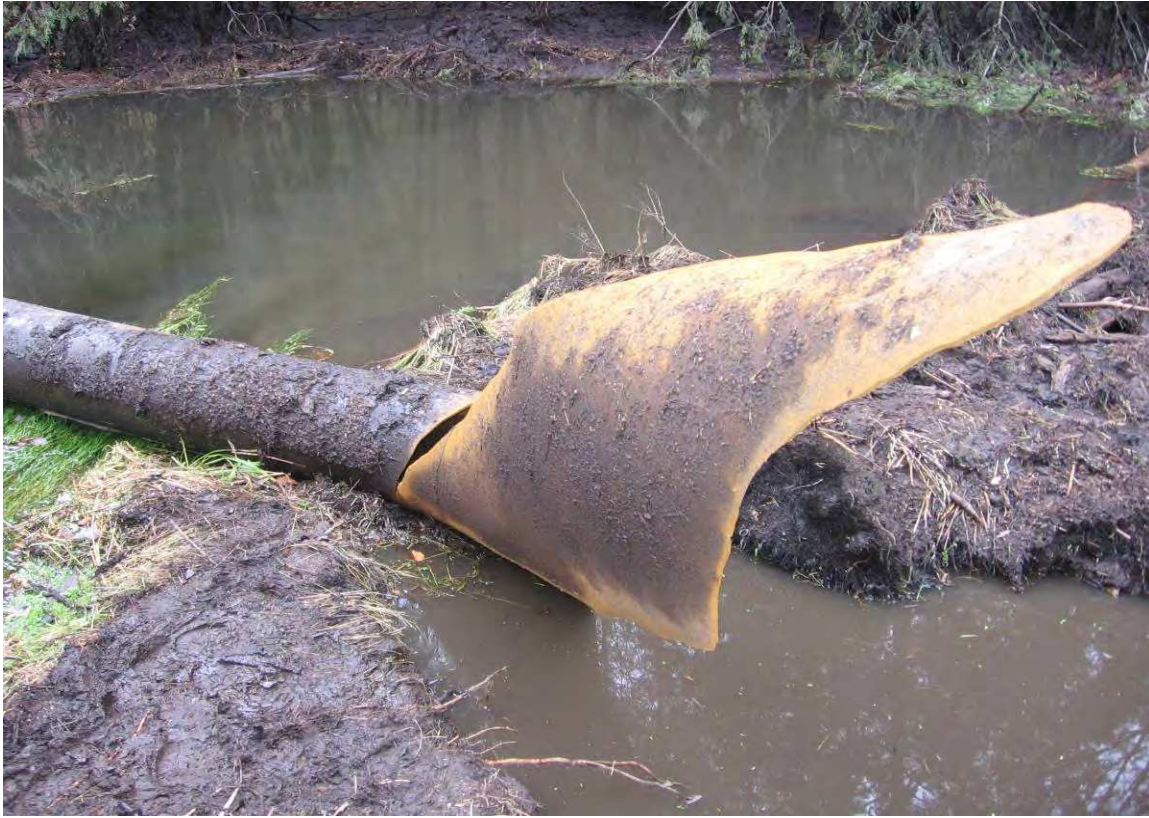
Figure 5: End of severed 37.1 foot section of pipeline

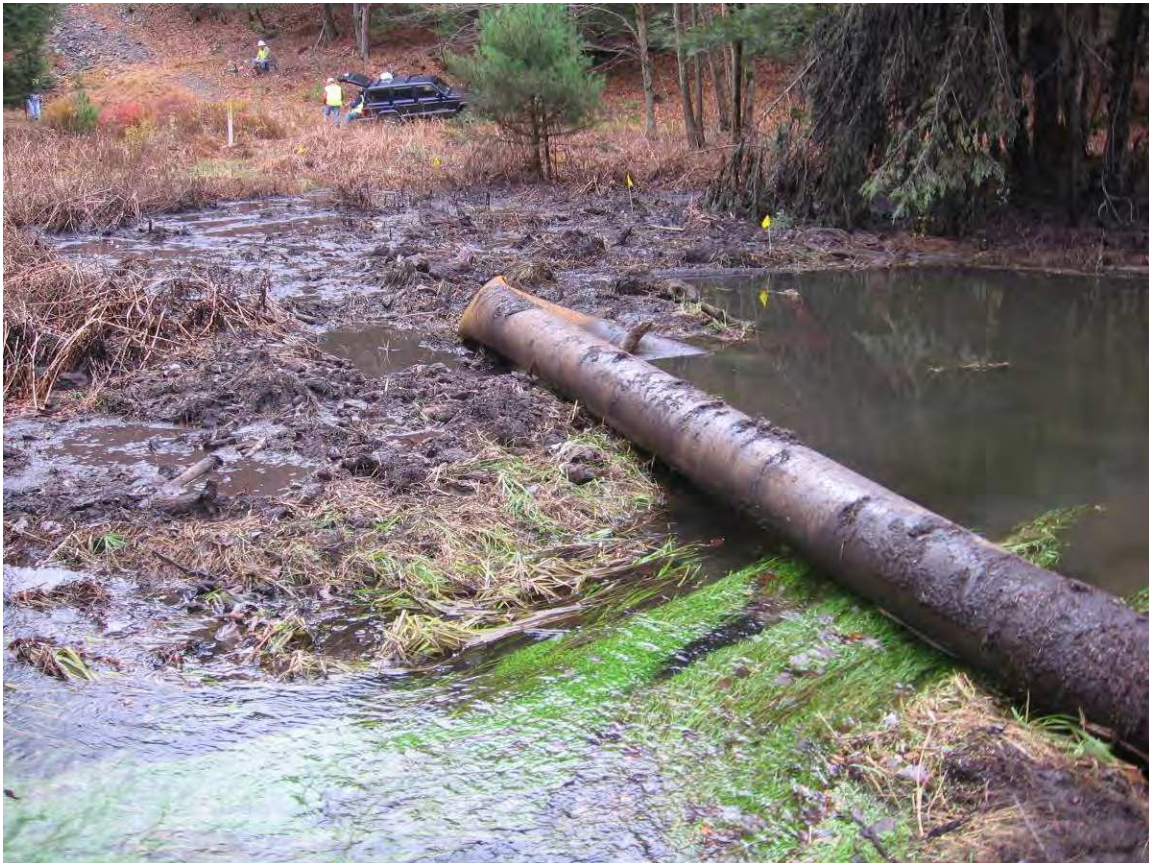
Figure 6: End of 21.7 foot section of pipe in swamp

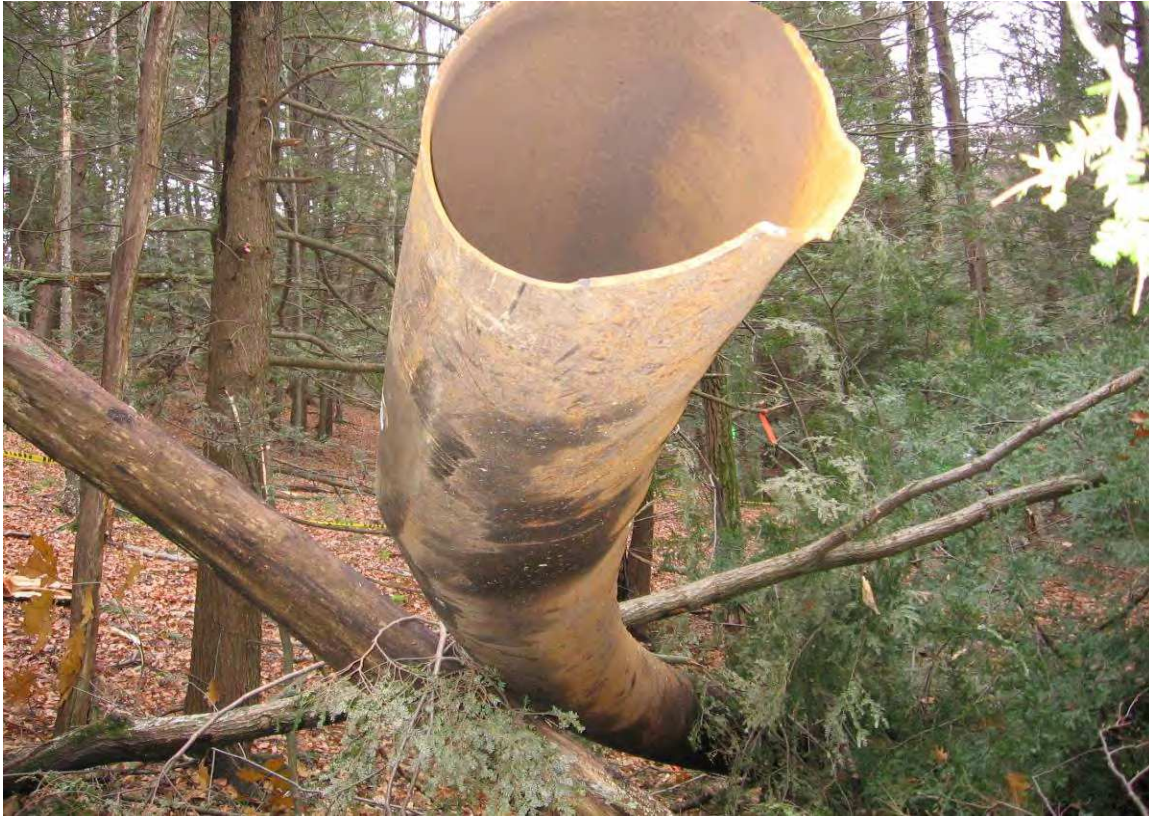
Figure 7: Bent 21.7 foot section of pipe in swamp

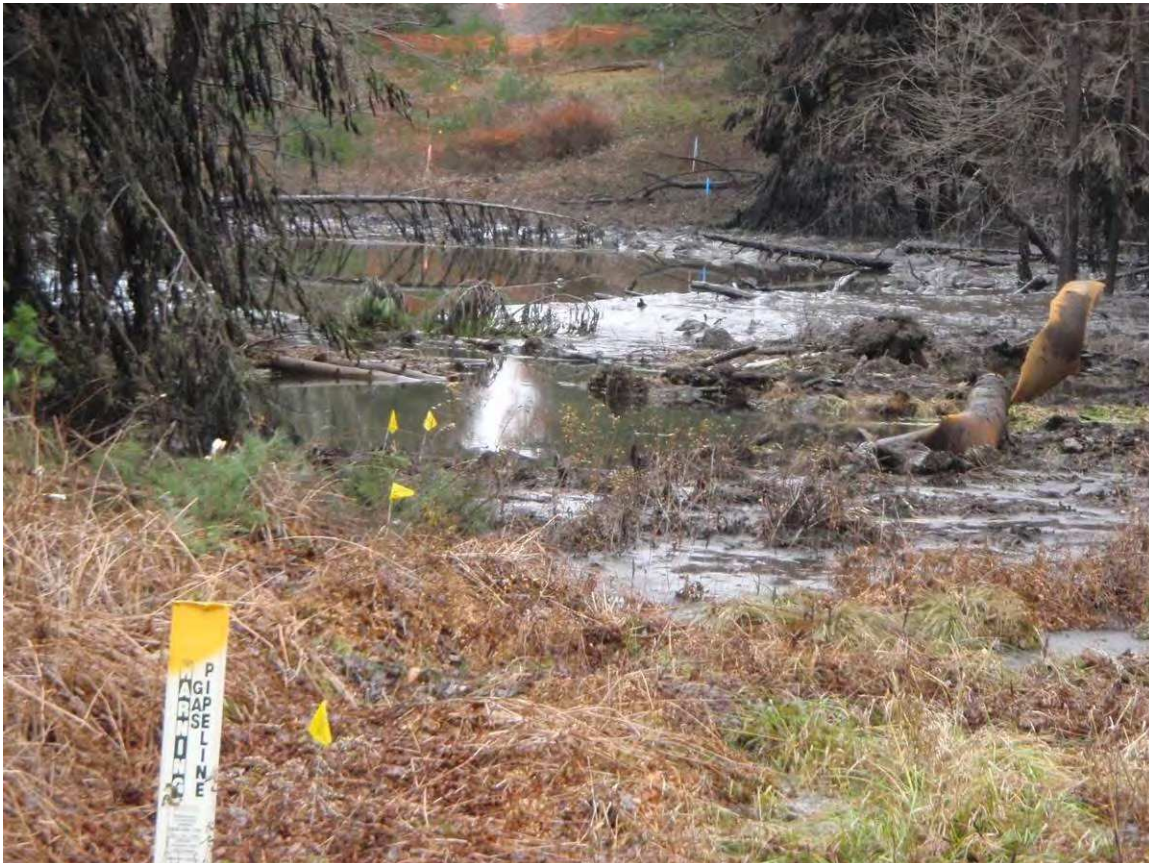
Figure 8: Ruptured pipe in swamp

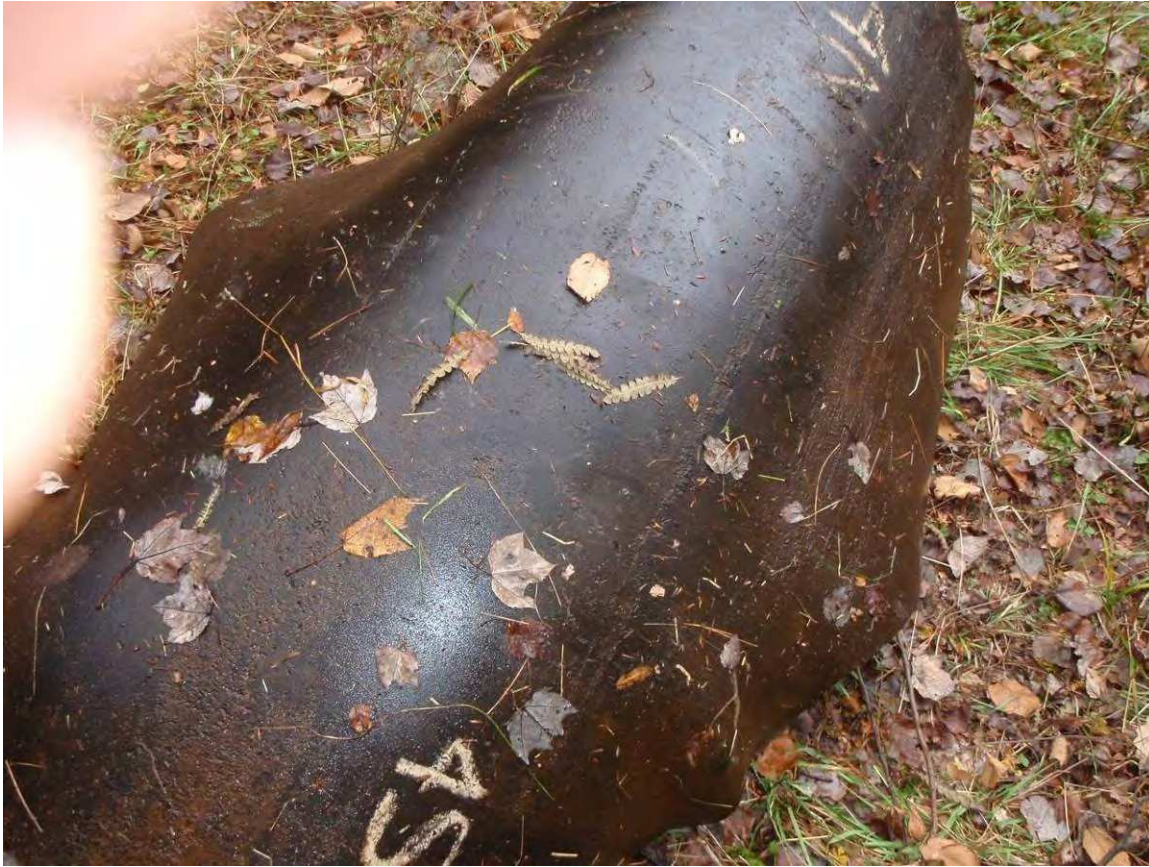
The failed section of pipe separated into four pieces. These pieces along with several other segment of the pipeline were visually examined and analyzed by Kiefner and Associates, Inc. The lab tests results indicated that the failure was caused by near-neutral-pH stress corrosion cracking (SCC). This has been noted in the company reported apparent cause in Part G of Appendix 3.

Figure 9: Piece 4 exhibiting corrosion

Columbia installed 510 feet of new 14-inch, coated, steel pipeline in the wetland area to replace the pipe that failed. On December 6, 2008, service was restored in the pipeline.

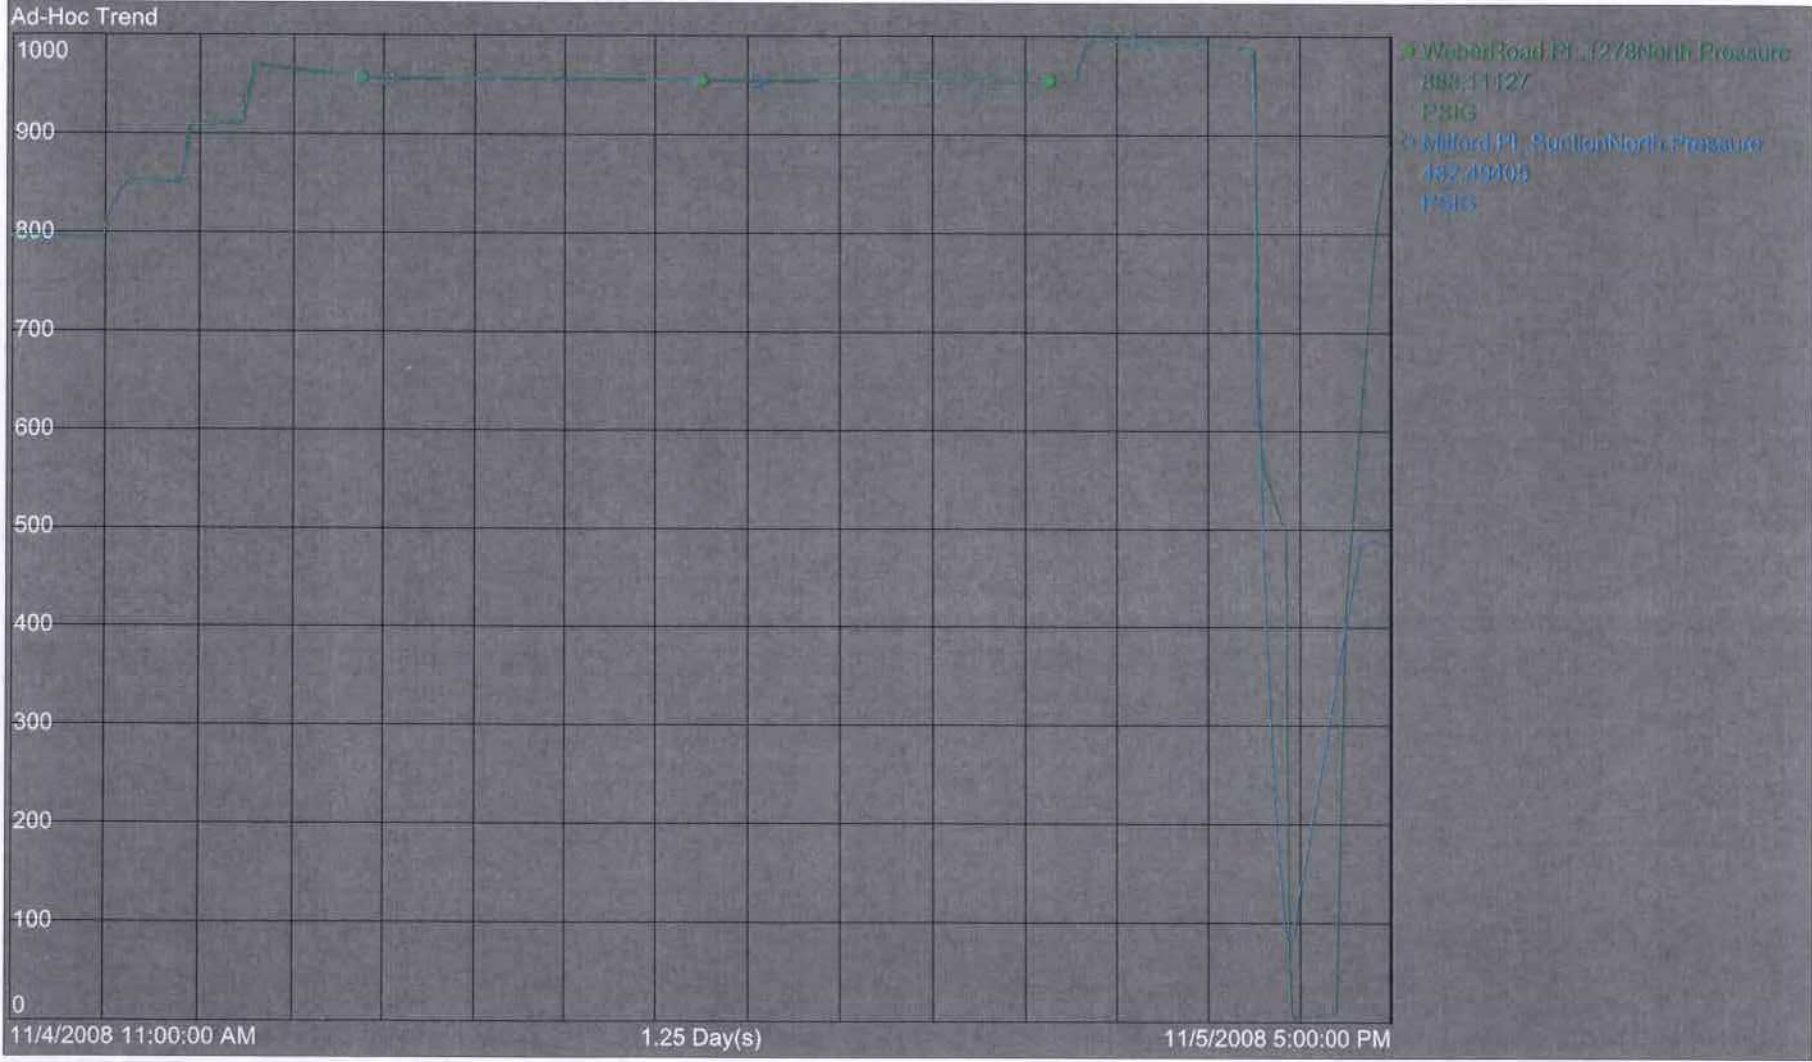
122980 Appendix 4 Columbia Pipeline Pressure test Graph

Pressure in the pipeline had been increased from 800 psig to 1000 psig in 50 psig increments. The operator then began to reduce the pressure, and at 986 psig the pipeline failed. There were no injuries. There was no ignition of gas. Valves were shut in both directions. No customers had service interrupted as a result of the pipeline failure. The failure occurred in a rural area.

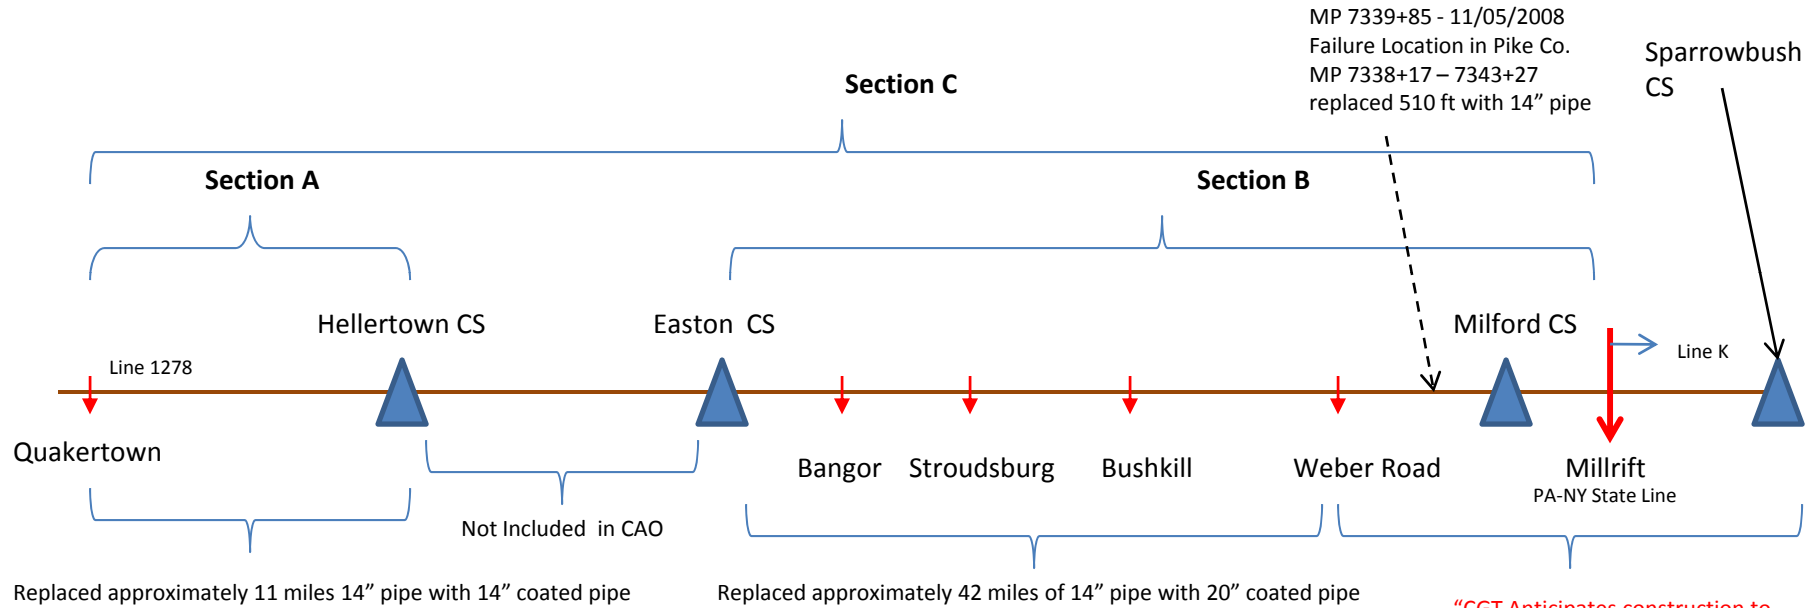
Columbia Gas Transmission Line 1278 and Line K 02/09/2011

MP 7339+85 - 11/05/2008
Failure Location in Pike Co.
MP 7338+17 – 7343+27
replaced 510 ft with 14" pipe

“CGT Anticipates construction to replace this section starting in May 2011 and ending in September 2011. NGT&S commits to maintaining the operating pressure at a restricted level of 800 psig, as established by the CAO, from Weber Road in PA to the Sparrowbush Compressor Station in NY. This section contains the remaining 14" bare pipe along Lines 1278 and Line K. NGT&S commits to replace the remaining bare pipe in PA; approximately 12 miles.” According to Columbia letter dated November 30, 2010.
