SUBJECT: A Packer in a Manufacturing Facility Dies When He is Struck by a Pipe that Rolled off a Storage Rack.

SUMMARY
California FACE Report #07CA003

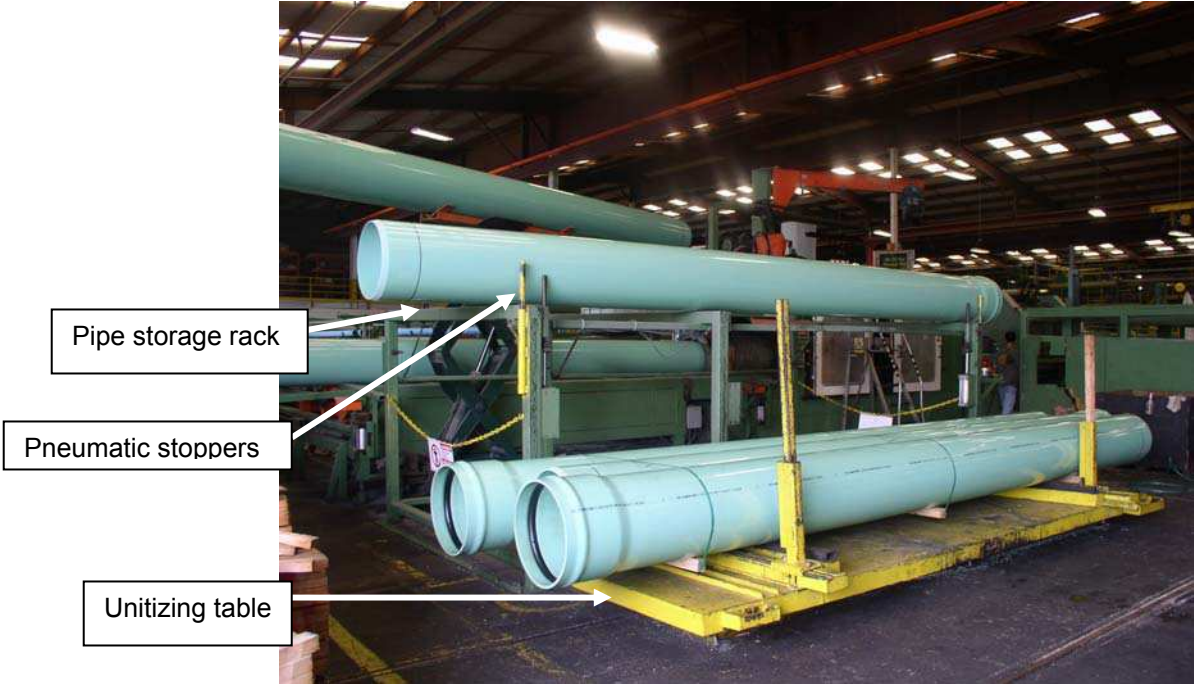
Exhibit1. The pipe storage rack and unitizing table.

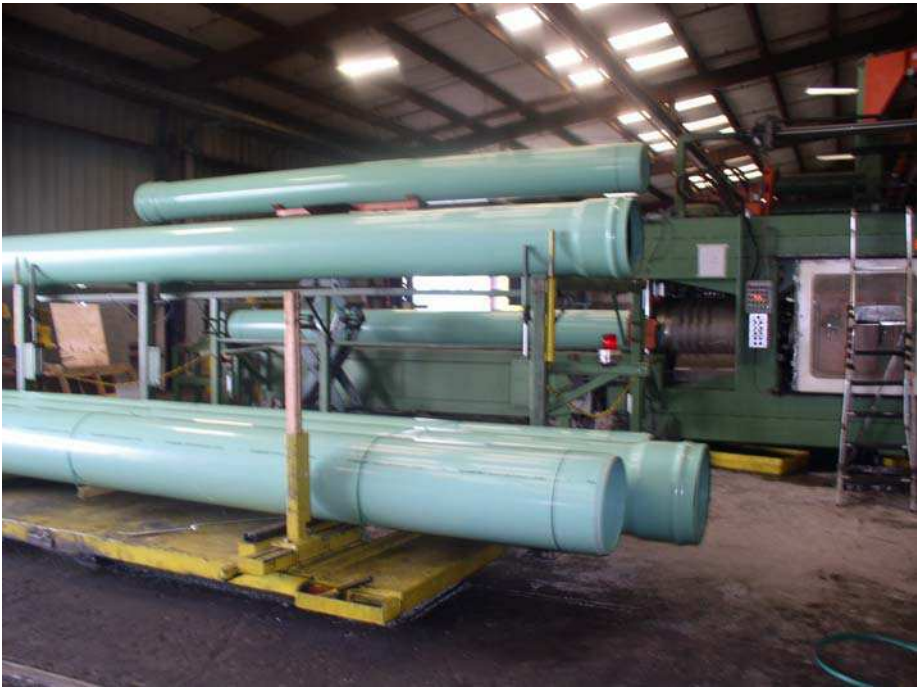
Exhibit 2. The pipe storage rack and unitizing table from a different angle.

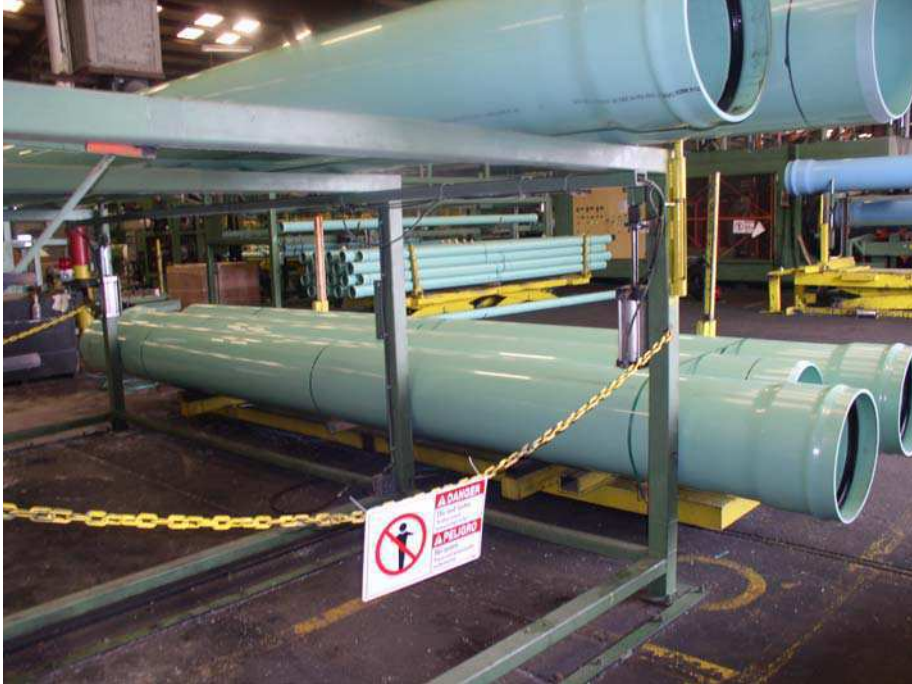
Exhibit 3. The area under the pipe storage rack where the victim was leaning over the pipe when the incident occurred.

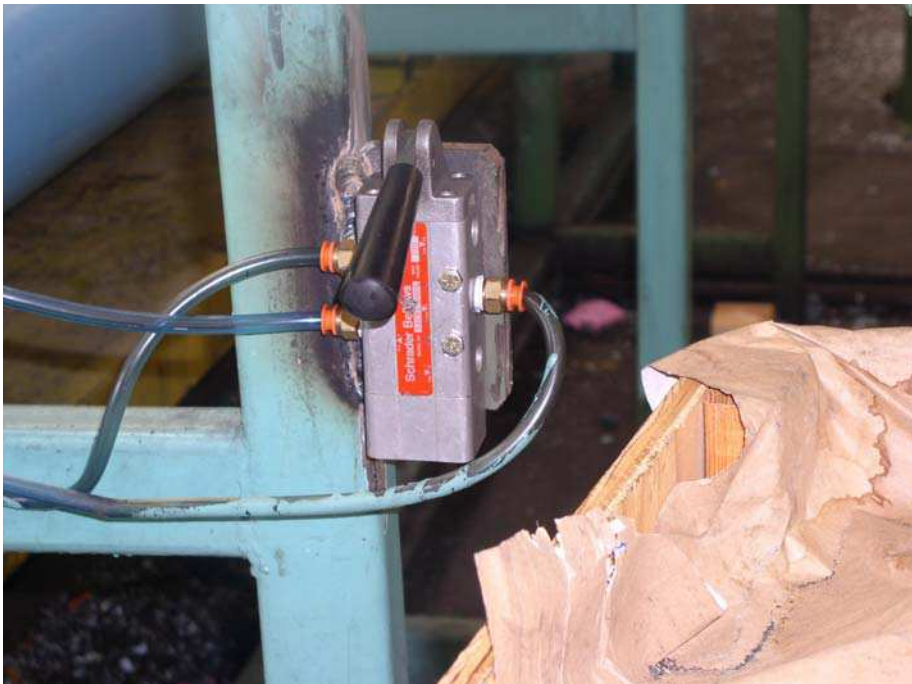
Exhibit 4. The switch used to activate the pipe storage rack stoppers.
