EPA/OSHA JOINT CHEMICAL ACCIDENT INVESTIGATION REPORT

Napp Technologies, Inc.
Lodi, New Jersey

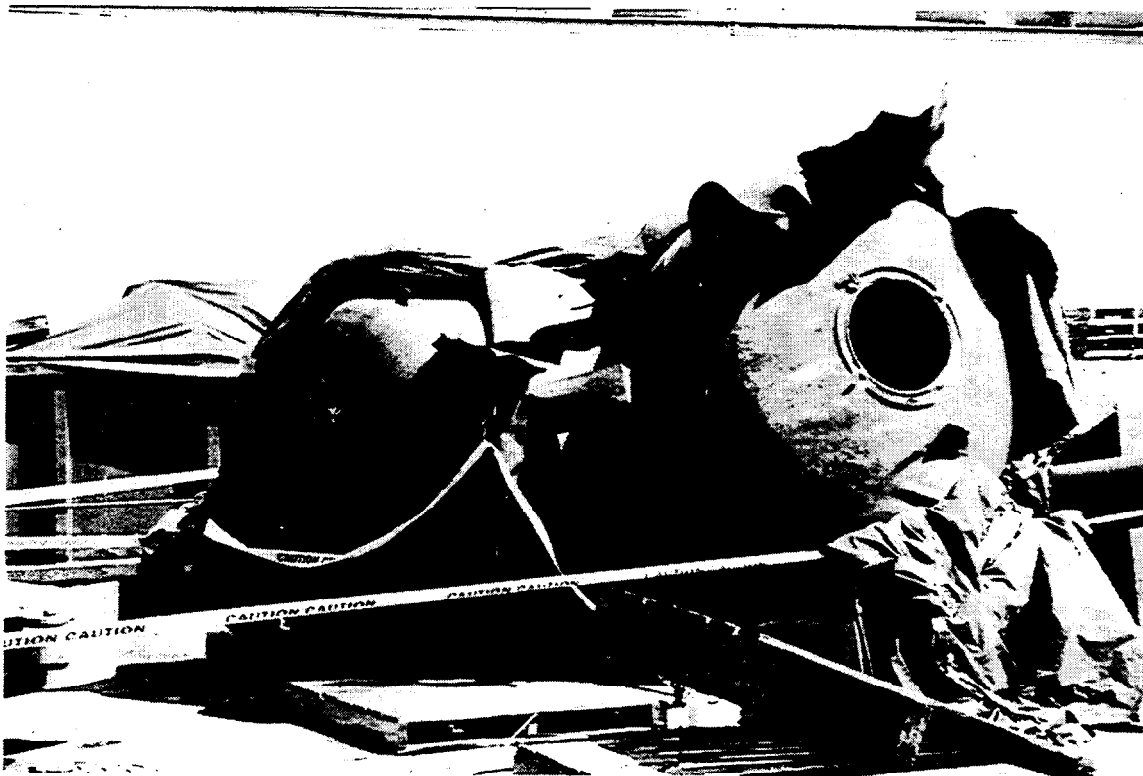
Figure 9: The general condition of the 125 cubic foot blender: a) the top access ports and damaged insulation jacket, and b) the flange to which the belt drive attaches.

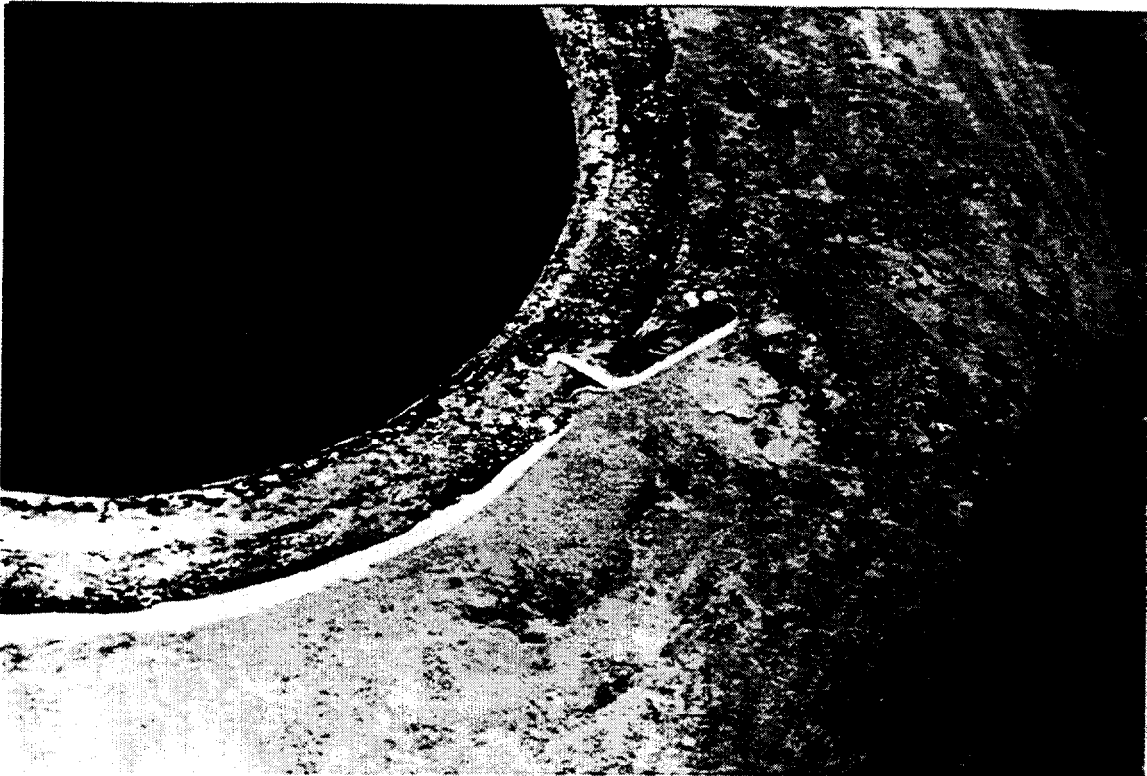
Figure 14: The insulation jacket has tom away from where it was attached to the stainless steel shell and the access door tabs are bent over against the shell.
