Home Inspection Report

**6754 Amber Lake Lane
Alpharetta, Georgia 30022**

**Prepared for Sue Cassidy
February 8, 2012**

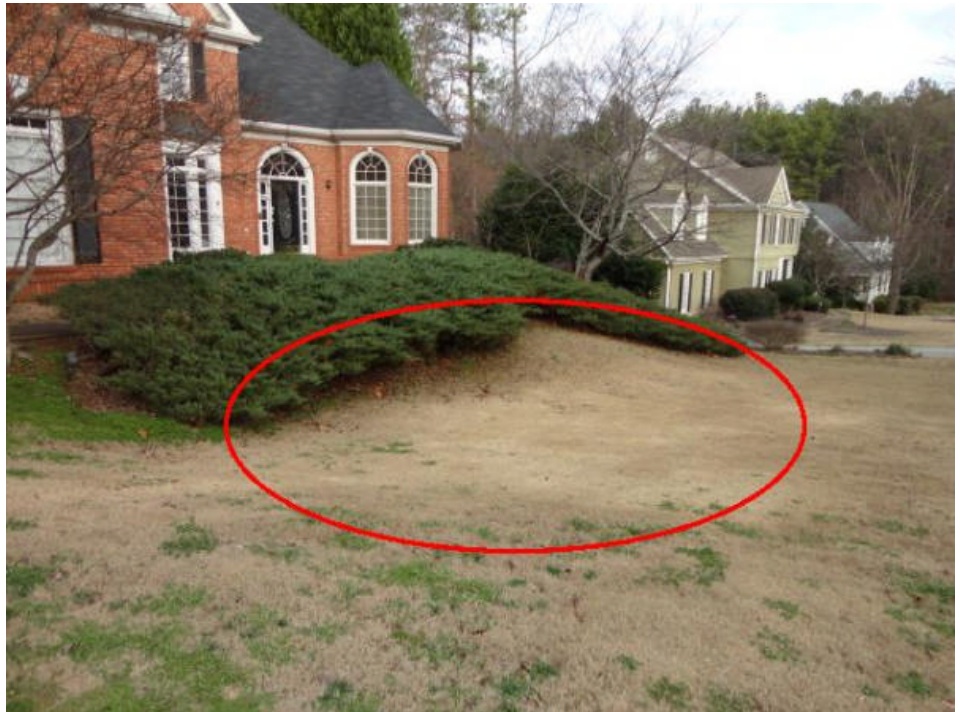
Site Drainage

There appears to be a trash pit in the front yard. The depression is caused by decaying wood material. Recommend removal, and build up with soil to slope the water away from the house and lot.

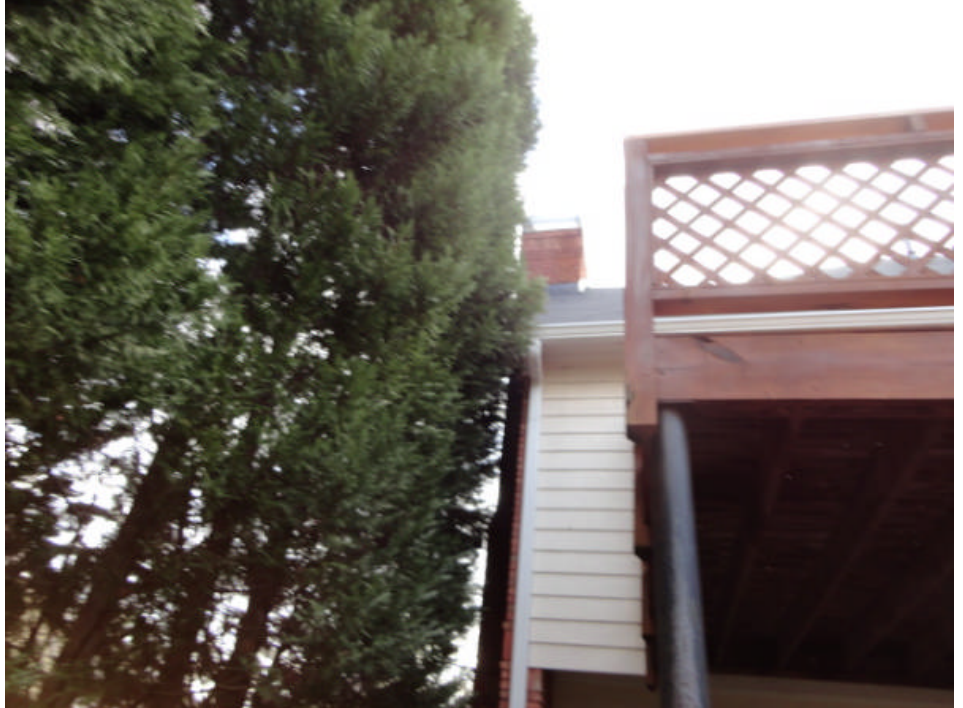
Bushes and Shrubs

The bushes need to be trimmed so that there is good airflow between the bushes and the building structure. This will help prevent water damage.

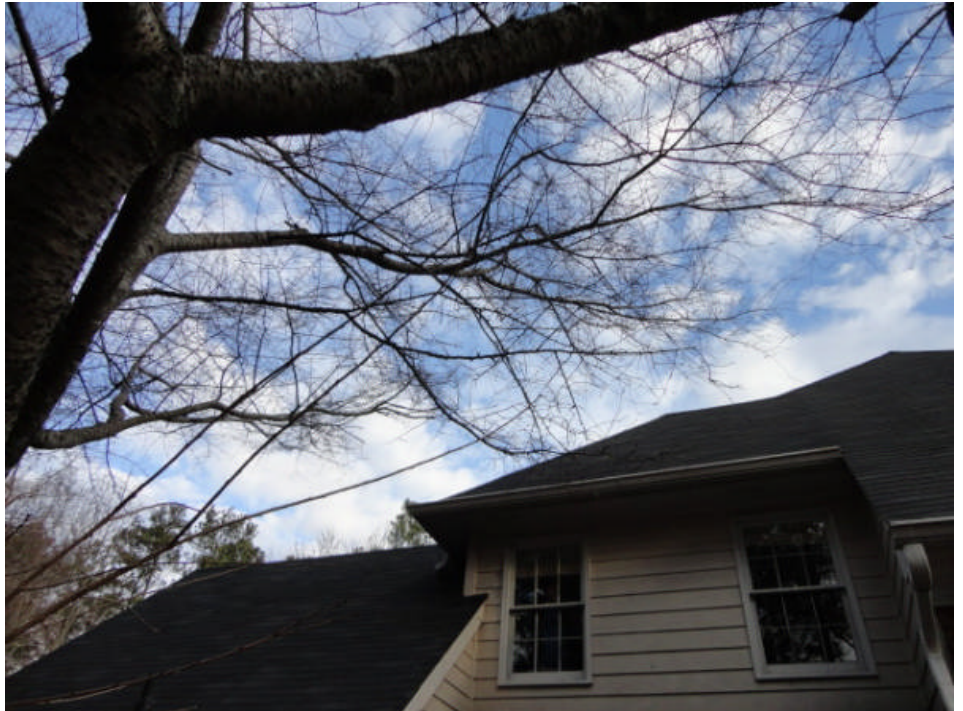
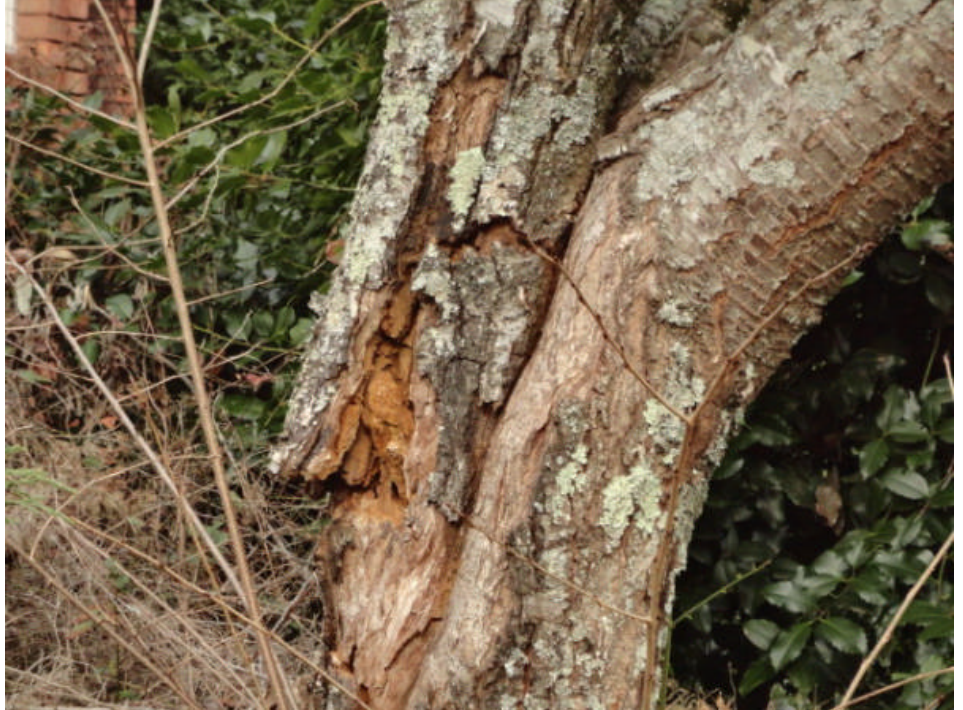
Trees

The trees near or overhanging the house need to be trimmed for safety. The dogwood in the front left yard is dead. Recommend removal.

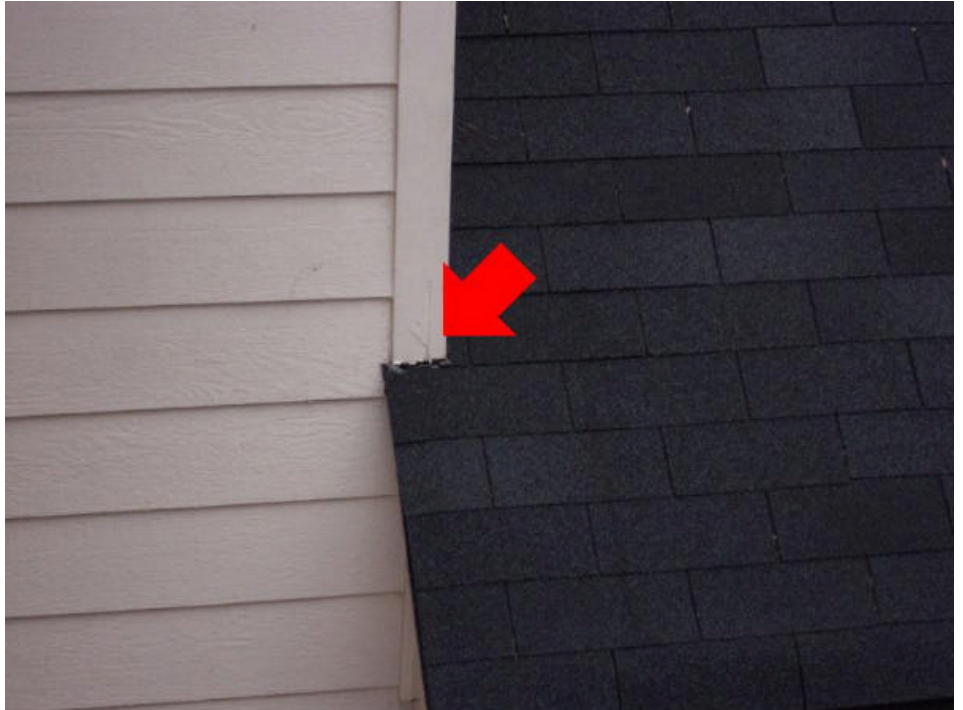
Flashing:

The kickout flashing has been damaged and nailed flat onto corner boards. Some sidewall flashing was also missing at wall corners. Recommend a roofer repair and install flashing and kickout flashing as needed.

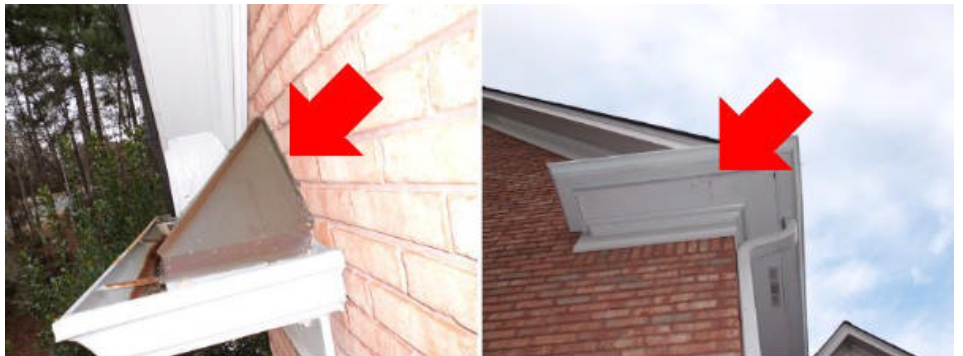
Valleys and Gable Returns:

The gable return roofs have loose and unsecured flashing at the brick. The gable return roofs were also not properly sealed between the roofing and the fascia and soffits. Water has been getting into the gable return roofs and causing damage to framing and fascia and soffits. Recommend the roofer repair all water damage before securing and sealing flashing and sealing gable return connections.

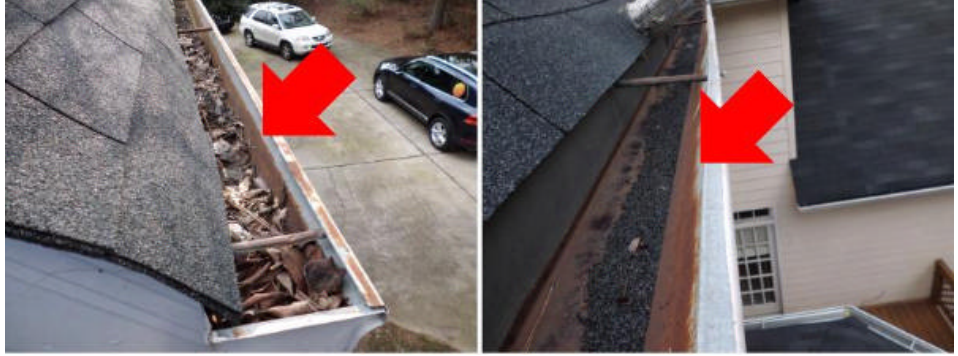
Roof Gutter System:

The gutters and downspouts are clogged and rusting. Several gutters are coming loose. Recommend securing and cleaning gutters. The rusting should be sanded and painted.

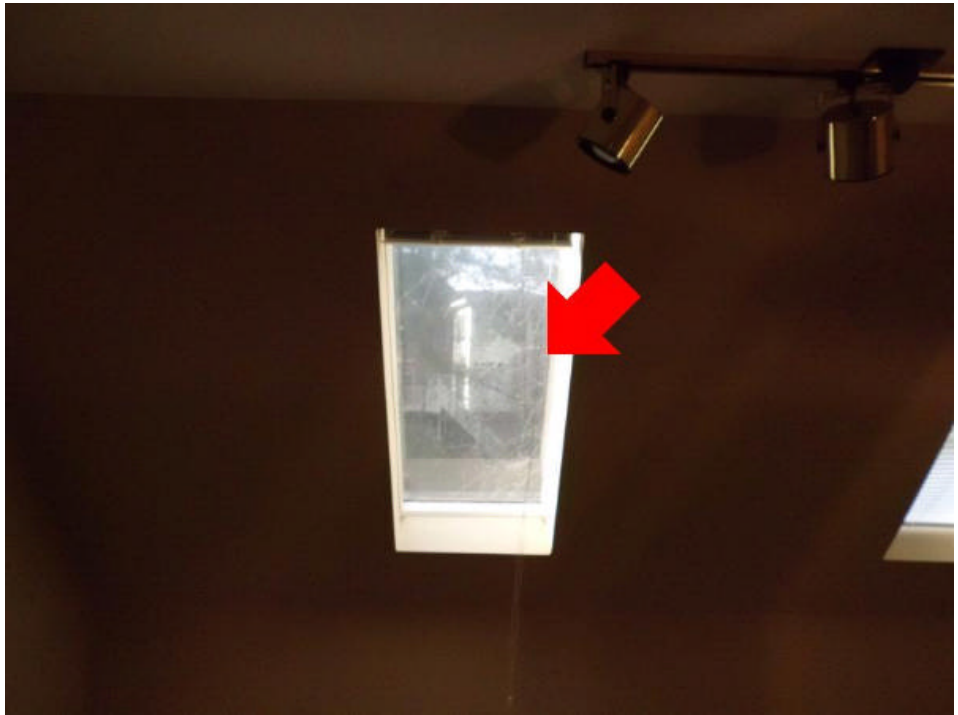
Skylights:

The seals between the glass in the skylights have failed. Recommend replacement of glass in skylights.

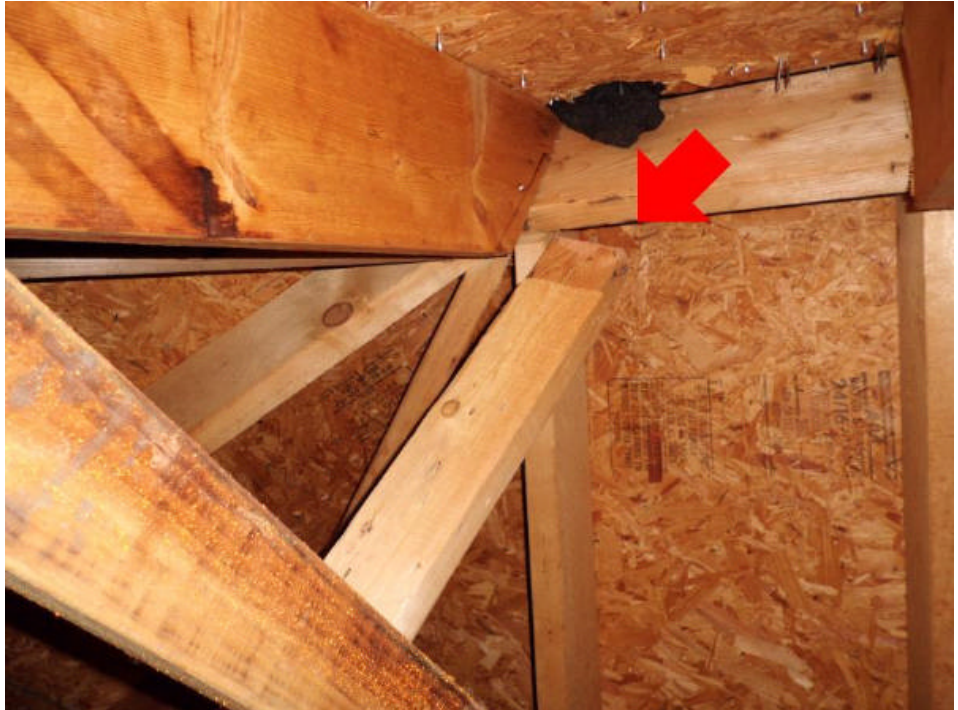
Roof Framing Condition:

The right ridge support has come loose for the center section of roof framing. Recommend a framing contractor secure the loose ridge support to the ridge.

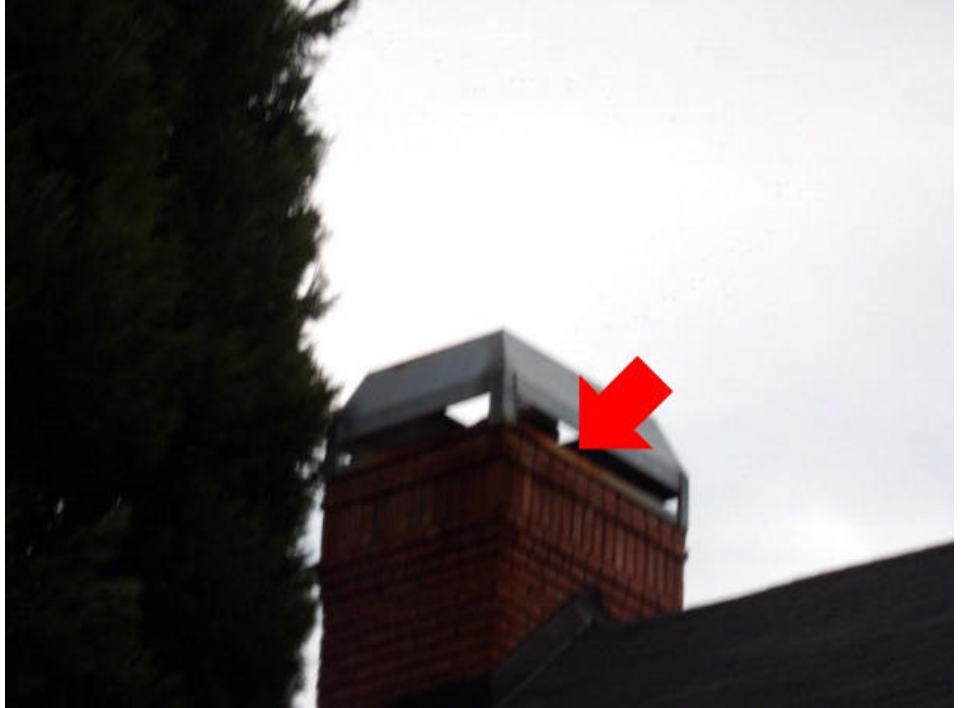
Chimney

The chimney cap is rusting. Recommend sanding and painting cap.

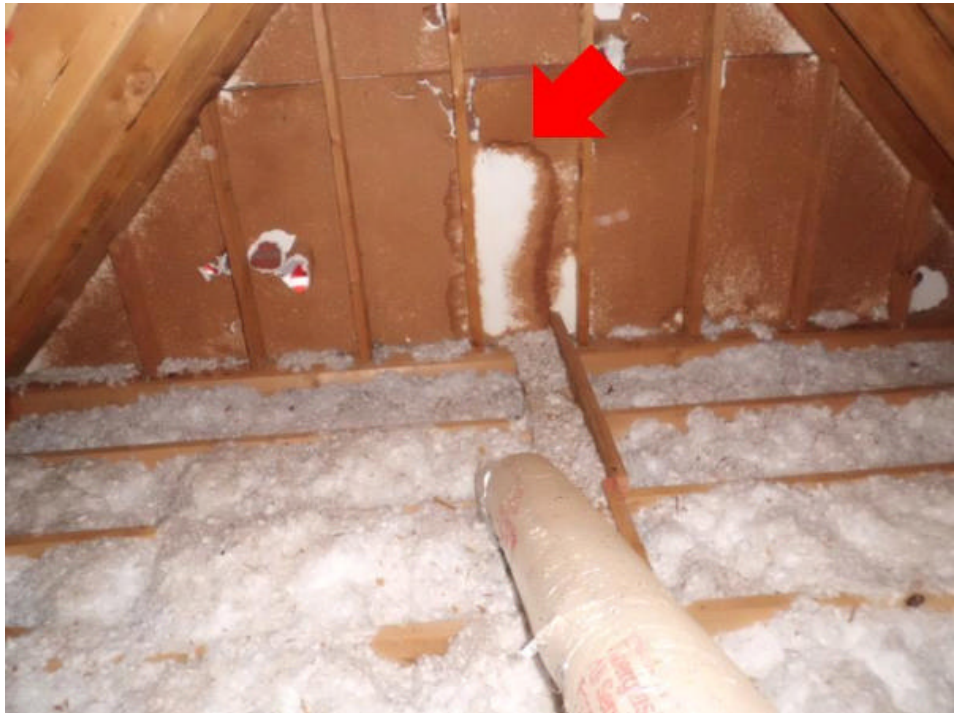
The front gable ends have water staining on the wall sheathing in the attic. The areas were dry at the time of inspection. Recommend monitoring these areas. If water is found to be entering the wall repair will be needed.

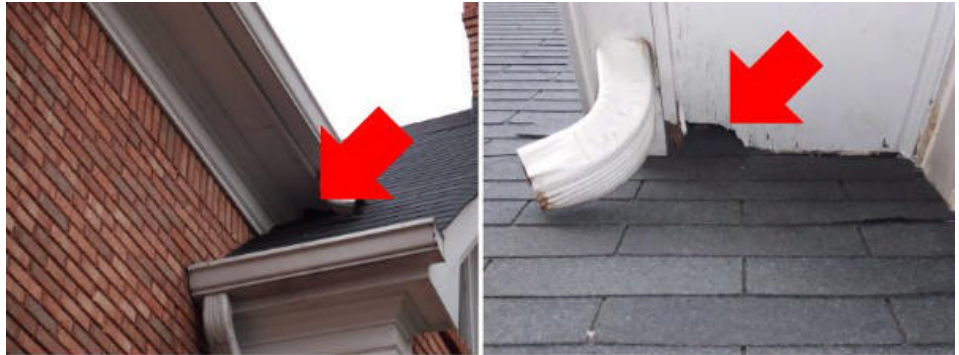
Attic Condition:

There is evidence of animals in the attic. Numerous holes and chewed trim were found around the house. Recommend having the animal removed and having a roofer inspect and close the openings where it is getting into the house.

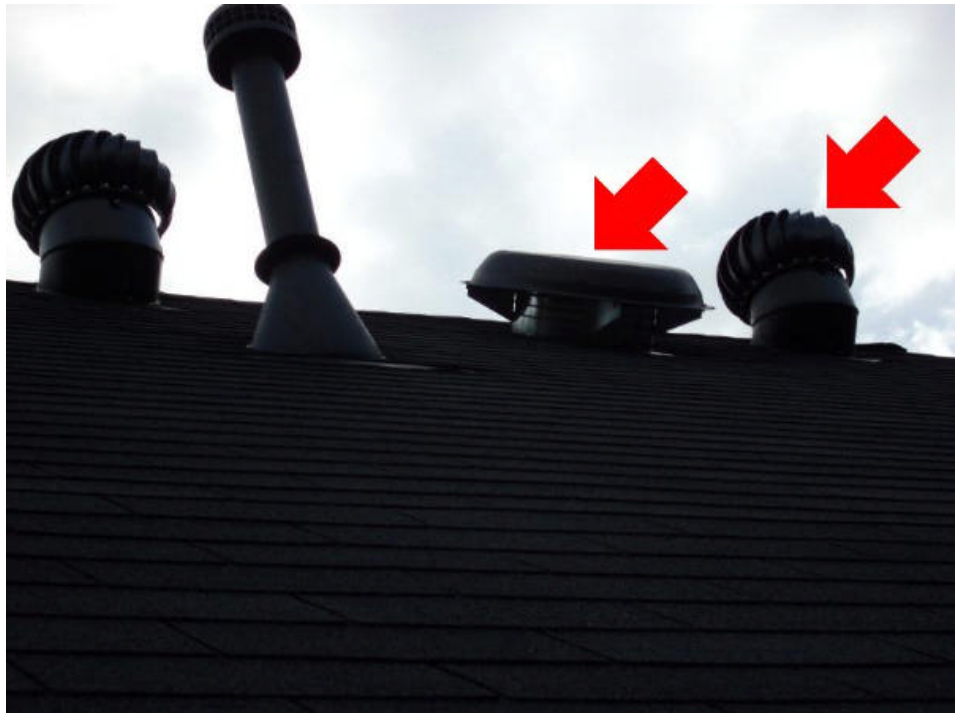
Attic Air Flow:

There is a power roof ventilation fan installed directly adjacent to the turbine vents. When operating, the fan will only pull air from the turbine vents thus trapping the lower attic air. Recommend turning off the fan.

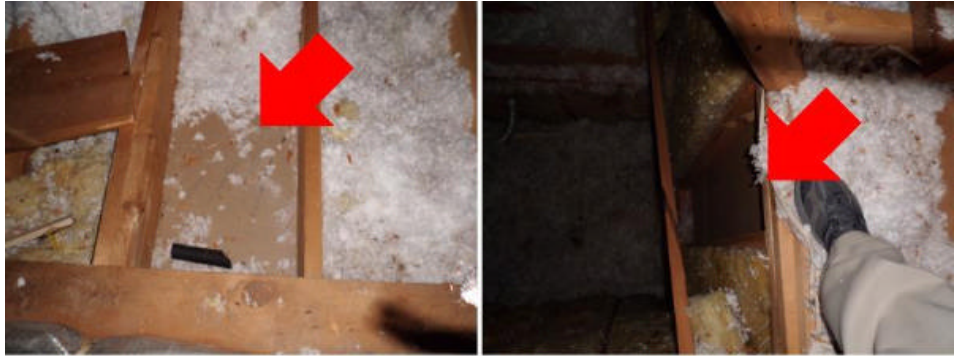
Insulation :

The insulation has been damaged and removed by animals. There also is fallen insulation on family room and living room walls in the attic. Recommend an insulation contractor inspect and install and repair attic wall and ceiling insulation as needed.

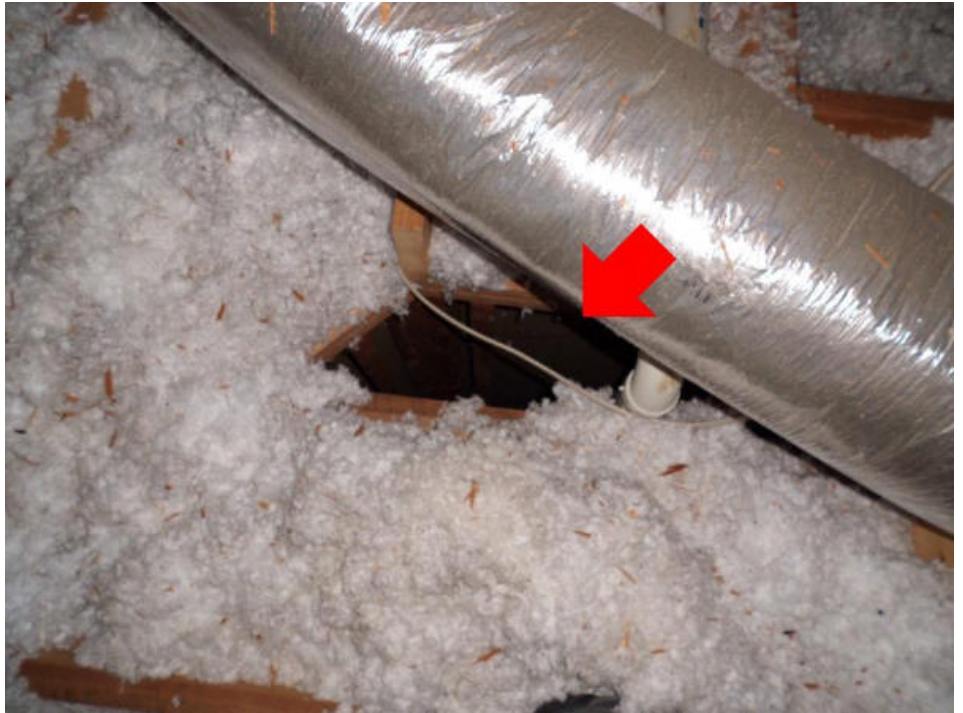
The firestop is missing between the attic and second floor at the chase by the jack and jill bathroom. Recommend installing the firestop and insulation.

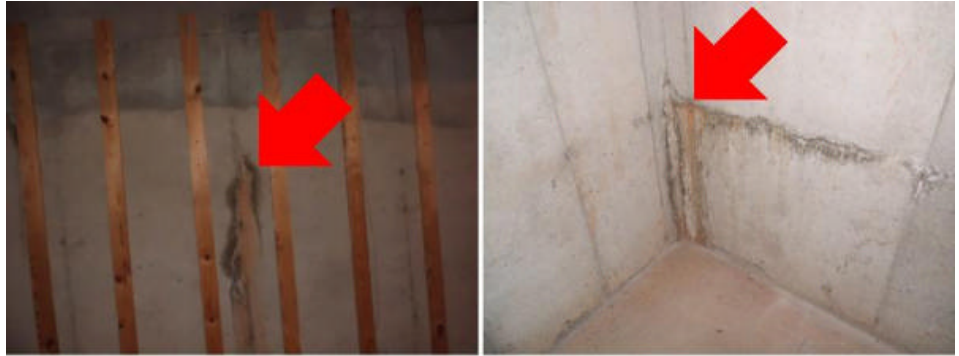
Visible Foundation Wall Cracks

There are cracks in the exposed foundation walls with evidence of water intrusion into the basement. The cracks do not appear to be from structural framing and are less than 1/4" in thickness. Recommend a waterproofing contractor inspect and seal cracks.

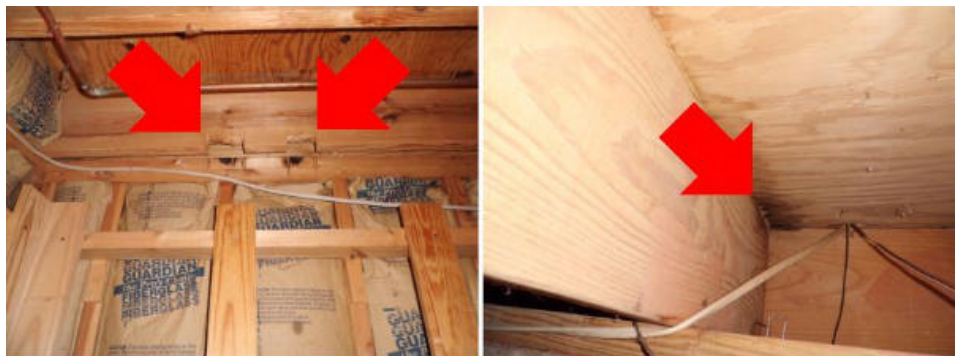
Floor/Ceiling Structure Condition:

The right floor joist under the master bathroom was improperly cut out along the bottom third. The joist was not sagging or cracking at the time of inspection. The floor decking and framing under the front entrance is water stained. Recommend having the front entrance brick, door and porch inspected and sealed as needed. The floor joist under the bathroom should be monitored. If cracking or movement is noticed repair will be needed.

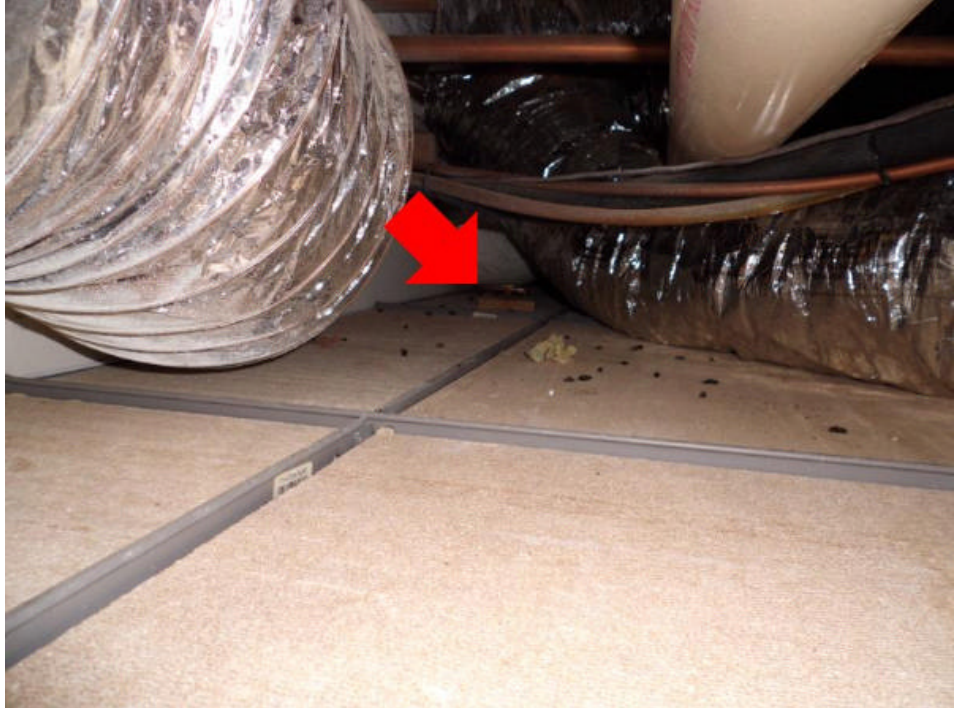
Basement Framing

There are animal droppings and a trap above the drop ceiling in the finished basement under the family room. Recommend removing droppings and animal and sealing openings around the house.

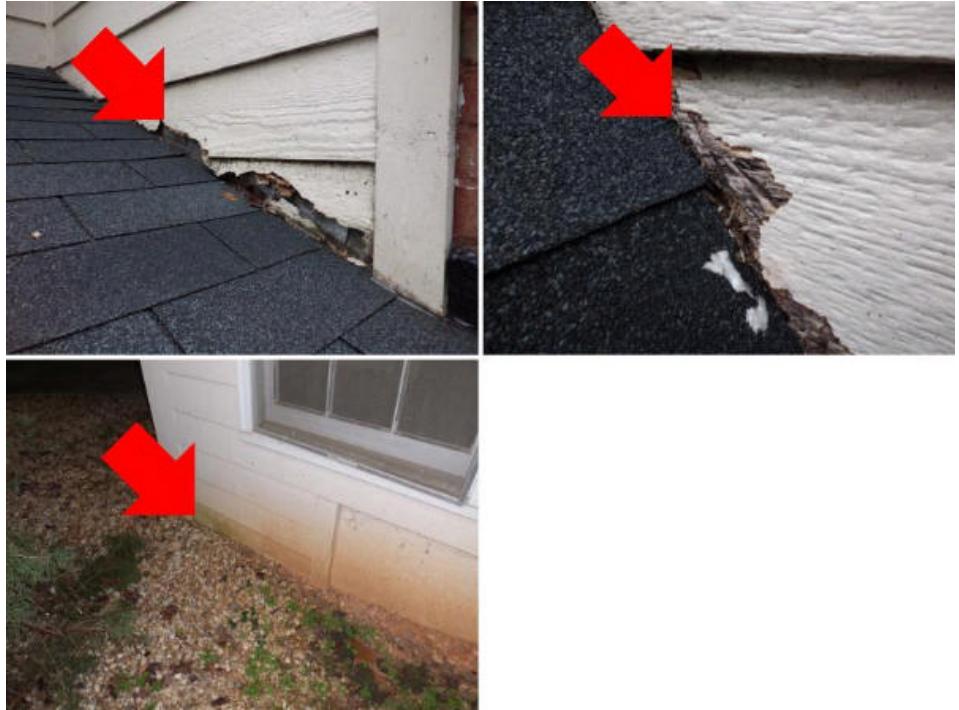
Siding Condition:

The siding was installed touching the roof shingles and it has become damaged from wicking water. This is at most locations. The rear siding also have several areas where the siding has swollen around nailing. This is an indication of water intrusion and siding failure. The rear siding and trim are also installed touching the ground in a couple areas. Recommend a siding contractor inspect and replace damaged and swollen siding. Siding should not touch the roof. The siding and trim should also not touch the ground. A four to six inch clearance is needed between the ground and siding and trim. This must be achieved while maintaining a six inch fall in grading away from the house within the first ten feet.

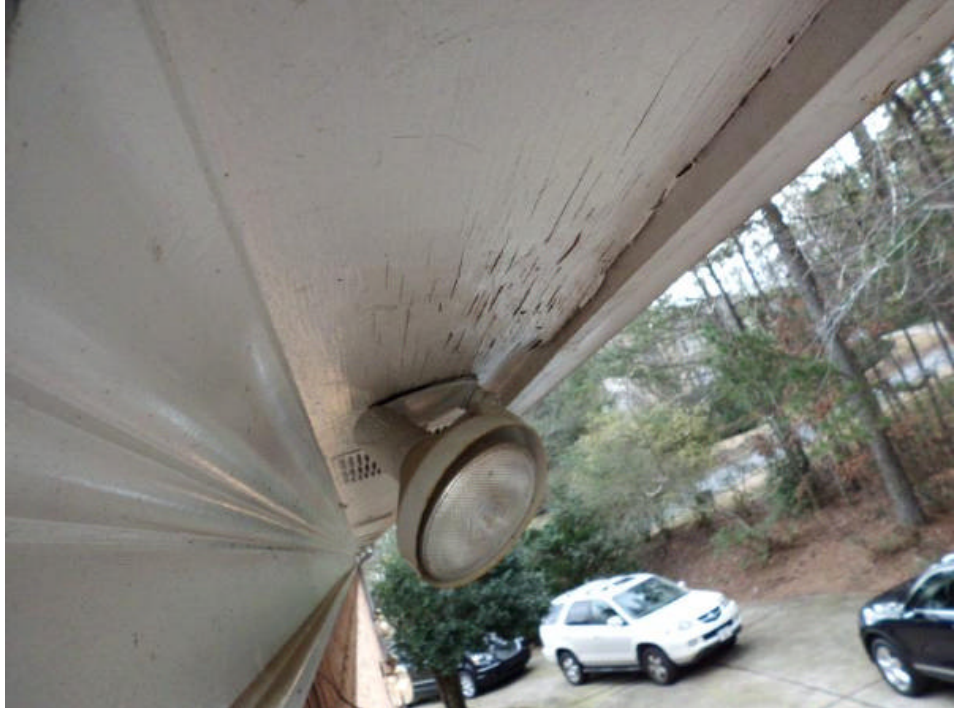
Soffit/Eaves:

Several soffits around the house are water damaged. Recommend having water damaged repaired.

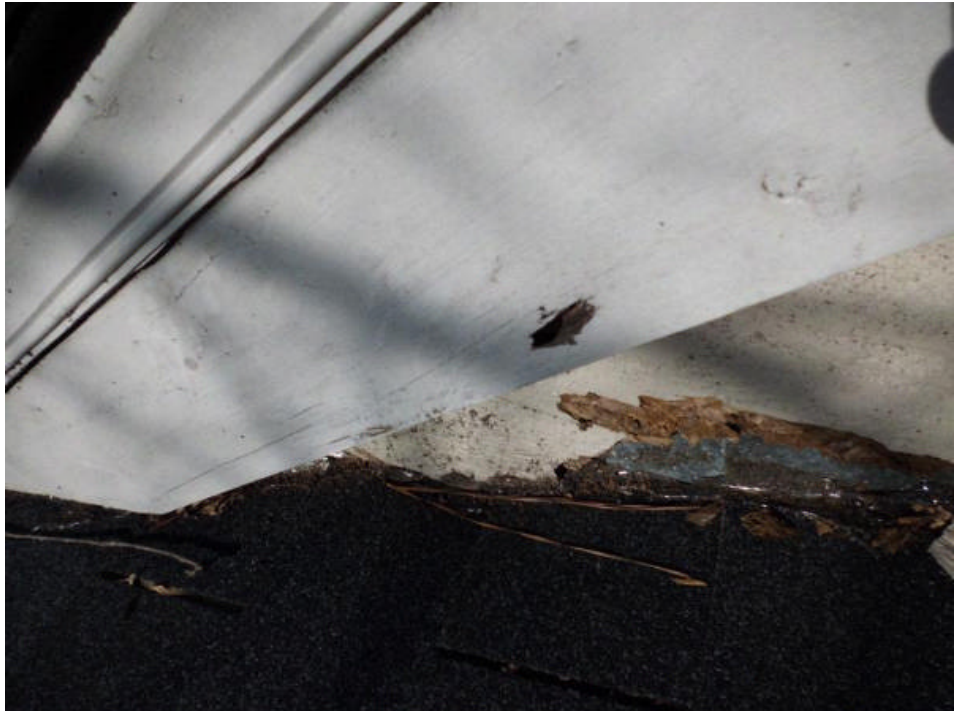
Fascia & Rake Boards:

Several fascia boards around the house are water damaged. Recommend repairing water damage.

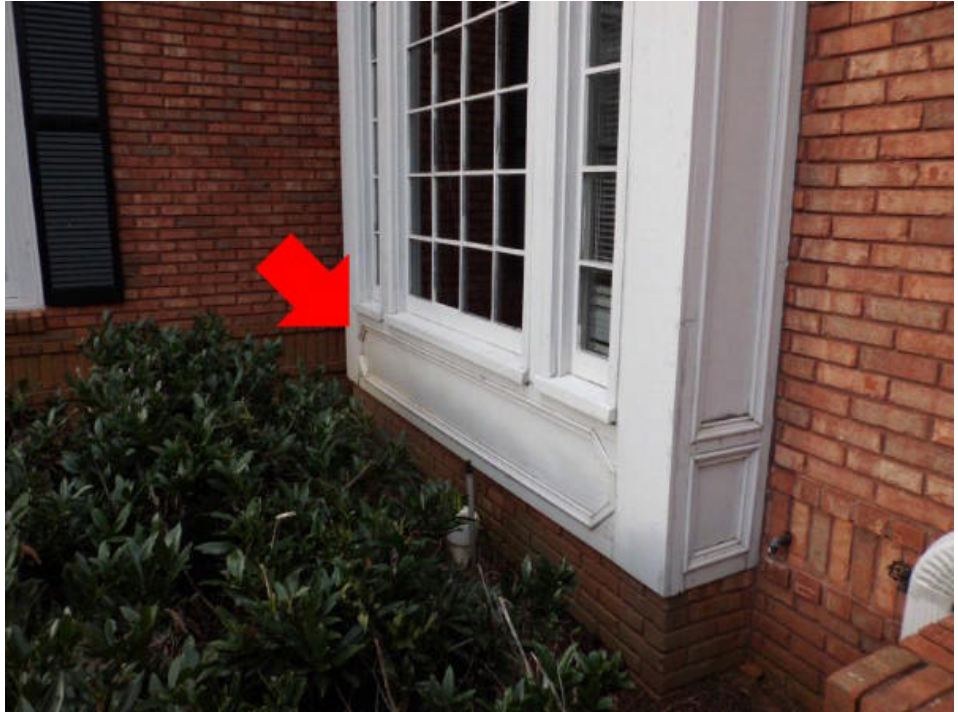
The front dining room bay wall trim and siding are water damaged. Recommend repairing water damage as needed.

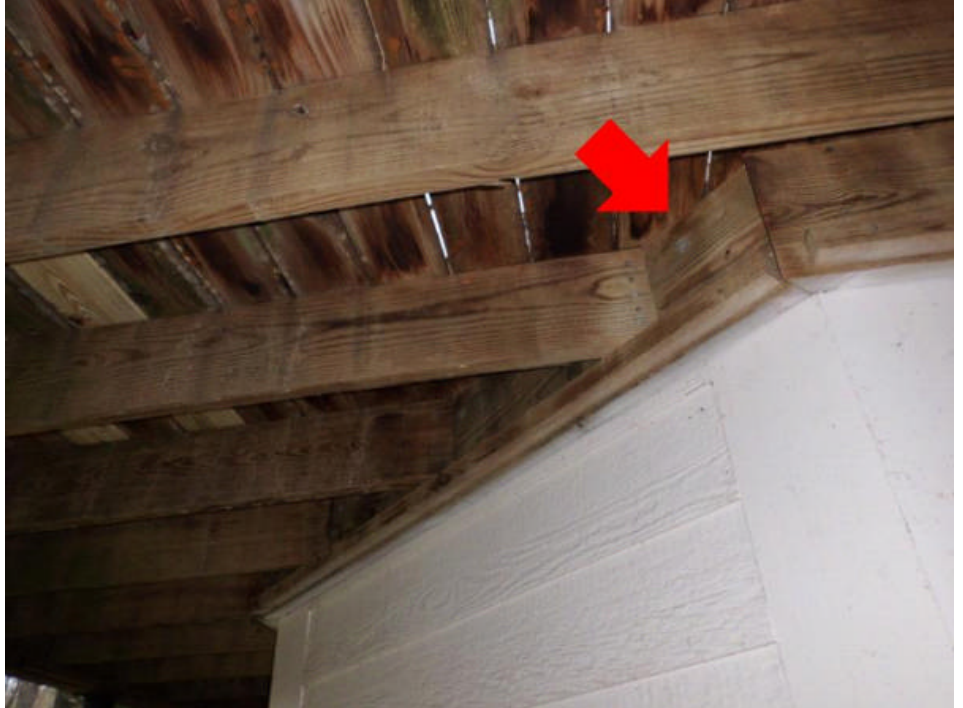
Condition of Framing:

There was no flashing installed between the rear deck ledger boards and siding. Swollen siding was noted from water penetration between the deck and house. Recommend removing ledger board so water damage can be repaired. Flashing should then be installed between the ledger boards and siding.

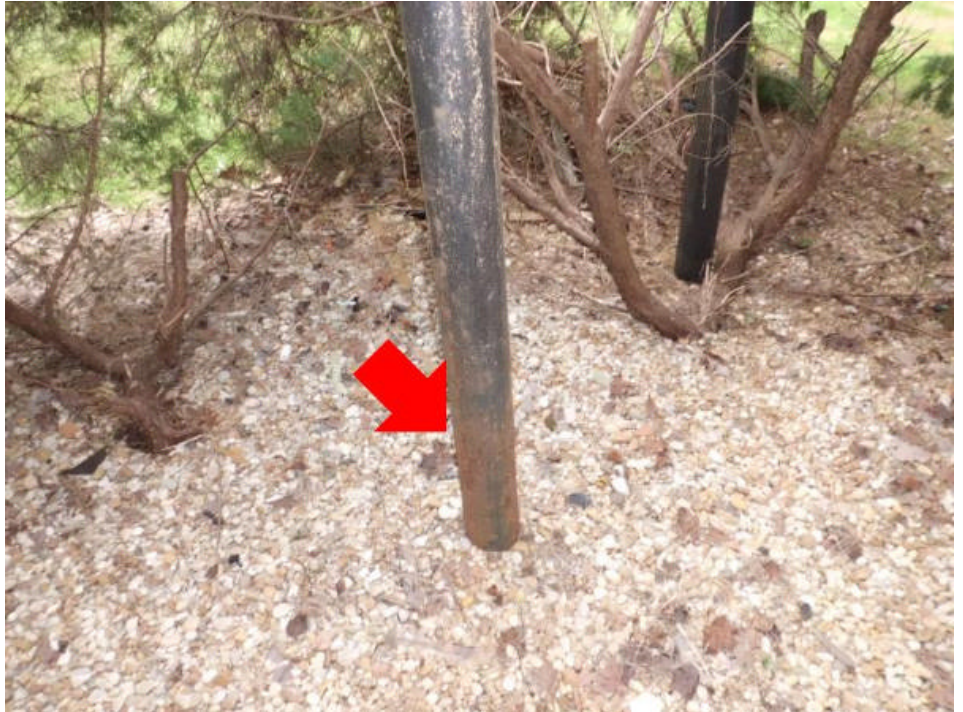
Support Posts:

The rear deck support posts are rusting. Recommend sanding and painting posts.

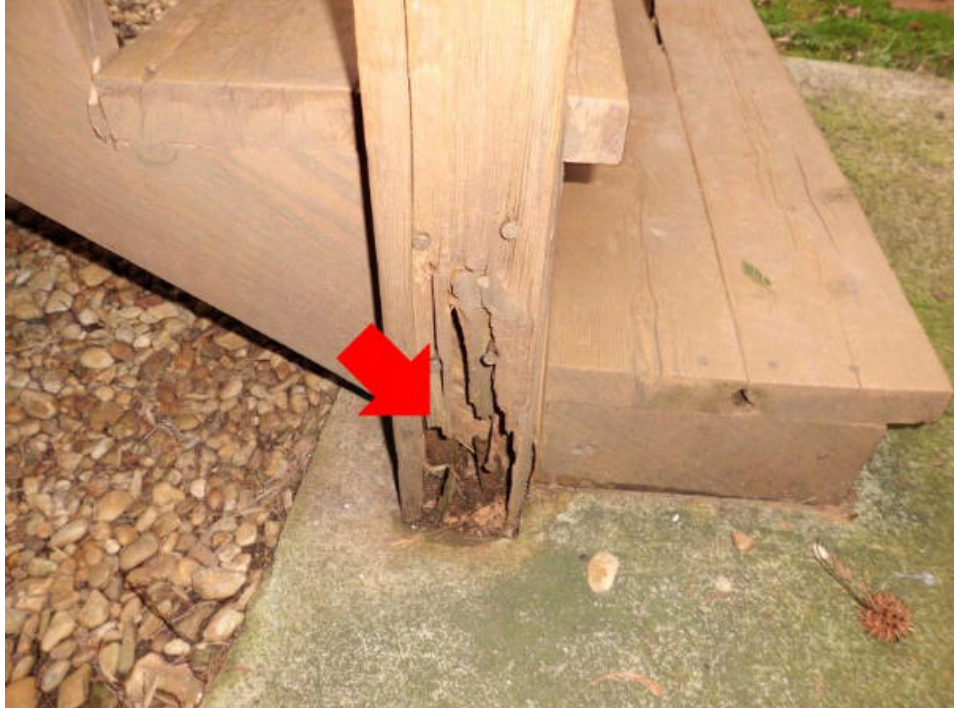
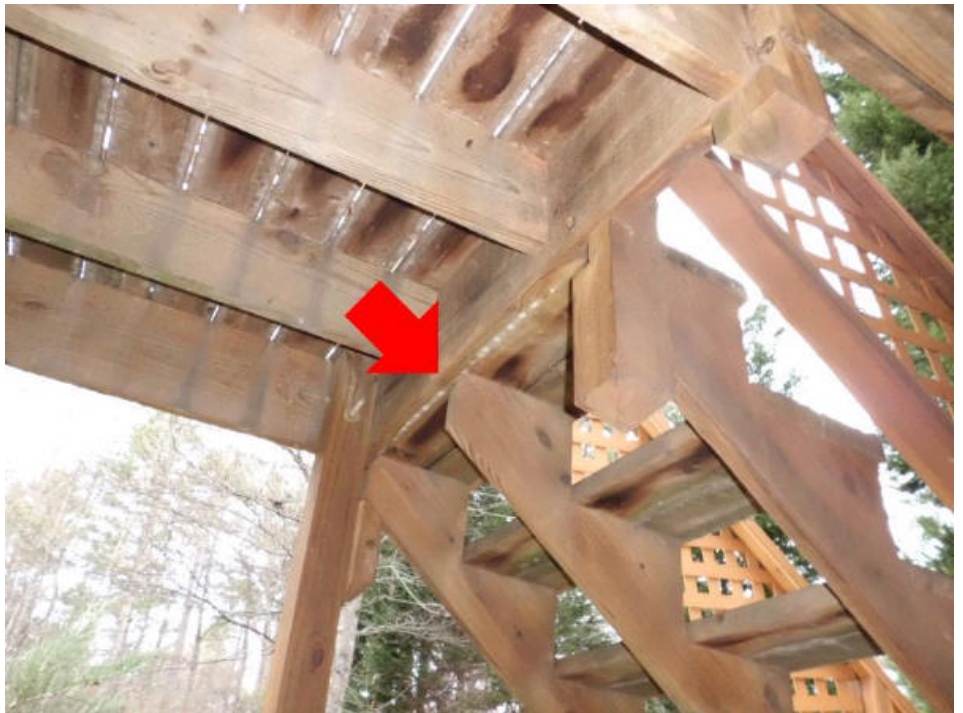
Deck Stairs Condition:

The rear deck staircase posts are fully rotted at the base. The staircase stringers are not properly supported at the deck band. Recommend replacement of rotted posts and properly securing and supporting stringers.

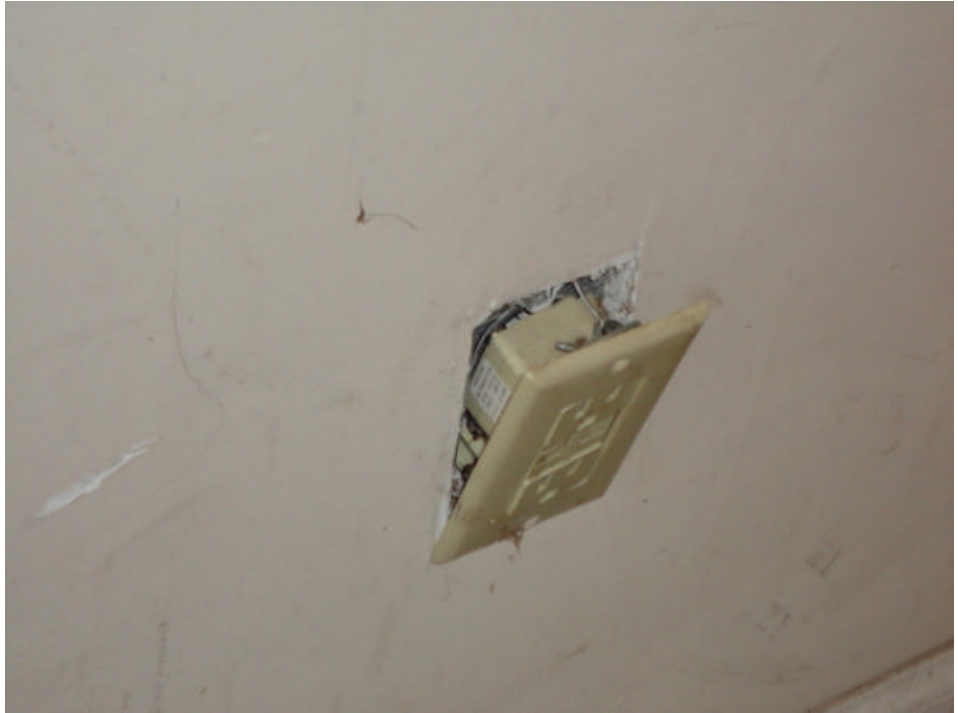
The outlets in the garage are loose and not properly secured inside of their mounting boxes. Recommend repair.

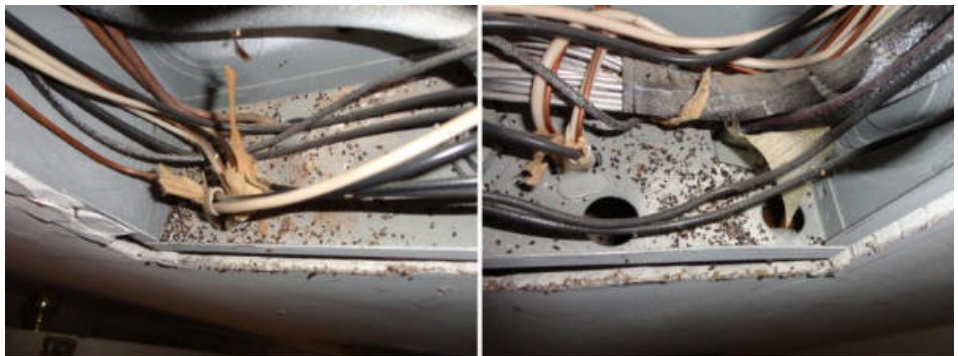
Condition of Wiring Entering and in Panel:

There are wires entering the main service panel that are not secured with an approved connector as required for safety. All wires entering the main service panel must be secured at the opening using an approved connector. The most common type is referred to as a Romex connector. Recommend a licensed electrician inspect and install the required missing connectors.

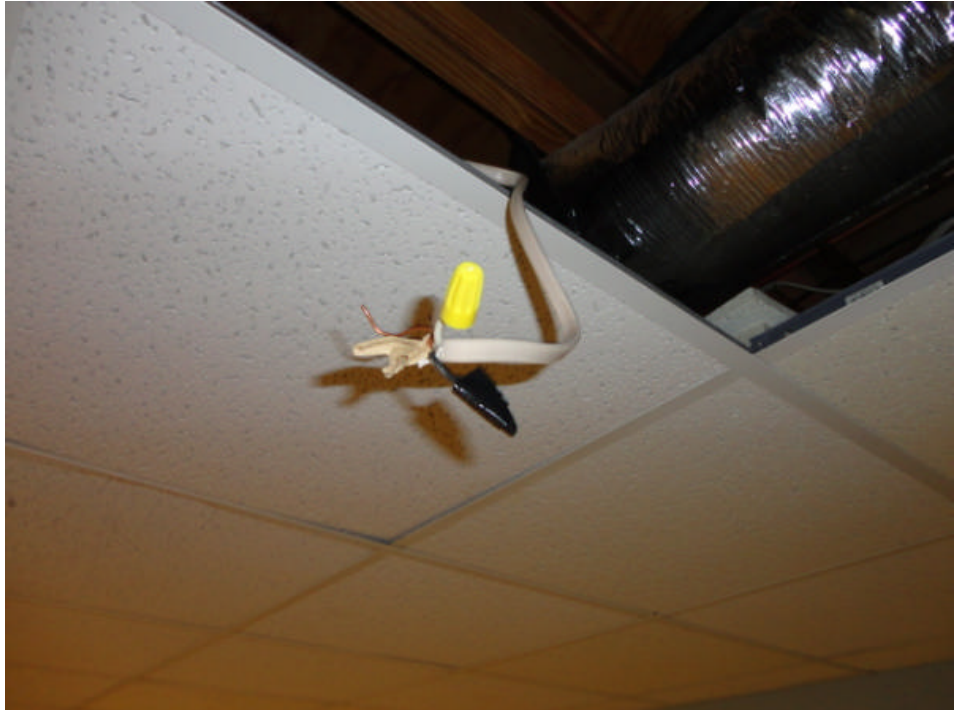
Condition of Junctions and Wiring:

There is a live branch circuit hanging from the basement ceiling. Recommend a licensed electrician secure.

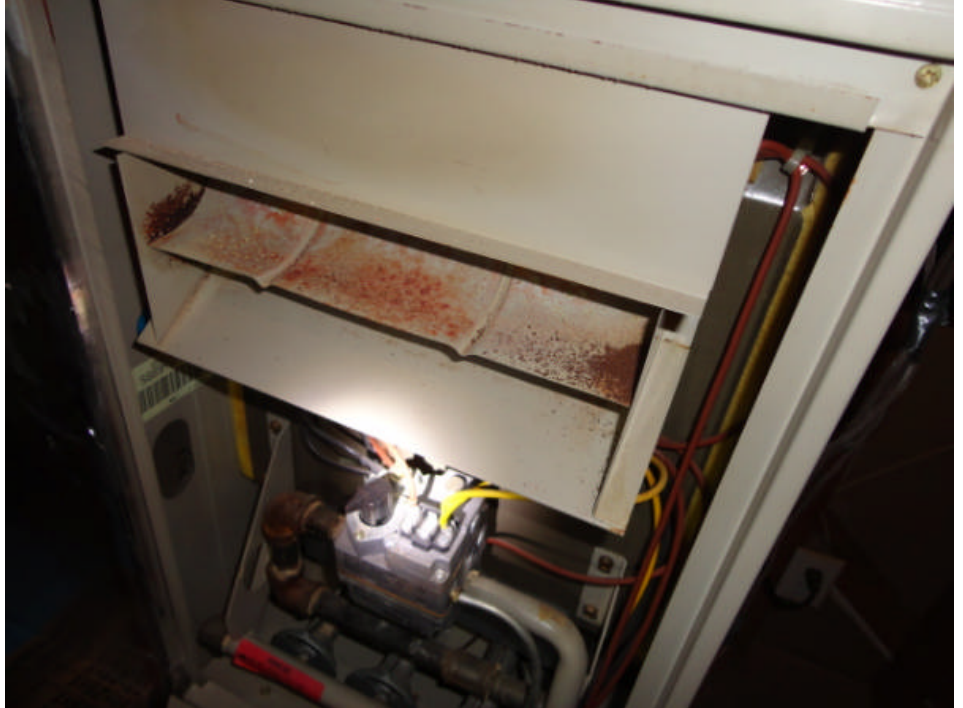
Central Unit Condition:

There is evidence of rust in or around the central unit. Recommend a trained HVAC technician inspect and repair or replace as needed.

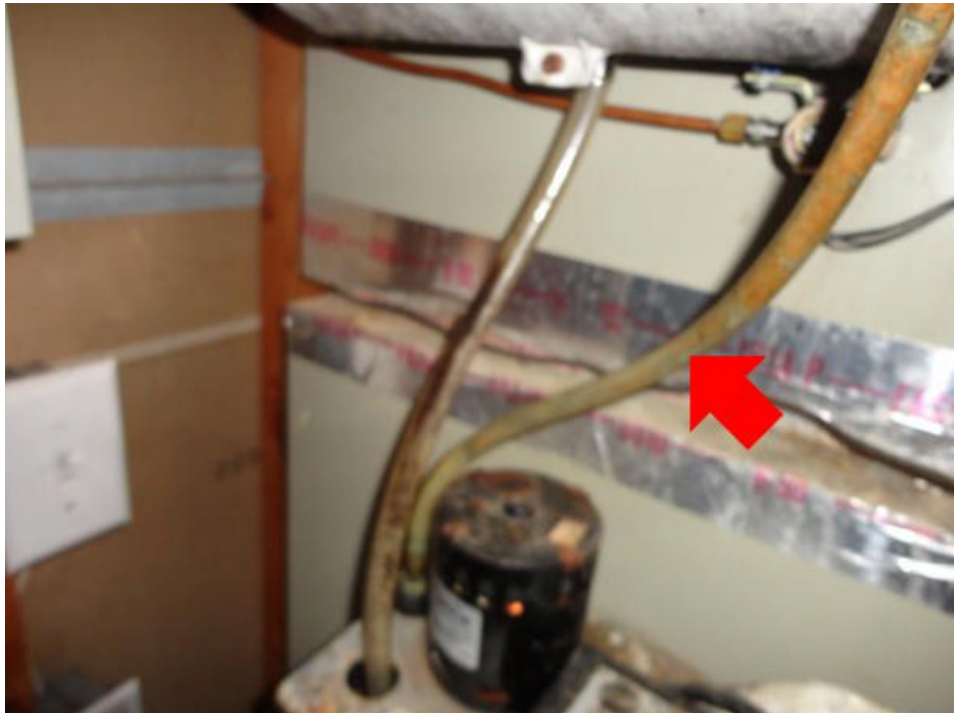
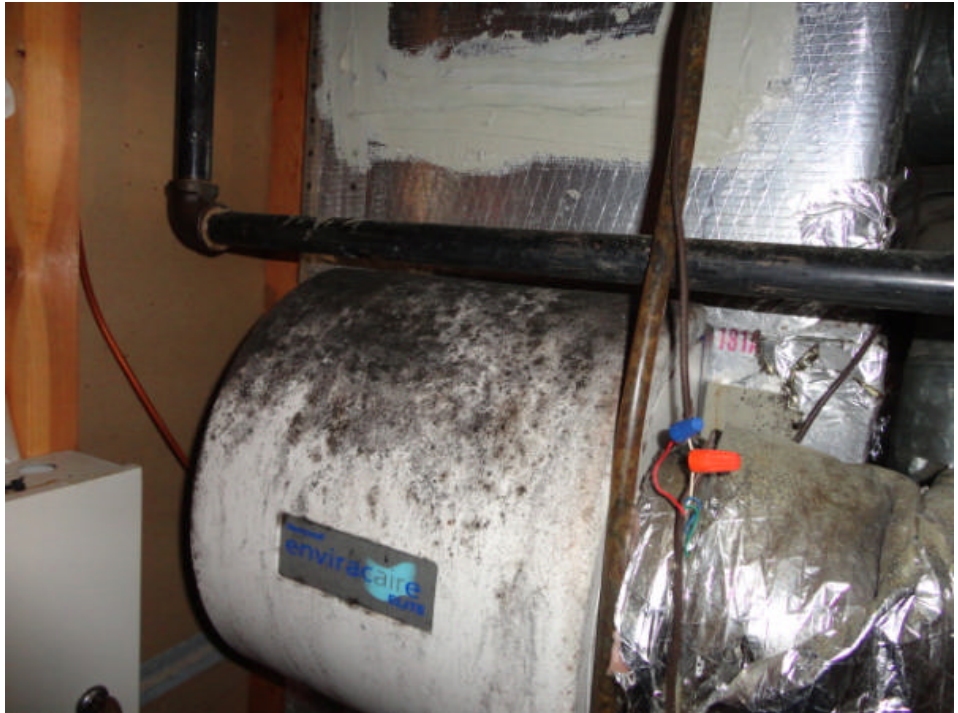
Condensation Line Serving the Central Unit:

There is a condensate pump installed to remove the water from the furnace cabinet. There is also a humidifier mounted on the system. These are prone to mold and fungal growth. The condensate pump drain tube is dirty. Mildew and scaling occur inside of this line. Recommend cleaning pump tray, line and humidifier with a mild solution of bleach

or detergent designed to removed mildew and scaling.

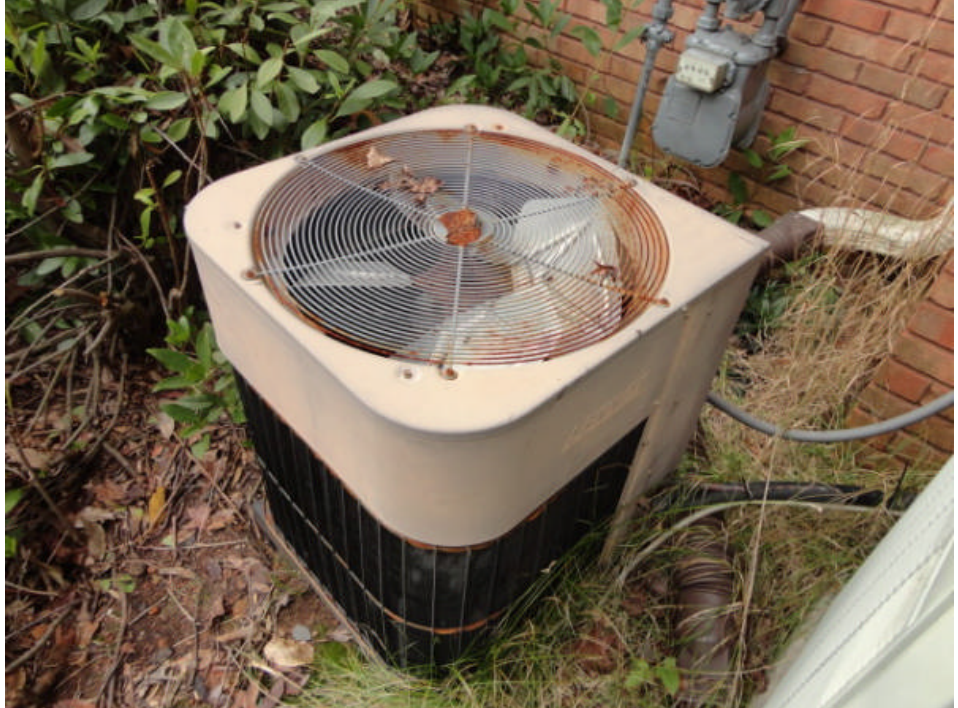
Compressor Condition:

The condensing coil appears to be dirty, which will reduce the unit's efficiency. Cleaning is needed.

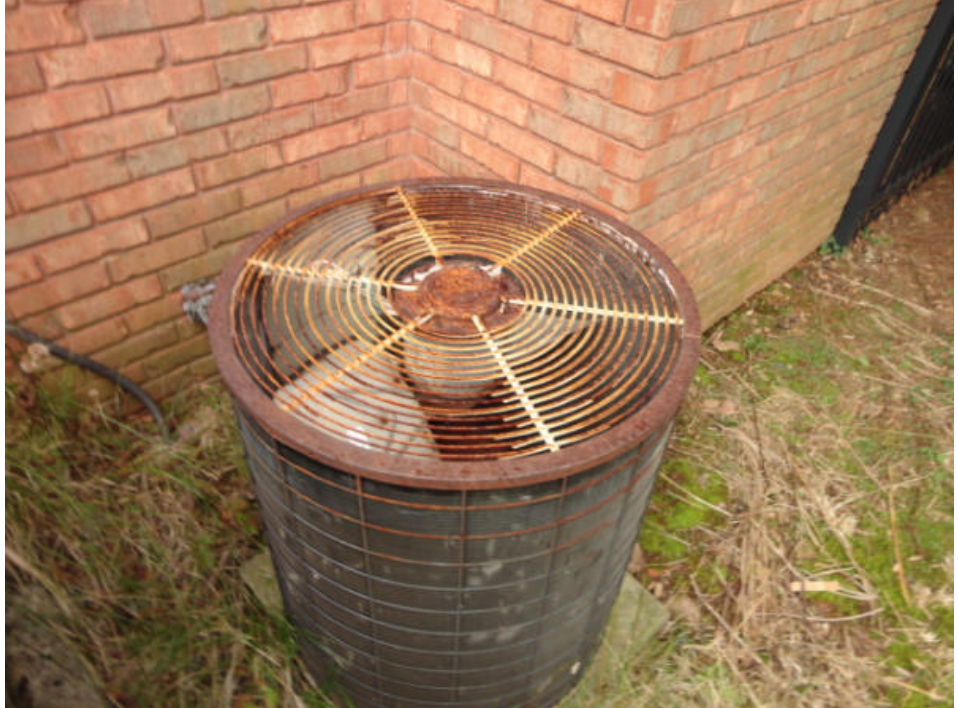
Compressor Condition:

The condensing coil appears to be dirty, which will reduce the unit's efficiency. Cleaning is needed. There is rust on the top of the air conditioning compressor. Recommend removing the existing rust with a wire brush and painting with an exterior enamel. The compressor to this unit is beyond the end of its design life. Recommend replacing as soon as practical.
