Home Inspection Report

**6754 Amber Lake Lane
Alpharetta, Georgia 30022**

**Prepared for Sue Cassidy
February 8, 2012**

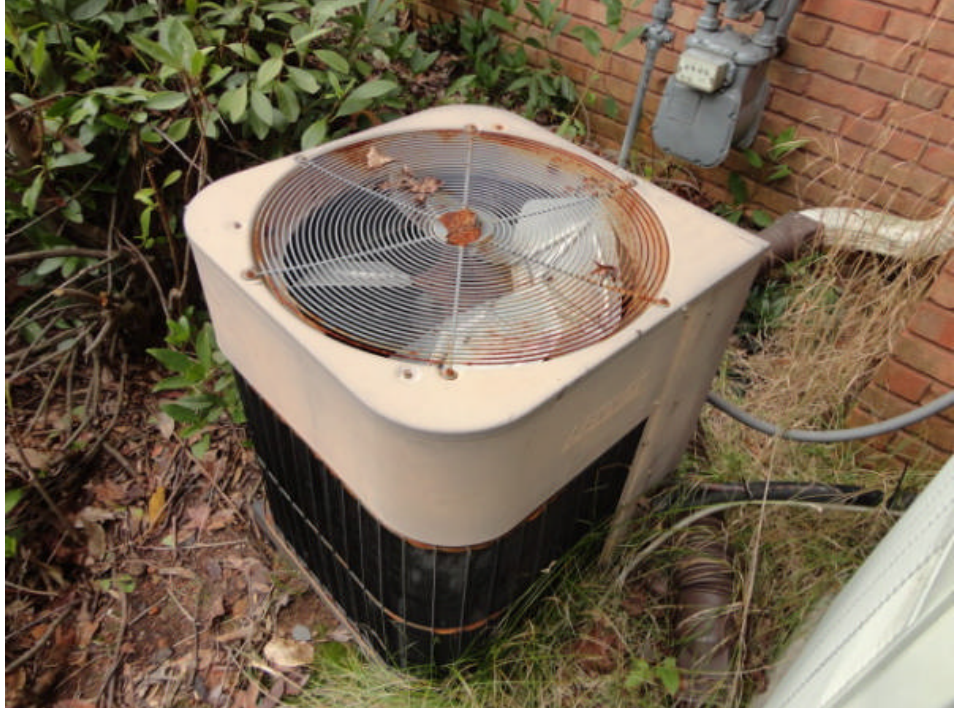
Compressor Condition:

The condensing coil appears to be dirty, which will reduce the unit's efficiency. Cleaning is needed. The compressor is partially blocked by bushes. Recommend trimming or moving the bushes to improve air flow to the coils. There is rust on the top of the air conditioning compressor. Recommend removing the existing rust with a wire brush and painting with an exterior enamel. The compressor to this unit is beyond the end of its design life. Recommend replacing as soon as practical.

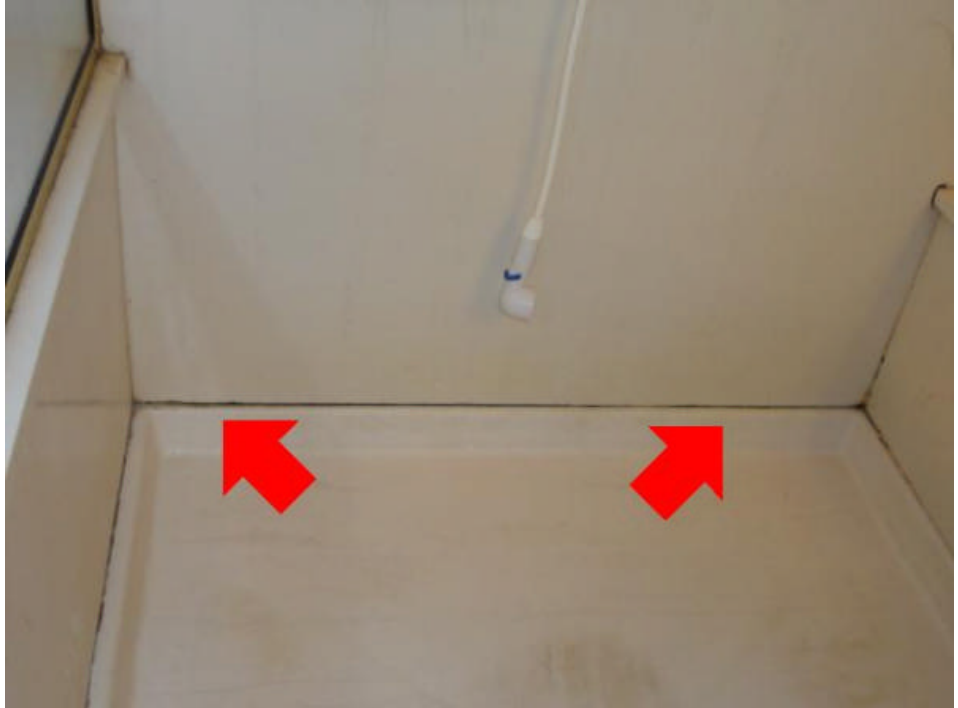
Caulking/Water Contact Areas:

The wall at the shower seam needs to be caulked to prevent moisture from entering the wall.
