## **MIFACE INVESTIGATION: #03MI103**

### **SUBJECT: Farmer Dies When Tractor With Front-End Loader Overturns In Ditch and Pins Him**

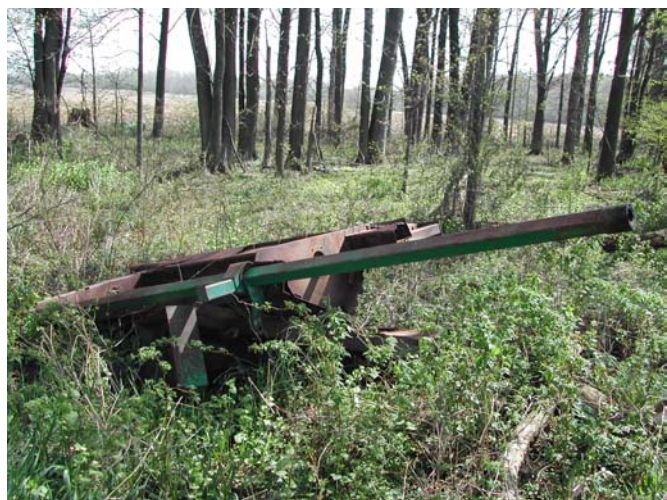
Figure 2. Salvage flail mower in woodlot

MIFACE estimated the salvage flail mower to exceed 700 pounds (See Figure 2).

Front-end loader buckets are not designed for carrying the large and heavy pieces of equipment, such as the flail chopper. Although a manual for the flail chopper was unavailable, the chopper's size and weight was close to exceeding the capacity of the tractor and made the tractor unstable even though the victim was driving slowly. It is unknown if the victim set the tractor wheels at the widest recommended setting, since a manual was also not available for the tractor and MIFACE was not able to see the tractor. The victim's wife indicated she did not think that extra ballast was added to the rear of the tractor to give the tractor extra stability. The ballast would counterbalance the extra weight on the front of the tractor and help prevent an overturn. Additionally, overloading a front-end loader on a tractor can cause instability and steering difficulty.

- Use equipment properly – front-end loader bucket isn't designed to carry a flail chopper.

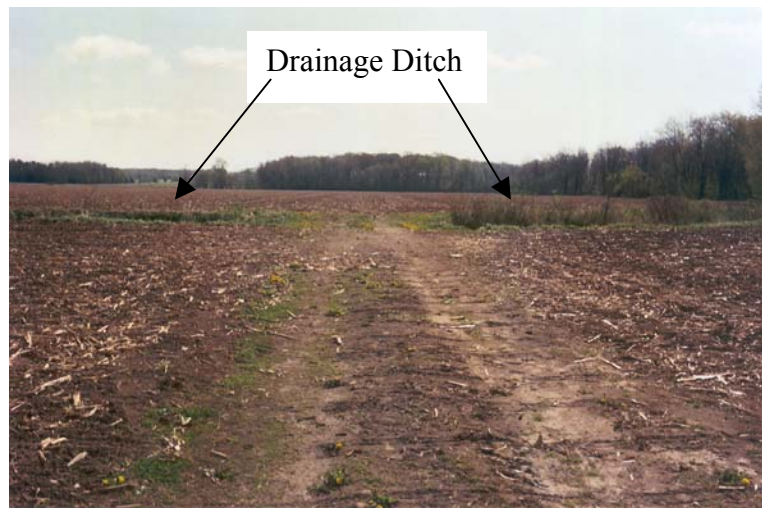
Figures 3-5 show the path he drove to the woodlot. Before transporting the flail chopper to the woodlot, he chained the chopper to the front-end loader/tines. He traveled down a wide lane between cornfields. This lane terminated into a cornfield and the woodlot was to the operator's right. The drainage ditch was to the victim's right and left.

Figure 3. Access lane between cornfields

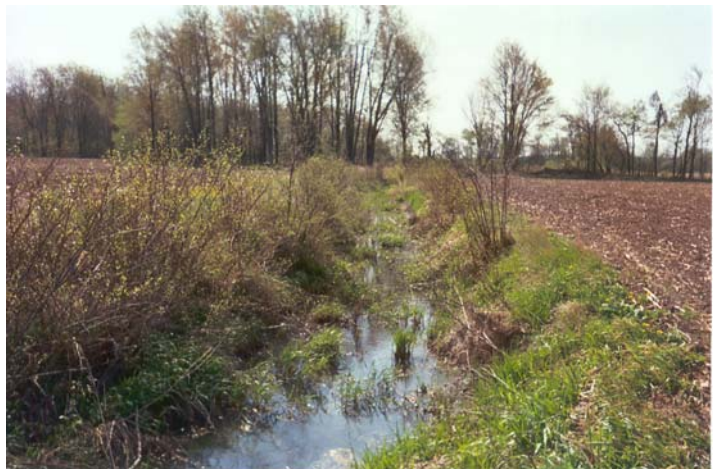
Figure 7. Undefined ditch edge

Mow away from the edge of the ditch and leave the tall grass as a marker. The tall grass boundary from the edge of the ditch should be at least equal to the depth of the ditch. If possible, when equipment movement occurs between the crop field edge and a depression such as a ditch, make a best effort to have a 12-20 foot access area (path) to accommodate equipment movement. It is unknown how well the ditch was defined at the time of the incident. The path, as shown in Figure 7 has tall grass and shrubbery at the very edge of the ditch and growing up from the sides of the ditch, making it difficult to determine the ditch edge.

- When mowing or planting, leave a visual cue to identify the edge of drainage ditches or other land depressions.
