NORTH TOPSAIL BEACH SHORELINE PROTECTION PROJECT - PHASE 5 BEACH RESTORATION CONSTRUCTION OBSERVATION REPORT - PAGE 1

DATE: April 1, 2015
OBSERVER: Julien Devisse

OBSERVATION REPORT NO: 106
COMMENCEMENT DATE: November 16, 2014
CONTRACT DAY: 137

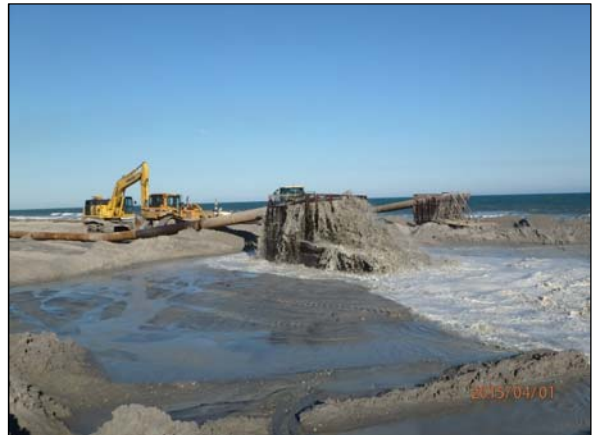
Photo 2. View of the landward and seaward outfalls and rock boxes at 17:45 near Sta. 674+00, looking northeast.

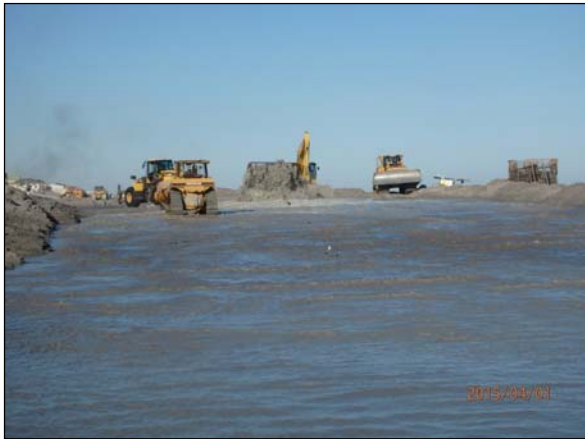
Photo 3. View of the landward discharge area at 17:50 near Sta. 674+00, looking north.

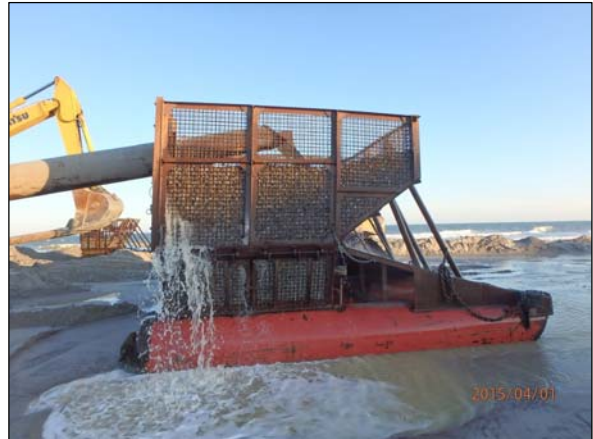
7. During dredging operations, the rock boxes were installed on both the seaward and landward outfalls to capture rock that is being discharged within the beach fill area. NDC emptied the material from the rock boxes and placed the material on the seaward side of the landward shore pipeline near Sta. 677+00. An excavator was utilized to scoop up rock from the outfalls that overflowed from the rock boxes. The installation of the 1.5 inch mesh was installed on the large rock box today at the Gray Street staging area. The 1.5 inch rock box screen was welded on top of the 2 inch mesh, resulting in a mesh size that is smaller than 1.5 inches. See Discussions #1 and #3.

Photo 4. View of the full rock box with the 1.5 inch mesh overlaid on top of the 2 inch mesh.

1. Chip Forbes (NDC) confirmed that the 1.5 inch rock box mesh will continue to be installed on top of the 2 inch mesh, resulting in a mesh size that is smaller than 1.5 inches. Chip indicated that the 1.5 inch mesh was installed on the larger rock box as this rock box already had a back plate that minimized overflow. The smaller rock boxes will need additional time compared to the larger rock box as they need to install both the 1.5 inch mesh and the additional screening on the back side to prevent overflow. Chip indicated that NDC has 4 welders working on the rock boxes and are attempting to complete all of the modifications as quickly as possible.

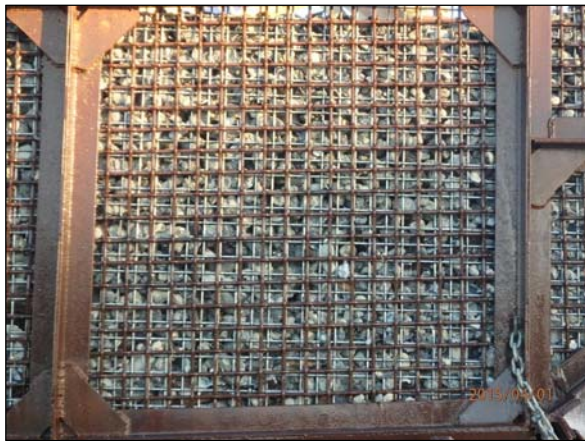
Photo 5. View of the full rock box with the 1.5 inch mesh overlaid on top of the 2 inch mesh.

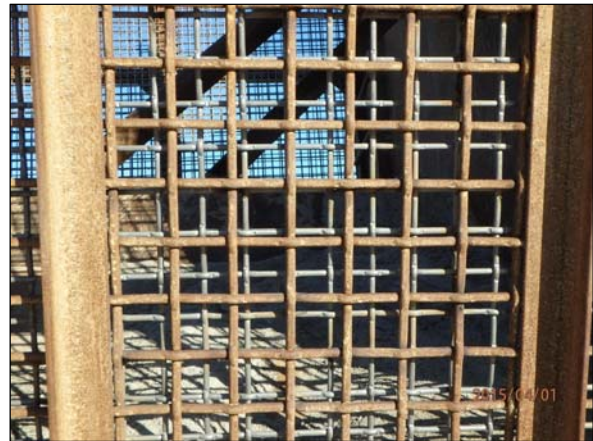
Photo 6. View of the rock box with the 1.5 inch mesh overlaid on top of the 2 inch mesh.

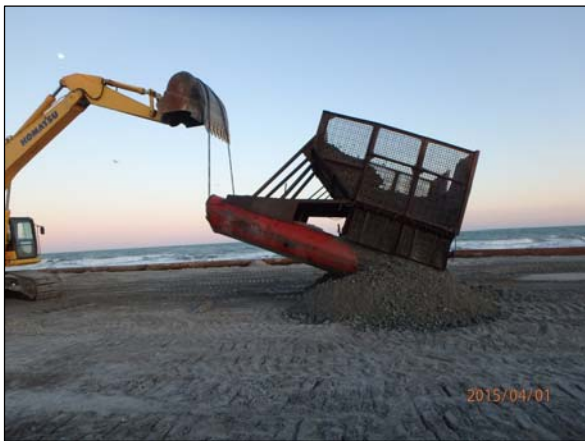
Photo 7. View of an excavator emptying a full rock box.

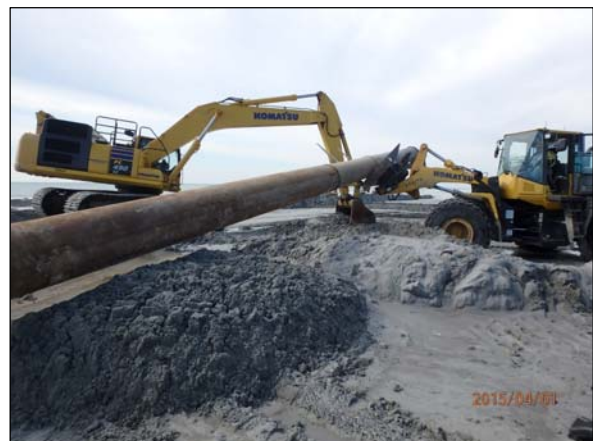
Photo 8. An excavator being used to collect the material from the rock boxes within the discharge area.

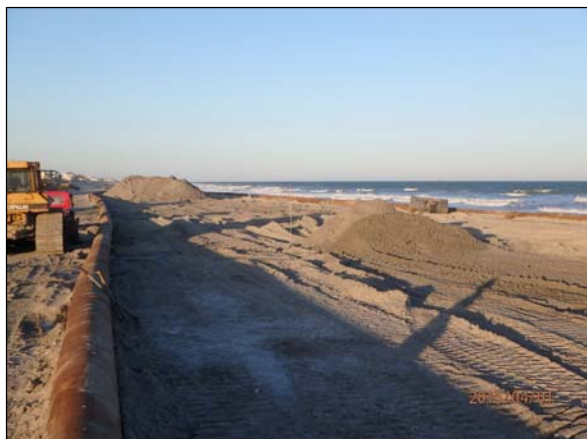
9. No rock was relocated off-site for NDC today. There are 3 stockpiled areas of rock box material within the beach fill area, near Sta. 694+00, 687+00 and 680+00.

Photo 9. View of the material from the rock boxes being stockpiled seaward of the landward shore pipeline near Sta. 680+00 and 677+00, looking north.

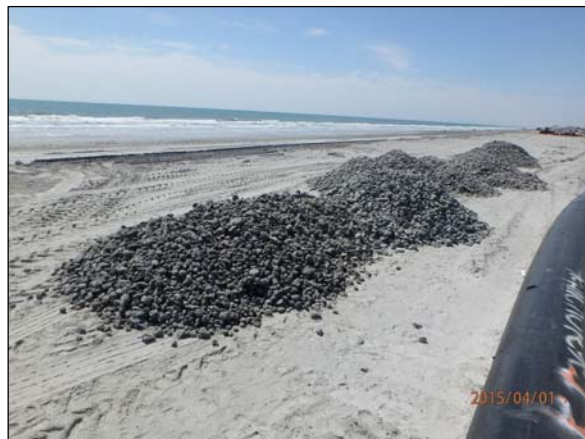
8. The rock picker was not operational today. Approximately 5 cy of rocks previously collected by the rock picker are being stockpiled near Sta. 721+50, approximately 8 cy of rocks are being stockpiled near Sta. 739+00 and approximately 36 cy of rocks are being stockpiled near Sta. 694+00 on the seaward side of the shore pipeline. See Discussion #2.

Photo 10. View of the rocks previously collected by the rock picker being stockpiled seaward of the shore pipeline near Sta. 694+00.

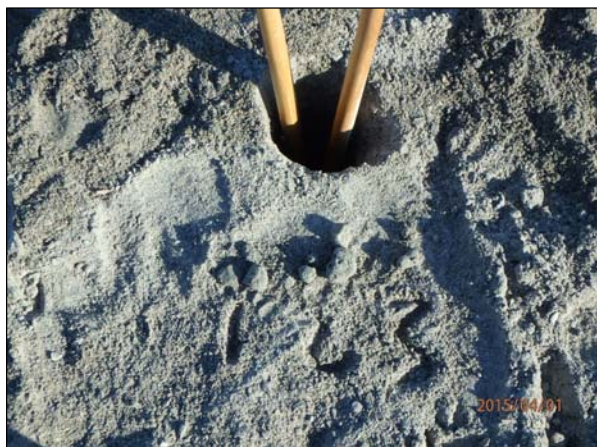
10. A post hole digger was utilized to dig 3 holes, approximately 3 feet deep and 8 inches wide, within the constructed berm area at Station at 676+00. The holes were constructed to determine the quantity of rocks up to 3 feet below existing grade. The quantity of rocks within the hole at the landward portion of the constructed berm between 0-1 feet below existing grade was 0, between 1-2 feet was 1 and between 2-3 feet was 1. The quantity of rocks within the hole at the center of the constructed berm between 0-1 feet below existing grade was 3, between 1-2 feet was 4 and between 2-3 feet was 2. The quantity of rocks within the hole at the seaward portion of the constructed berm between 0-1 feet below existing grade was 3, between 1-2 feet was 2 and between 2-3 feet was 1.

Photo 11. The quantity of rocks within the hole at the center of the constructed berm at Sta. 676+00 between 0-1 feet below existing grade was 3, between 1-2 feet was 4 and between 2-3 feet was 2.

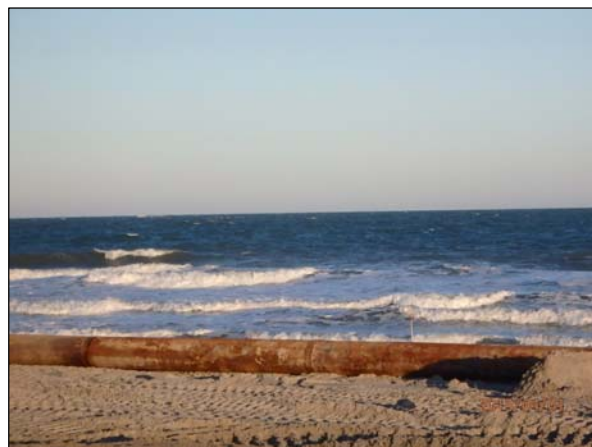
Photo 12. Wave conditions at 18:40.

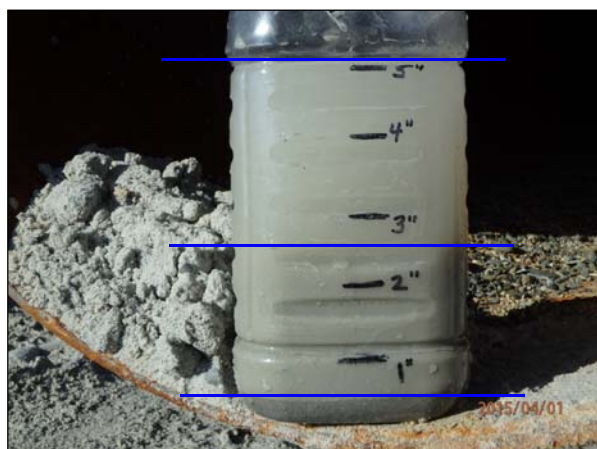
4. A sample of the discharge from the outfall was collected at 17:30 in a plastic bottle to determine the relative silt content; documentary photographs were taken at the 5-minute and 15-minute marks. After settling for 5 minutes the air/water interface was near the 5.1" line, the water/silt interface was near the 2.5" line, and the silt/sand interface was near the 0.3" line. After settling for 15 minutes the air/water interface was near the 5.1" line, the water/silt interface was near the 1.3" line, and the silt/sand interface was near the 0.3" line.

Photo 13. Discharge sample after settling for 5 minutes. The blue lines are used to show sand, silt, and water interfaces.

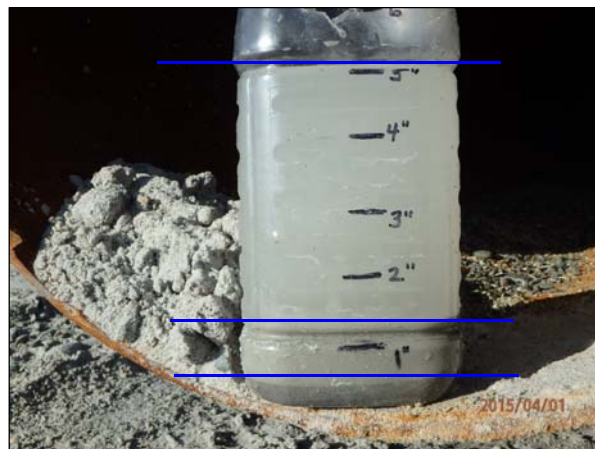
Photo 14. Discharge sample after settling for 15 minutes. The blue lines are used to show sand, silt, and water interfaces.

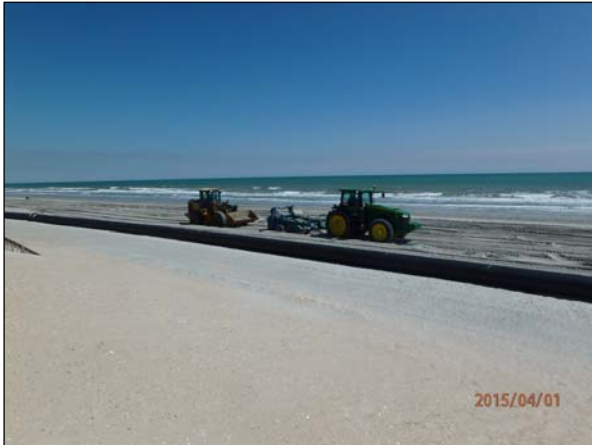
13. Contractor performed Piping Plover and Red Knot monitoring between 08:35-08:50 and noted that no birds or nests were observed.
14. Tigerhole Landscaping commenced rock picking operations up to 36 inches below the constructed grade of the berm area between Sta. 720+00 and 715+00. The Town's off-road truck was utilized to relocate 3 truck loads of rock (36 cy) that were removed by the rock picker from the constructed berm area between Sta. 720+00 and 715+00. See Discussion #4.

Photo 15. Tigerhole Landscaping commenced rock picking operations up to 36 inches below the constructed grade of the berm area between Sta. 720+00 and 715+00.

4. Tigerhole Landscaping indicated that they would provide a schedule update tomorrow after they have had sufficient time to estimate the time needed to rock pick up to 36 inches below the constructed grade of the berm area between Sta. 720+00 and 715+00.

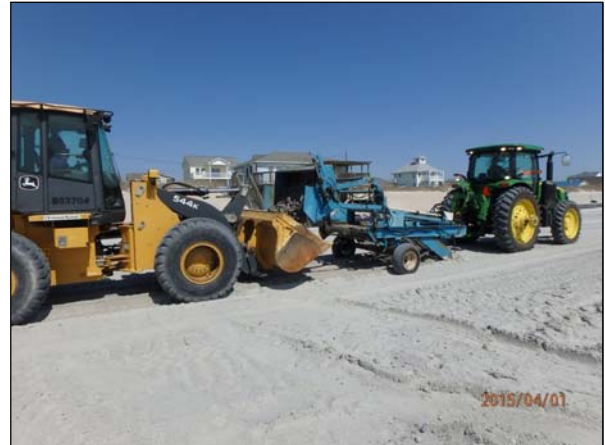
Photo 16. Tigerhole Landscaping emptying the rock picker hopper into a front end loader for removal.

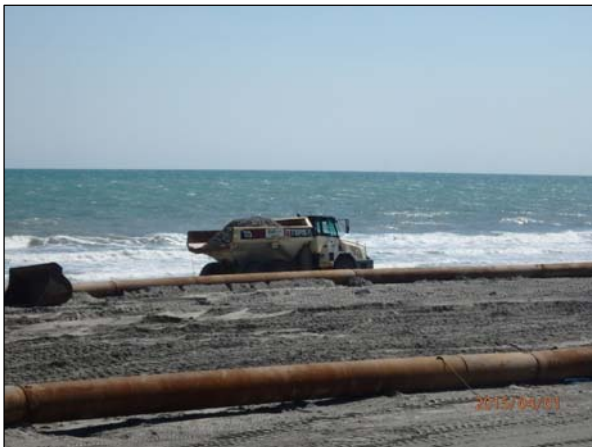
Photo 17. The Town's off-road truck was utilized to relocate 3 truck loads of rock (36 cy) that were removed by Tigerhole Landscaping's rock picker from the constructed berm area between Sta. 720+00 and 715+00.

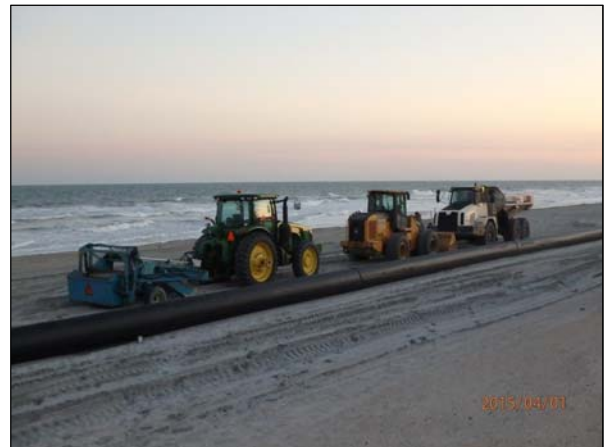
Photo 18. Tigerhole Landscaping's equipment being stored overnight near the shore pipeline in the vicinity of Sta. 720+00.

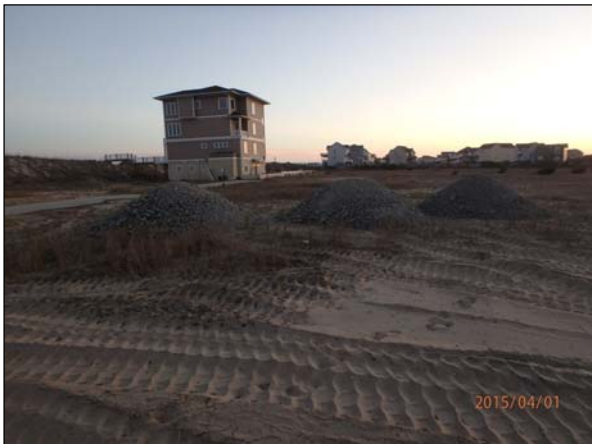
Photo 19. View of the material from Tigerhole Landscaping's rock picking operations being stockpiled at the lot 2 blocks south of the Gray Street access.

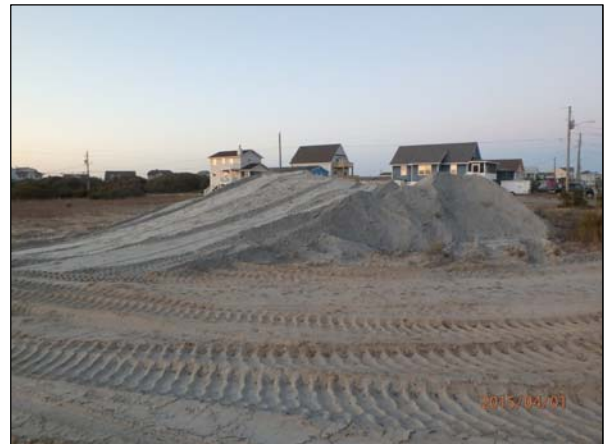
Photo 20. View of the material from the rock boxes being stockpiled at the lot 2 blocks south of the Gray Street access.
