**NORTH TOPSAIL BEACH SHORELINE PROTECTION PROJECT - PHASE 5 BEACH RESTORATION
CONSTRUCTION OBSERVATION REPORT - PAGE 1**

DATE: April 1, 2015
OBSERVER: Julien Devisse

OBSERVATION REPORT NO: 106
COMMENCEMENT DATE: November 16, 2014
CONTRACT DAY: 137

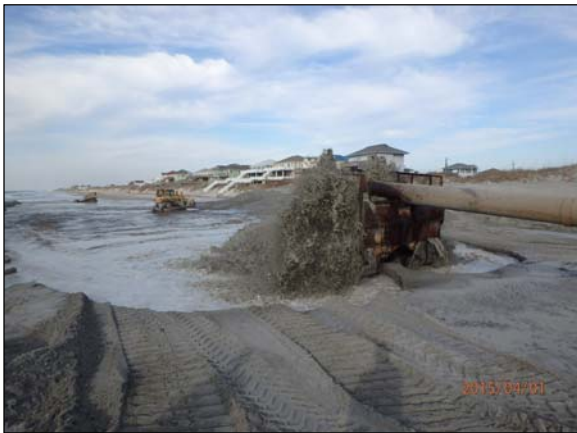
Photo 1. View of the seaward outfall and rock box at 08:50 near Sta. 674+00, looking south.

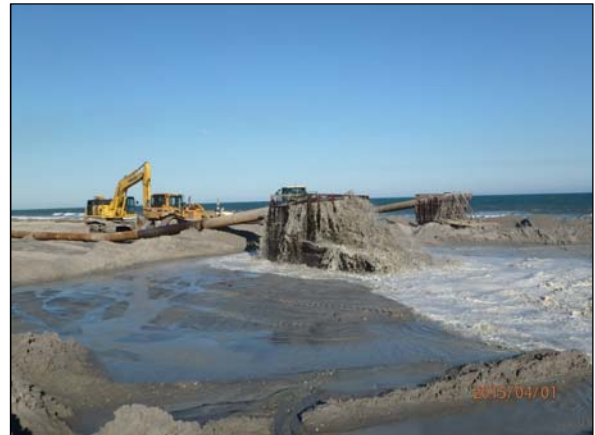
Photo 2. View of the landward and seaward outfalls and rock boxes at 17:45 near Sta. 674+00, looking northeast.

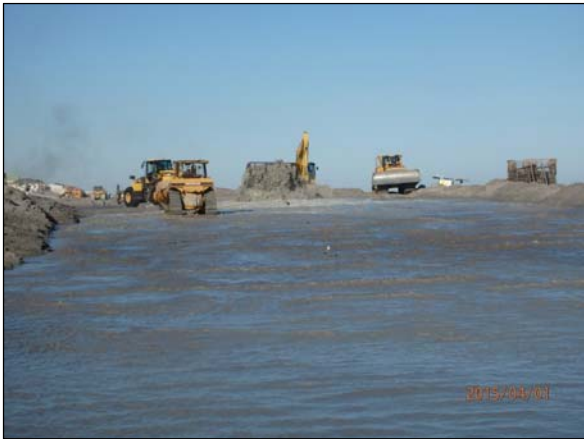
Photo 3. View of the landward discharge area at 17:50 near Sta. 674+00, looking north.

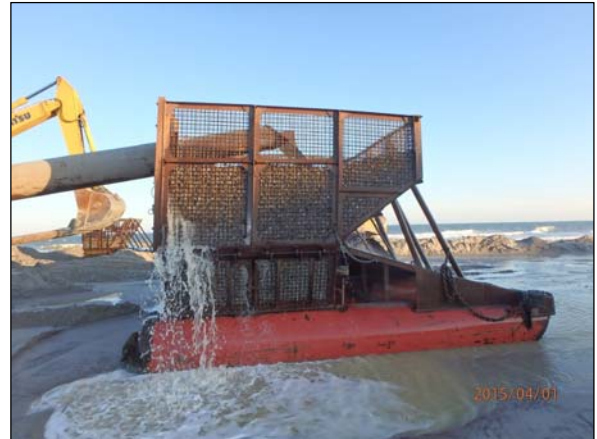
7. During dredging operations, the rock boxes were installed on both the seaward and landward outfalls to capture rock that is being discharged within the beach fill area. NDC emptied the material from the rock boxes and placed the material on the seaward side of the landward shore pipeline near Sta. 677+00. An excavator was utilized to scoop up rock from the outfalls that overflowed from the rock boxes. The installation of the 1.5 inch mesh was installed on the large rock box today at the Gray Street staging area. The 1.5 inch rock box screen was welded on top of the 2 inch mesh, resulting in a mesh size that is smaller than 1.5 inches. See Discussions #1 and #3.

Photo 4. View of the full rock box with the 1.5 inch mesh overlaid on top of the 2 inch mesh.

1. Chip Forbes (NDC) confirmed that the 1.5 inch rock box mesh will continue to be installed on top of the 2 inch mesh, resulting in a mesh size that is smaller than 1.5 inches. Chip indicated that the 1.5 inch mesh was installed on the larger rock box as this rock box already had a back plate that minimized overflow. The smaller rock boxes will need additional time compared to the larger rock box as they need to install both the 1.5 inch mesh and the additional screening on the back side to prevent overflow. Chip indicated that NDC has 4 welders working on the rock boxes and are attempting to complete all of the modifications as quickly as possible.

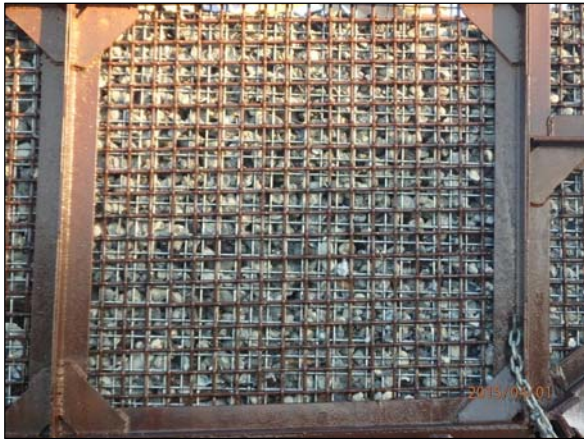
Photo 5. View of the full rock box with the 1.5 inch mesh overlaid on top of the 2 inch mesh.

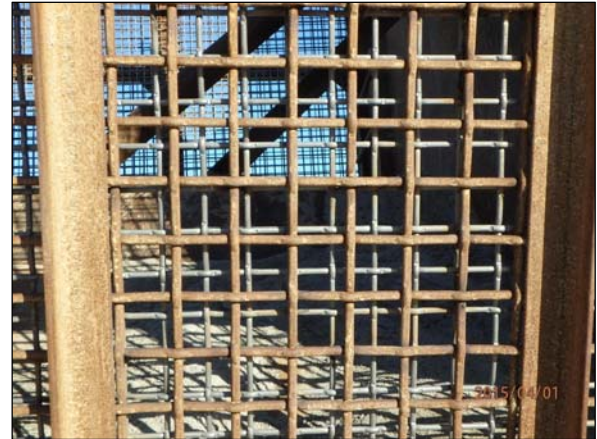
Photo 6. View of the rock box with the 1.5 inch mesh overlaid on top of the 2 inch mesh.

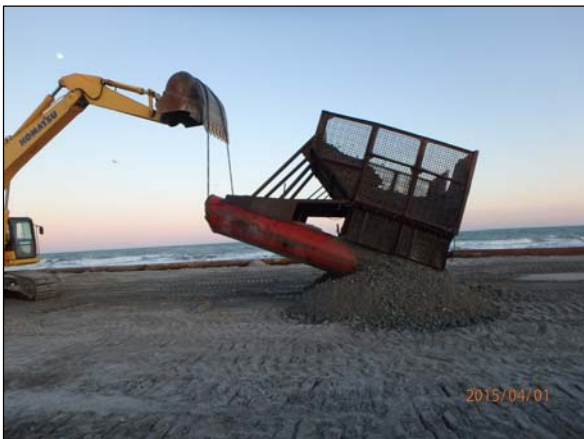
Photo 7. View of an excavator emptying a full rock box.

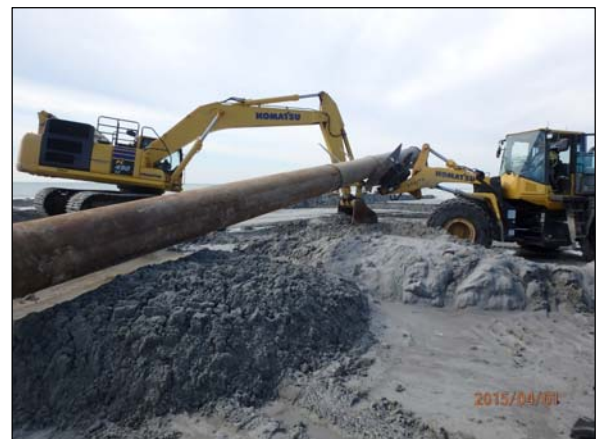
Photo 8. An excavator being used to collect the material from the rock boxes within the discharge area.

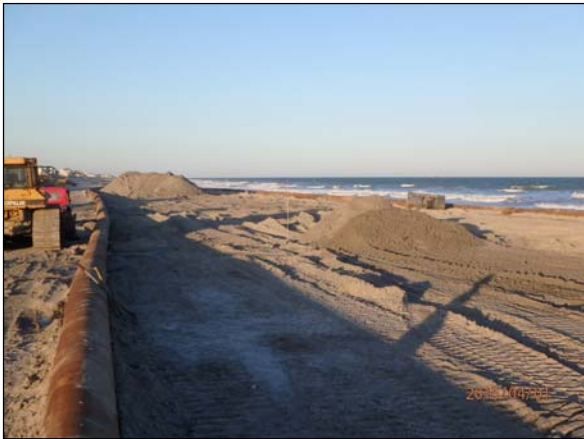
9. No rock was relocated off-site for NDC today. There are 3 stockpiled areas of rock box material within the beach fill area, near Sta. 694+00, 687+00 and 680+00.

Photo 9. View of the material from the rock boxes being stockpiled seaward of the landward shore pipeline near Sta. 680+00 and 677+00, looking north.

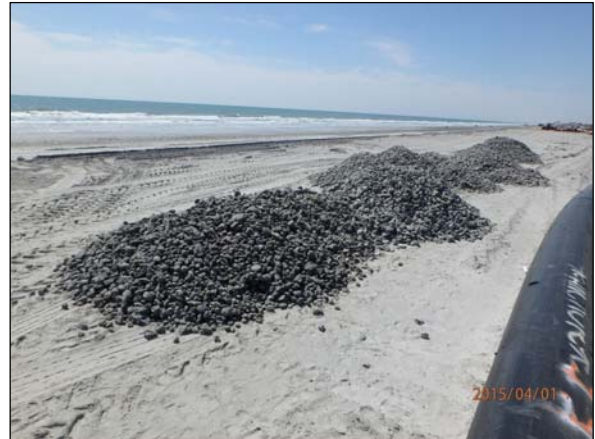
8. The rock picker was not operational today. Approximately 5 cy of rocks previously collected by the rock picker are being stockpiled near Sta. 721+50, approximately 8 cy of rocks are being stockpiled near Sta. 739+00 and approximately 36 cy of rocks are being stockpiled near Sta. 694+00 on the seaward side of the shore pipeline. See Discussion #2.

Photo 10. View of the rocks previously collected by the rock picker being stockpiled seaward of the shore pipeline near Sta. 694+00.

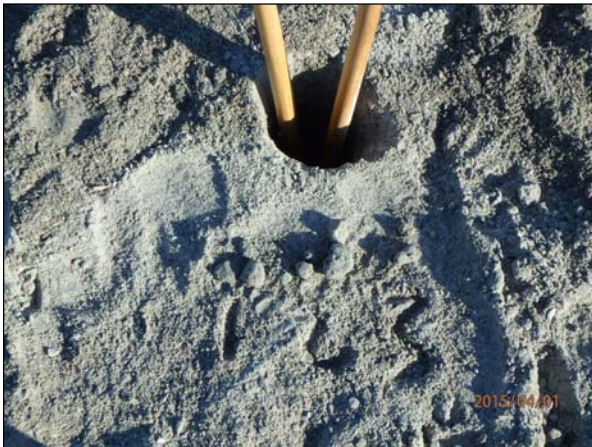
10. A post hole digger was utilized to dig 3 holes, approximately 3 feet deep and 8 inches wide, within the constructed berm area at Station at 676+00. The holes were constructed to determine the quantity of rocks up to 3 feet below existing grade. The quantity of rocks within the hole at the landward portion of the constructed berm between 0-1 feet below existing grade was 0, between 1-2 feet was 1 and between 2-3 feet was 1. The quantity of rocks within the hole at the center of the constructed berm between 0-1 feet below existing grade was 3, between 1-2 feet was 4 and between 2-3 feet was 2. The quantity of rocks within the hole at the seaward portion of the constructed berm between 0-1 feet below existing grade was 3, between 1-2 feet was 2 and between 2-3 feet was 1.

Photo 11. The quantity of rocks within the hole at the center of the constructed berm at Sta. 676+00 between 0-1 feet below existing grade was 3, between 1-2 feet was 4 and between 2-3 feet was 2.

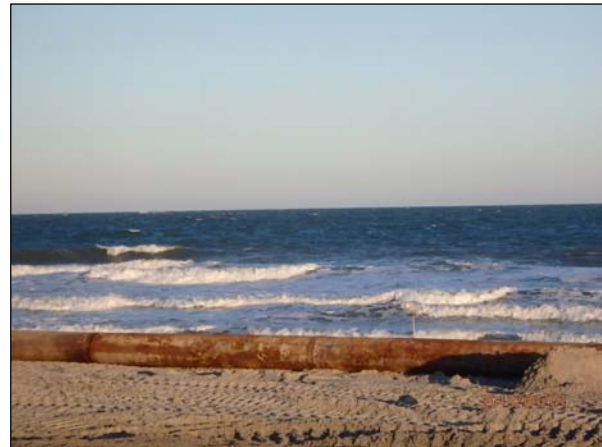
Photo 12. Wave conditions at 18:40.

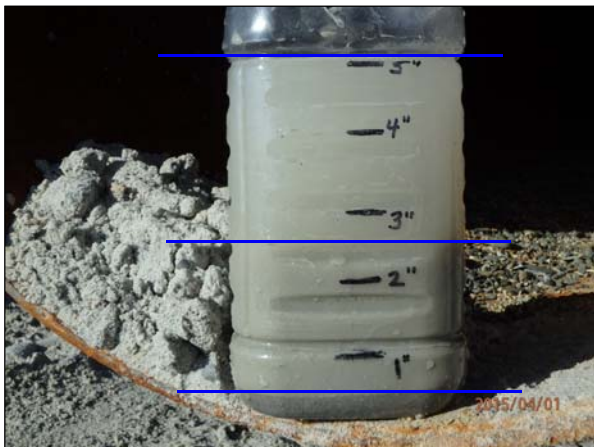
4. A sample of the discharge from the outfall was collected at 17:30 in a plastic bottle to determine the relative silt content; documentary photographs were taken at the 5-minute and 15-minute marks. After settling for 5 minutes the air/water interface was near the 5.1" line, the water/silt interface was near the 2.5" line, and the silt/sand interface was near the 0.3" line. After settling for 15 minutes the air/water interface was near the 5.1" line, the water/silt interface was near the 1.3" line, and the silt/sand interface was near the 0.3" line.

Photo 13. Discharge sample after settling for 5 minutes. The blue lines are used to show sand, silt, and water interfaces.

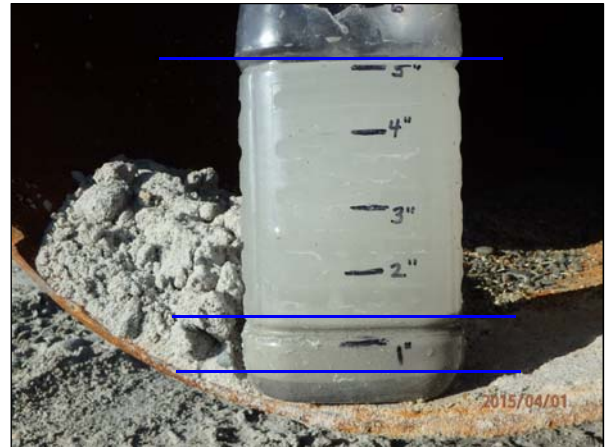
Photo 14. Discharge sample after settling for 15 minutes. The blue lines are used to show sand, silt, and water interfaces.

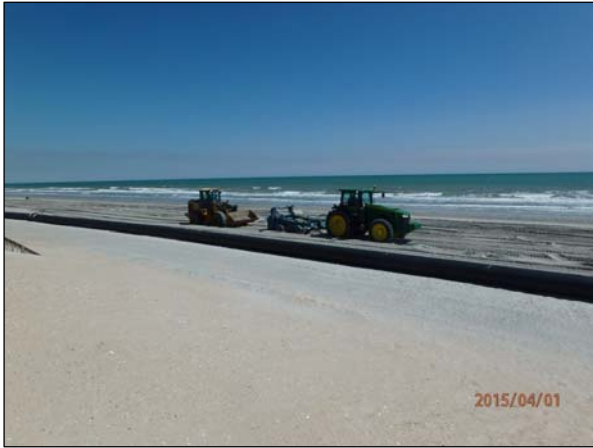
13. Contractor performed Piping Plover and Red Knot monitoring between 08:35-08:50 and noted that no birds or nests were observed.
14. Tigerhole Landscaping commenced rock picking operations up to 36 inches below the constructed grade of the berm area between Sta. 720+00 and 715+00. The Town's off-road truck was utilized to relocate 3 truck loads of rock (36 cy) that were removed by the rock picker from the constructed berm area between Sta. 720+00 and 715+00. See Discussion #4.

Photo 15. Tigerhole Landscaping commenced rock picking operations up to 36 inches below the constructed grade of the berm area between Sta. 720+00 and 715+00.

4. Tigerhole Landscaping indicated that they would provide a schedule update tomorrow after they have had sufficient time to estimate the time needed to rock pick up to 36 inches below the constructed grade of the berm area between Sta. 720+00 and 715+00.

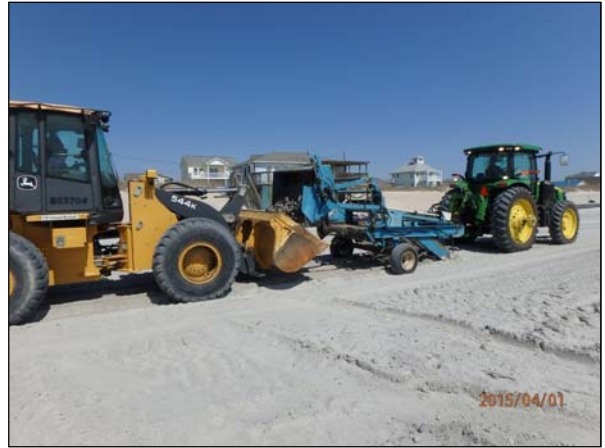
Photo 16. Tigerhole Landscaping emptying the rock picker hopper into a front end loader for removal.

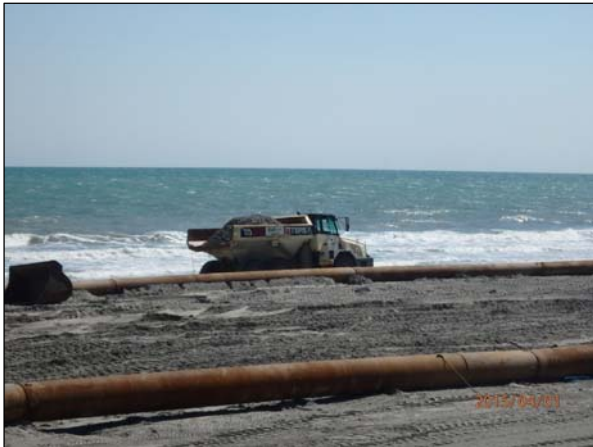
Photo 17. The Town's off-road truck was utilized to relocate 3 truck loads of rock (36 cy) that were removed by Tigerhole Landscaping's rock picker from the constructed berm area between Sta. 720+00 and 715+00.

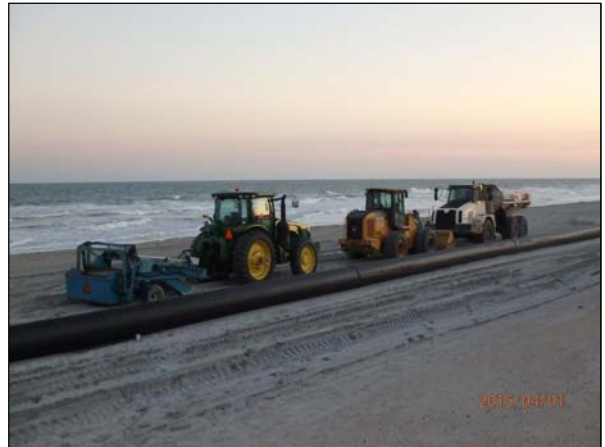
Photo 18. Tigerhole Landscaping's equipment being stored overnight near the shore pipeline in the vicinity of Sta. 720+00.

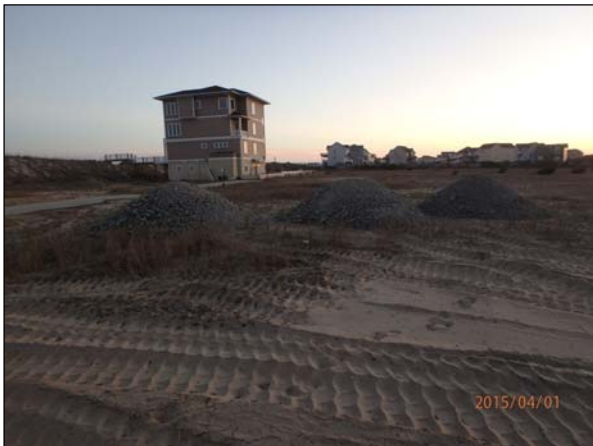
Photo 19. View of the material from Tigerhole Landscaping's rock picking operations being stockpiled at the lot 2 blocks south of the Gray Street access.

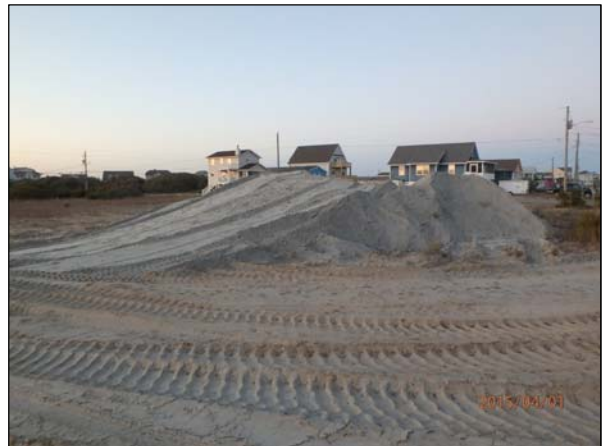
Photo 20. View of the material from the rock boxes being stockpiled at the lot 2 blocks south of the Gray Street access.

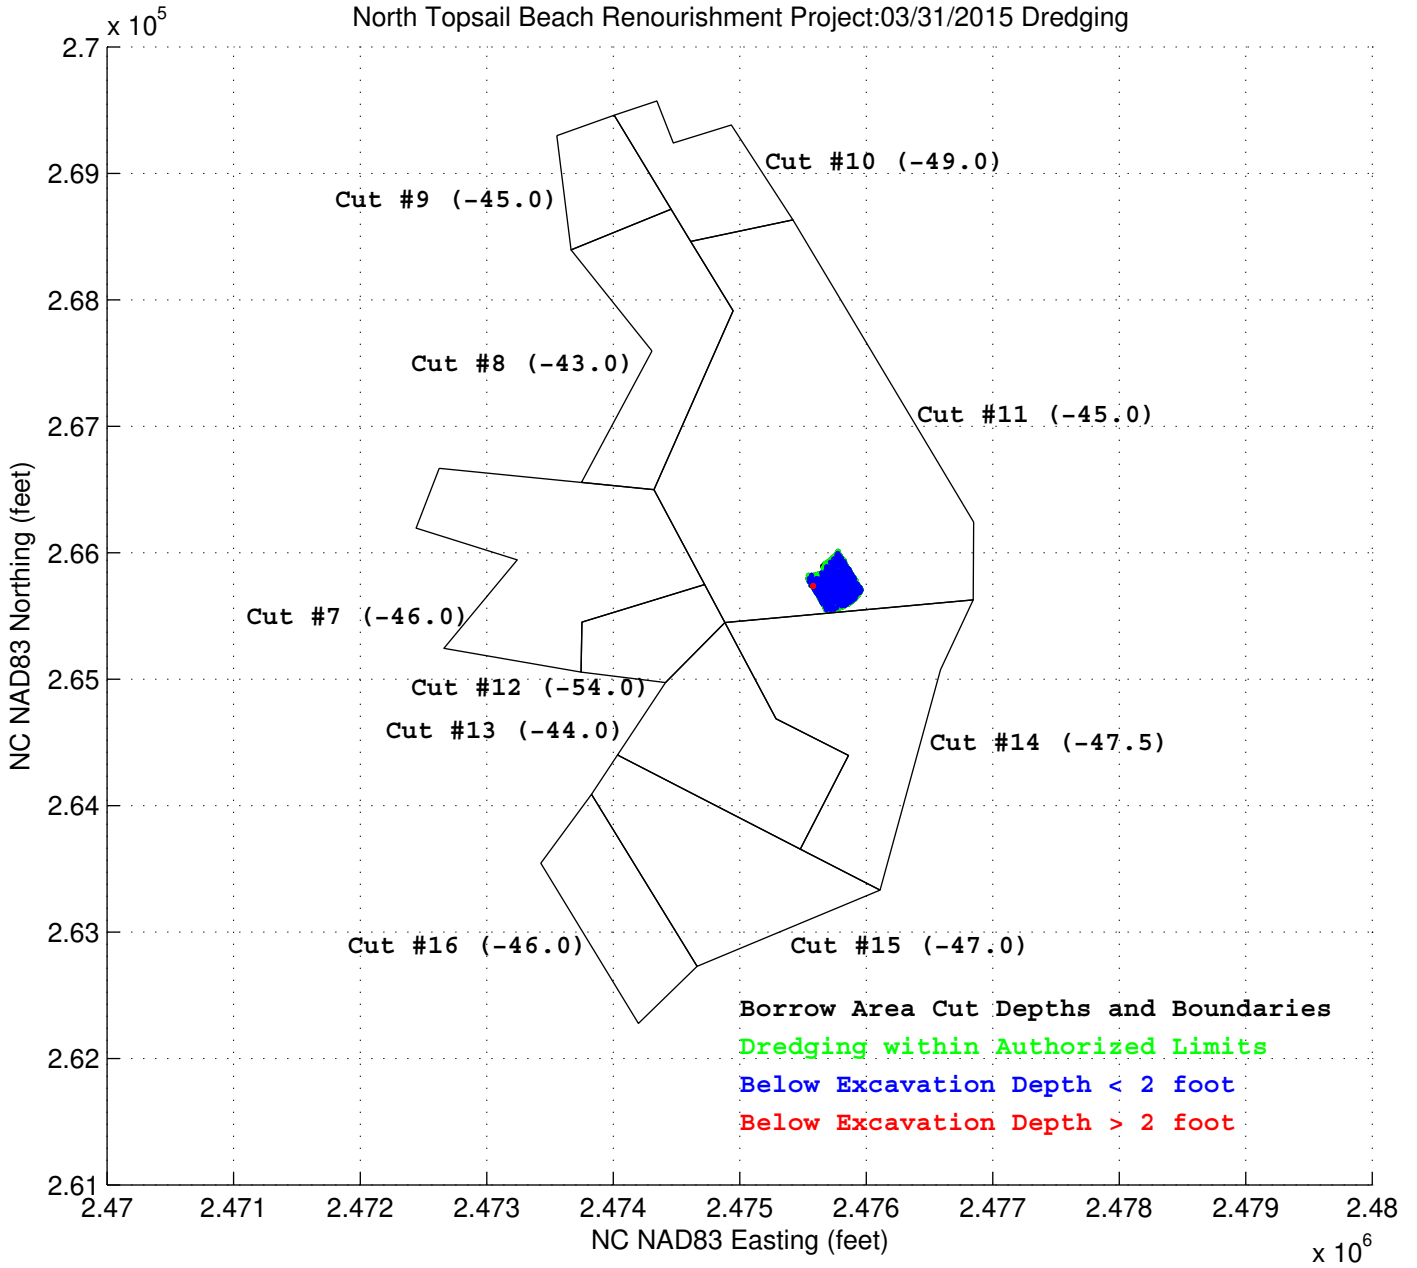
North Topsail Beach Renourishment Project:03/31/2015 Dredging

5. All dredge data submitted was reported within the 15 second required interval for dredging conducted on March 31, 2015.
6. Dredge records for 3/31 showed that the dredge Charleston was within the permitted borrow area limits. There was 1 occasion where the cutterhead extended below the maximum disturbance elevation. The total time in violation lasted less than 3 minutes and was not indicative that systematic dredging below the maximum disturbance elevation occurred.
