# WOOD DESTROYING PESTS AND ORGANISMS INSPECTION REPORT

Building Address: <b>204 N. N St., Lompoc, CA 93436</b>		Date of Inspection <b>06/02/2015</b>	Number of Pages <b>7</b>
Hornet Fumigation 1105 North E Street Lompoc CA 93436 Phone: (805) 736-4195 Fax: (805) 735-8191			Report # <b>W8063</b>
			Lic. Registration # <b>PR 4524</b>
			Escrow #
Ordered by: Santa Barbara Estates 1072 Casitas Pass Rd. Carpinteria, CA 93013	Property Owner and/or Party of Interest: Santa Barbara Estates 1072 Casitas Pass Rd. Carpinteria, CA 93013	Report Sent to: Santa Barbara Estates 1072 Casitas Pass Rd. Carpinteria, CA 93013	
COMPLETE REPORT <input checked="" type="checkbox"/> LIMITED REPORT <input type="checkbox"/> SUPPLEMENTAL REPORT <input type="checkbox"/> REINSPECTION REPORT <input type="checkbox"/>			
General Description: Split level single family residence with a composition roof and an attached garage		Inspection Tag Posted:    Garage	
		Other Tags Posted: None	
An inspection has been made of the structure(s) shown on the diagram in accordance with the Structural Pest Control Act. Detached porches, detached steps, detached decks and any other structures not on the diagram were not inspected.

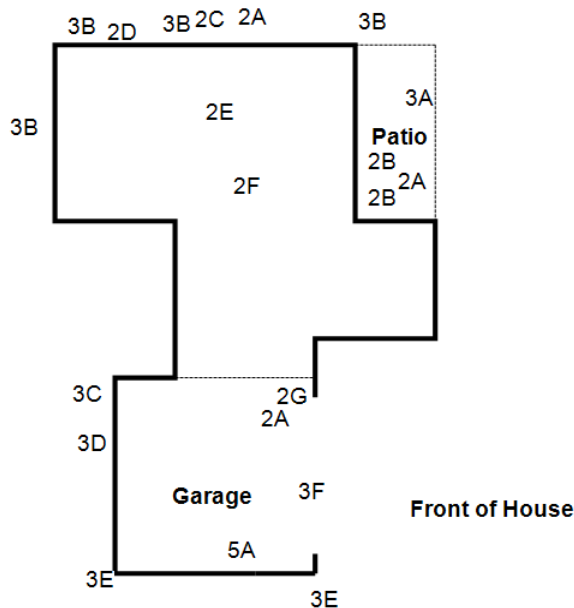
This Diagram is not to scale

- 2A (Section I)  
FINDINGS: Evidence of drywood termite infestation at attached patio cover and siding trim as indicated on the diagram.  
RECOMMENDATION: Vacate the premises and seal the structure for fumigation with Vikane Gas. Remove or cover accessible evidence of infestation. Fumigation warranted for two years. Fumigation awareness notice must be signed prior to fumigation. See fumigation notice for terms and liabilities.

- 2B (Section I)  
FINDINGS: Evidence of termite damaged wood members noted at time of inspection at patio joists as indicated on the diagram.  
RECOMMENDATION: Replace termite damaged wood members as necessary. painting with one coat of primer is included in this estimate.

- 2C (Section I)  
FINDINGS: Evidence of termite damaged wood members noted at time of inspection at siding trim as indicated on the diagram.  
RECOMMENDATION: Replace termite damaged wood members as necessary. painting with one coat of primer is included in this estimate.

- 2D (Section I)  
FINDINGS: Evidence of termite damaged wood members noted at time of inspection at wood siding as indicated on the diagram.  
RECOMMENDATION: Replace termite damaged wood members as necessary. painting with one coat of primer is included in this estimate.

- 2E (Section I)  
FINDINGS: Evidence of termite damaged wood members noted at time of inspection at interior door trim as indicated on the diagram.  
RECOMMENDATION: Replace termite damaged wood members as necessary. painting with one coat of primer is included in this estimate.

- 2F (Section I)  
FINDINGS: Evidence of termite damaged wood members noted at time of inspection at base boards as indicated on the diagram.  
RECOMMENDATION: Replace termite damaged wood members as necessary. painting with one coat of primer is included in this estimate.

- 2G (Section I)  
FINDINGS: Evidence of termite damaged wood members noted at time of inspection at garage wall framing as indicated on the diagram.  
RECOMMENDATION: Replace termite damaged wood members as necessary. painting with one coat of primer is included in this estimate.

- 3A (Section I)  
FINDINGS: Dry-rot wood members found at time of inspection at patio support post as indicated on the diagram.  
RECOMMENDATION: Replace dry-rot damaged wood members as necessary. painting with one coat of primer is included in this estimate.

- 3B (Section I)  
FINDINGS: Dry-rot wood members found at time of inspection at siding trim as indicated on the diagram.  
RECOMMENDATION: Replace dry-rot damaged wood members as necessary. painting with one coat of primer is included in this estimate.

- 3C (Section I)  
FINDINGS: Dry-rot wood members found at time of inspection at roof sheathing as indicated on the diagram.  
RECOMMENDATION: Replace dry-rot damaged wood members as necessary. painting with one coat of primer is included in this estimate.

- 3D (Section I)  
FINDINGS: Dry-rot wood members found at time of inspection at garage pedestrian door as indicated on the diagram.  
RECOMMENDATION: Replace dry-rot damaged wood members as necessary. painting with one coat of primer is included in this estimate.

- 3E (Section I)  
FINDINGS: Dry-rot wood members found at time of inspection at corbels as indicated on the diagram.  
RECOMMENDATION: Replace dry-rot damaged wood members as necessary. painting with one coat of primer is included in this estimate.

- 3F (Section I)  
FINDINGS: Dry-rot wood members found at time of inspection at garage door trim as indicated on the diagram.  
RECOMMENDATION: Replace dry-rot damaged wood members as necessary. painting with one coat of primer is included in this estimate.
