Abstract: Since the year 2000, the city of Gweru has had an unprecedented proliferation of unattended potholes on most of its roads. These potholes have caused discomfort to the motoring public, caused death to others and damaged vehicles. This paper presents the results of a study that sought to establish the spatial distribution of potholes and determine their socio-economic impacts in Gweru's residential areas. Pothole location and dimensions were measured in the field whilst interviews and questionnaires were administered to vehicle owners, motor mechanic experts, drivers and the travelling public to determine their socio-economic and mechanical impacts. Stratified, convenience and purposive sampling methods were used in the selection of study streets and respondents to questionnaires and interviews. Results revealed that potholes are more concentrated in high density residential areas. Other causes of pothole formation identified during this study are poor drainage on the roads, rainfall impact, advanced age of roads, poor or lack of maintenance, type and volume of traffic as well as the effect of tree-root prying on paved surfaces. It is recommended that Gweru City Council en

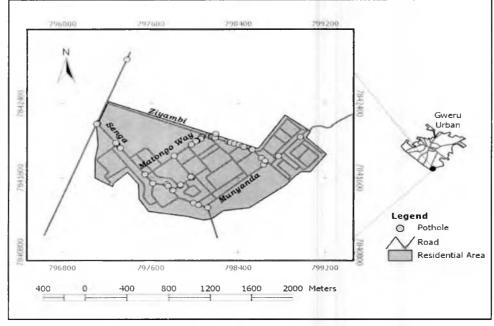
Fig. 3 Distribution of potholes on sampled streets in Senga-Nehosho residential area.

A total of 47 potholes were analysed on sampled roads in Senga and Nehosho residential areas. A stretch of about 11 m × 6 m at the intersection of Ziyambi Drive and Matongo Way and a 20 m × 6 m stretch along Ziyambi Drive are now more of gravel than paved surfaces. 36% of the studied potholes were small (less than 150 cm in circumference), 34% were medium sized (151-300 cm in circumference) whilst 30% were large (more than 300 cm). Large potholes at some points such as at the intersection of Chiwaya Street and Senga Road have circumferences averaging 568 cm, diameter of 242 cm and 6.2 cm in depth covering almost the whole lane. The distribution of potholes recorded and measured on sampled streets in Senga and Nehosho high density areas is shown in Fig. 3.

Ziyambi Drive is the most highly potholed road compared to other streets in the two suburbs as evidenced by the high pothole concentration per unit distance. Some potholes have merged along this road to form about 20 meters of continuous gravel stretches. Drivers and passengers also concurred that Ziyambi Drive leading to Nehosho and Senga road leading to Midlands State University have most potholes. This was because these are the major roads used by public transport into the suburbs. Damage is even worse at the corners and intersections of these busy roads. This was corroborated by direct observation. Senga road leading to Midlands State University however has the advantage of receiving frequent and thorough attention from the city council at the insistence of the university authorities who ply the road almost on a daily basis. This road is therefore generally in a moderate state when compared to Ziyambi Drive and others of similar utilization intensity. Matongo Way and Chiwaya Streets both also have fewer potholes because fewer commuter omnibuses and small vehicles ply these roads.

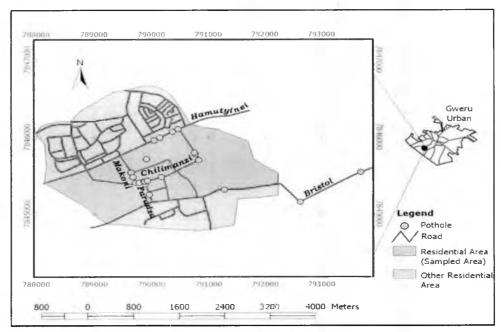
Fig. 5 Distribution of potholes on sampled streets in Mkoba 6 and 7.

There were about 17 potholes recorded on sampled roads in Mkoba 6/7. Patching work using pit sand had just been done on several roads at the time of study but Paradza Road linking Mkoba Road and Chilimanzi Road had not been patched despite clear evidence that the city council was through with maintenance work in the area. This was because the city council targeted major roads only. At the intersection of Chilimanzi and Hamutyinei Roads the formerly tarred surface is now just a gravel surface. Observations showed that the main cause of damage along these two roads were the construction trucks heavily loaded with sand, bricks and concrete to the recently established residential area where the housing construction business is booming. The Gweru city council roads engineer revealed that Hamutyinei Road was resealed in 2009, but with the high traffic volumes found along the route, potholes of various sizes are already a common feature and the demand for frequent maintenance is beyond the current capacity of the local authority. The city engineer felt that with the current challenges bedevilling the city council, Hamutyinei Road was in a good state despite the existence of occasional potholes. The main affected area in Mkoba 6 and 7 was the intersection of Paradza and Chilimanzi Roads where five potholes with circumferences above 301 cm were identified. These were mainly due to poor or lack of maintenance work done on Paradza Road. Fig. 5 shows the distribution of sampled potholes in villages 6 and 7 of Mkoba high density residential area.

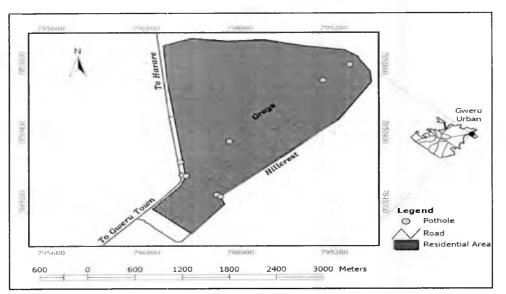
Fig. 6 Potholes on sampled streets in Ridgemont residential area.

has since been abandoned as it resembles a gravel road. There has been extensive soil filling on the road. Grays Road has eight potholes which are generally spaced. The biggest pothole recorded along this road measured about 510 cm in circumference, 236 cm in diameter and had a shallow depth of about 0.8 cm. Shallow depths indicate that Grays Road has a strong and thick surface and the tar surface is only giving in due to age, stress caused by tyre pressure and climatic variations. Although potholes in this area are few, majority of them are large (60%) whilst 40% are medium size. This implies that there has been little work done on maintenance recently as there is no much formation of new potholes but continued freaking of the already existing ones. The few potholes found on Grays Road can be attributed to the aging of the roads and little or no maintenance services by the city council. Ridgemont suburb roads are not frequently maintained because among other reasons. The suburb's residents are less influential politically as well as in council matters. Fig. 6 shows potholes on sampled roads in Ridgemont low density suburb.

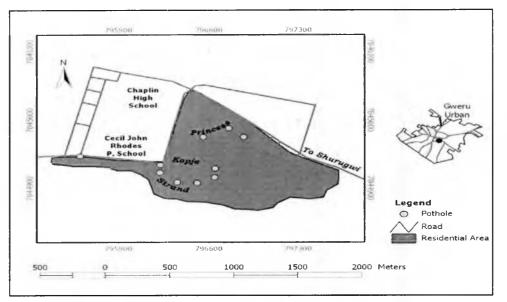
Fig. 7 Potholes on sampled streets in Kopje residential area.

This suburb has roads with the least amount of damage compared to all the other sampled residential areas. Among the four sampled roads only Strand Street had two large potholes with diameters of 212 cm and 186 cm, depths of 3.56 and 2.8 cm and circumferences of 528 cm and 394 cm, respectively. These potholes are a result of road weakening due to overgrown road side tree-roots prying laterally below the surface leading to the development of road surface cracks. The cracks promote water infiltration and are therefore both widened and deepened by vehicle movement forming the potholes that were observed. Kopje Road, George Avenue and Princess Street are in perfect condition despite their advanced ages. These roads have been resistant to weakening caused by water infiltration because they were constructed at a gradient that facilitate good drainage. In addition, the low density suburbs such as Kopje are homes to some of the most influential individuals in the city such as high ranking city fathers, political heavy weights and top business people. This results in streets in these

suburbs receiving urgent attention whenever their conditions deteriorate. Some points where signs of surface freaking due to aging were evident were however recorded but they were not well developed to be a cause for concern. However, this is the stage at which maintenance should be done to neap the problem whilst it is still in the buck and keep both maintenance and vehicle damage low. Fig. 7 shows pothole positions in Kopje low density suburb.

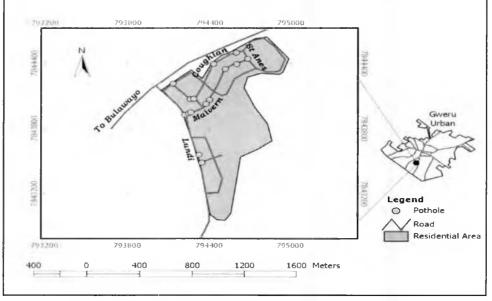
Fig. 8 Potholes on sampled streets in Lundi Park residential area.

Lundi Park, a medium density residential area, had clear signs of negligence as far as road maintenance is concerned. The potholes in this residential area range from 66 cm to 337 cm in circumference, 25.3 cm to 168 cm in diameter and depths between 0.96 cm and 3.6 cm.

Most potholes are on Malvern Street where eight potholes were recorded and 83% of these were on the centre of the road with an average depth of 1.83 cm. 67% of the potholes were small, 17% were medium and 16% large in size.

The big proportion of the small potholes shows that there are higher rates of pothole formation associated with the rain season. The low gradient of the roads promotes the accumulation of water thereby weakening road surfaces that causes potholing of several sections. This is worsened by little or lack of timeous maintenance work to arrest further road deterioration in the residential areas. Fifteen potholes were recorded on the sampled streets in Lundi Park suburb as shown in Fig. 8.

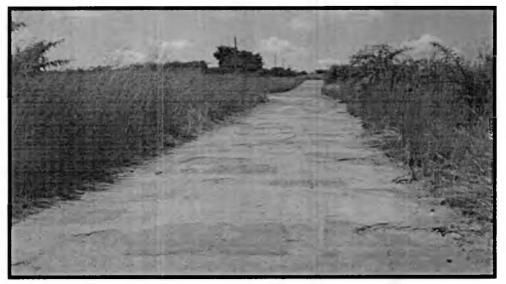
There is no doubt that by any standards, roads in this area are in a very dilapidated state with little patches of tarmac remaining behind predominantly gravel surfaces. Most commuter omnibus owners whose vehicles ply these routes complained of serious mechanical damage to vehicles warranting high frequency of repair services and raising the costs of the transport business in the area. In addition to the causes of poor road conditions in the area already stated, the roads in the area particularly Murified Road are frequented by heavy vehicles carrying construction sand further accelerating the rate of deterioration of the roads in the area. In the inner areas of the suburb, commuter omnibuses are the main vehicle traffic. These have also caused their own fare share of damage along Turnberry, Rosemere and Gulane roads as evidenced by the presence of some long elongated

Fig. 9 Aged and neglected Murifield road strip in Ivene residential area.

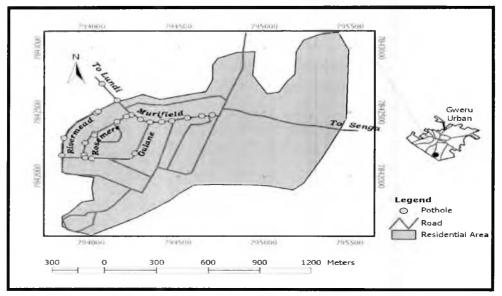
Fig. 10 Potholes on the sampled streets in Ivene residential area.

Of all the potholes that were recorded on sampled roads in Ivene residential area, 47% were large, 33% were medium and 20% were small. The largest pothole which resembles a wilderness ditch along Murifield Road has a circumference of 598 cm, depth of 8.7 cm and a diameter of 305 cm. This poor condition of roads in Ivene is a result of a combination of factors chief among them being aging, substandard construction, gentle gradient promoting water infiltration, weak unconsolidated sand soils that dominate the area and lack of maintenance. A stretch on Murifield Road leading to Ivene shops shown in Fig. 9 bears testimony to what commuter omnibus drivers and the suburb residents called "the suburb of the bumpy roads".

potholes along these inner suburb roads. The recorded potholes are shown on the street map of Ivene in Fig. 10.

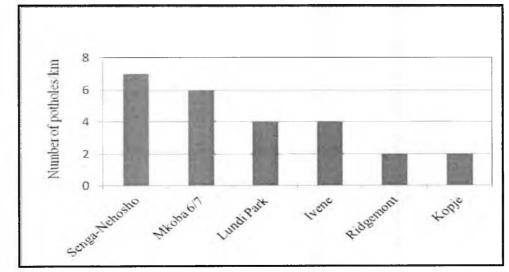
Fig. 11 Number of potholes found on sampled roads per kilometre in residential area.

There are higher rates of pothole formation in the high density residential areas as compared to low density residential areas. In fact, the potholes follow the population density trend in the residential areas of Gweru. High density residential areas have the highest rates of pothole formation per unit distance, followed by medium density suburbs and lastly low density suburbs of Kopje and Ridgemont as shown in Fig. 11. This tallies with the city roads engineer's survey results in which she highlighted that the roads in high density residential areas are more prone to pothole development due to the low cost surfacing applied as

The pothole formation rates per kilometre in the sampled suburbs are shown in Fig. 11.
