## RIDGE HOUSE INSPECTIONS, LLC.

November 3, 2014

**Keith Customer inspection photos 11-1-2014**  
**See report for details**

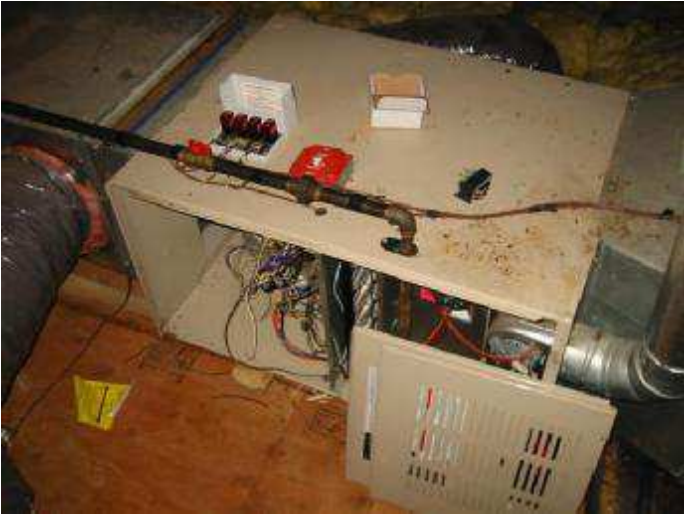
*Furnace in attic under repair.*

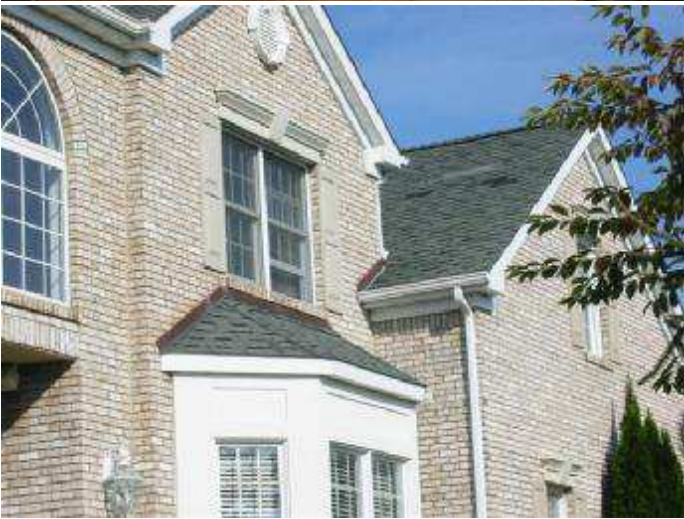
*Damaged, missing roof shingles above garage area.*

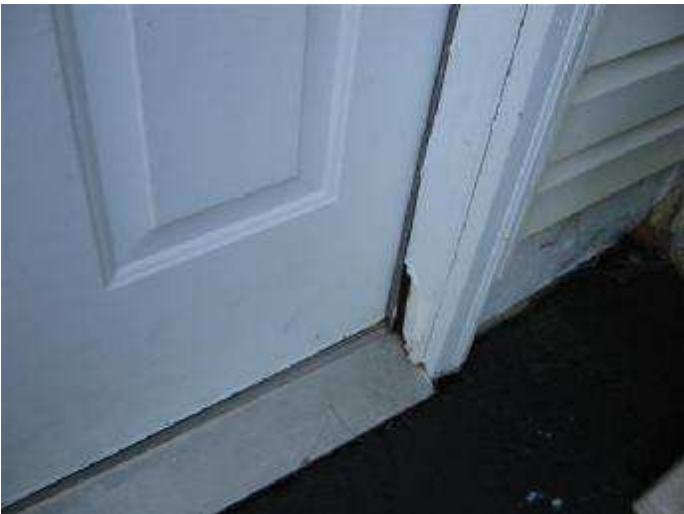
*Rotted trim at door to garage.*

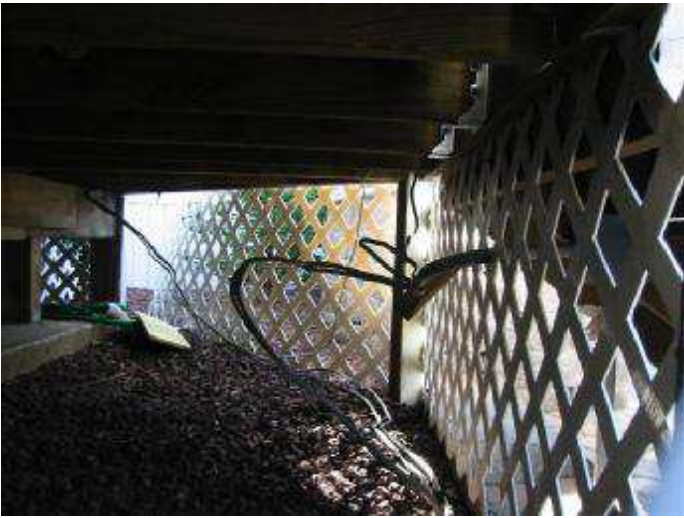
*Dangling electrical cable near hot tub.*

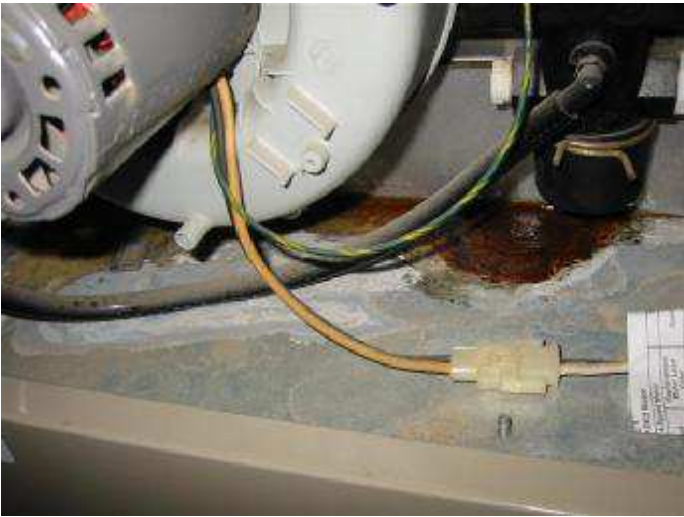
*Condensate leaking inside basement furnace.*

**Attention Needed** - There is a condensate leak inside the furnace, and this should be repaired by a competent heating contractor prior to closing.

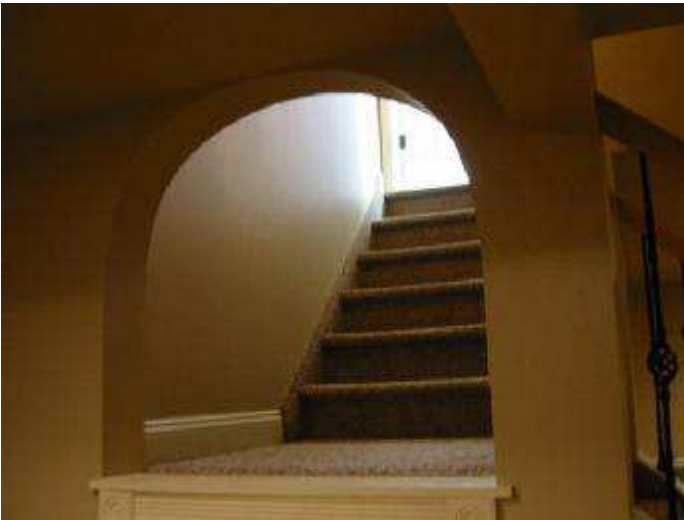
*Install balusters at open arch at basement stairway landing.*

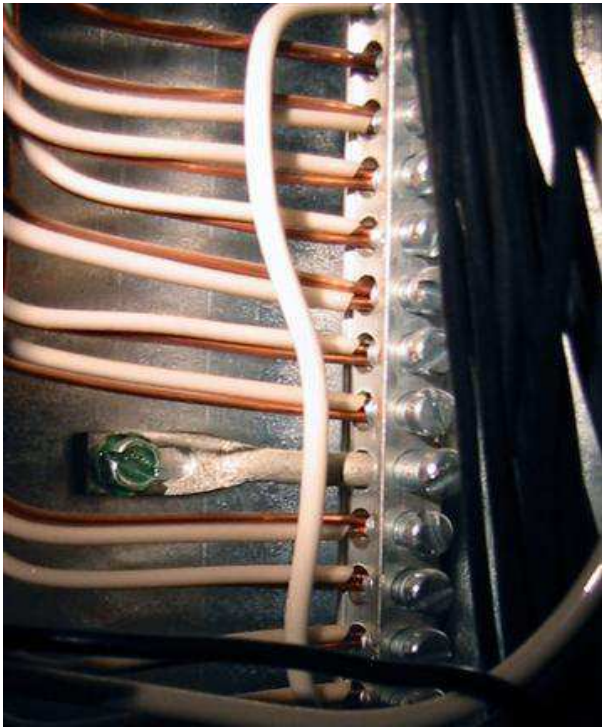
*Grounding and neutral conductors should not be under same terminals at main electric panel.*

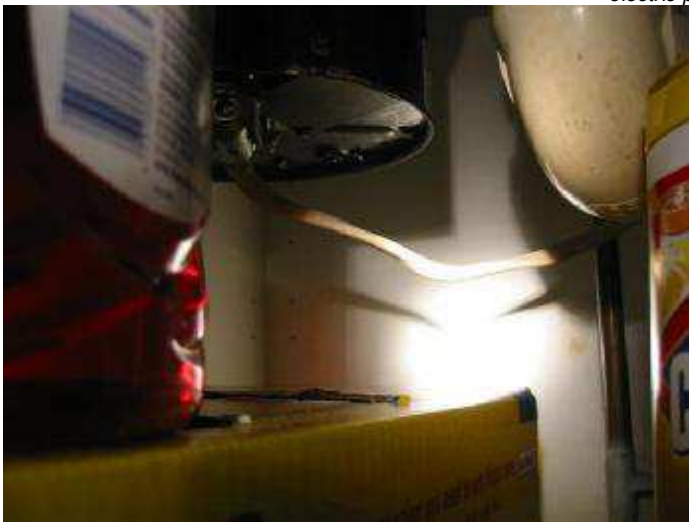
*Unprotected electric cable below kitchen sink.*

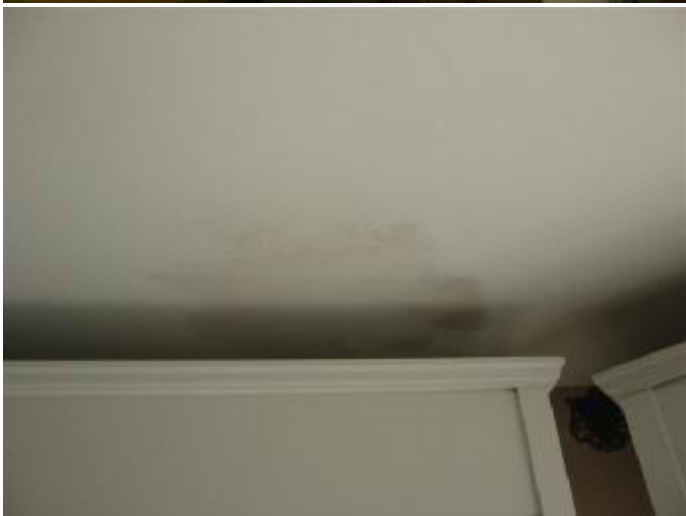
*Moisture stains at office room ceiling. Contact a plumber.*

**Attention needed** - There water stains or damage - evidence of leakage - at two ceilings. The water stains appear to be from an active leak. The cause of the leak must be investigated and repaired, then the damage to the wall/ceiling should be repaired. Consult with qualified contractors for cost estimates before closing.

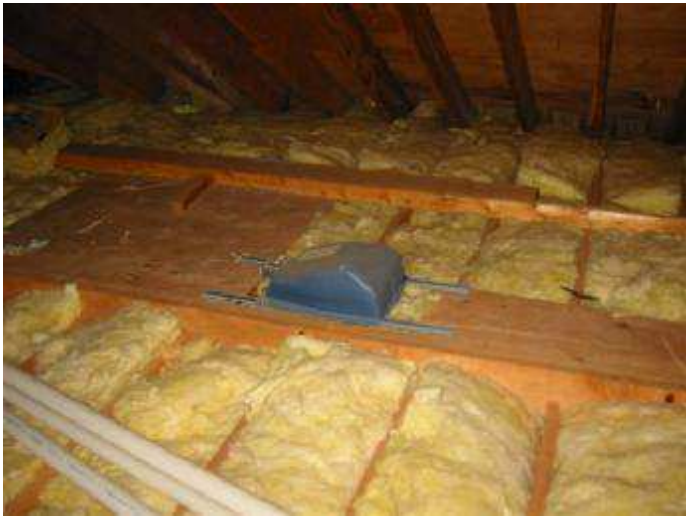
*Chandelier motor – this is a nice feature.*

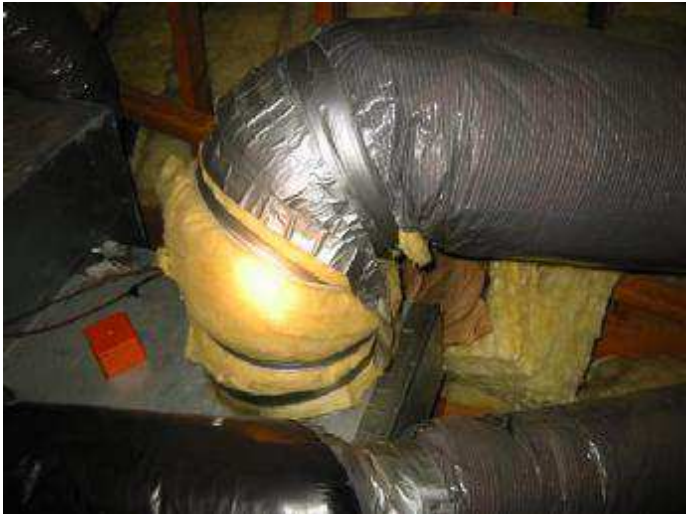
*Damaged wrapping on insulation in attic. Peeling duct tape. Sample of kinked ductwork in attic area. Contact a heating system contractor.*
