**PROPERTY INSPECTION
REPORT BY**

REPORT SUMMARY

Inspection Address: 1111 Sample Rd
Boca Raton, FL

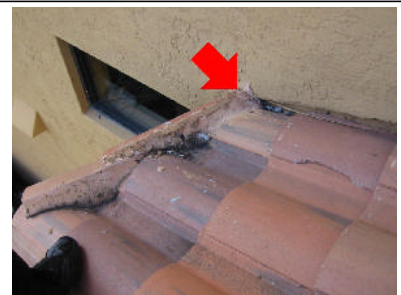
Metal/Lead. The kick out flashing is missing at the north side of the home, where the lower roof meets the wall outside the kitchen. *Kick out flashing is a metal water diverter installed where roof areas meet a wall, to prevent water from entering behind the wall covering (ie: stucco or siding). A licensed roofing contractor should be called to add the proper flashing.*

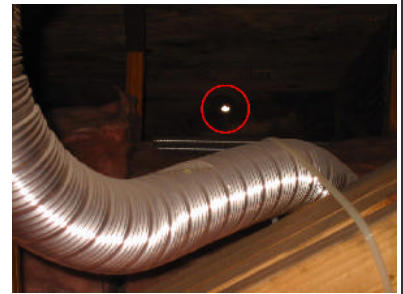
Hole in the fascia at the upper north wall as viewed from the attic looking north from the upstairs hatch. Fill to prevent water intrusion.

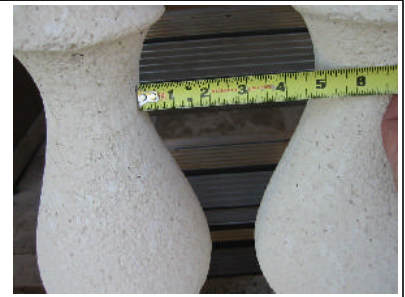
- The guard rail post spacing does not meet the industry standard of 4 inches in width, at the front balcony concrete post spacing. Children have been known to slip through over spaced post openings. **Safety Hazard.**

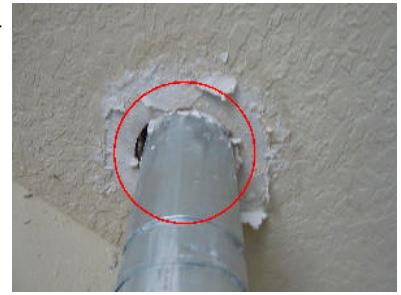
- Improper clearance of the water heater vent to combustibles. The vent is touching the drywall ceiling. There should be a 1 inch separation. *Please see the diagrams in the additional photo section of this plumbing report.*

CONDITION: Hot water was present at the time of the inspection. A water shutoff valve is installed, Pressure relief valve noted and tested good, **No active leaks are noted at the time of inspection.**
- Improper clearance of the water heater vent to combustibles. The vent is touching the drywall ceiling. There should be a 1 inch separation. Please see the diagrams in the additional photo section of this plumbing report.

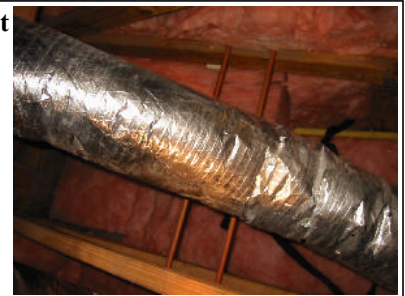
**-The duct support strap is broken / come loose at the attic area over the master bathroom.
-The register is hanging down /loose at the NW bedroom and near the attic hatch in the NW bedroom closet.**

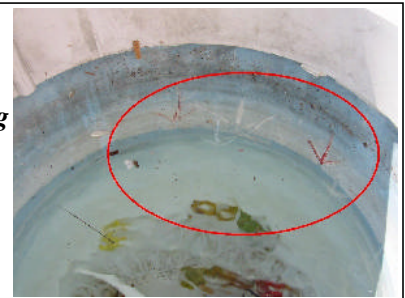
- Inquire with the sellers as to any leakage problems which may have or are now occurring. This is because of the lines and arrows that are marked inside the skimmer indicating the checking of the pool for leaks.

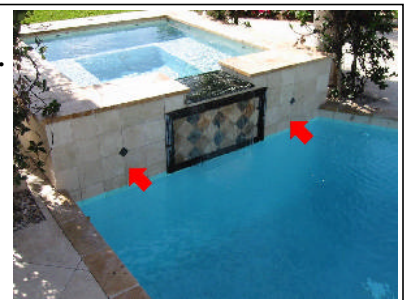
- The hand holds or permanently installed ropes are missing from pool or spa walls over 12" high.

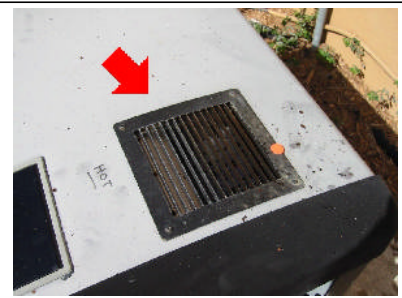
The heater was not fully check because of the following problem: When the heater was turned on the fan motor has heavy vibrations and shot rust out of the vent. The unit was quickly shut down. A qualified pool equipment contractor should be called to make further evaluation and repairs as needed.

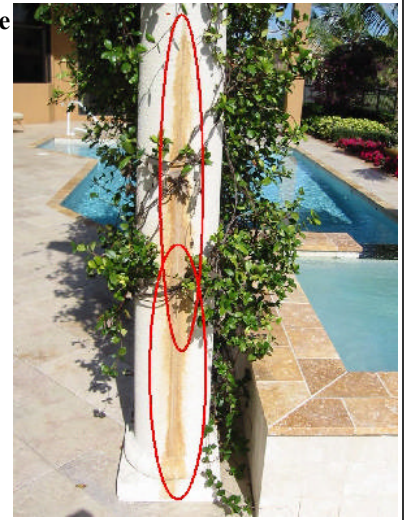
There is a stain indicating water penetration at the rear column near the jacuzzi. *Recommend sealing column.*
