<b>EASA</b>	<b>EMERGENCY AIRWORTHINESS DIRECTIVE</b>

<p><b>AD No.: 2014-0118-E</b></p> <p><b>Date: 13 May 2014</b></p> <p>Note: This Emergency Airworthiness Directive (AD) is issued by EASA, acting in accordance with Regulation (EC) No 216/2008 on behalf of the European Community, its Member States and of the European third countries that participate in the activities of EASA under Article 66 of that Regulation.</p>	
<p>This AD is issued in accordance with EU 748/2012, Part 21.A.3B. In accordance with EC 2042/2003 Annex I, Part M.A.301, the continuing airworthiness of an aircraft shall be ensured by accomplishing any applicable ADs. Consequently, no person may operate an aircraft to which an AD applies, except in accordance with the requirements of that AD, unless otherwise specified by the Agency [EC 2042/2003 Annex I, Part M.A.303] or agreed with the Authority of the State of Registry [EC 216/2008, Article 14(4) exemption].</p>

<p><b>Design Approval Holder Names:</b> BELL HELICOPTER TEXTRON Inc.</p>	<p><b>Type/Model designation(s):</b> 212, 412, and 412EP helicopters</p>	
<p>TCDS Numbers:     FAA USA H4SW</p>		
<p>Foreign AD:         None</p>		
<p>Supersedure:       None</p>

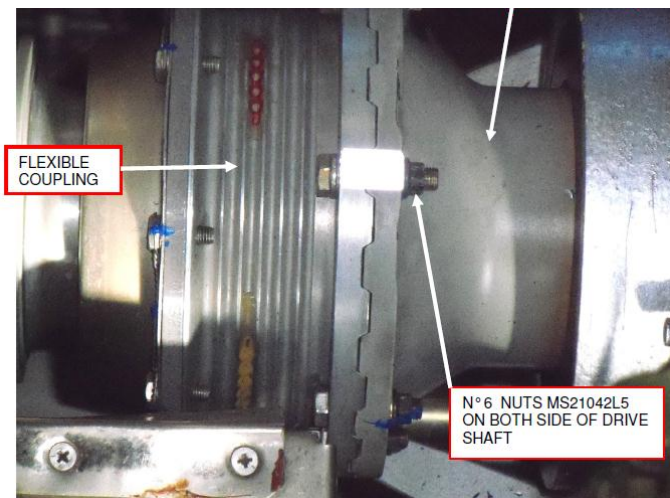
Fig. 1

1. Prepare helicopter for safe ground maintenance; disconnect battery and all the electric power source and/or the external power supply.
2. In accordance with the applicable Maintenance Manual Chapter 63, gain access to the engine-to-transmission drive shaft.
3. Using a source light and a mirror, inspect the nuts P/N MS21042L5 connecting the flexible coupling with the adapter installed on the engine-to-transmission drive shaft (refer to Fig. 1) or inspect the nuts P/N MS21042L4 connecting the flexible coupling with the adapter and nuts P/N MS21042L4 connecting the drive shaft with the flexible coupling (refer to Fig. 2). The configuration depends on the helicopter model and s/n.

1. In accordance with the applicable Maintenance Manual Chapter 63, replace the nuts P/N MS21042L5 with nuts P/N MS21043-5 or the nuts P/N MS21042L4 with nuts MS21043-4, as applicable depending on helicopter configuration (it is recommended to replace the nuts one at a time). Restore witness mark as required.
2. In accordance with the applicable Maintenance Manual Chapter 63, reinstall the access panel and close the access doors previously removed/opened and return the helicopter to a “ready to flight” condition.
