# WOOD DESTROYING PESTS AND ORGANISM INSPECTION REPORT

Building No. <b>1254</b>	Street <b>Regency Drive</b>	City <b>San Jose</b>	ZIP <b>95129</b>	Date of Inspection <b>9/12/2009</b>	Number of Pages <b>Page 1 of 9</b>
<div style="display: flex; justify-content: space-between; align-items: center;"> <div style="text-align: center;">

<p><b>HomeGuard Incorporated</b></p> </div> <div> <p><b>510 Madera Ave San Jose, CA 95112 (408) 993-1900 • Fax (408) 993-1944 Registration # PR1452</b></p> </div> <div style="text-align: right;"> <p>HomeGuard Rpt #: <b>135714</b></p> </div> </div>					
Ordered By: <b>Ron Ramirez C21 RFP 3535 Pruneridge Ave. Santa Clara, CA 95051</b>		Property Owner/Party in Interest		Report Sent to:      Escrow#:	
COMPLETE REPORT <input checked="" type="checkbox"/> LIMITED REPORT <input type="checkbox"/> SUPPLEMENTAL REPORT <input type="checkbox"/> REINSPECTION REPORT <input type="checkbox"/>					
General Description: <b>Two story, single family wood framed residence with wood and brick exterior.</b>				Inspection Tag Posted <b>Garage</b> Other Tags Posted <b>None Noted</b>

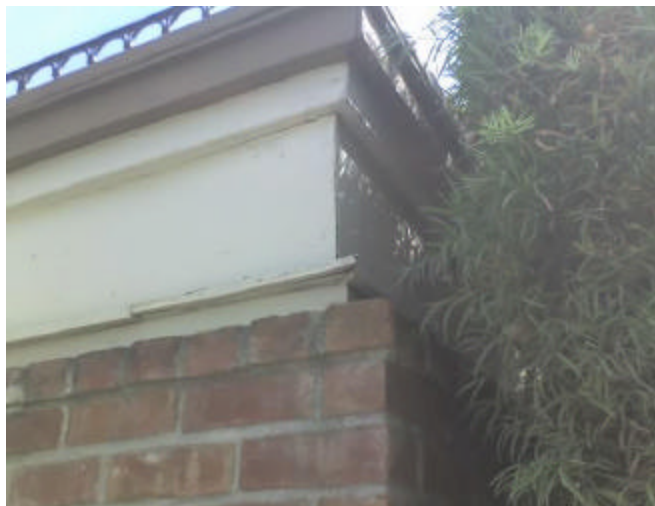
Picture 1

**1A.** FINDING: The rain table and trim have been damaged by fungus at the front. (See Picture 1)  
RECOMMENDATION: Remove and replace all the damaged wood members. If any damage is found to extend into any enclosed areas a supplemental report and bid will be issued.

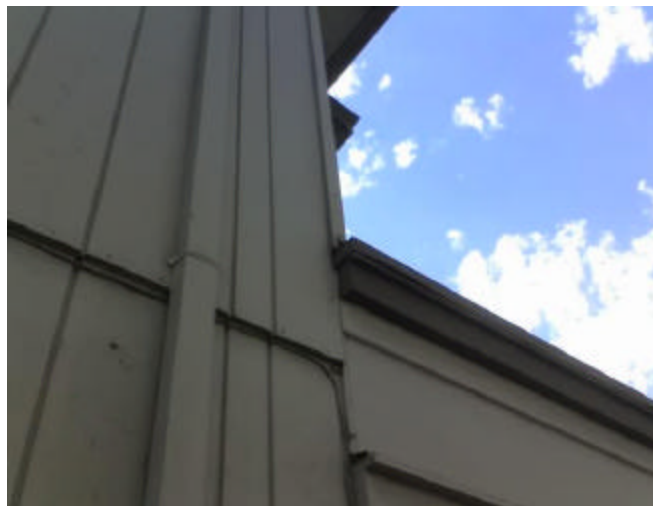
Picture 2

**1B.** FINDING: The trim has been damaged by fungus at the area indicated on the diagram. (See Picture 2)  
RECOMMENDATION: Remove and replace all the damaged wood members. If any damage is found to extend into any enclosed areas a supplemental report and bid will be issued.

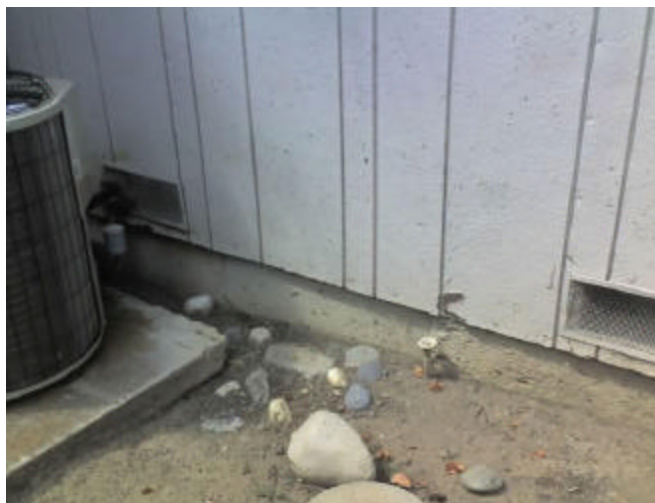
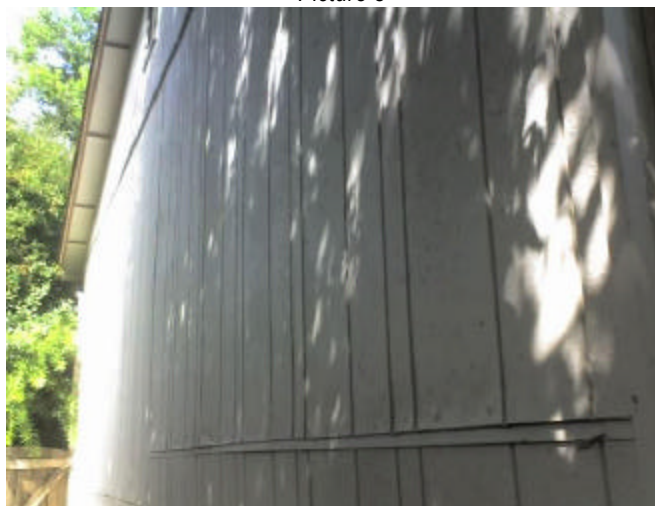
**1C.** FINDING: The siding has been damaged by fungus at the rear and right. (See Picture 3) (See Picture 5)  
RECOMMENDATION: Remove and replace all the damaged wood members. If any damage is found to extend into any enclosed areas a supplemental report and bid will be issued.

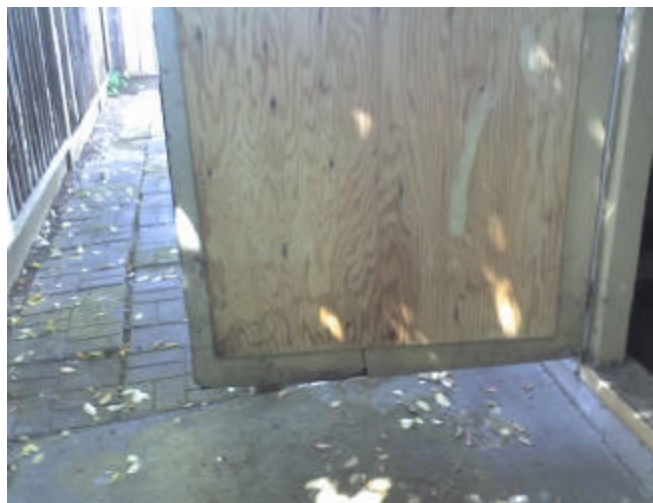
Picture 4

**1D.** FINDING: The subarea door has been damaged by fungus at the right side. (See Picture 4)  
RECOMMENDATION: Remove and replace all the damaged wood members. If any damage is found to extend into any enclosed areas a supplemental report and bid will be issued.

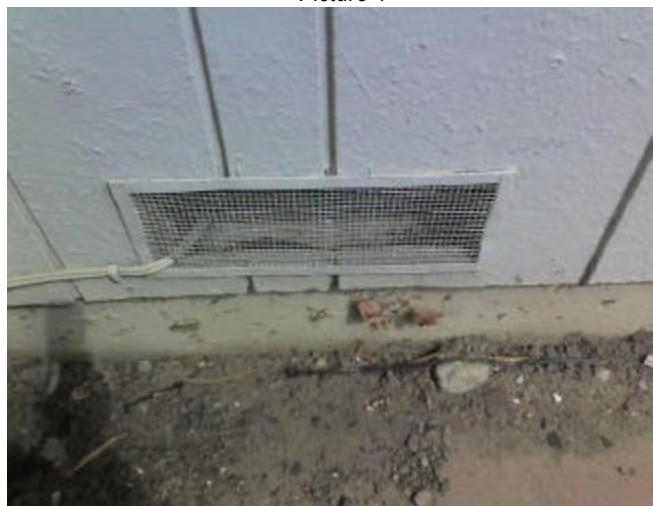
Picture 6

**1E.** FINDING: Infestation by Drywood Termites was noted at the subarea. (See Picture 6)

**1F.** FINDING: Drywood termite pellets were evident as noted in the above recommendation. (See Picture 6)

RECOMMENDATION: Due to the nature of these infestations, it will be necessary to seal the entire structure and fumigate it with Vikane (sulfuryl fluoride), using Chloropicrin as a warning agent. The entire structure must be vacant for this process. It is the owners responsibility to make any preparations required by the fumigators or to have someone to do so at a separate expense and to have the gas turned back on when the fumigation is complete. Due to current Cal OSHA Safety Standards work above 7.5 feet demands fall protection, this requires the installation of anchor points at the roof ridge line. HomeGuard will repair any damage caused by the installation of the anchor. However, in the case of metal roof coverings it is the owners responsibility to make areas on the roof ridge accessible to secure the anchors. HomeGuard Incorporated guarantees all fumigations for a period of two years.

RECOMMENDATION: Remove and/or mask over all accessible termite pellets. It is possible for the Drywood Termite pellets to sift down or reappear in these areas where they have been masked over.

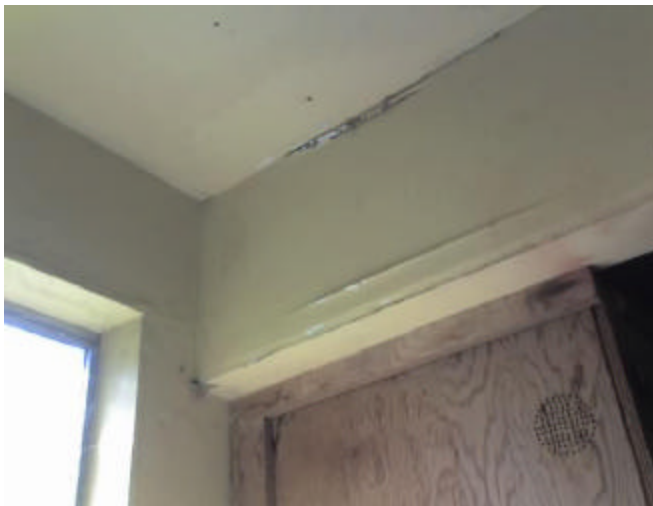
*Picture 7*

**3A.** FINDING: Water stains were noted on the ceiling in the garage. (See Picture 7)

RECOMMENDATION: Open this area to determine the source of these stains and if any damage exists. All findings, recommendations, and bids will be issued in a supplemental report.

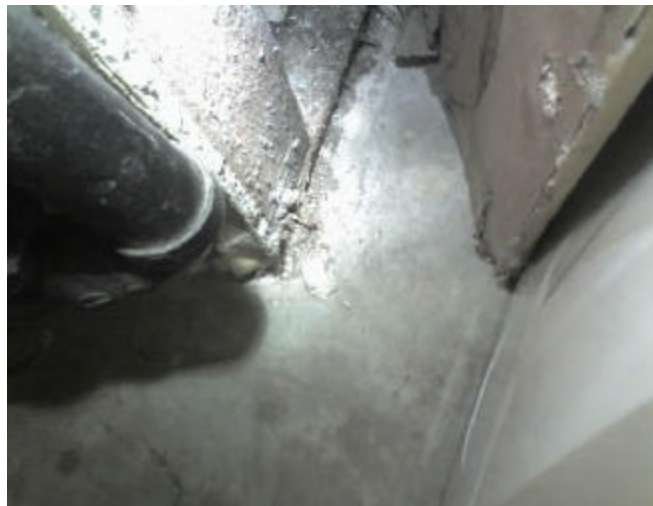
*Picture 8*

**1G.** FINDING: Subterranean Termites have entered the structure from the earth fill under the garage. (See Picture 8)

**1H.** FINDING: There is evidence of Subterranean Termite migratory tubes as noted in the above recommendation. (See Picture 8)

RECOMMENDATION: Drill holes through the garage and inject Termidor SC (Fipronil:5-amino-1-(2,6-dichloro-4-(trifluoromethyl) phenyl)-4-((1,8,5)-trifluoromethyl)sulfinyl)-1-H-pyrazole-3-carbonitrile) into the earth below. We will be as careful as possible with our repair; however, we assume no responsibility for any damage to the surface covering the floor in the area to be treated. NOTE: In order to perform this treatment the property will need to be vacated for the period during and 3 hours after the treatment is performed.

RECOMMENDATION: Break down & brush away all termite migratory tubes.

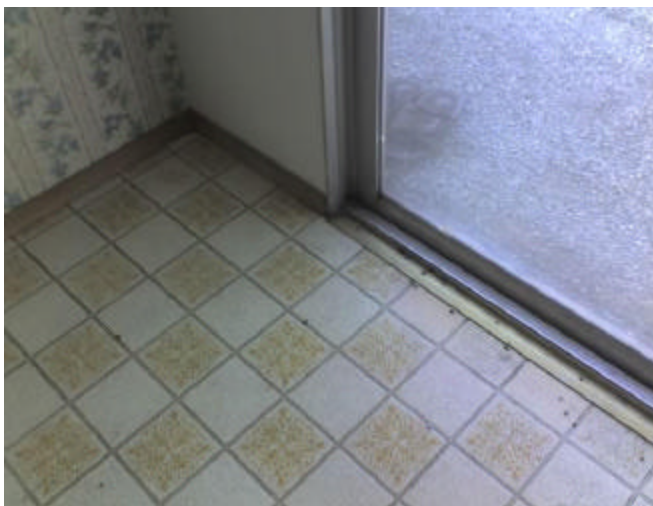
*Picture 9*

**3B.** FINDING: Swelling in the floor covering adjacent to the upstairs master bedroom sliding glass door could indicate a water damaged underlayment. (See Picture 9)

RECOMMENDATION: We will pull the linoleum back in this area to allow for further inspection. All findings, recommendations, and bids will be issued in a supplemental report. If no additional damage is found, HomeGuard will re-secure the floor covering in this area. Please note all due caution will be taken when performing this item. However, it is possible for the floor covering to be damaged during this process. If this happens, HomeGuard will supply a bid for replacement of the entire floor if so desired.

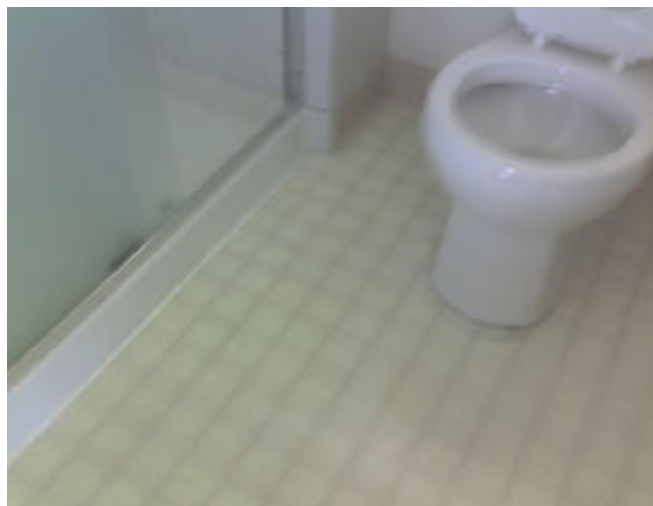
*Picture 10*

**3C.** FINDING: Swelling in the floor covering adjacent to the upstairs master bathroom toilet could indicate a water damaged underlayment. (See Picture 10)

RECOMMENDATION: We will pull the linoleum back in this area to allow for further inspection. All findings, recommendations, and bids will be issued in a supplemental report. If no additional damage is found, HomeGuard will re-secure the floor covering in this area. Please note all due caution will be taken when performing this item. However, it is possible for the floor covering to be damaged during this process. If this happens, HomeGuard will supply a bid for replacement of the entire floor if so desired.

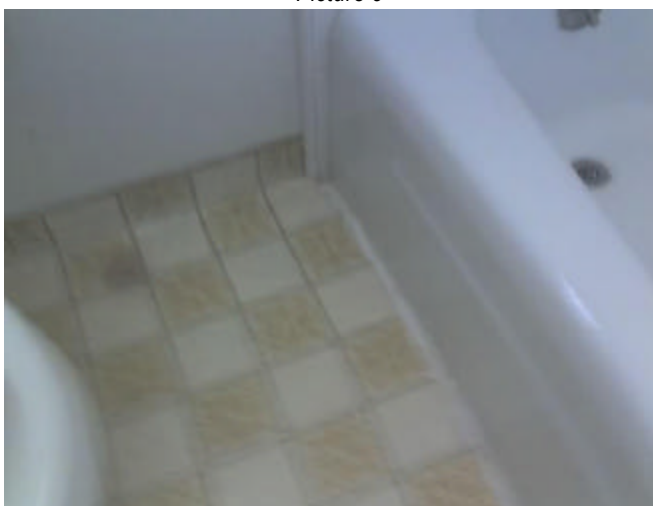
*Picture 11*

**3D.** FINDING: Swelling in the floor covering adjacent to the upstairs hall bathroom tub could indicate a water damaged underlayment. (See Picture 11)

RECOMMENDATION: We will pull the linoleum back in this area to allow for further inspection. All findings, recommendations, and bids will be issued in a supplemental report. If no additional damage is found, HomeGuard will re-secure the floor covering in this area. Please note all due caution will be taken when performing this item. However, it is possible for the floor covering to be damaged during this process. If this happens, HomeGuard will supply a bid for replacement of the entire floor if so desired.
