## **FINAL** **Hazardous Building** **Materials Assessment**

MJ Hobbs Public School, 2296  
Taunton Road, Hampton,  
Ontario

### **Kawartha Pine Ridge District** **School Board**

March 10, 2016

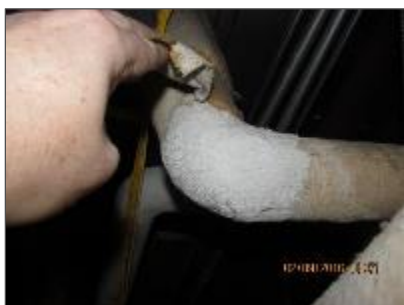
Photo 1 – Damaged parging cement on hot water heating piping in Corridor 108H

| Material and Quantity | Location | Recommended Procedure |
|---|---|---|
| Repair or remove damaged and unjacketed parging cement | Custodian 100B, Corridor 108H, Pipe Chases P01 and P02, Classroom 204, Prep room 201A | Type 2 procedures (and Type 3 procedures if all parging cement is to be removed from Pipe Chases P01 and P02) |

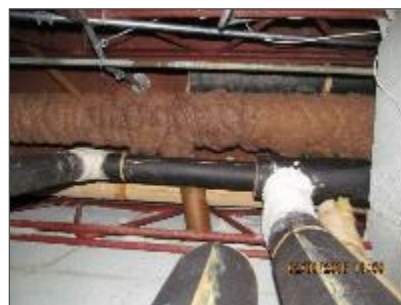
Photo 2 – Unjacketed parging cement on an unknown pipe system in Pipe Chase P01.

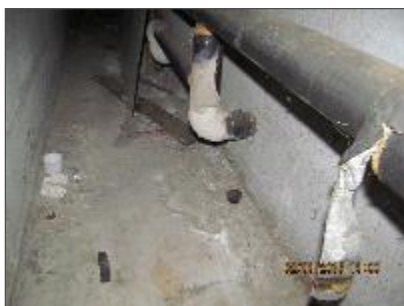
Photo 3 – Damaged parging cement insulation in Pipe Chase P01. Parging cement debris present on the floor.

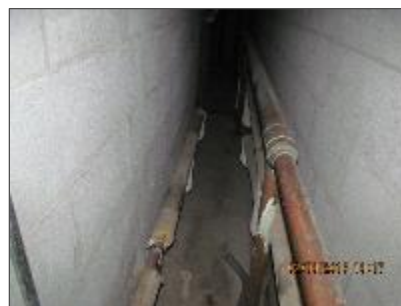
Photo 4 – Damaged parging cement insulation in Pipe Chase P02. Parging cement debris present on the floor.

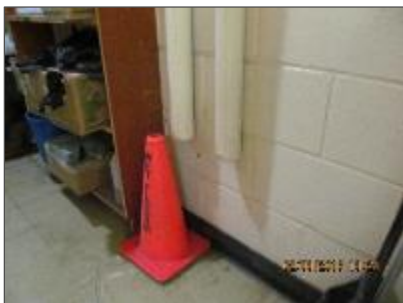
Photo 5 – Seams and butt ends of fibreglass insulation with parging cement on domestic water pipes in Custodian 100B.

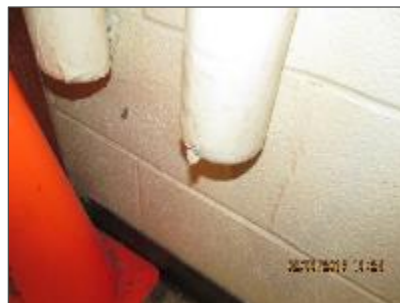
Photo 6 – Damaged butt ends of insulation in Custodian 100B.

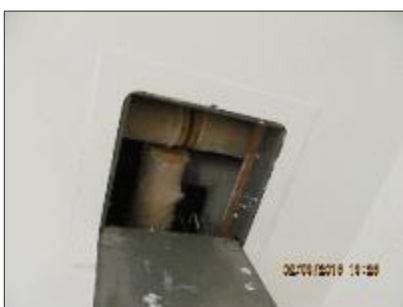
Photo 7 – Parging cement on domestic water pipes above ceiling in Washroom 102A.

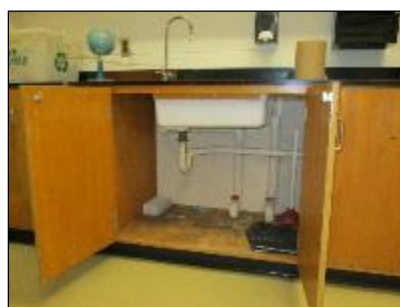
Photo 8 – Parging cement on domestic water piping beneath a sink on the 2<sup>nd</sup> floor.

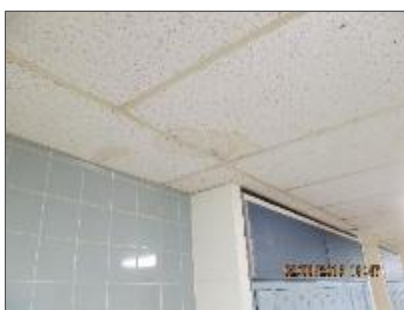
| Size, Type, Pattern, Photo # | Locations | Sample Number or Date Code | Asbestos Type |
|---|---|---|---|
| 24"x48", horizontal fissure and pinhole, Photo 9 | Corridor 108H | Date Code 1996 | None |

Photo 9 – Non-asbestos ceiling tile in Corridor 108H.

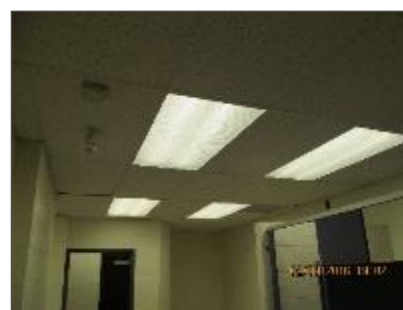
| Size, Type, Pattern, Photo # | Locations | Sample Number or Date Code | Asbestos Type |
|---|---|---|---|
| 24"x48", horizontal fissure with variable pinhole, Photo 10 | Boys WR 120 and 120V | Date Code 2013 | None |

Photo 10 – Non-asbestos ceiling tile in Boys WR 120 and 120V.

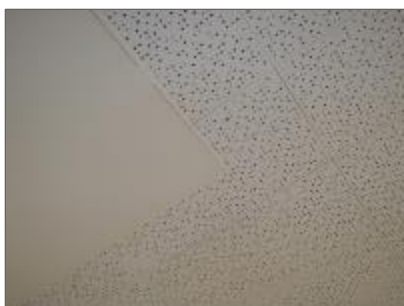
Photo 11 - Example of non-asbestos 12" x 12" glued-on ceiling tile.

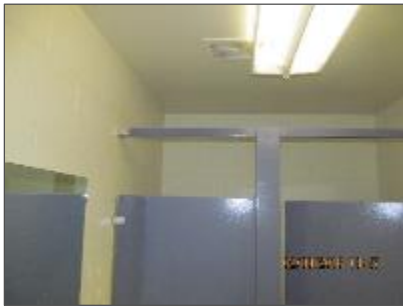
Photo 12 – Drywall ceiling in Boys 109.

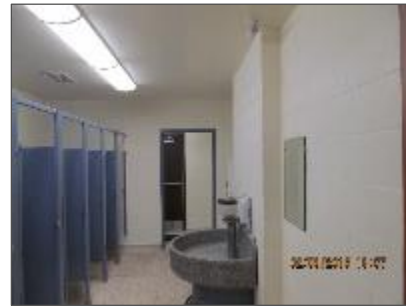
Photo 13 – Drywall ceiling in Girls WR 114.

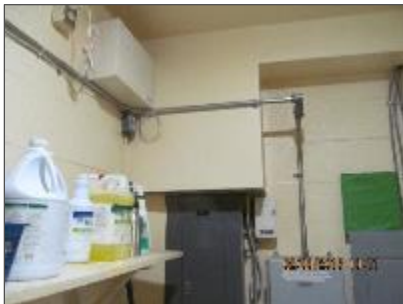
Photo 14 – Drywall on wall of Custodian 208.

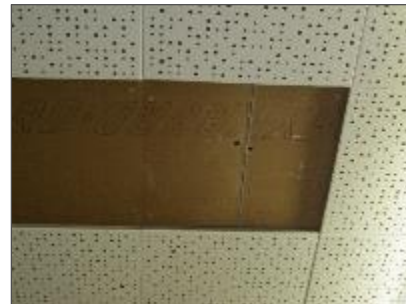
Photo 15 – Gypsum panels supporting ceiling tile with no mud on seams in a typical classroom.

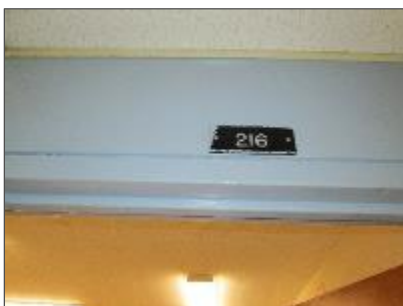
Photo 16 – Typical view of drywall above doorframes found only on doorways common to corridors.

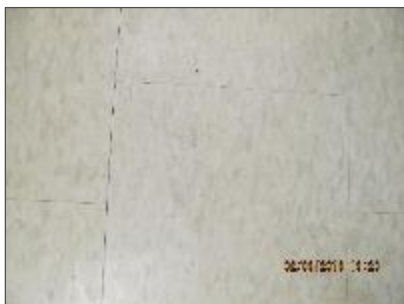
Photo 17 – Non-asbestos floor tile.

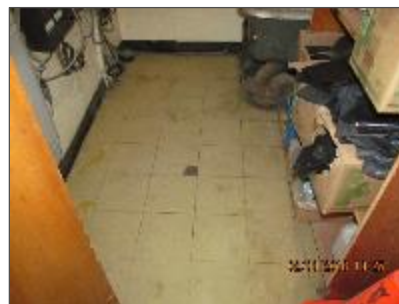
Vinyl floor tile is non-friable and was found in good condition in all assessed areas, excluding Custodian 100B where tile was found in fair condition.

Photo 18 – Asbestos floor tile in Custodian 100B.

| Material and Quantity | Location | Recommended Procedure |
|---|---|---|
| Damaged vinyl floor tile | Custodian 100B | Type 1 procedures |
