First Choice Inspections

# Property Inspection Report

17763 ABC Court  
San Diego, CA 92131

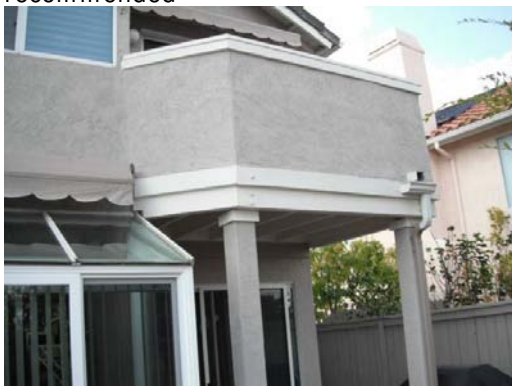
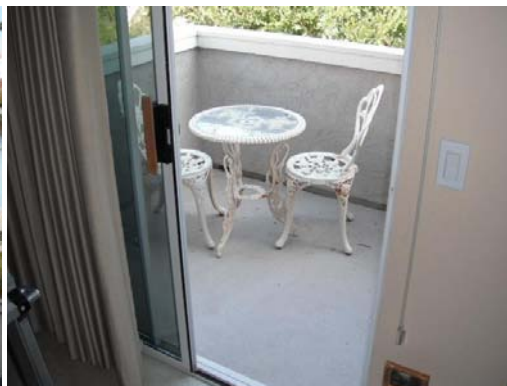
- Walks:** Concrete
- Patio:** Concrete
- Balcony:** Polymer coated The waterproof membrane at the balcony decking is cracked open- Prone to water penetration, Evaluation and repairs by a qualified licensed deck/balcony specialist are recommended

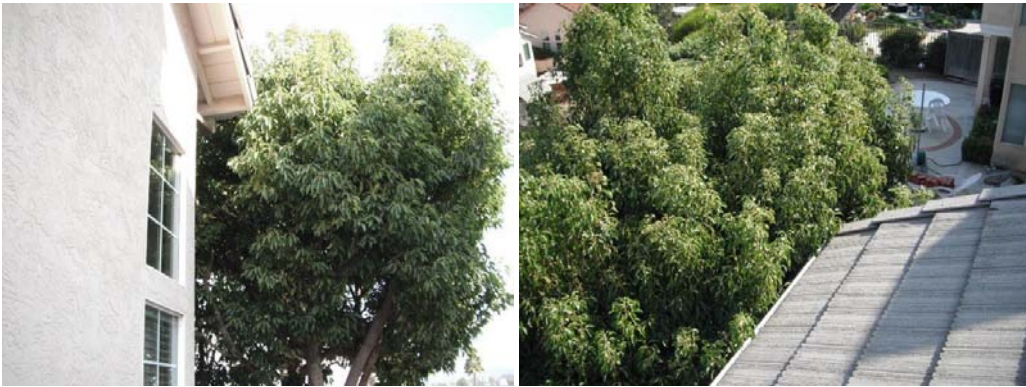
**Vegetation:** The tree limbs hang over the rear corner of the roof- Pruning by a qualified licensed arborist is recommended to prevent damage to the roofing material, and to prevent insect and rodent access into the house

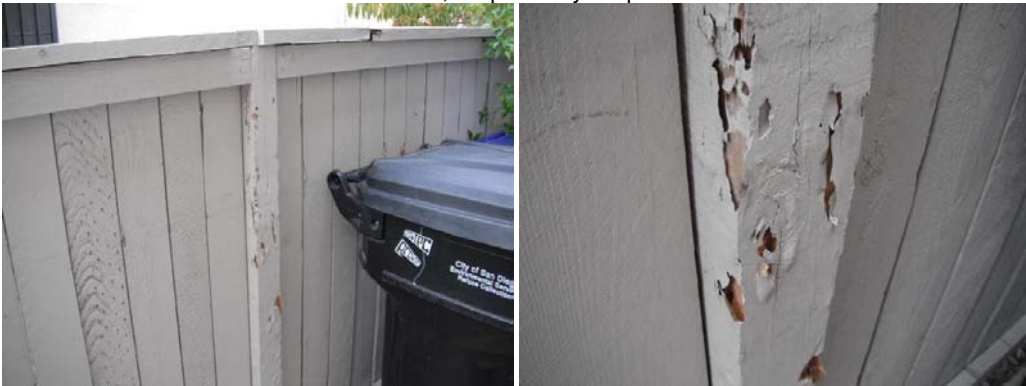
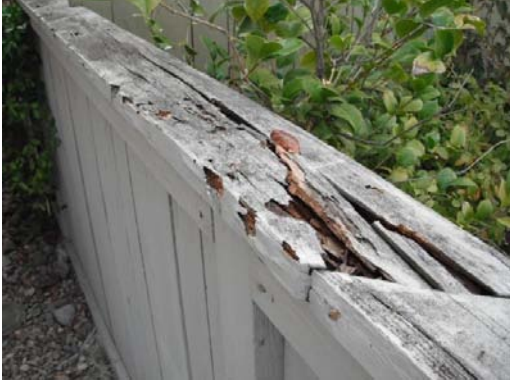
**Fences:** Wood, Metal There is dry rot and wood-destroying pest damage in the components of the wood fence at the left side of the lot, Repairs by a qualified licensed contractor are recommended

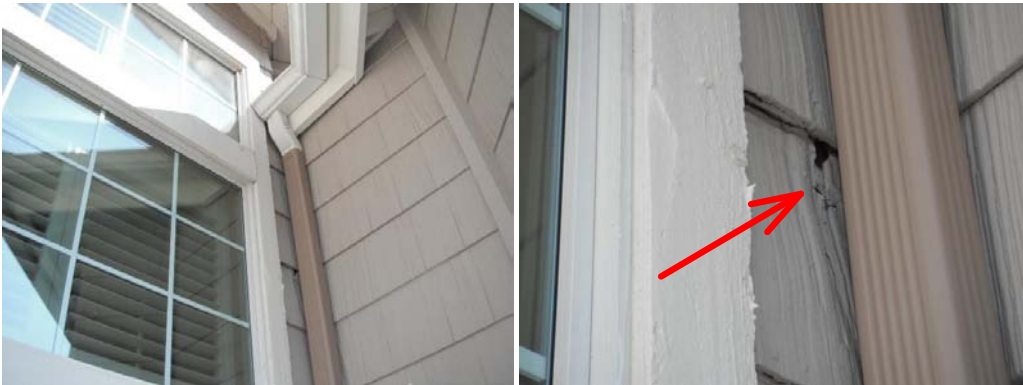
1.     **Type:** Stucco, Wood shingles There is moisture damage and dry rot in the wood shingles behind the gutter downspout by the front entry- Refer to the termite report, Repairs by a qualified licensed contractor are recommended

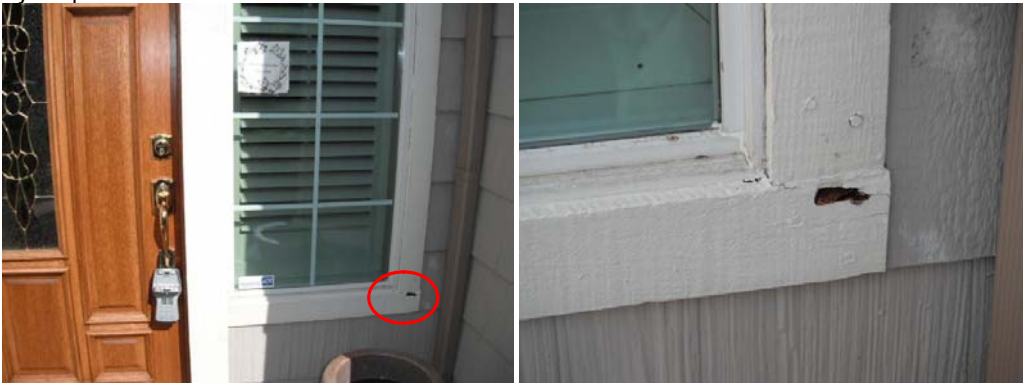
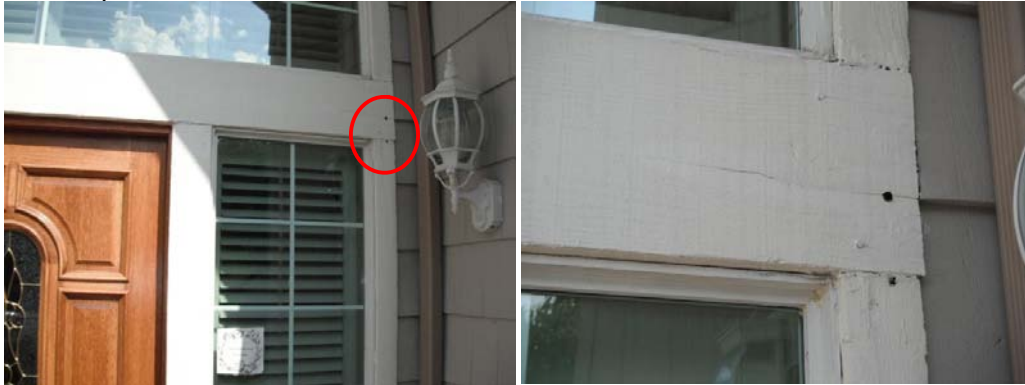
2.     **Trim:** Wood There is dry rot in the window trim at the front entry, Refer to the termite report, Repairs by a qualified licensed contractor are recommended

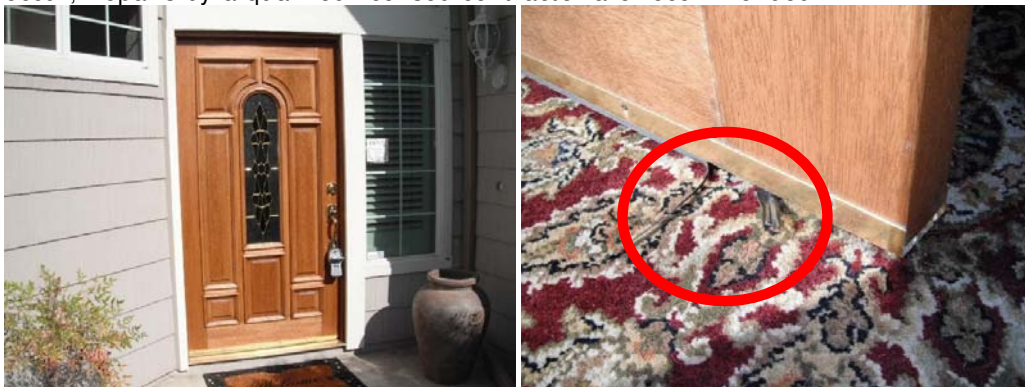
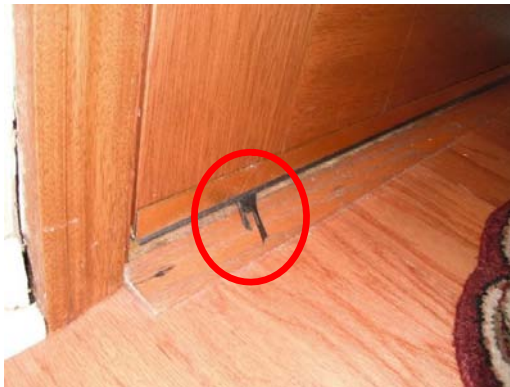
- 3.     **Fascia:** Wood Refer to the termite report
- 4.     **Soffits:** Wood Refer to the termite report
- 5.     **Door Bell:**
- 6.     **Entry Door:** Wood The weather seal at the bottom of the front entry door is torn- Water intrusion may occur. Repairs by a qualified licensed contractor are recommended

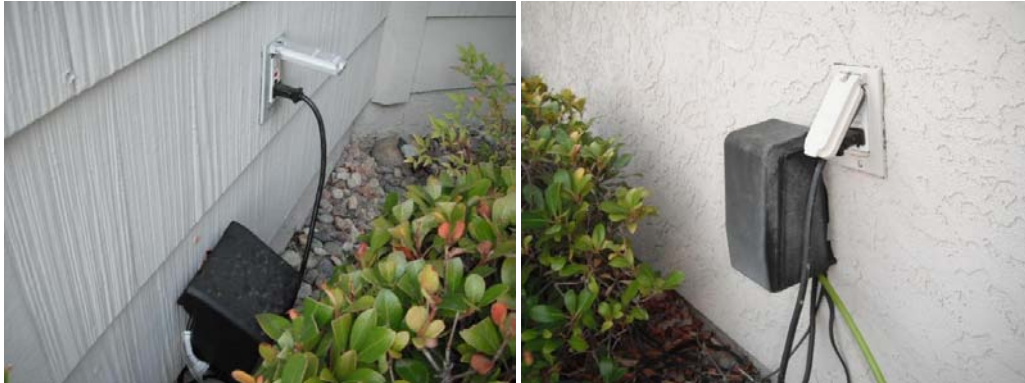
12.  **Exterior Electric Outlets:** An "in-use" cover is not installed on the exterior electrical outlets used by the timer boxes- Prone to water intrusion- Fire/Shock hazard, Repairs by a qualified licensed electrician are recommended

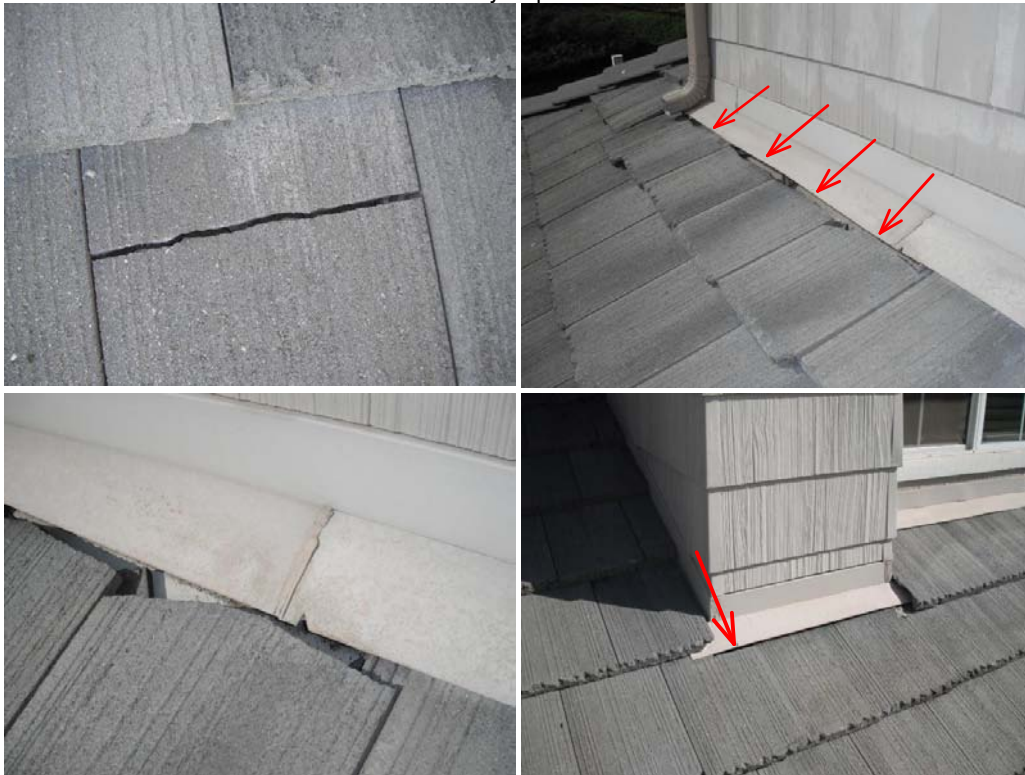
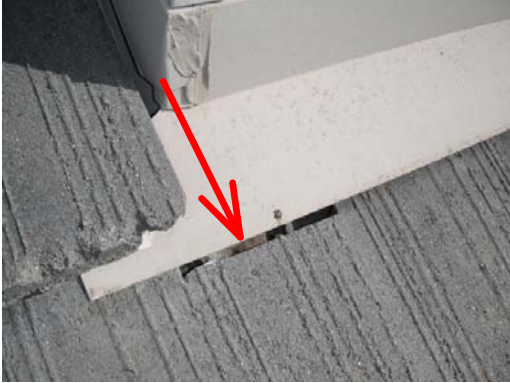
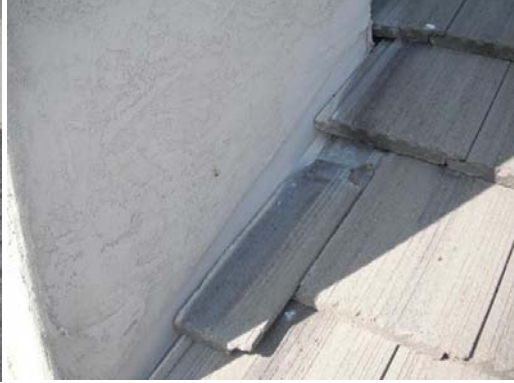
2.  **Material:** Concrete tile There are several broken and/or loose tiles on the roof at various locations- Water intrusion and roof leakage may occur, A qualified licensed roofing contractor is recommended to evaluate the roof and make all necessary repairs

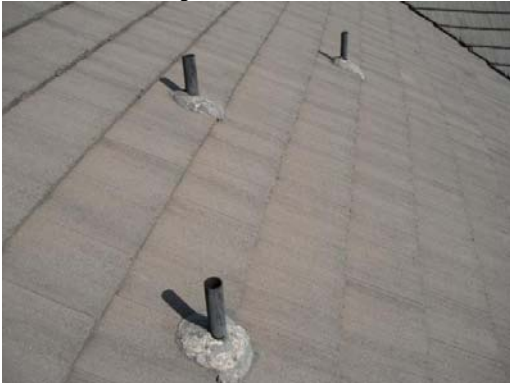
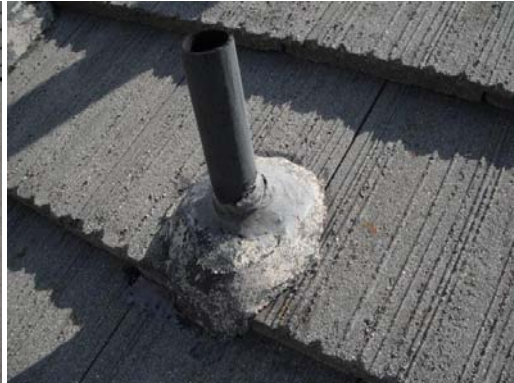
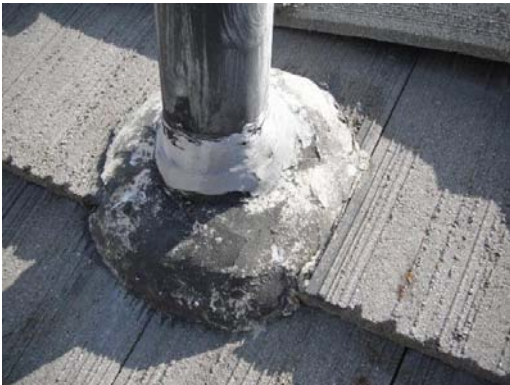
4.     **Flashing:** Lack of metal flashing was noted at the roof penetrations (mortar used- prone to crack and leak)- Substandard installation- Prone to water penetration, Upgrades to metal flashing by a qualified licensed roofing contractor are recommended

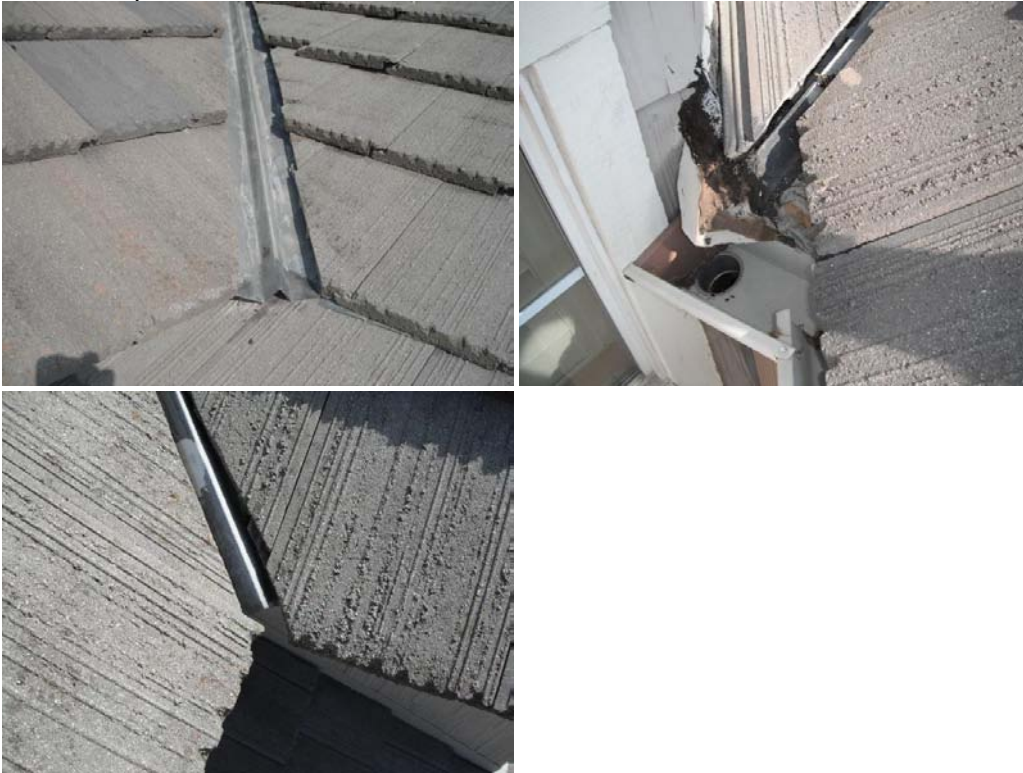
5.     **Valleys:** Pre-formed galvanized metal The valley flashing terminates under the roof tiles in several places- Substandard installation- Water intrusion may occur, There is evidence of possible water intrusion at one or both of the valleys over the front entry- See "Exterior Surface and Components- Type", Evaluation and repairs by a qualified licensed roofing contractor are recommended

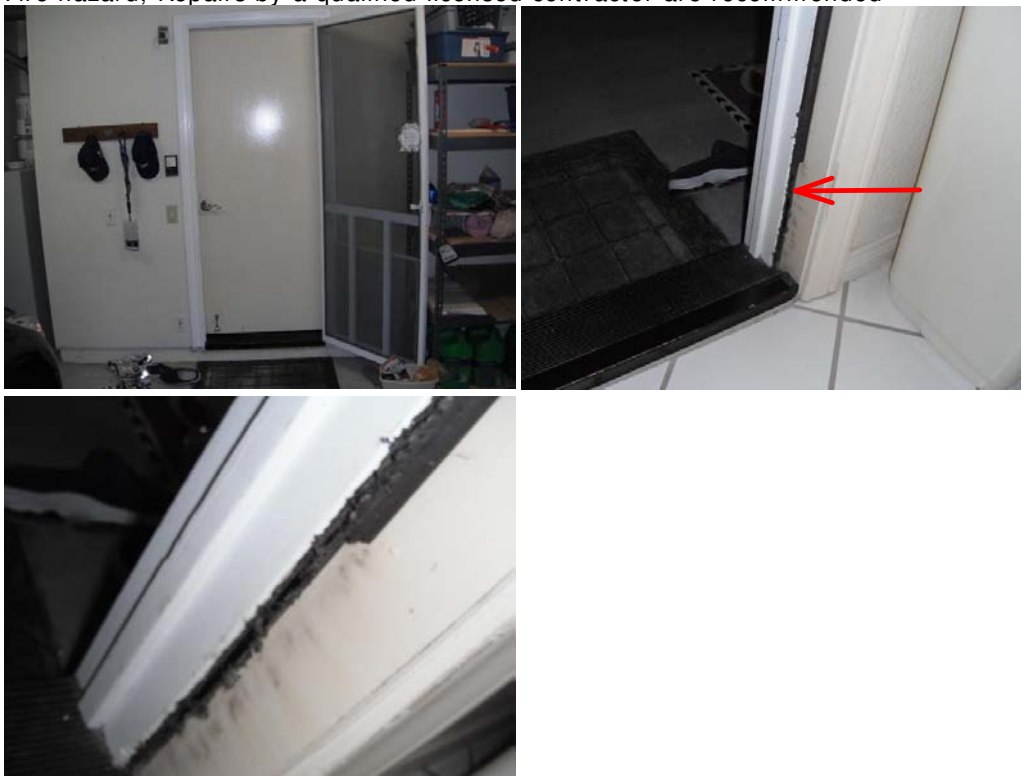
1. **Type of Structure:** Attached **Car Spaces:** 2
2.     **Garage Doors:** Metal- sectional roll-up- Insulated
3.     **Door Operation:** Mechanized
4.     **Door Opener:** Lift Master
5.     **Fire Door:** The weather-stripping at the jamb of the garage fire door (leading into the house) is damaged from a pet, causing a breach in the fire-protective barrier between the garage and the house- Fire hazard, Repairs by a qualified licensed contractor are recommended

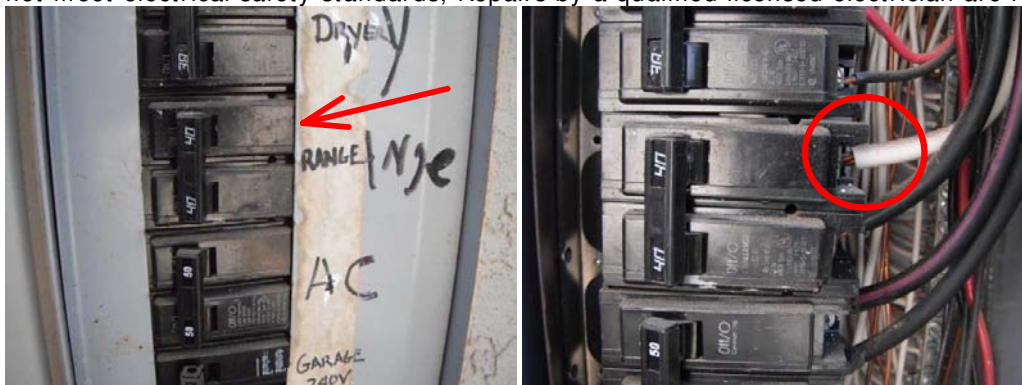
- 1. **Service Size Amps:** 200 **Volts:** 120/240 VAC
- 2.  **Service:** Underground
- 3.  **110 VAC Branch Circuits:** Copper
- 4.  **220 VAC Branch Circuits:** The white wire connected to the 40-amp "Range" breaker in the electrical panel is not properly identified or marked as a hot wire- Substandard installation- Safety hazard- Does not meet electrical safety standards, Repairs by a qualified licensed electrician are recommended

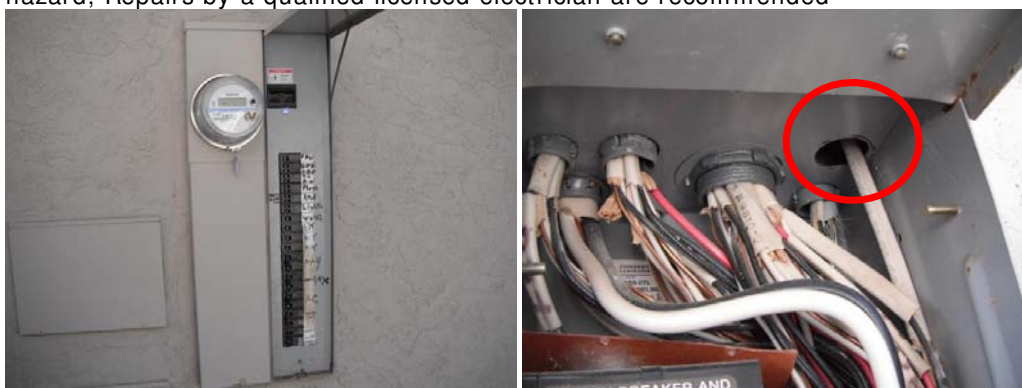
- 9.  **Manufacturer:** Challenger A strain relief clamp is not installed where one of the electrical circuits enters the top of the electrical panel box- This installation does not meet electrical safety standards- Fire hazard, Repairs by a qualified licensed electrician are recommended

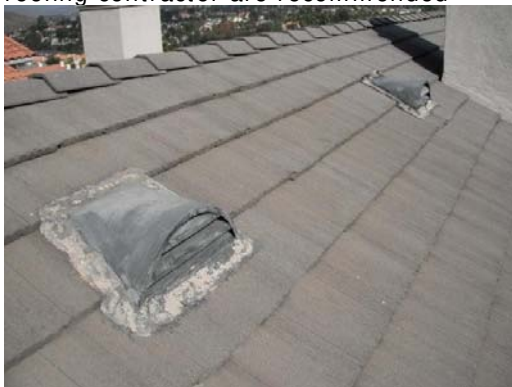
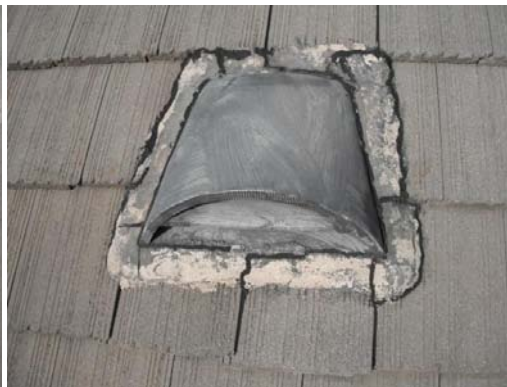
1. **Method of Inspection:** In the attic  
 2.     **Access:**  
 3.     **Roof Framing:** Wood truss  
 4.     **Sheathing:** Plywood  
 5.     **Ventilation:** Gable and eave vents Three of the four roof vents are flashed improperly (first three photos are incorrect)- Substandard installation- Prone to water intrusion, Repairs by a qualified licensed roofing contractor are recommended

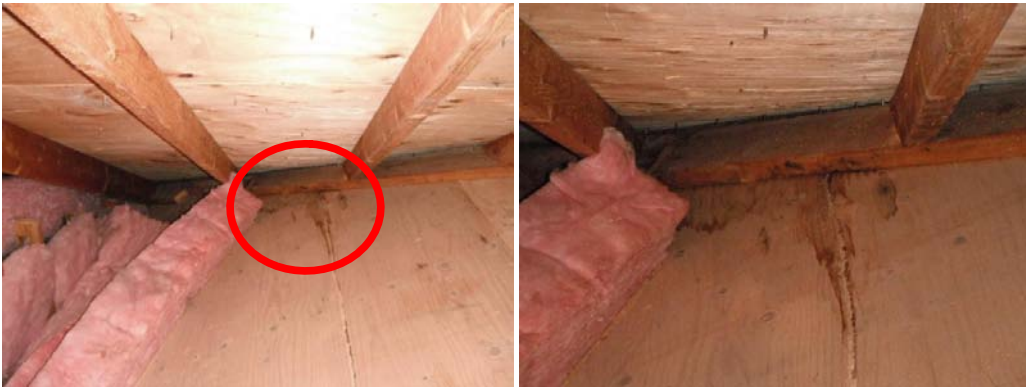
- 6.     **Insulation:** Fiberglass batt
- 7.     **Insulation Depth:** Approx. 6"
- 8.     **Moisture Penetration:** Yes Water stains are visible in the attic under the front roof valley from a past or present leak- Evaluation by a qualified licensed roofing contractor is recommended, See "Living Space-Walls"

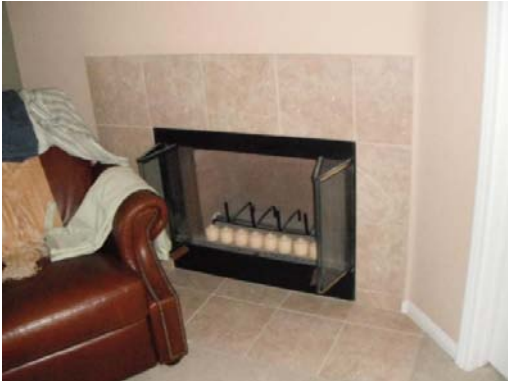
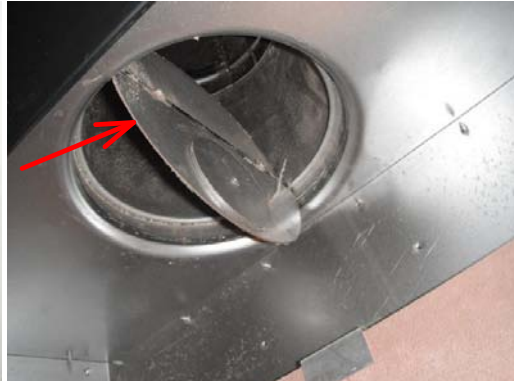
7.     **Fireplace Construction:** Factory built
8. **Type:** Gas log
9.     **Smoke Chamber:** Metal
10.     **Flue:** Metal Not fully visible
11.     **Damper:** A damper clamp is not installed on the fireplace damper- Safety hazard- The damper is required to be permanently blocked open in fireplaces containing a gas fixture- Installation by a qualified licensed contractor is recommended

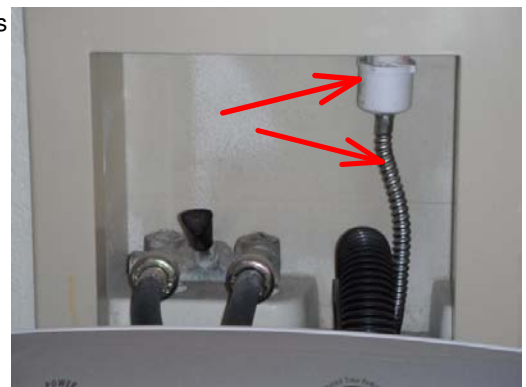
1.     **A/ C System:** Functional
2.     **Condensate Removal:** PVC The A/C condensate drain line is reduced in size at the laundry hose bib box- Does not meet industry standards- Clogging and leakage may occur causing water damage, Repairs by a qualified licensed HVAC contractor are recommended

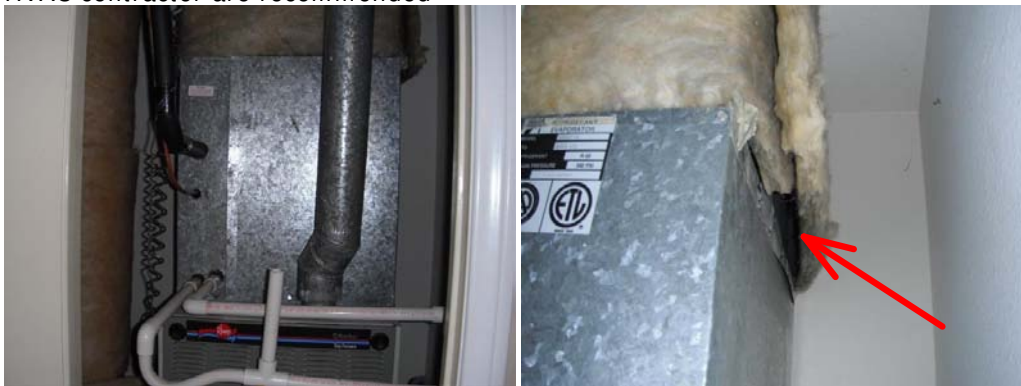
- 4. **Fuel Type:** 220-240 VAC **Temperature Differential:** 20
- 5. **Type:** Central A/C **Capacity:** 5 Ton
- 6.     **Visible Coil:** Copper core with aluminum fins
- 7.     **Refrigerant Lines:** Serviceable condition
- 8.     **Electrical Disconnect:** Fused
- 9.     **Exposed Ductwork:** There is an air leak at the top of the evaporator coil (on top of the furnace)- Conditioned air is being lost- Reduced efficiency of the system may occur, Repairs by a qualified licensed HVAC contractor are recommended

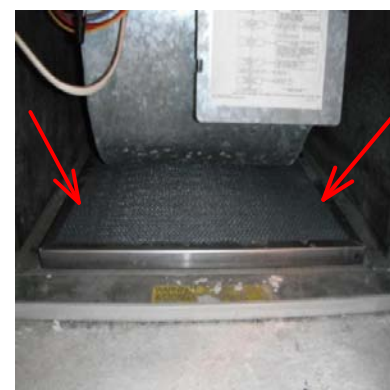
- 1.     **Heating System:** Functional
- 2. **Manufacturer:** Rheem
- 3. **Type:** Forced air unit **Capacity:** 100,000 BTU
- 4. **Fuel Type:** Natural gas
- 5.     **Heat Exchanger:** 4 Burner
- 6.     **Blower Fan/ Filters:** The hold-down for the furnace air filter is missing- Dirt and dust can bypass the filter resulting in reduced efficiency and shortened life-span of the unit, Repairs by a qualified licensed HVAC contractor are recommended

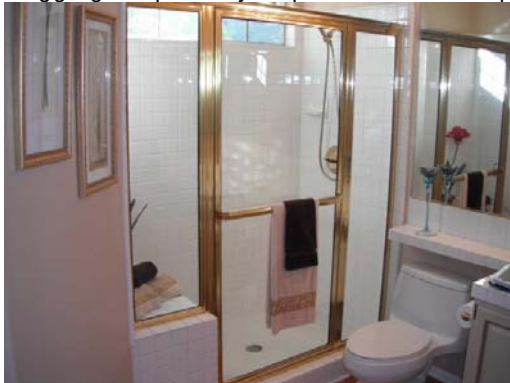
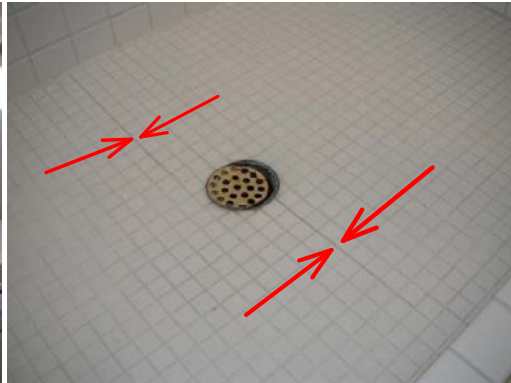
- 1.     **Ceiling:** Drywall
- 2.     **Walls:** Drywall
- 3.     **Floor:** Hardwood
- 4.     **Doors:** Hollow core
- 5.     **Windows:** Metal with dual-pane glass
- 6.     **Electrical:** 110 VAC GFCI outlets, Lighting
- 7.     **Counter Top:** Tile
- 8.     **Cabinets:** Wood
- 9.     **Sinks:** Porcelain single-bowl
- 10.     **Plumbing/ Fixtures:**
- 11.     **Shower:** Tile There is a crack running through the shower pan- Water penetration may occur- Evaluation by a qualified shower pan specialist is recommended, The drain cover is loose- Prone to clogging- Repairs by a qualified licensed plumber are recommended

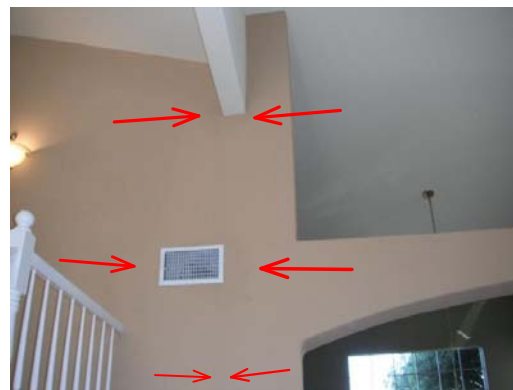
- 1.     **Closets:**
- 2.     **Ceilings:** Drywall
- 3.     **Walls:** Water staining is visible on the living room wall below the ceiling beam from a past or present roof leak- Evaluation by a qualified licensed roofing contractor is recommended, See "Attic- Moisture Penetration"

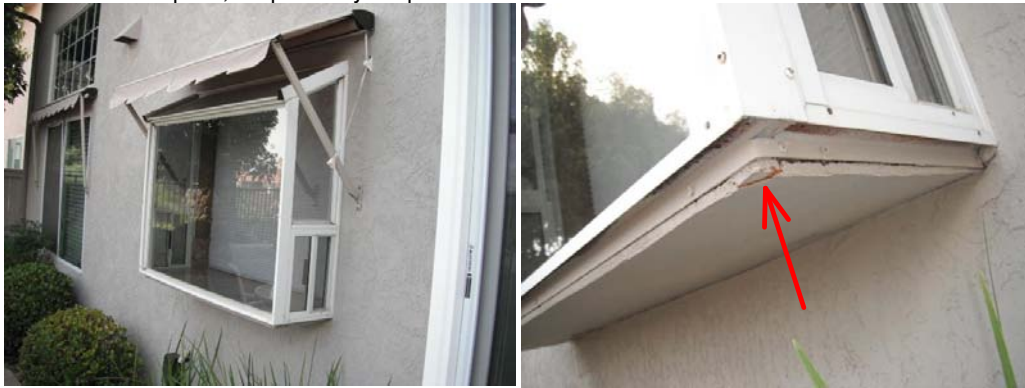
1.     **Cooking Appliances:** Maytag, General Electric
2.     **Ventilator:** General Electric
3.     **Disposal:** In-Sinkerator
4.     **Dishwasher:** General Electric
5. **Air Gap Present?**  Yes  No
6.     **Microwave:** General Electric
7.     **Sink:** Enamelized steel dual-bowl
8.     **Electrical:** 110 VAC GFCI outlets, Lighting
9.     **Plumbing/ Fixtures:**
10.     **Counter Top:** Granite
11.     **Cabinets:** Wood
12.     **Pantry:**
13.     **Ceiling:** Drywall
14.     **Walls:** Drywall
15.     **Floor:** Hardwood
16.     **Doors:** Hollow core
17.     **Windows:** The exterior wood at the bottom of the kitchen garden window is moisture-damaged- Refer to the termite report, Repairs by a qualified licensed window contractor are recommended

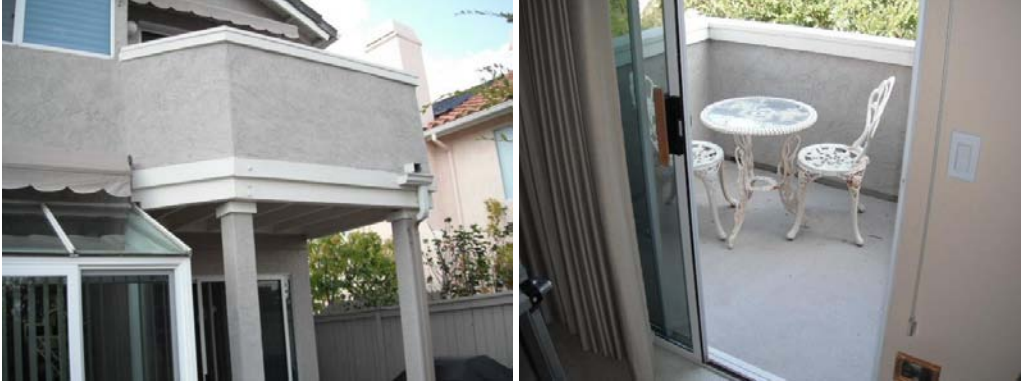
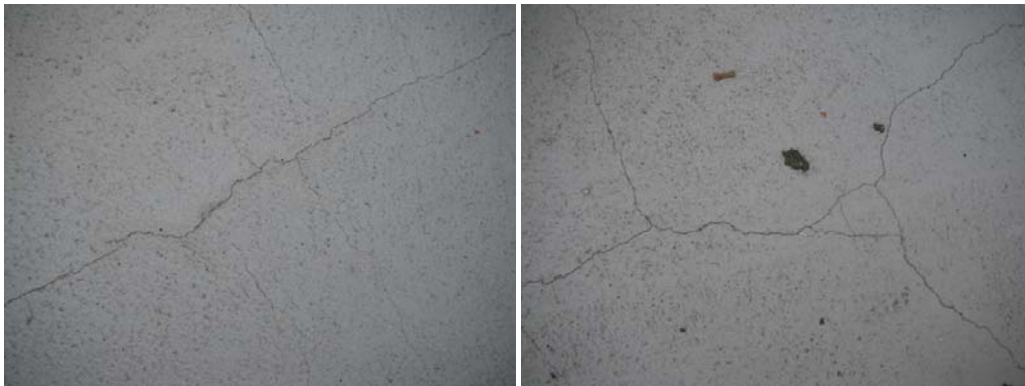
1. **Balcony:** Polymer coated The waterproof membrane at the balcony decking is cracked open- Prone to water penetration, Evaluation and repairs by a qualified licensed deck/balcony specialist are recommended

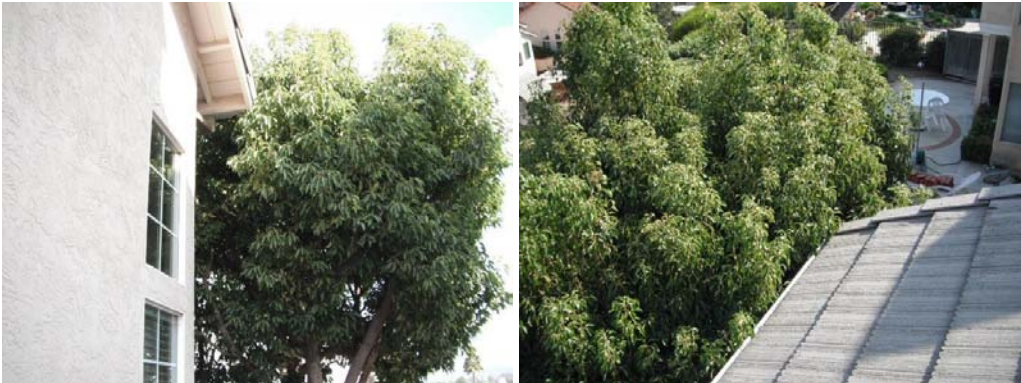
2. **Vegetation:** The tree limbs hang over the rear corner of the roof- Pruning by a qualified licensed arborist is recommended to prevent damage to the roofing material, and to prevent insect and rodent access into the house

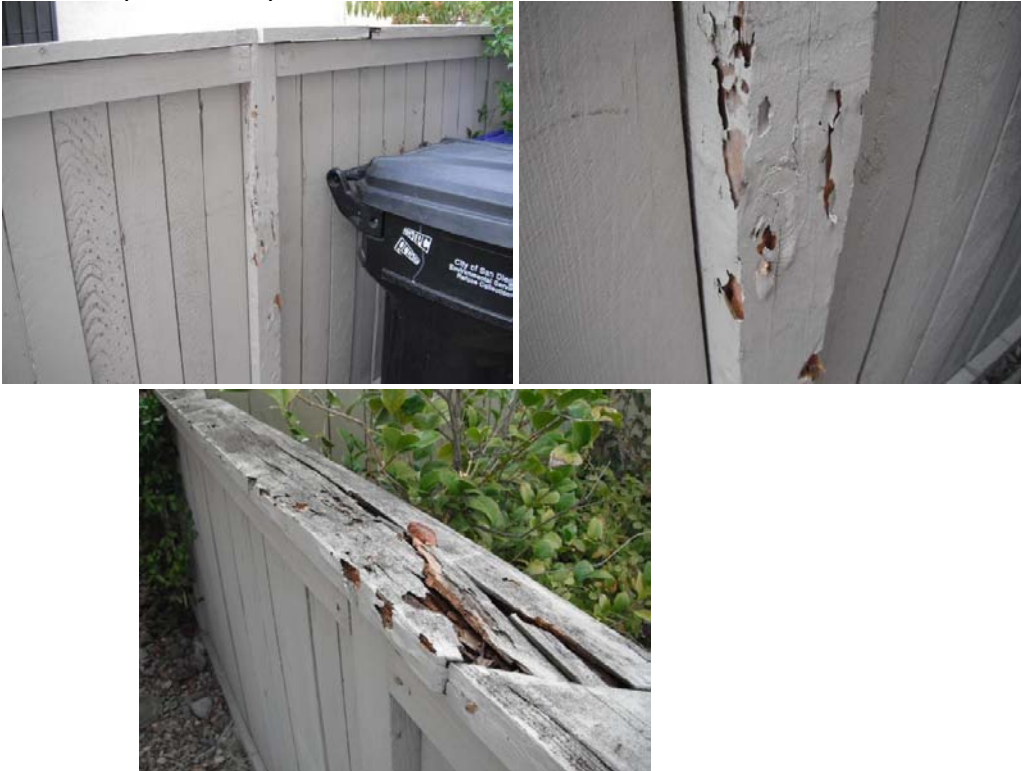
3. **Fences:** Wood, Metal There is dry rot and wood-destroying pest damage in the components of the wood fence at the left side of the lot, Repairs by a qualified licensed contractor are recommended

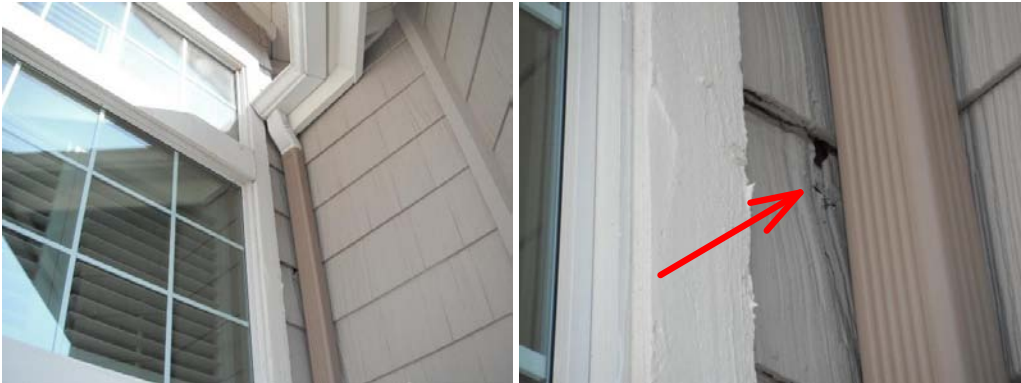
4. **Exterior Surface Type:** Stucco, Wood shingles There is moisture damage and dry rot in the wood shingles behind the gutter downspout by the front entry- Refer to the termite report, Repairs by a qualified licensed contractor are recommended

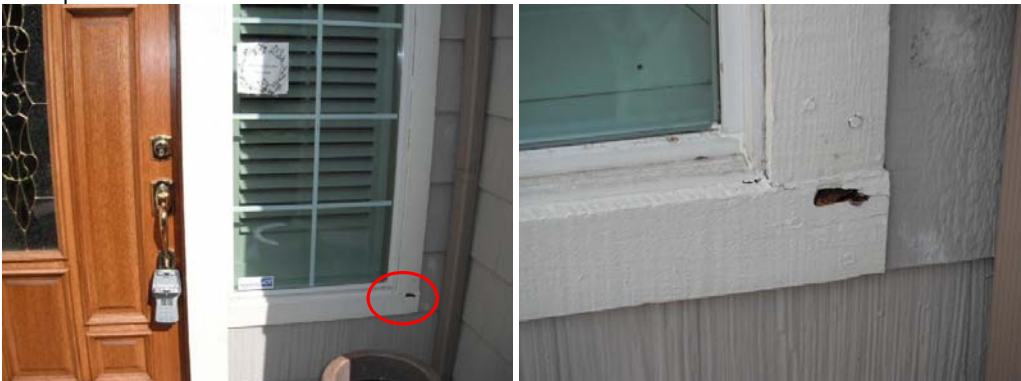
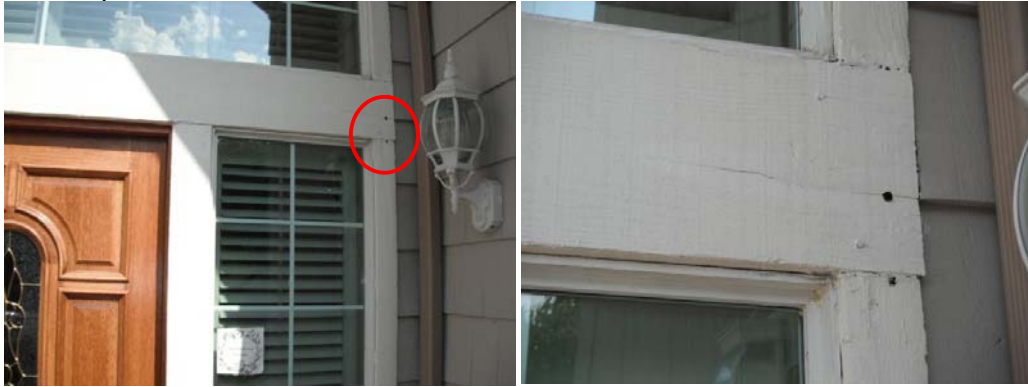
5. **Trim:** Wood There is dry rot in the window trim at the front entry, Refer to the termite report, Repairs by a qualified licensed contractor are recommended

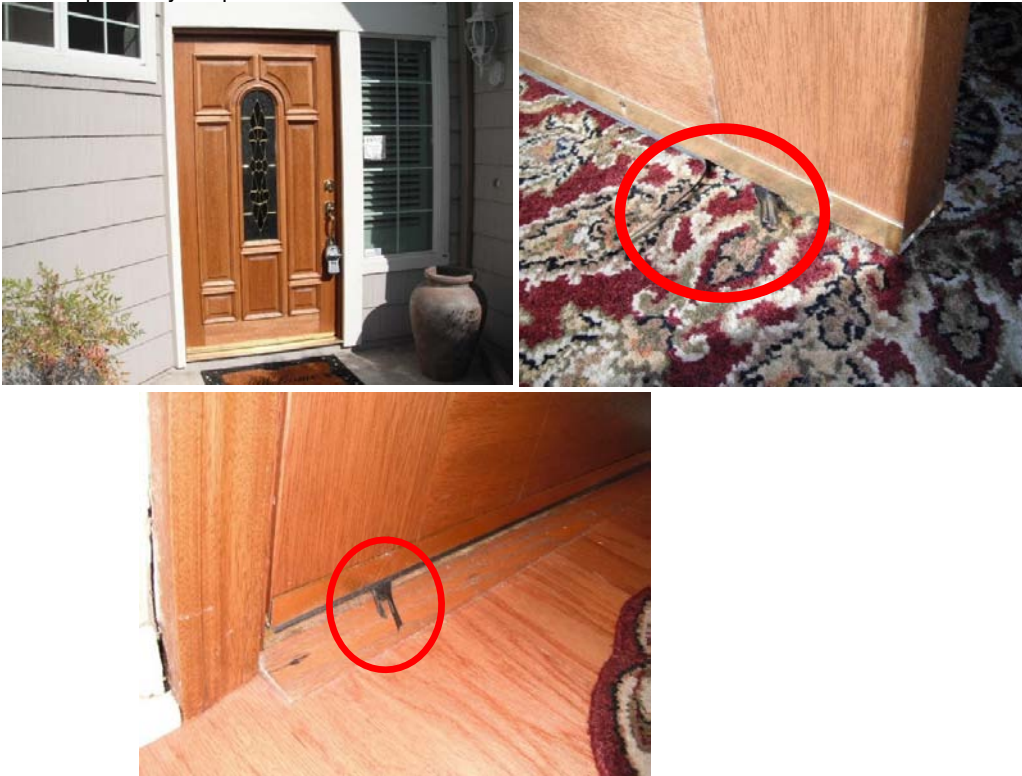
6. **Entry Door: Wood** The weather seal at the bottom of the front entry door is torn- Water intrusion may occur, Repairs by a qualified licensed contractor are recommended

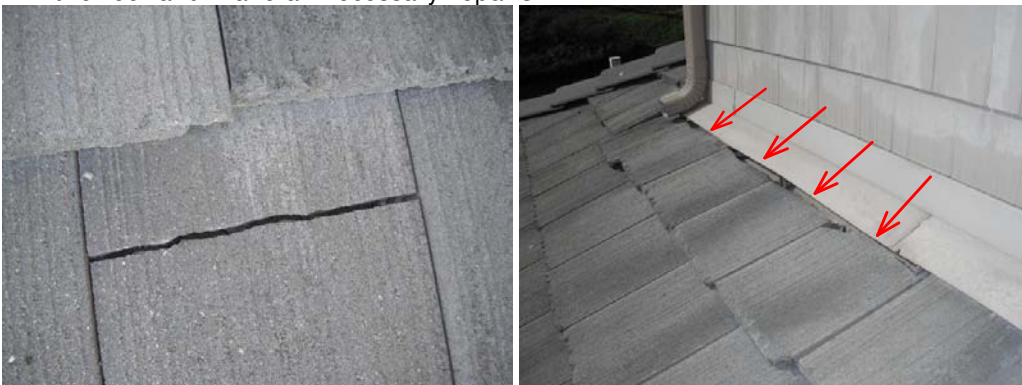
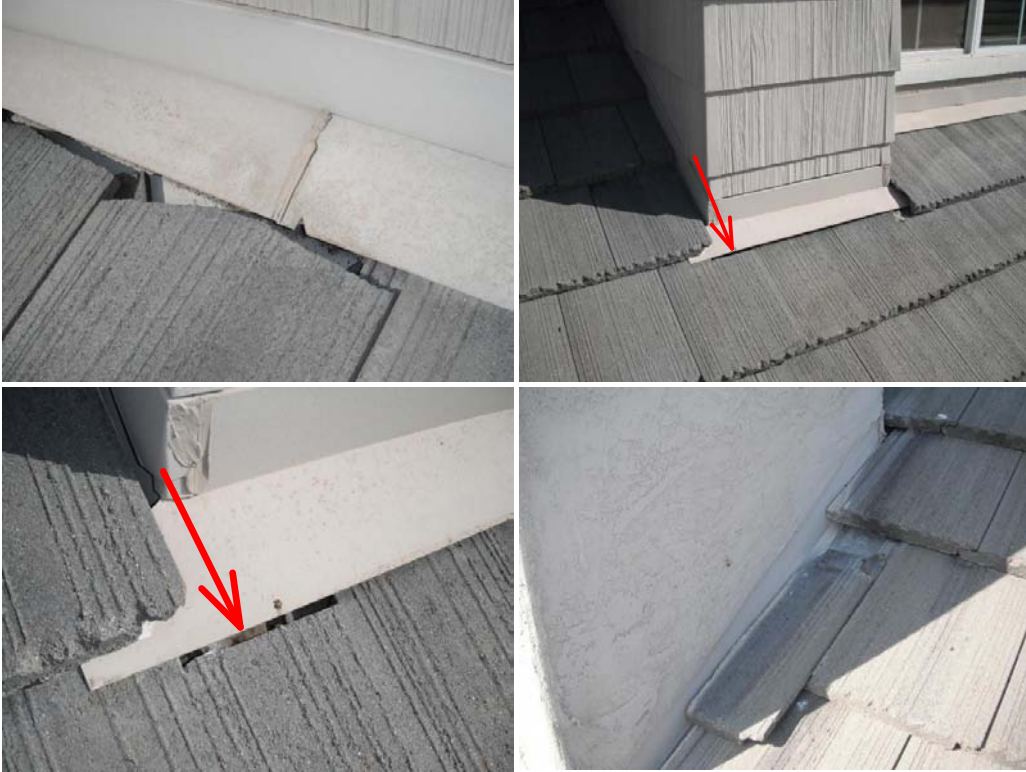
7. **Roof Surface Material: Concrete tile** There are several broken and/or loose tiles on the roof at various locations- Water intrusion and roof leakage may occur, A qualified licensed roofing contractor is recommended to evaluate the roof and make all necessary repairs

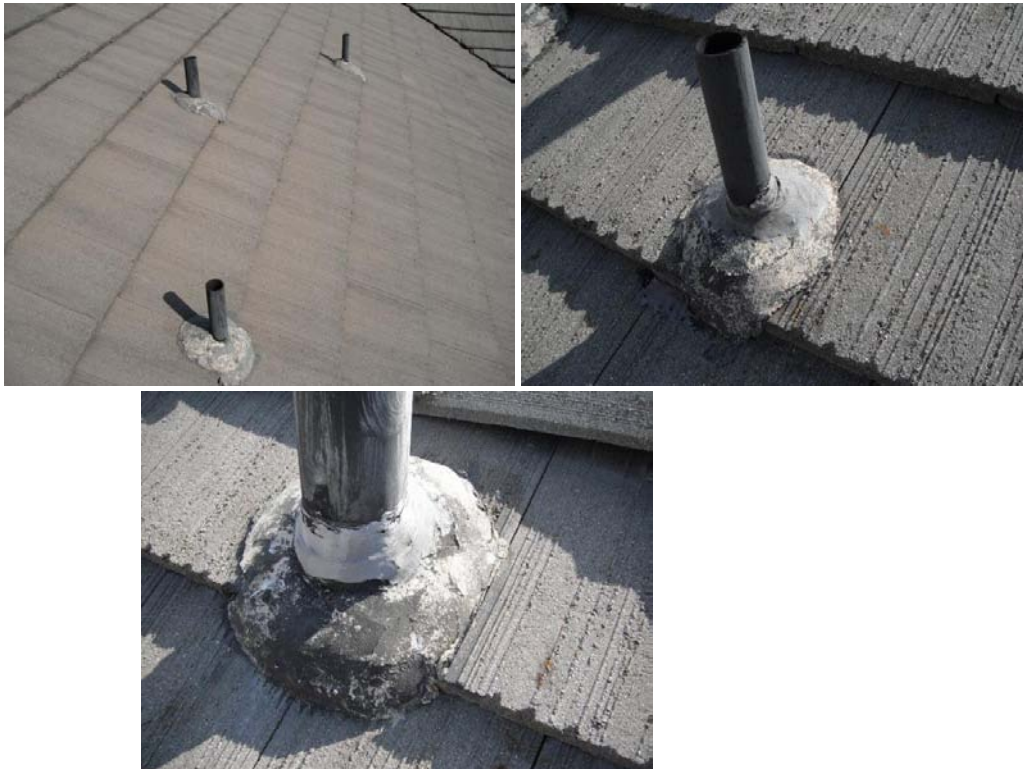
8. **Flashing:** Lack of metal flashing was noted at the roof penetrations (mortar used- prone to crack and leak)- Substandard installation- Prone to water penetration, Upgrades to metal flashing by a qualified licensed roofing contractor are recommended

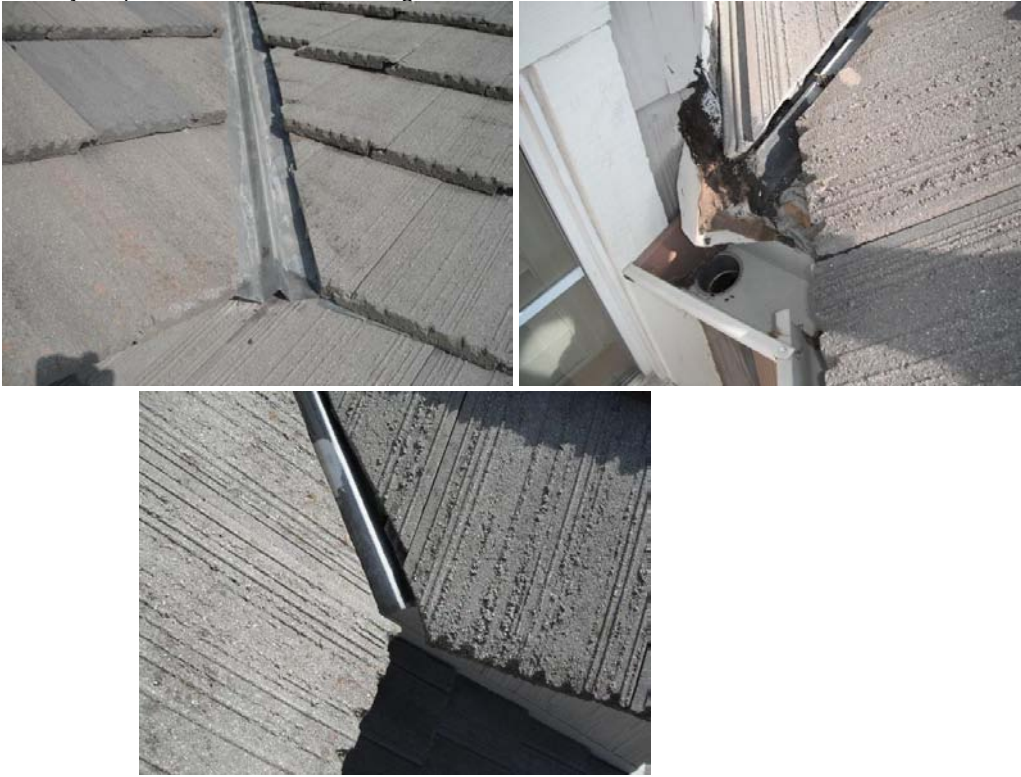
9. **Valleys:** Pre-formed galvanized metal The valley flashing terminates under the roof tiles in several places- Substandard installation- Water intrusion may occur, There is evidence of possible water intrusion at one or both of the valleys over the front entry- See "Exterior Surface and Components- Type", Evaluation and repairs

by a qualified licensed roofing contractor are recommended

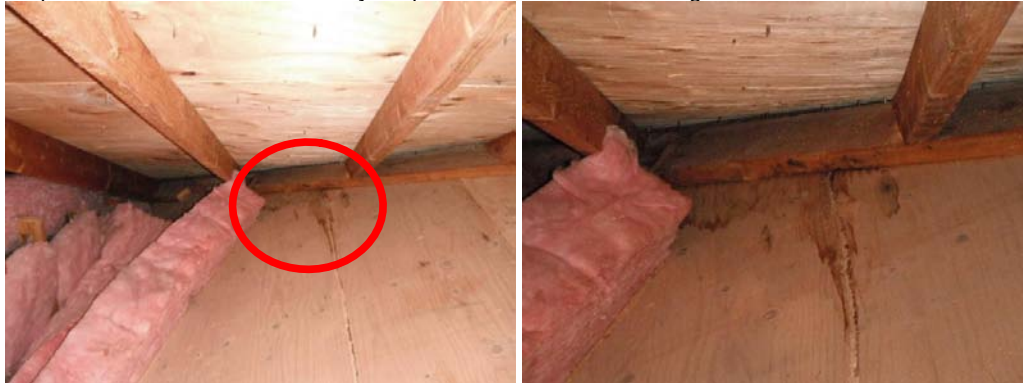
11. **Attic Moisture Penetration:** Yes Water stains are visible in the attic under the front roof valley from a past or present leak- Evaluation by a qualified licensed roofing contractor is recommended, See "Living Space- Walls"

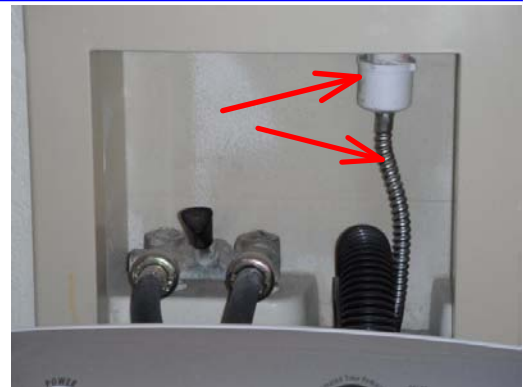
12. **AC System Condensate Removal:** PVC The A/C condensate drain line is reduced in size at the laundry hose bib box- Does not meet industry standards- Clogging and leakage may occur causing water damage, Repairs by a qualified licensed HVAC contractor are recommended

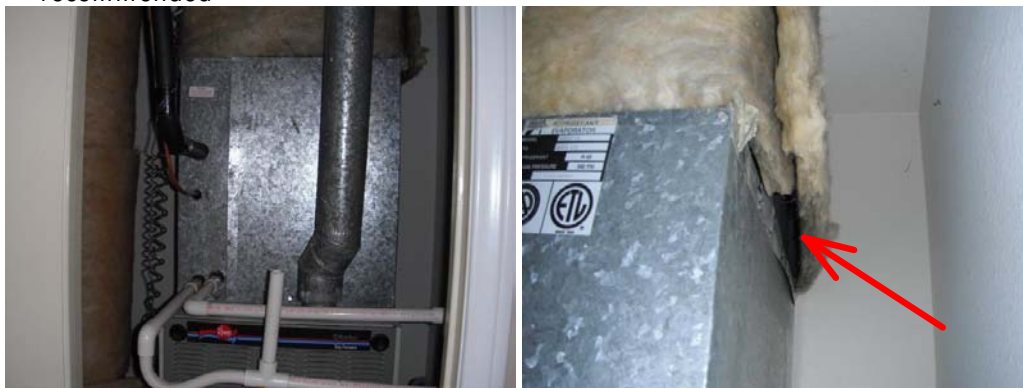
13. **Exposed Ductwork:** There is an air leak at the top of the evaporator coil (on top of the furnace)- Conditioned air is being lost- Reduced efficiency of the system may occur, Repairs by a qualified licensed HVAC contractor are recommended

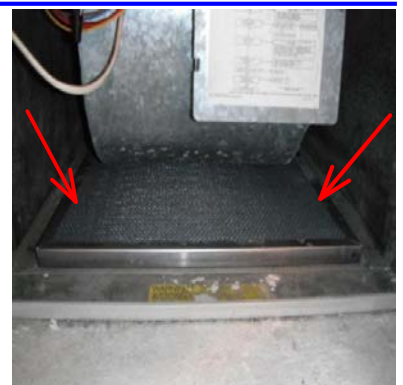
14. **Heating System Blower Fan/ Filters:** The hold-down for the furnace air filter is missing- Dirt and dust can bypass the filter resulting in reduced efficiency and shortened life-span of the unit, Repairs by a qualified licensed HVAC contractor are recommended

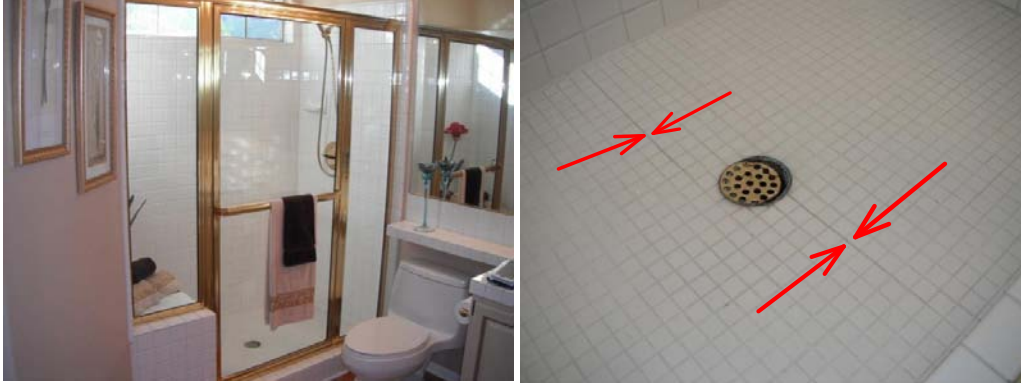
15. **1st Floor Bathroom Shower:** Tile There is a crack running through the shower pan- Water penetration may occur- Evaluation by a qualified shower pan specialist is recommended, The drain cover is loose- Prone to clogging- Repairs by a qualified licensed plumber are recommended

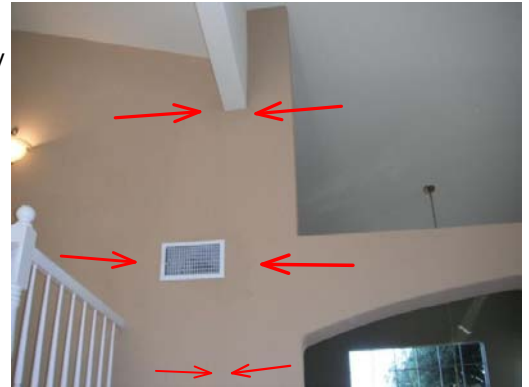
16. **Living Space Walls:** Water staining is visible on the living room wall below the ceiling beam from a past or present roof leak- Evaluation by a qualified licensed roofing contractor is recommended, See "Attic-Moisture Penetration"

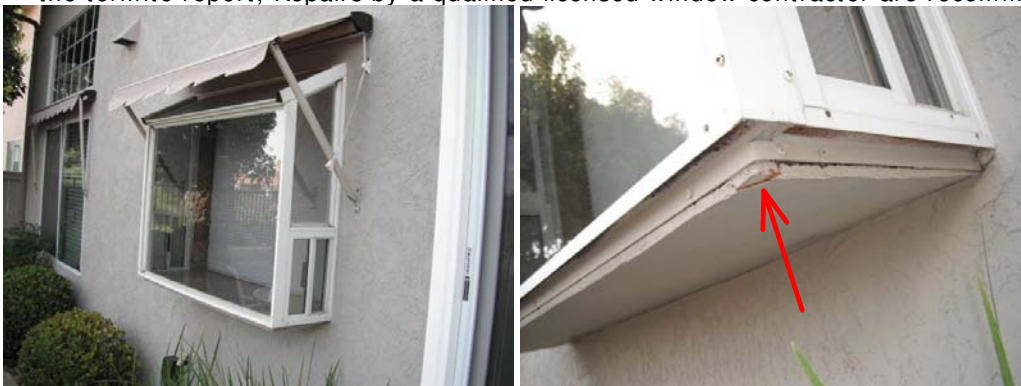
17. **Kitchen Windows:** The exterior wood at the bottom of the kitchen garden window is moisture-damaged- Refer to the termite report, Repairs by a qualified licensed window contractor are recommended
