First Choice Inspections

# Property Inspection Report

17763 ABC Court  
San Diego, CA 92131

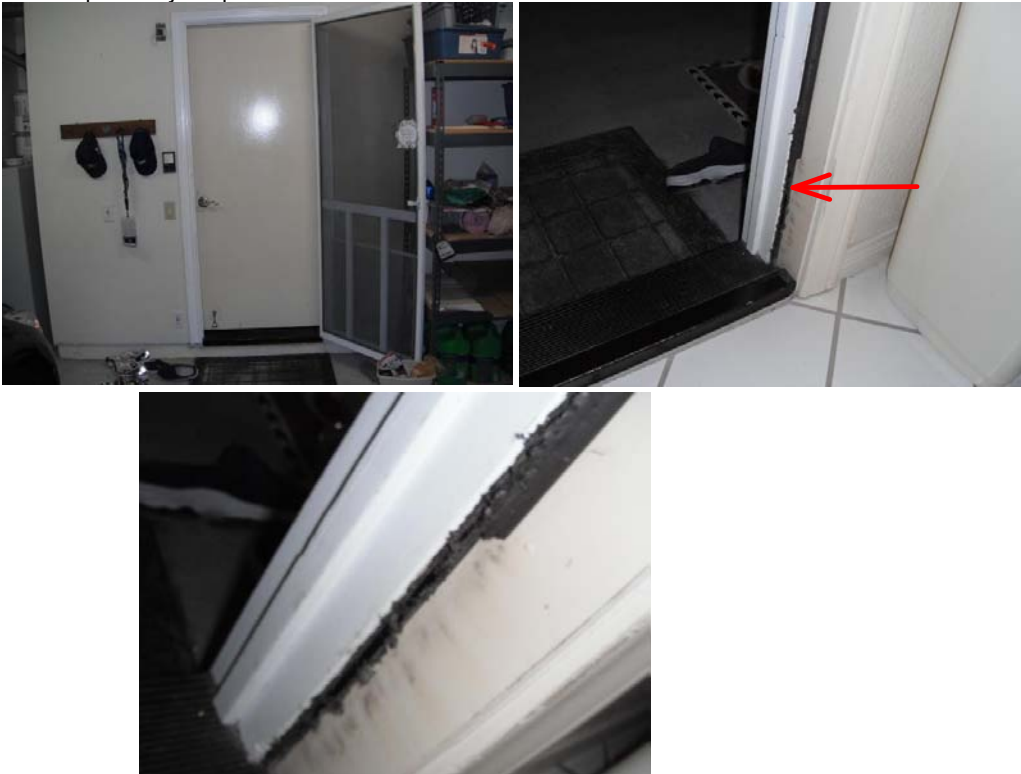
- 2. Garage Fire Door:** The weather-stripping at the jamb of the garage fire door (leading into the house) is damaged from a pet, causing a breach in the fire-protective barrier between the garage and the house- Fire hazard, Repairs by a qualified licensed contractor are recommended

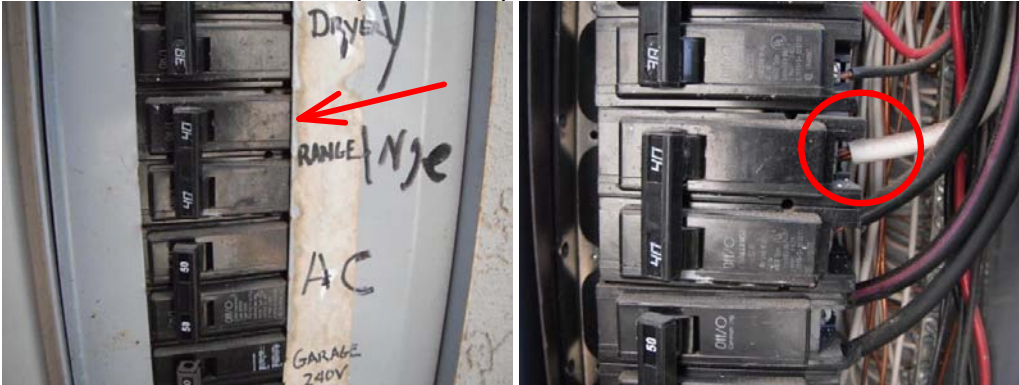
- 3. 220 VAC Branch Circuits:** The white wire connected to the 40-amp "Range" breaker in the electrical panel is not properly identified or marked as a hot wire- Substandard installation- Safety hazard- Does not meet electrical safety standards, Repairs by a qualified licensed electrician are recommended

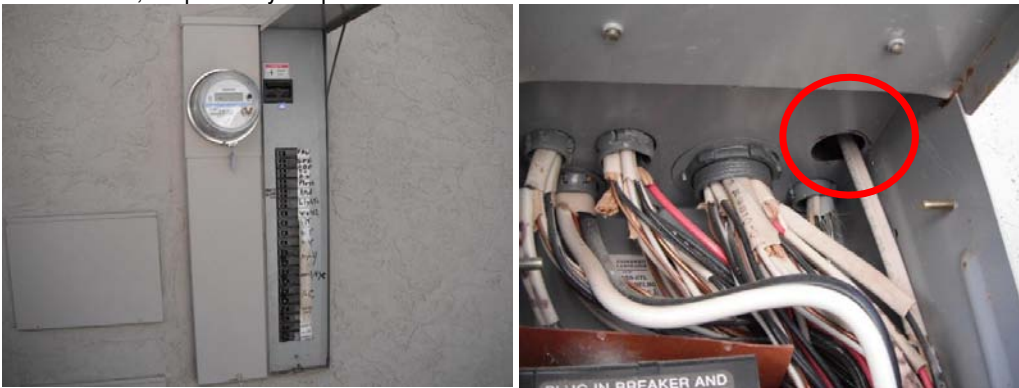
4. **Electric Panel Manufacturer: Challenger** A strain relief clamp is not installed where one of the electrical circuits enters the top of the electrical panel box- This installation does not meet electrical safety standards- Fire hazard, Repairs by a qualified licensed electrician are recommended

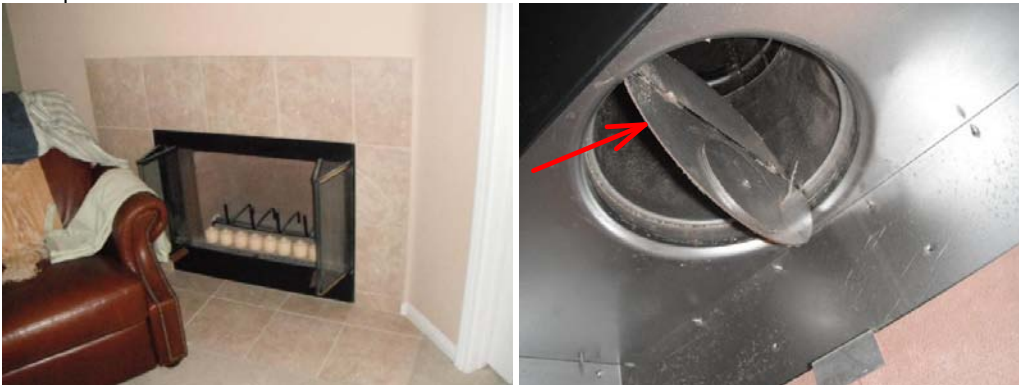
5. **Master Bedroom Fireplace Damper:** A damper clamp is not installed on the fireplace damper- Safety hazard- The damper is required to be permanently blocked open in fireplaces containing a gas fixture- Installation by a qualified licensed contractor is recommended
