PROPERTY INSPECTION REPORT

Concerning: _____
Lazy Oak, Plano, TX
(Address or Other Identification of Inspected Property)

Report Identification: Lazy Oak, Plano, TX

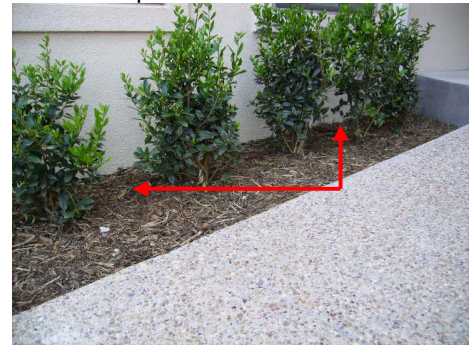
Lower soil to expose at least two inches of foundation and slope to drain away from structure. Do not create a condition where water will pool up against the foundation. Areas of concern include south side of garage and NW corner of entry at base of step.

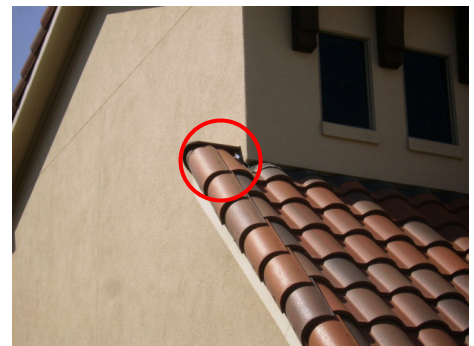
Appears to be in good condition, however possible leak refer to the Section **F. Ceilings & Floors**. I can see plastic zip ties at the northeast corner of the garage holding tiles in place, not an acceptable method of attachment.

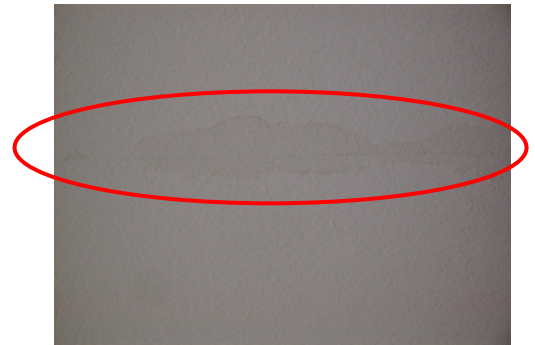
Stain and crack in ceiling finish at the game room may be water penetration from the roof, review and correct.

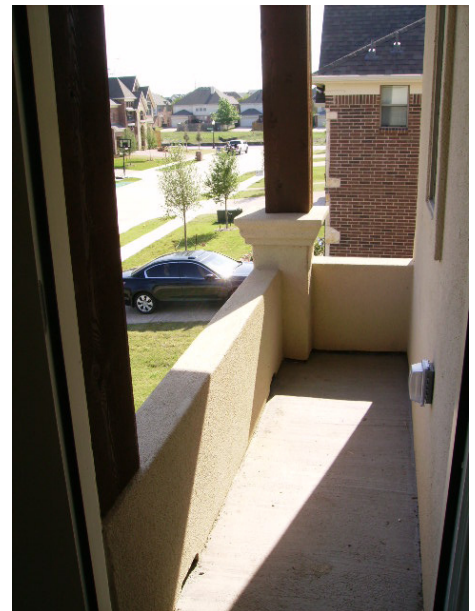
K. Porches, Balconies, Decks, and Carports Comments:
Exterior Balcony:
Missing a guard rail at the north balcony. Guard rail required where the distance from any standing surface to the ground below is 30 inches or more.

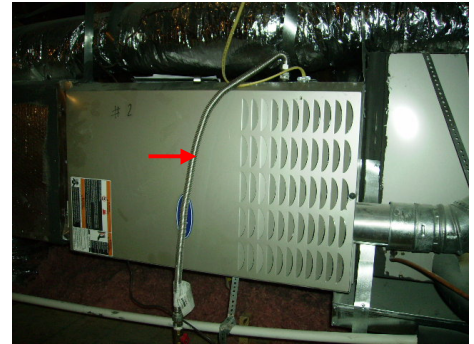
Note the gas lines are tight against the burner covers making it difficult for a mechanic to access the burner compartment.

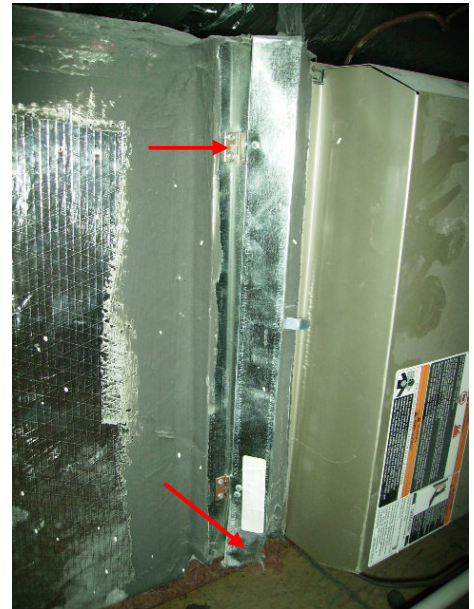
Downstairs zone the filter cover is bent, one hinge is broken, draws in attic air.

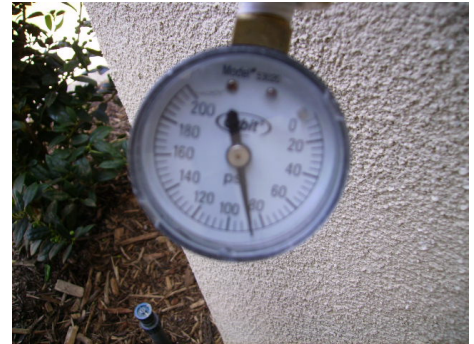
Static water pressure reading: **water pressure exceeds 80** psi and does not have a pressure regulator, contact plumbing concern. The PSI reading is - 87

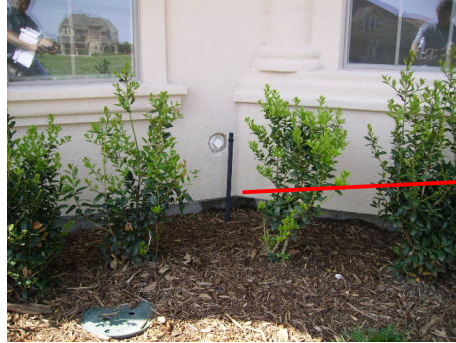
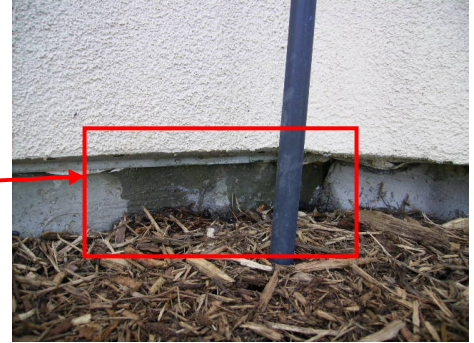
Apparent leak associated with this bathroom. When running the sink and tub water drips out from behind the stucco at the grade level in the front planter below.

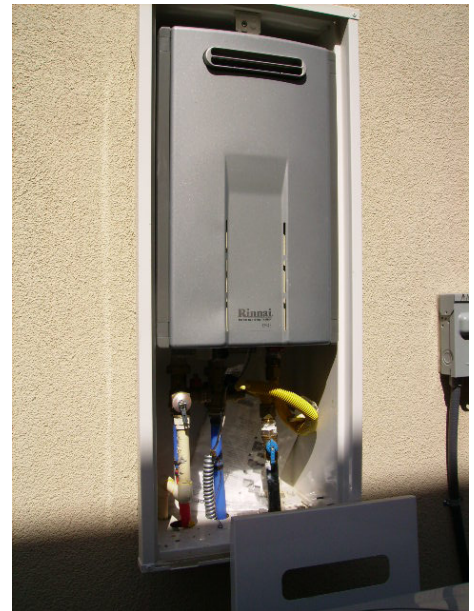
Mounted to the exterior of the home at the east elevation.

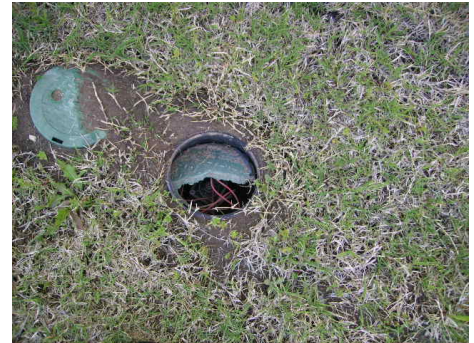
Valve cover broken at the west yard.

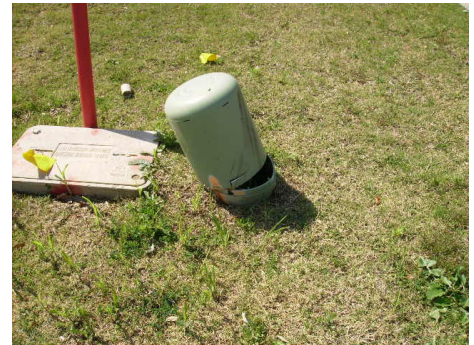
Cable cover box is damaged at the NE corner of the lot.
