The severe Tohoku Sequake in Japan and its impact on the Fukushima Daiichi nuclear power plant

*Bernhard Kuczera, Karlsruhe/Germany,
and Ludger Mohrbach, Essen/Germany*

Volume 56 (2011), Issue 4/5 | April/May

**International
Journal for
Nuclear Power**

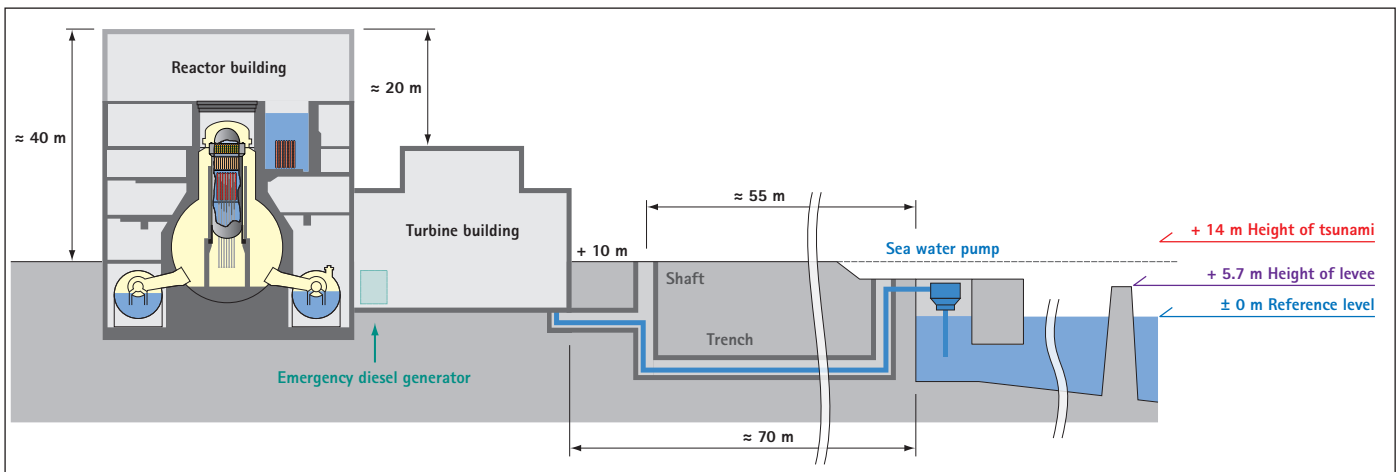
with a height of about 14 metres at the Daiichi site. The seawall with a height of 5.7 metres (see Figure 4) might have absorbed some of the wave's impact, but was easily inundated. However, the site ground level of 10 m submerged, causing severe damage to all seaward installations and flooding the turbine halls after breaking their doors.

Fig. 4. The height of the tsunami wave relative to the level of the nuclear power plant's facilities.

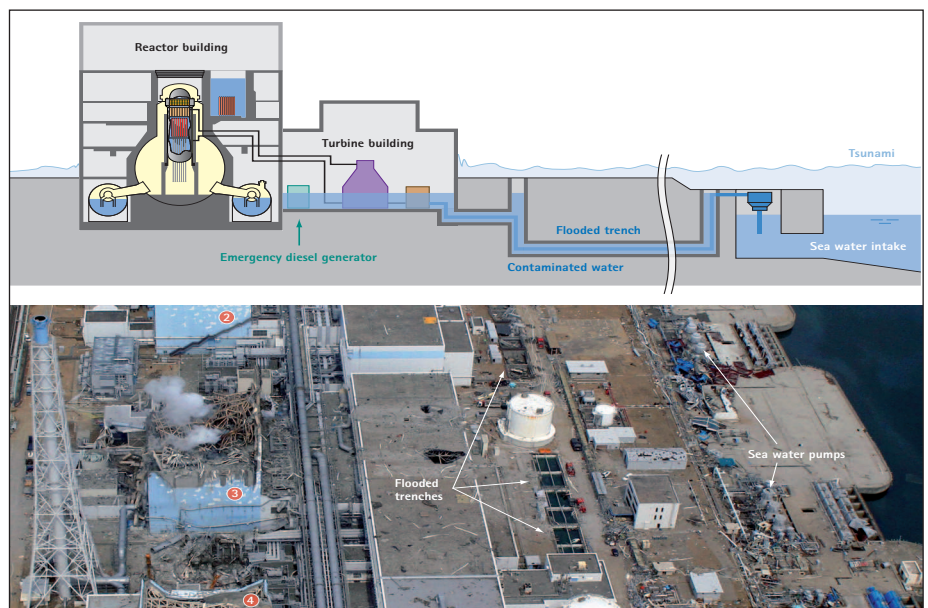
All emergency diesel generators, located on the turbine hall floor below ground level, except one air-cooled extra set in unit 6, were knocked out by the water ingress, leaving the units 1 to 4 without AC power supply (the remaining diesel was afterwards able to supply AC electricity for units 5 and 6, see Table 1).

Thus units 1 to 4 saw a total station blackout (see also Figure 5).

Fig. 5. Flooding of the turbine hall basement.

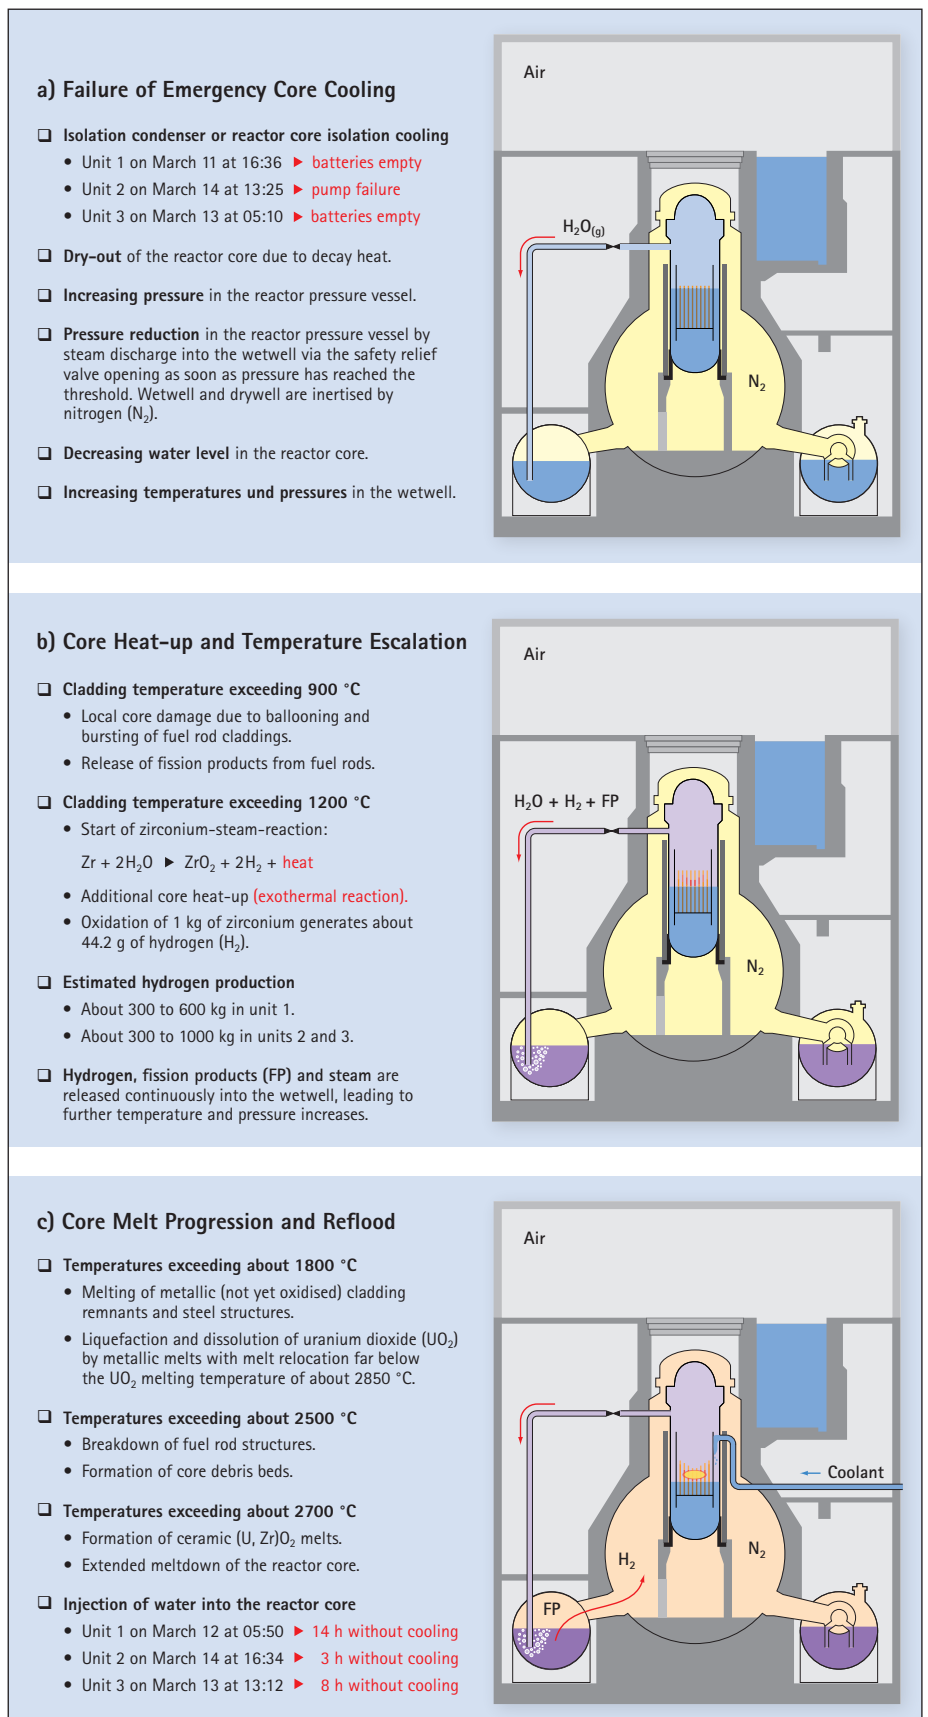
The accident scenario that developed in the following has been basically known from risk studies. It is shown in sequential pictures and according to [1] in a self-explanatory way in Figures 6a to 6f.

For unit 1, this scenario resulted on Saturday, March 12, 2011, at 15:36 h in an explosion of hydrogen formed from the reaction of the fuel cladding material zirconium with water at high temperatures, as shown in Figure 6f. It has not been settled yet how hydrogen could escape from the reactor core to the upper parts of the reactor building, instead of being vented through the exhaust stack.

The explosion destroyed the steel wall structures of the upper part of the reactor building, above the reactor service floor, where also the spent fuel pool is situated ("secondary containment"). Consequently, gaseous and volatile fission products escaped into the atmosphere.

At this stage, the core must have been uncovered, fuel rods damaged, relocating the fuel pellets downwards, where they are suspected to have reached fuel melting temperatures.

Fig. 6 a-c. Development of the accident in the Fukushima Daiichi unit 1 [1].

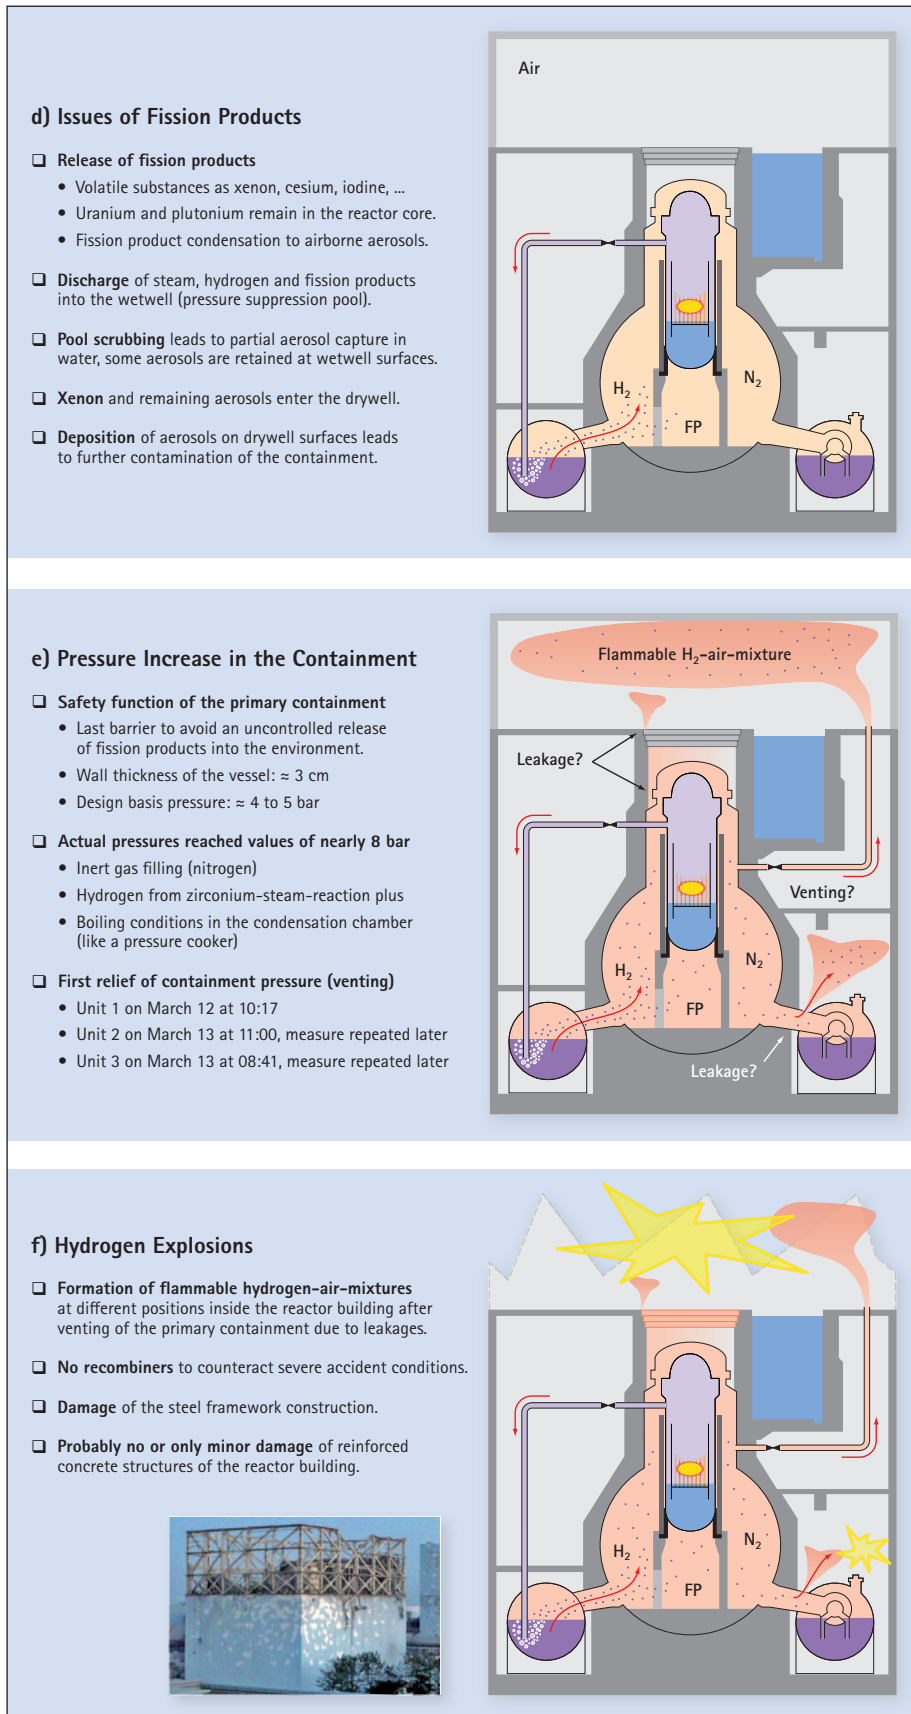
Fig. 6 d–f. Development of the accident in the Fukushima Daiichi unit 1 [1].

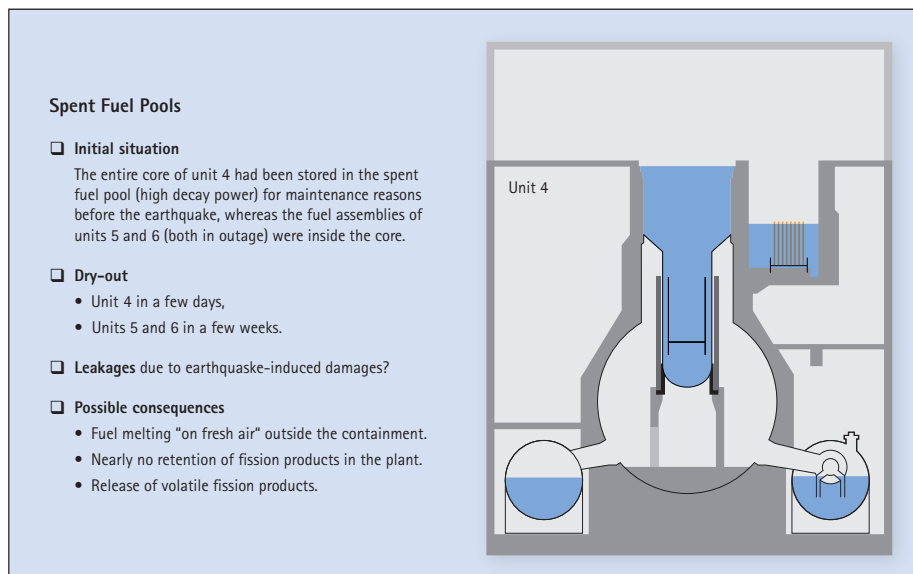
stored. The cooling water in the pool of unit 4 evaporated slowly within a couple of days after pool cooling had failed due to unavailability of the cooling pumps. Fuel assemblies ruptured and released their noble gases and volatile fission products to

the atmosphere. However, photos taken from the pool later (mid-May) show that the racks and the assembly heads seem to be still intact, indicating that refilling of the pool prohibited large-scale melting (see Figure 7). Nevertheless, an explosion

The entire core of unit 4 had been stored in the spent fuel pool (high decay power) for maintenance reasons before the earthquake, whereas the fuel assemblies of units 5 and 6 (both in outage) were inside the core.

- Unit 4 in a few days,
- Units 5 and 6 in a few weeks.

Leakages due to earthquake-induced damages?

- Fuel melting "on fresh air" outside the containment.
- Nearly no retention of fission products in the plant.
- Release of volatile fission products.

Fig. 7. Melting of fuel rods in the spent fuel pool of unit 4.

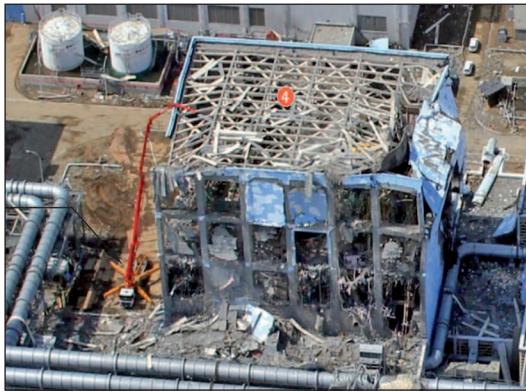
Fig. 8. A mobile concrete pump with a capacity of 120 t/h and a flexible, truck-type arm with a length of 58 m was used for about three hours in the late afternoon of 22 March 2011, to spray a total of 150 tonnes of sea water from the top onto the destroyed unit 4 and to fill the spent fuel cooling pool with water. This measure was repeated several times on the following days

In the following days, endeavours were made to fill up the spent fuel pools of units 1, 3 and 4 with the aid of helicopters dropping seawater on the units. Later, fire brigade, police and military services with water cannons were also employed. The most sustainable option turned out to be Putzmeister concrete pump cars with elevation heights of up to 70 m, partly delivered from the USA and Germany by Antonov airlift (see Figure 8).

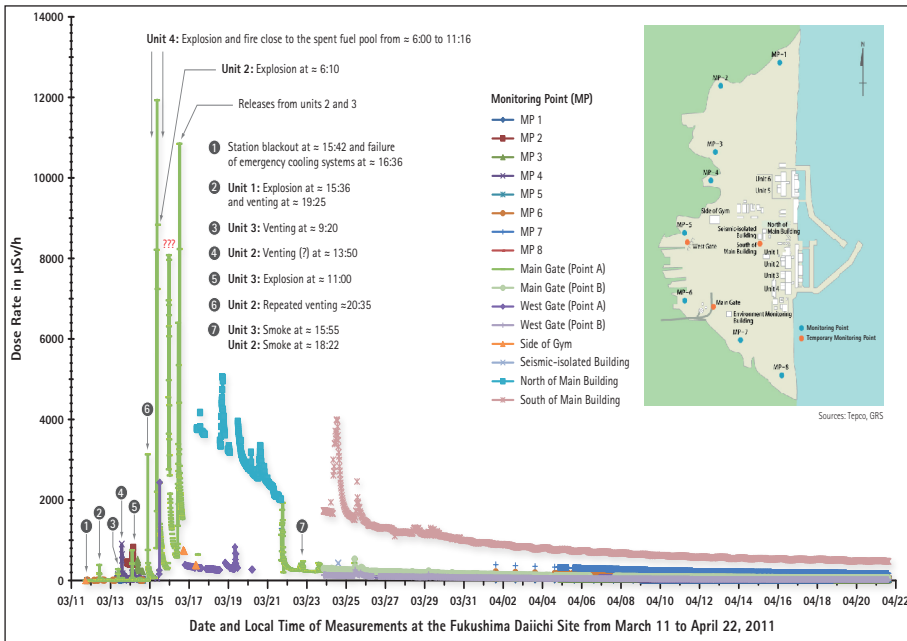
Figure 9 shows data on the release of radioactivity into the environment. The *Tepco* records for the period 12 to 30 March 2011, show an initial slight release of radioactivity during the first three days after the tsunami disaster, caused by e.g. deliberate venting of the primary containments of units 1 and 2. The first larger release was recorded in the morning hours of 15 March 2011, within the course of the explosions that occurred in units 4 and 2 and on 16 March 2011, from the already damaged unit 3. Peak values of local radiation dose rates were around 10 to 12 mSv/h with a tendency of first strong and then asymptotic decrease⁶.

Fig. 9. Radiation exposure at the Fukushima Daiichi site.
