PROPERTY INSPECTION REPORT

**12345 Main Street
Fairfax, VA 22030**

Prepared by: My EstatePro Inspector

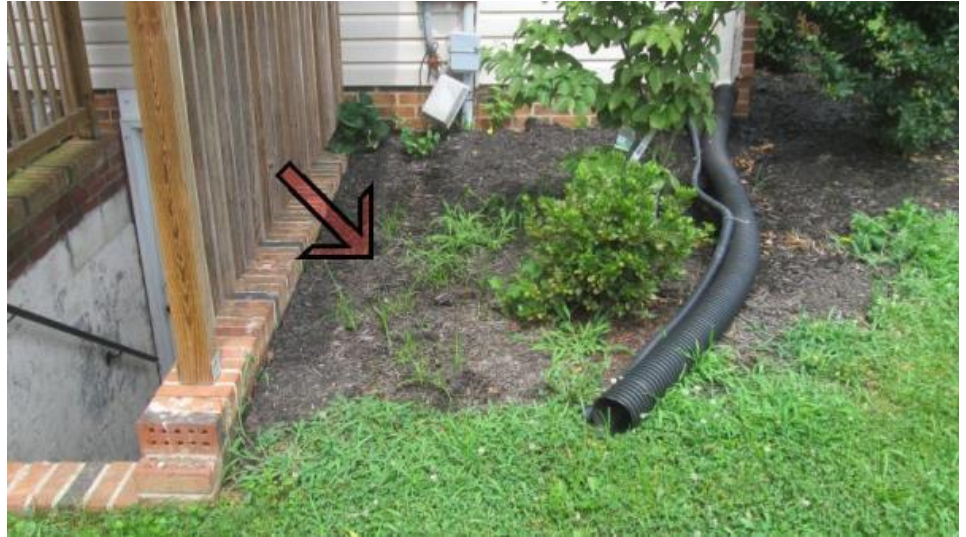
Reverse or Marginal grade noted. Grading should be altered or underground drainage installed in order to lead water away from the foundation. Locations include but may not be limited to: rear front and sides.

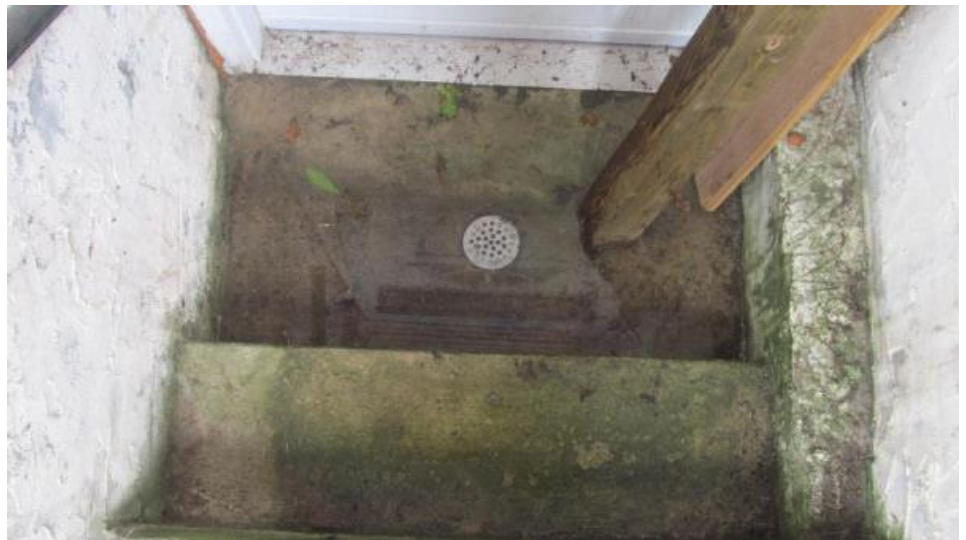
3.5 UNDERGROUND DRAINAGE:

Underground drainage found at A drain is located at the exterior entrance.. The testing of underground drainage systems is beyond the scope of this inspection. Please ask owner about condition and/or perform your own testing before the close of escrow. It is further recommended that any underground drainage system be flushed at least once a year.

The rear stair drain is not draining. Inquire with the seller as to the condition or have the drain repaired. The roof may not protect you from all weather conditions.

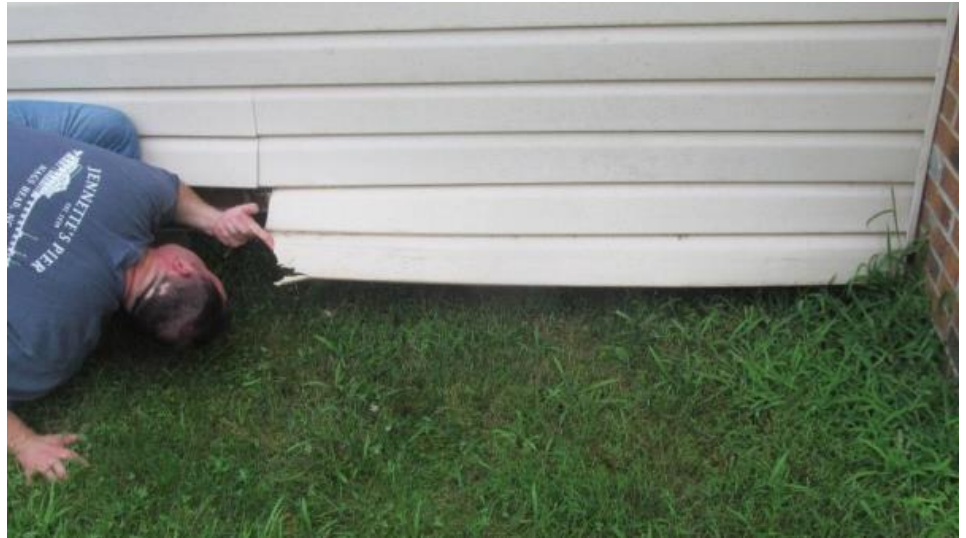
4.2 SIDING CONDITION:

Holes noted in the siding. We recommend sealing any holes or other penetrations in the siding to prevent future moisture intrusion. Locations include: right.

The siding has become loose or detached in one or more areas. This condition can allow moisture to enter the structure. Recommend re-securing and sealing all siding to prevent moisture damage. Locations include right. Hidden damage is not reportable. Remove the lowest siding and add trim at the right by the chimney. Siding should not be this close to the ground and is not attached to the house. This can lead to deterioration and pest infestation.

Some siding has been replaced on the right. Inquire with the seller about the condition. The siding does not match.

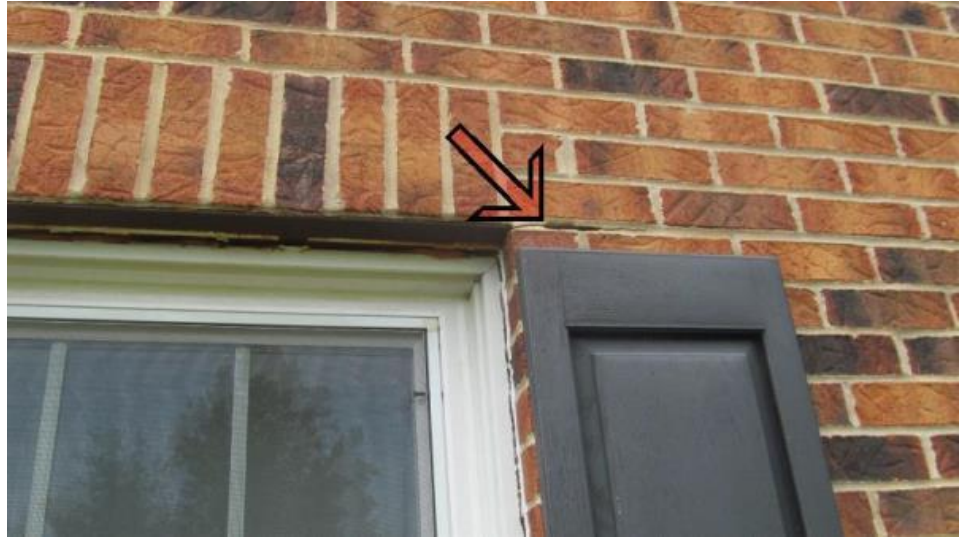
4.3 BRICK CONDITION:

Intact. General condition serviceable. Paint the metal window or garage lintels. Do not caulk above them. This space acts as a natural weep hole for trapped moisture.

Cracking along or around the lintel noted. re-grout with mortar to seal it. Front window.

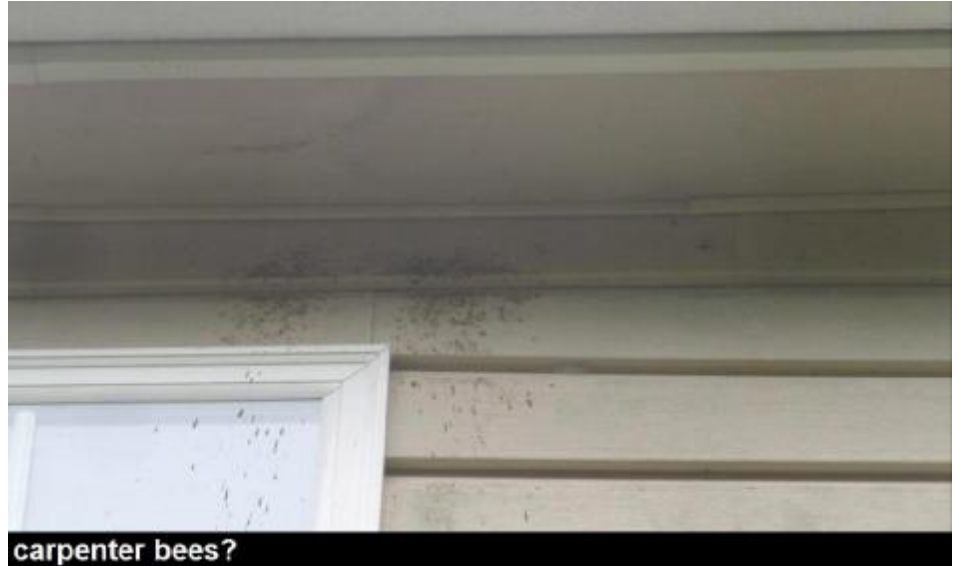
4.4 MOLDINGS & TRIM
CONDITION:

Some of the trim is metal or plastic wrapped to reduce on going maintenance of wood products. Monitor the caulking to keep a good seal. Usually the wrap is installed to eliminate ongoing maintenance of the underlying material, usually wood. Often you find that the underlying material has some form of deterioration if added later, or with poorly maintained caulking. Evaluation of these hidden materials is beyond the scope of our inspection.

Possible carpenter Bee activity noted at: the rear soffit. Not conclusive. Have the Bug professional further review the condition.

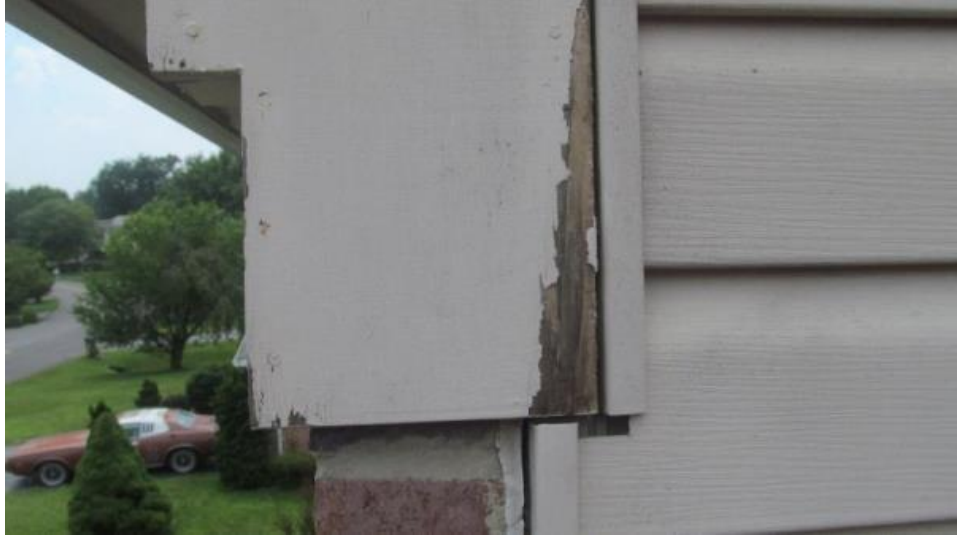
4.5 TRIM AND PAINT
CONDITION:

Minor localized peeling/flaking noted. Suggest painting to preserve wood.

Areas of the trim were found to be unpainted. Recommend painting the soffit at the front and the trim at the garage door opening to preserve the wood and prevent deterioration.

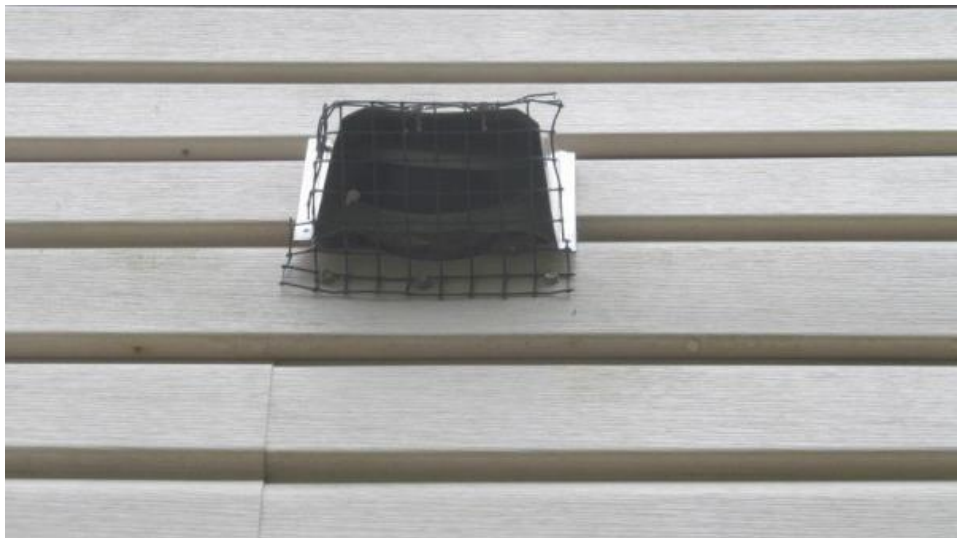
4.9 EXTERIOR OTHER
CONDITIONS:

An exhaust vent back draft damper is broken, stuck open or damaged. Suggest repair or replacement to prevent pests and cold air from entering the house. Rear.

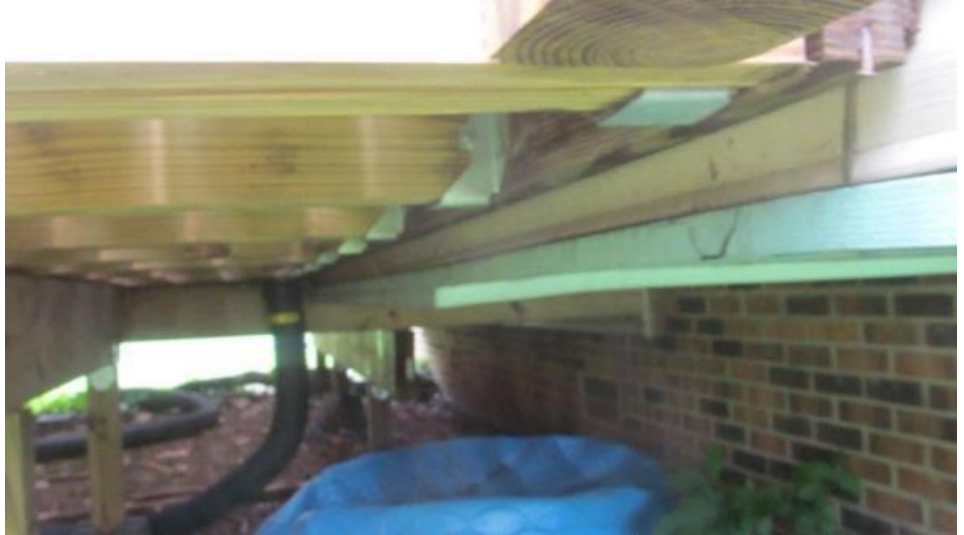
The framing around the bay window or chimney is not in accordance with the standard deck detail calling for a double header frame. Update for increased safety. This portion of the deck is only nailed to the house.

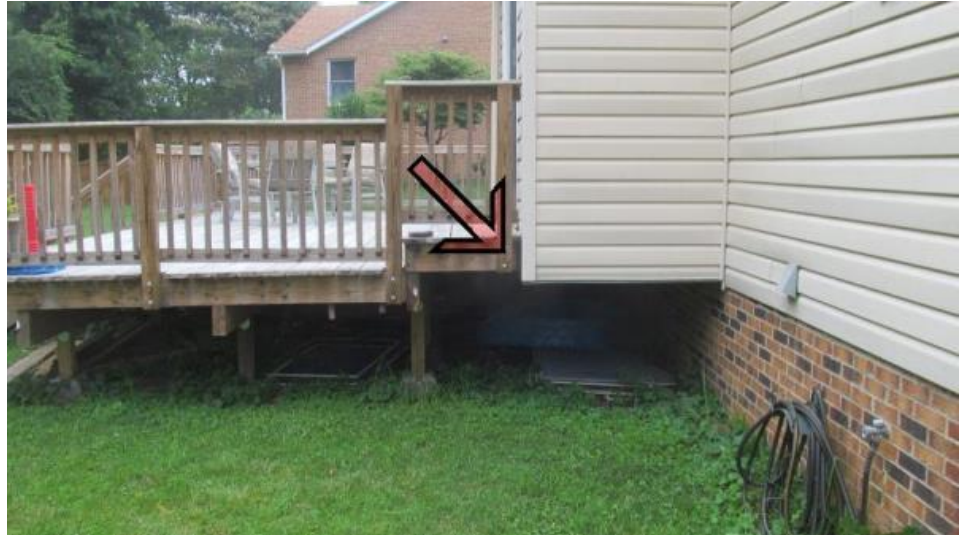
4.16 POSTS AND BEAMS
4.17 FLASHING

Flashing is missing, or partially missing where the deck is attached to the house. It is usually wrapped under the siding on top, under the floor, and over the ledger board to keep moisture from entering behind the ledger board. This condition could allow water to migrate to the interior. Additionally, over time water will deteriorate the bolts where they won't be visible. There is no evidence of water intrusion today.

We recommend you install flashing, or monitor the interior for signs of water intrusion; and if the deck is not free standing, add posts so you are not relying on the bolts for safety.

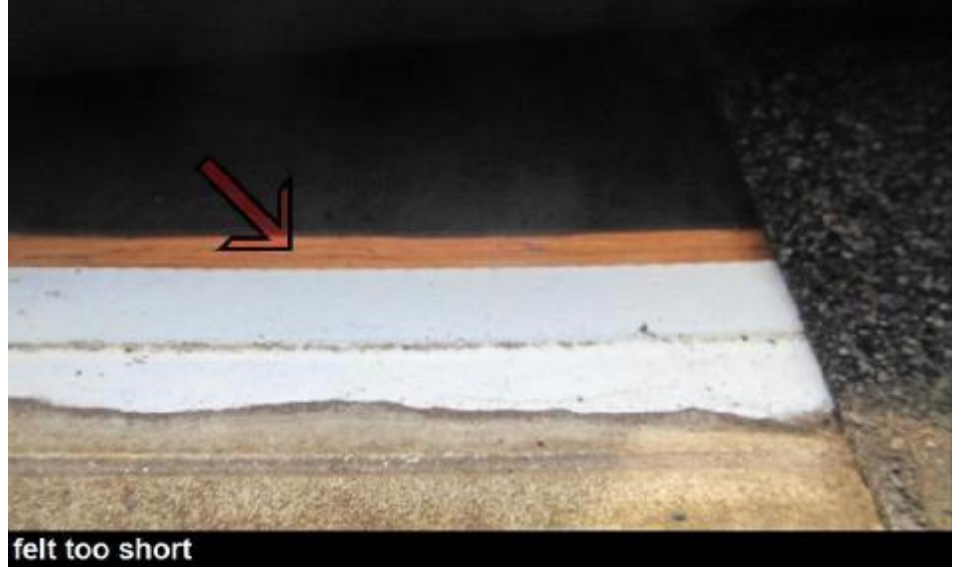
5.1 INSPECTION METHOD:

Walked on the roof. Some of the roof was walked, but not all of it was easily accessible.

The drip edge does not fit under the felt and in some areas the felt is too short to go over the edge of the roof sheathing or drip edge. Monitor or repair as needed.

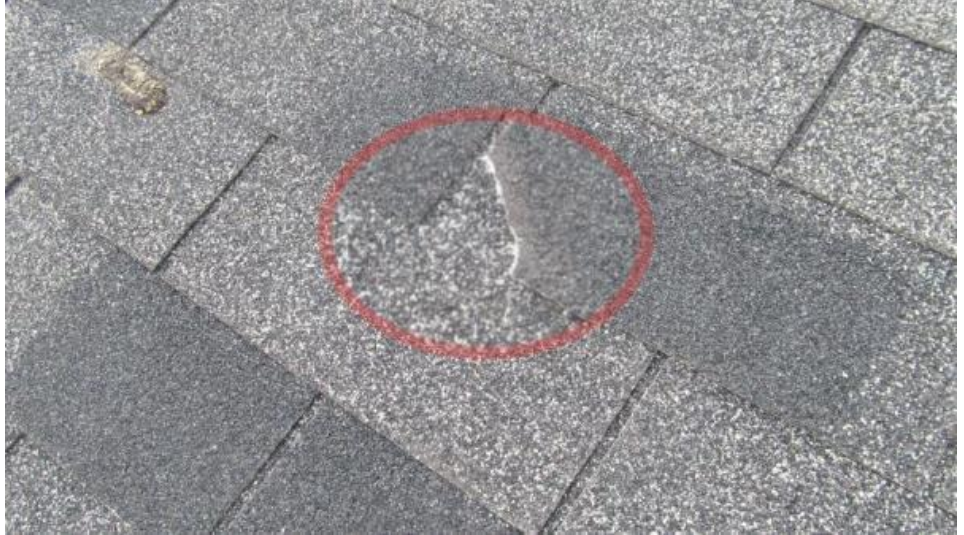
5.3 ROOFING CONDITION:

The roof is serviceable and functional. The roof appears to be in fair condition.

Some minor damage noted.

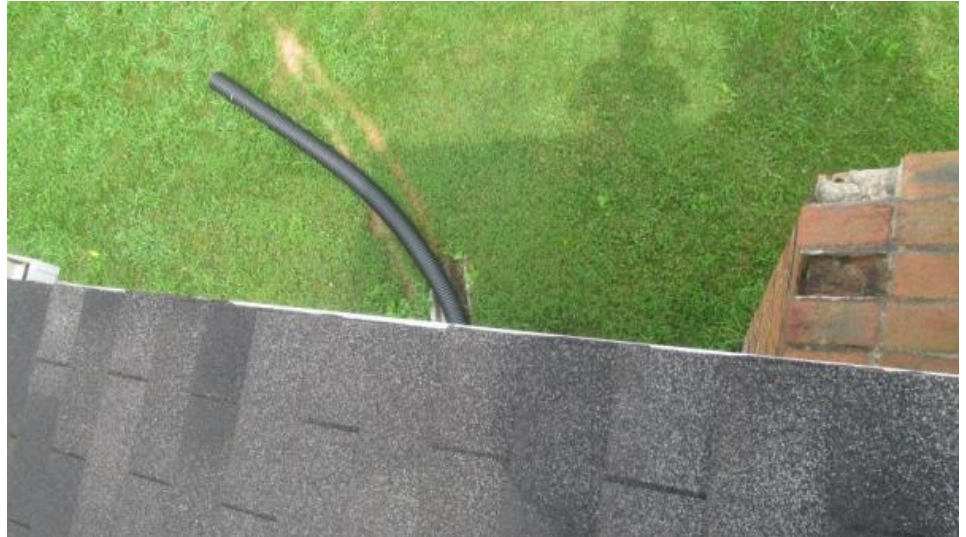
5.9 ROOF COVERING STATUS:

The roof covering does not extend over the gable ends or rake boards at all sides. This will allow water under the roof material and lead to premature deterioration of the wood structure underneath. Possibly the roofing material, metal, wood or vinyl can be secured under the shingles, or new shingle material will be required. We recommend a roofing contractor further review and repair as needed or monitor for water intrusion.

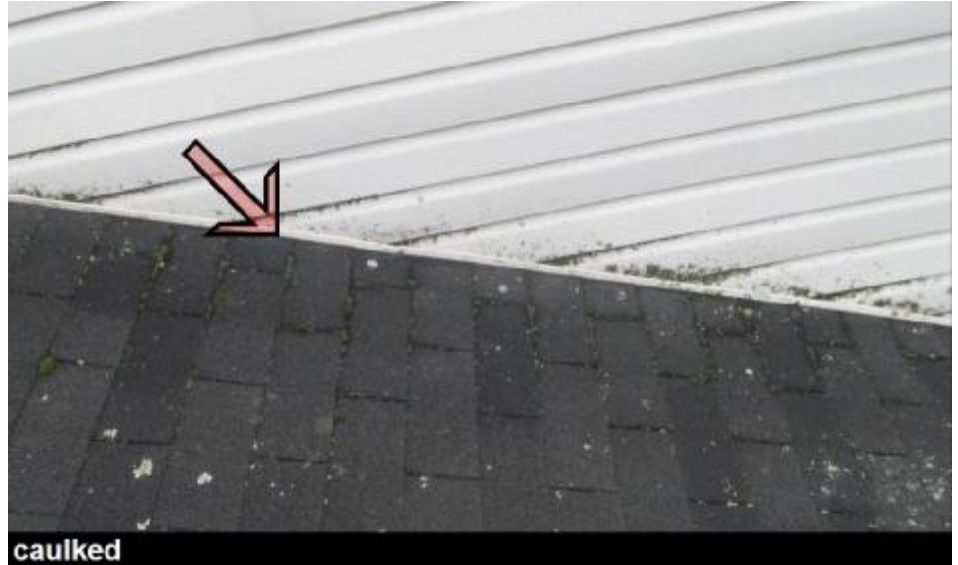
5.13 ROOF METAL/FLASHINGS:

Caulking or sealant is installed along the roof and siding in some areas. If flashed properly you should not need caulk. Inquire with the seller about the need.

Usually a metal flashing is installed where the garage roof attaches to the brick front. Caulk or add flashing to seal the area.

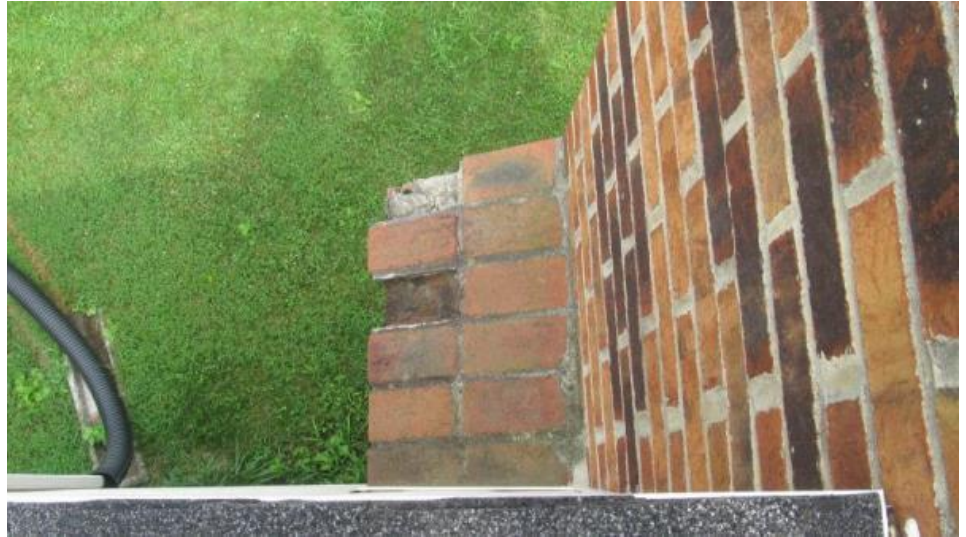
5.18 SPECIFIC CONDITIONS:

Replace the missing bricks at the chimney near the bottom.

Install the missing bricks.

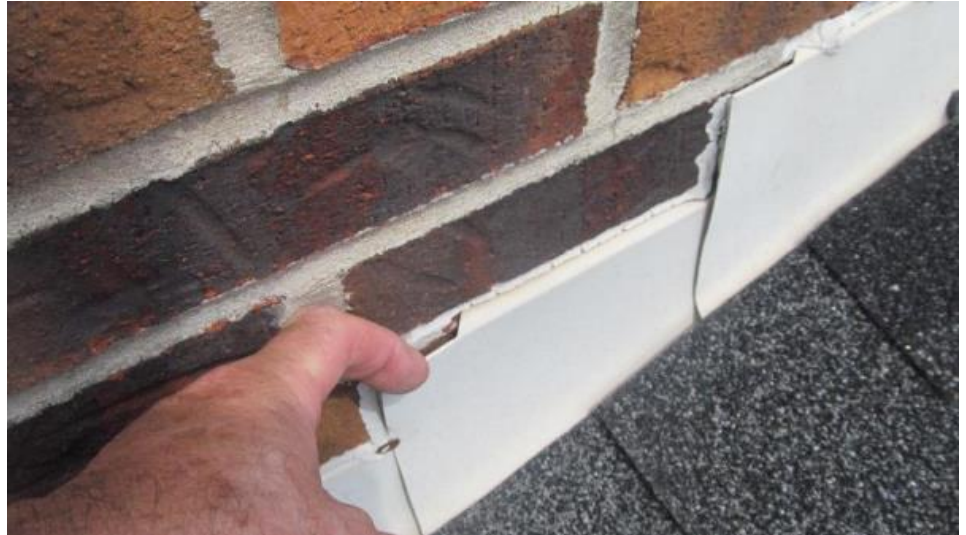
5.23 ROOF JOINT:

The following conditions were noted: **The chimney/roof joint shows deferred maintenance separation cracks. Recommend sealing with the appropriate sealant.**

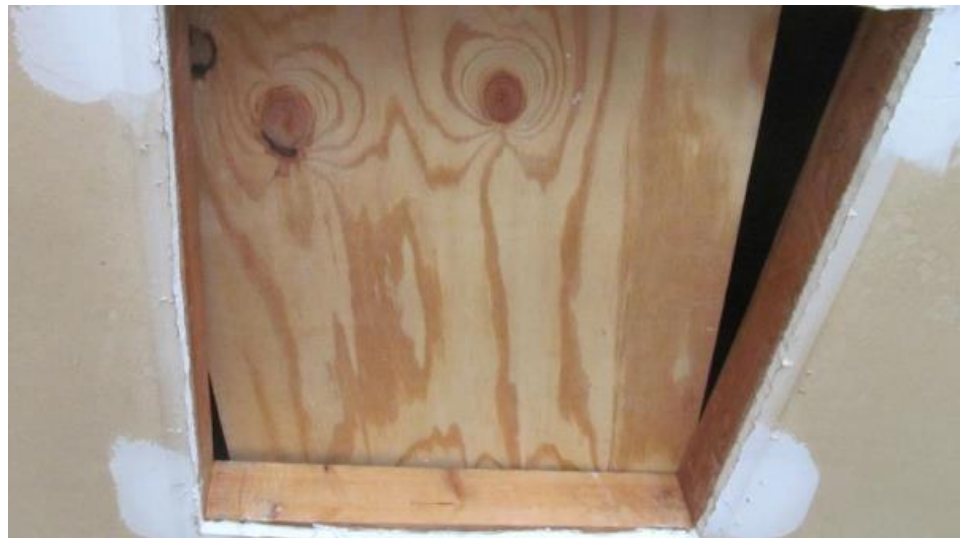
6.5 FIREWALL CONDITION:

The firewall integrity is compromised by, There is a non-fire rated access hatch into the attic.

Drywall seam tape is loose/missing. holes in the sheetrock.

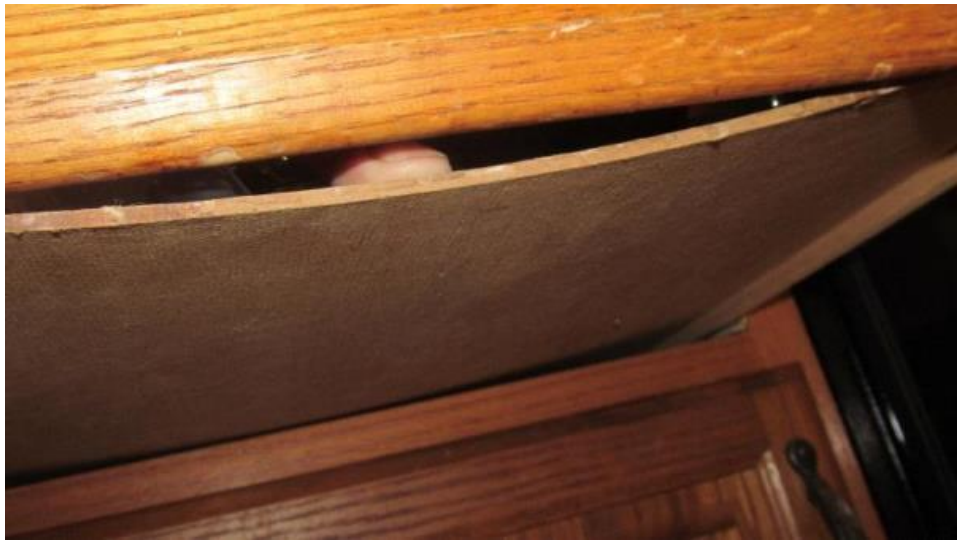
Serviceable and functional, **Some of the door handles are broken or missing.**

One drawer floor is loose and is bellying under weight. Minor repair needed.

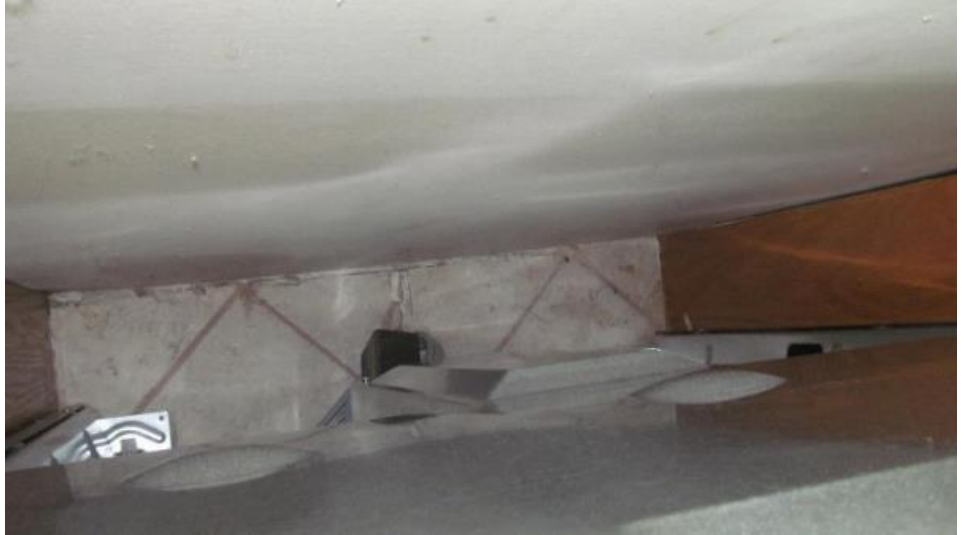
8.13 STOVE (or Cook Top):

Electric, **Properly secure the loose 240 outlet on the floor, or the wall.**

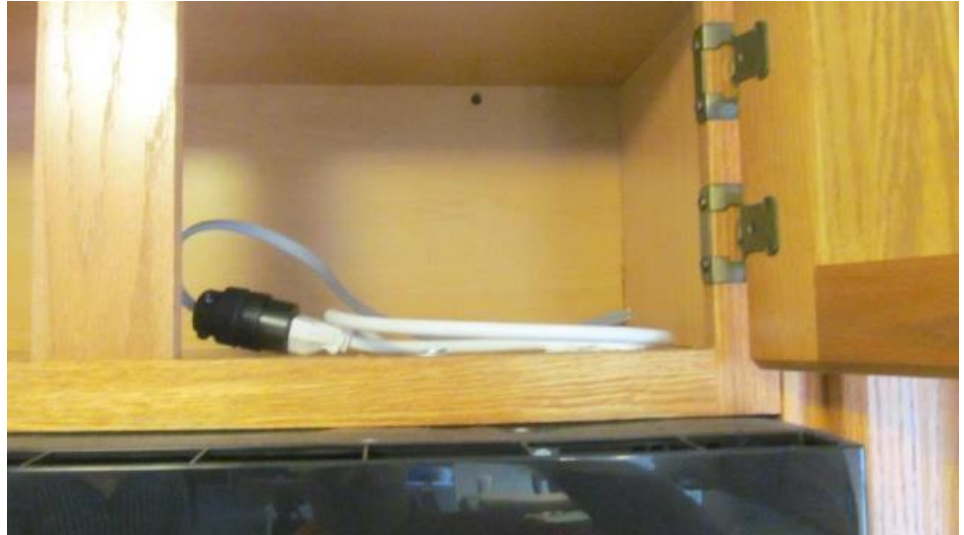
8.15 BUILT-IN MICROWAVE:

Separate circuits required for new installations at or after 2005. The appliance is plugged into an extension cord. Permanent or semi- permanent appliances shall not be powered via extension cords for safety. Run a new outlet for this device.

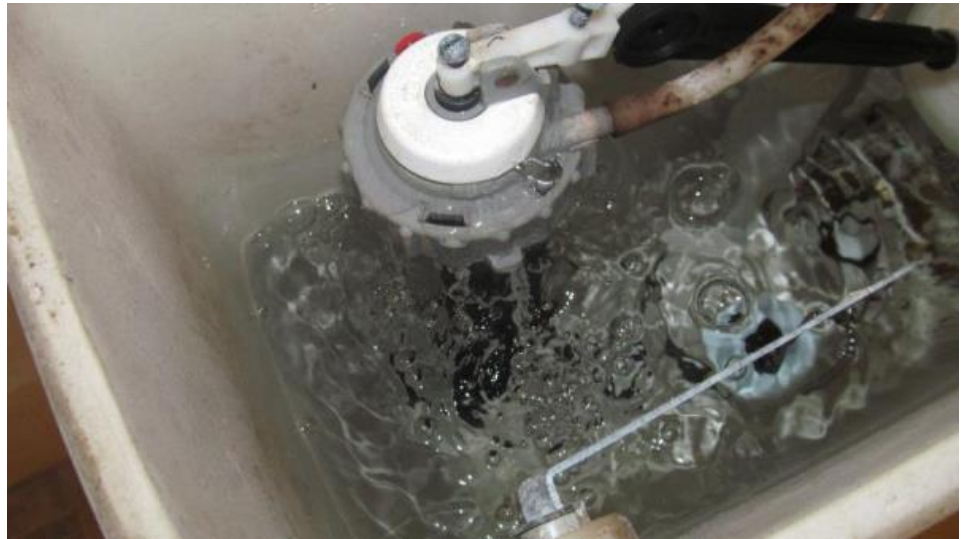
The toilet tank filler device in the tank leaks at the seams. This is a sign of failure and should be replaced now before water leaks out over the lid.

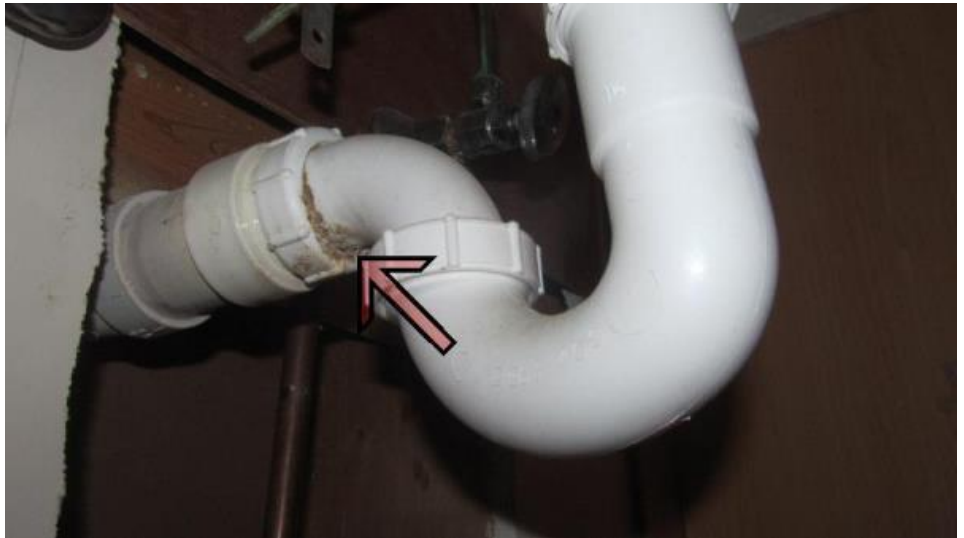
There is evidence of a past leak under the sink. Monitor.

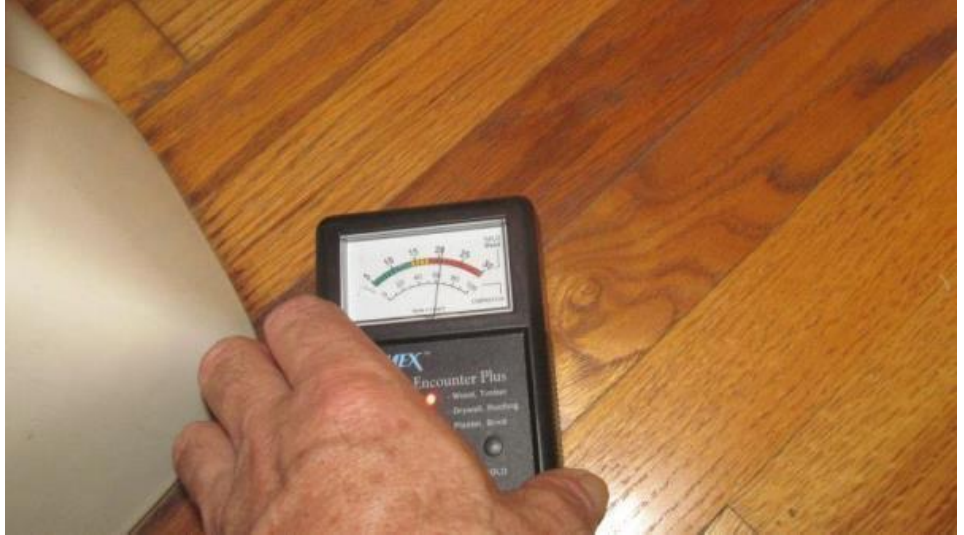
9.56 FLOORING:

Wood floor stained at the toilet. The wood is damaged. Repair the floor. See toilet for more details.

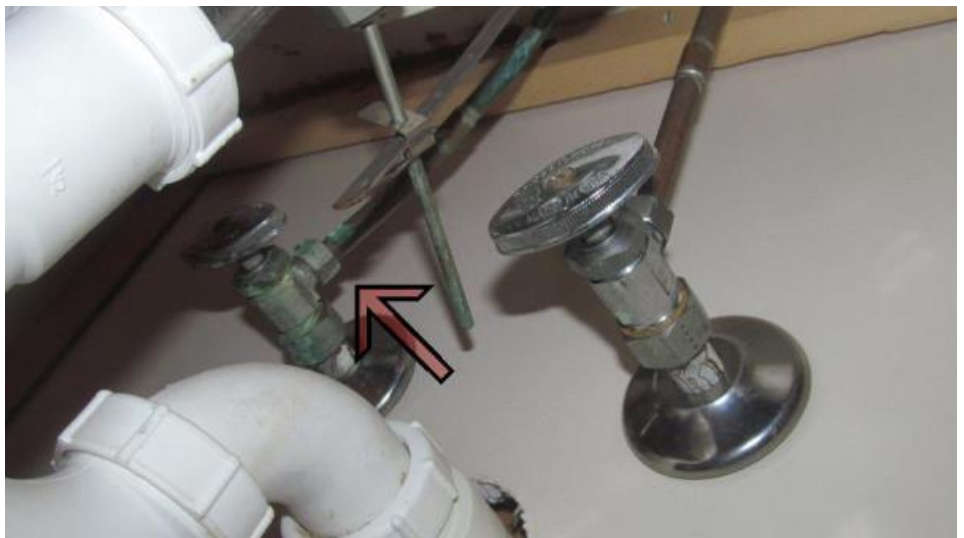
9.65 SINK PLUMBING LEAKS:

There is evidence of a past leak under the sink. Monitor.

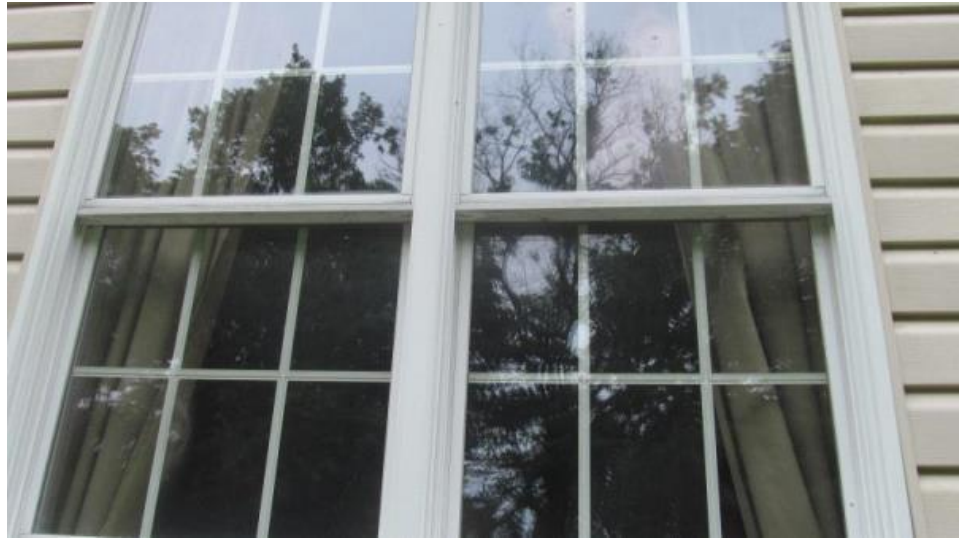
10.1 WINDOWS:

Some emergency exit windows are caulked shut in the bedrooms. This is a safety hazard and should be repaired now. Repair and re-test.

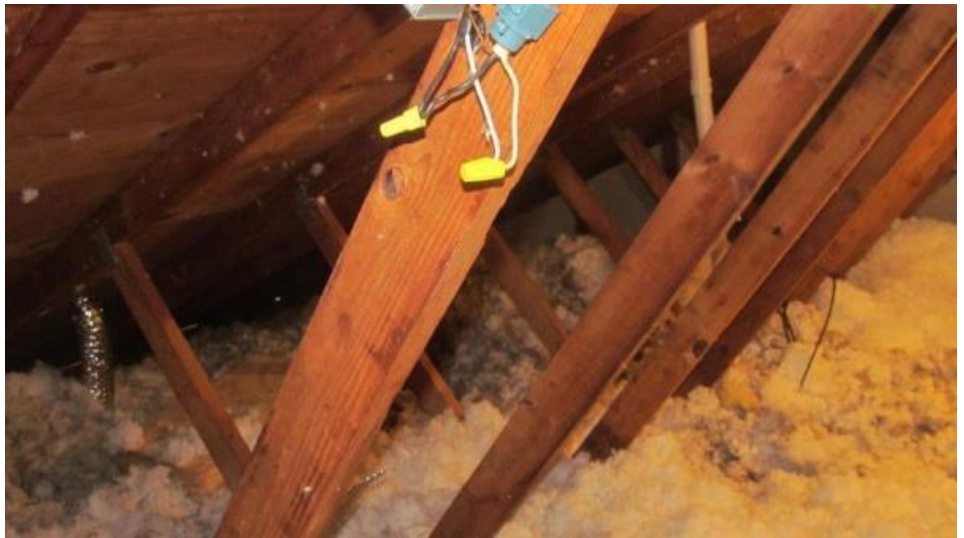
11.10 ATTIC ELECTRICAL:

The electrical junction box does not have a cover and the wires are exposed. This condition may be easily corrected with the installation of an inexpensive cover.

Some of the electrical connections are not properly installed in the safety of the electrical boxes as required. Repair at the attic fan and verify the fan thermostat is working and the fan functions as intended.

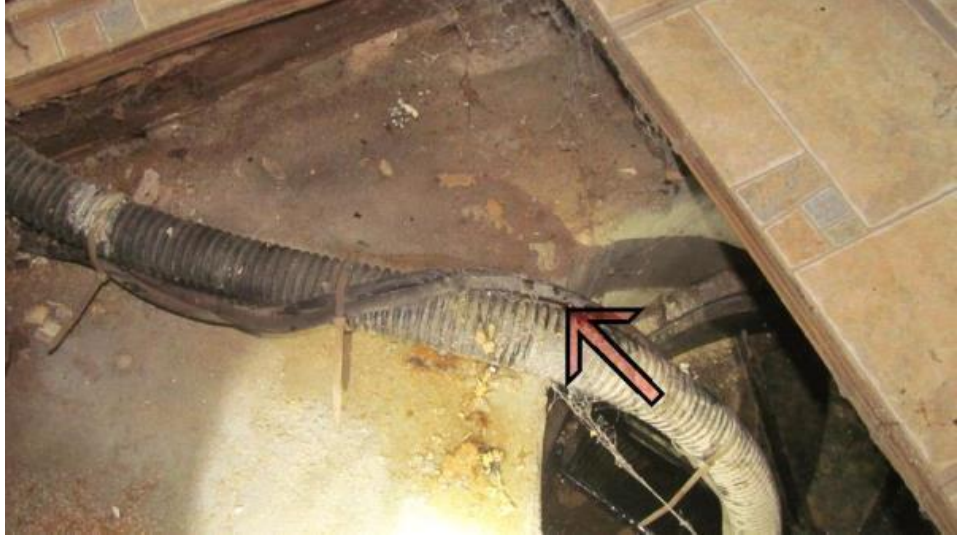
12.15 SUMP PUMP CONDITION:

Sump pump condition: Replace the leaking drain hose and seal the crack to deter mold under the floor.

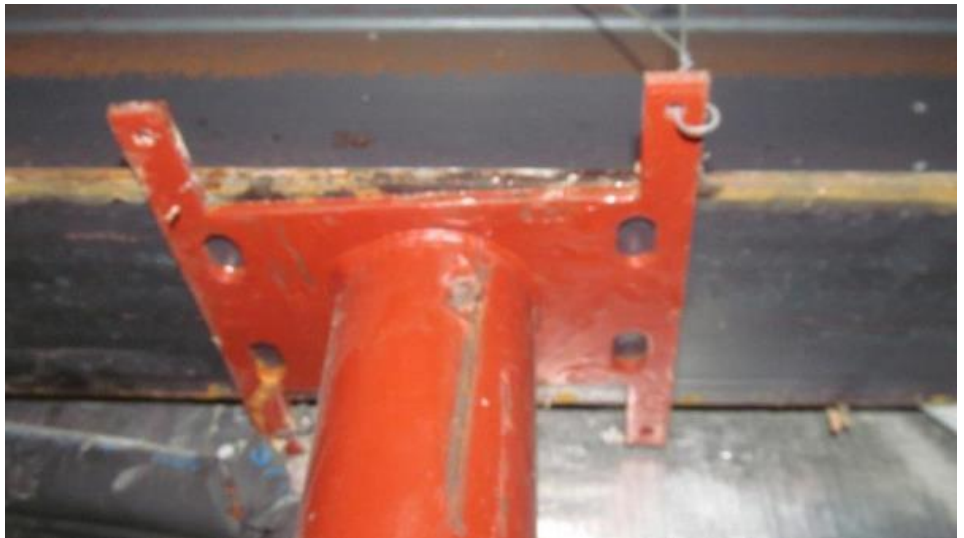
12.16 OTHER BASEMENT
CONDITIONS:

Bolt or weld the support post to the overhead beam.

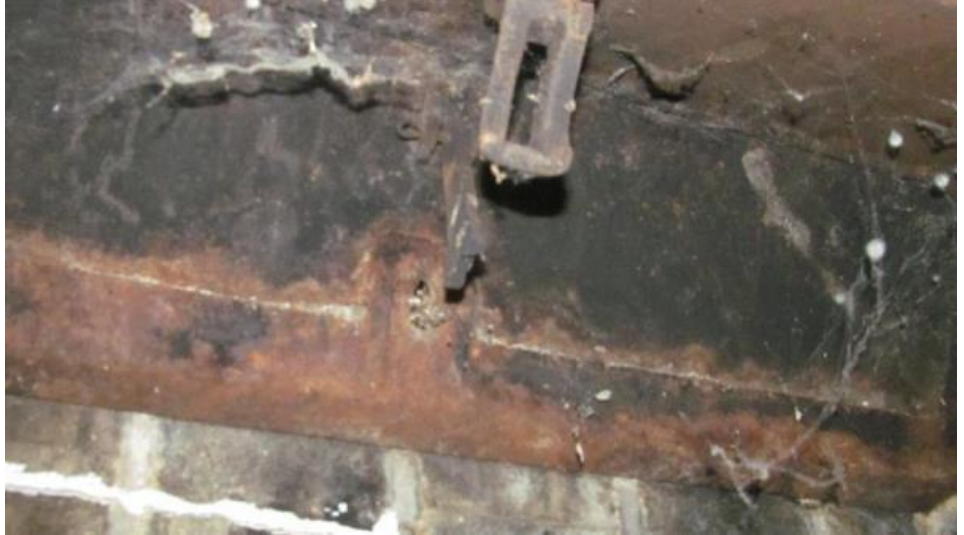
13.20 TYPE OF UNIT:

Standard brick and mortar fireplace. **The handle or damper is broken or not working. Repair needed.**

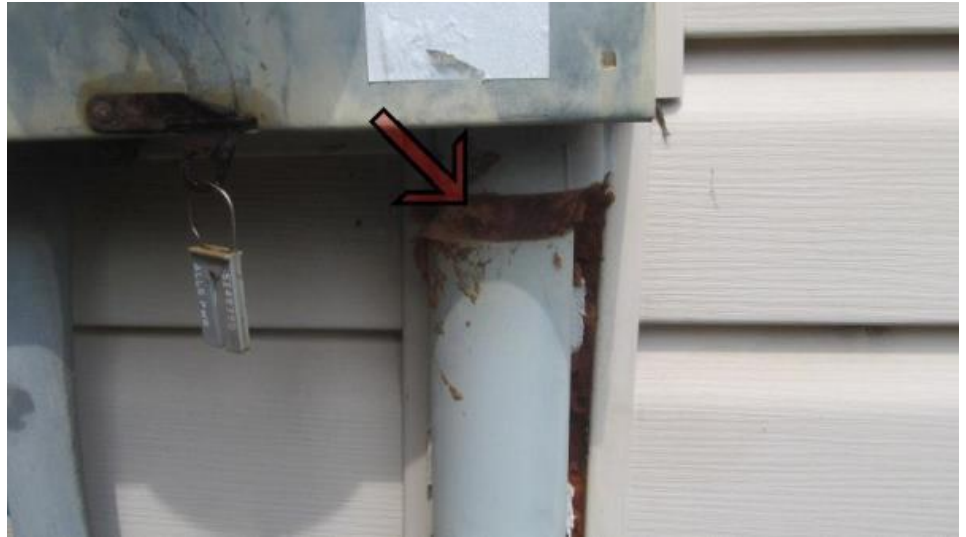
14.1 SERVICE
AREA/CONDITION:

Service Panel Location, There is a gap at the entrance conduit by the meter. The electrical cable is exposed. This is a serious safety hazard that should be corrected. Have the electric company repair the defect.

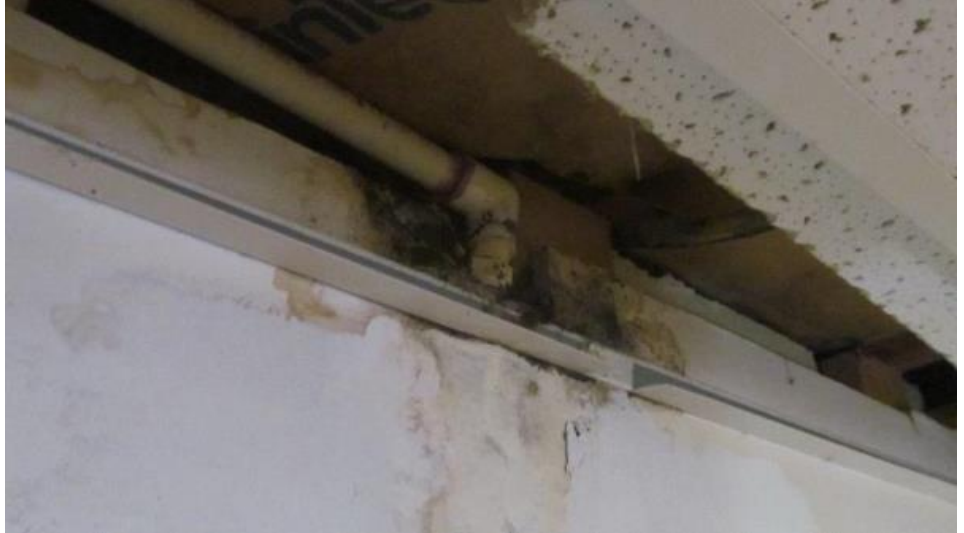
15.9 SUPPLY PIPE LEAKS:

Evidence of supply pipe leaks. Water is leaking from the basement cold water shut off valve for the old washer hook up. Repair the leak and replace the drywall in the cove. it will be moldy on the back side.
