PROPERTY INSPECTION REPORT

**12345 Main Street
Fairfax, VA 22030**

**This Report is the Exclusive Property of:
John & Jane Doe**

Prepared by: My EstatePro Inspector

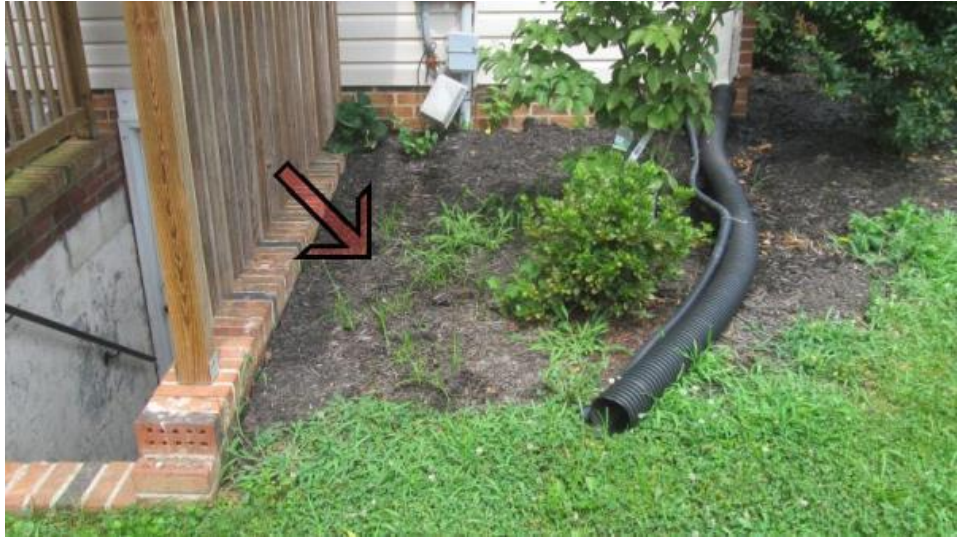
Reverse or Marginal grade noted. Grading should be altered or underground drainage installed in order to lead water away from the foundation. Locations include but may not be limited to: rear front and sides.

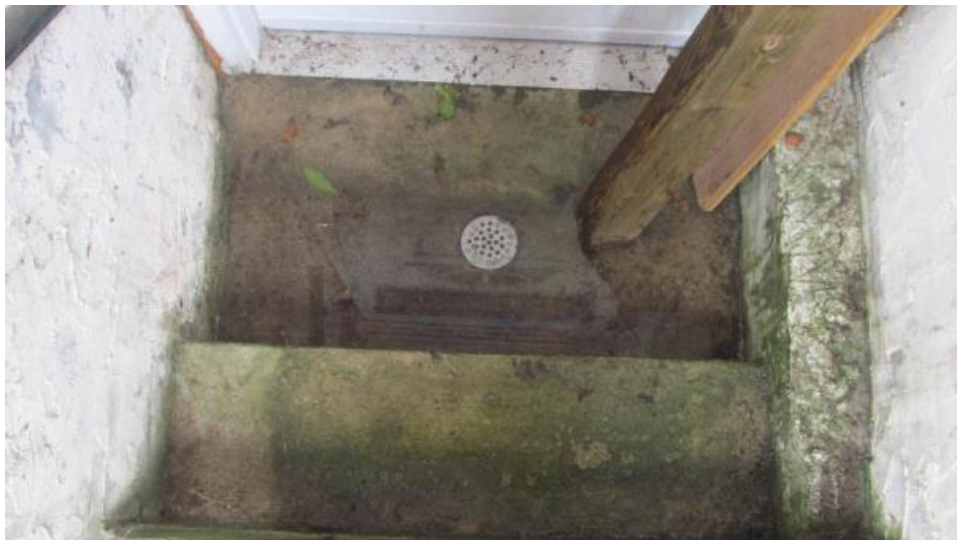
3.5 UNDERGROUND DRAINAGE:

Underground drainage found at A drain is located at the exterior entrance.. The testing of underground drainage systems is beyond the scope of this inspection. Please ask owner about condition and/or perform your own testing before the close of escrow. It is further recommended that any underground drainage system be flushed at least once a year.

The rear stair drain is not draining. Inquire with the seller as to the condition or have the drain repaired. The roof may not protect you from all weather conditions.

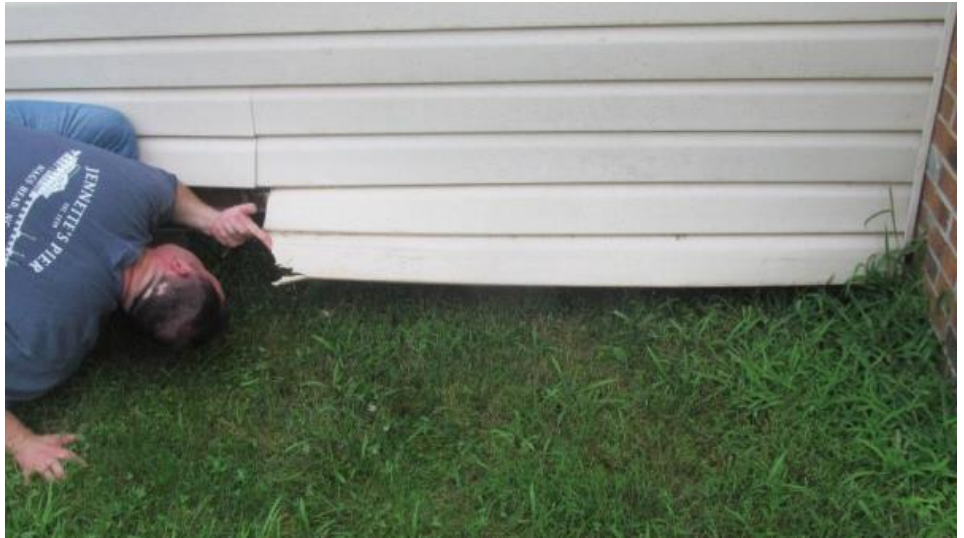
4.2 SIDING CONDITION:

Holes noted in the siding. We recommend sealing any holes or other penetrations in the siding to prevent future moisture intrusion. Locations include: right.

The siding has become loose or detached in one or more areas. This condition can allow moisture to enter the structure. Recommend re-securing and sealing all siding to prevent moisture damage. Locations include right. Hidden damage is not reportable. Remove the lowest siding and add trim at the right by the chimney. Siding should not be this close to the ground and is not attached to the house. This can lead to deterioration and pest infestation.

Some siding has been replaced on the right. Inquire with the seller about the condition. The siding does not match.

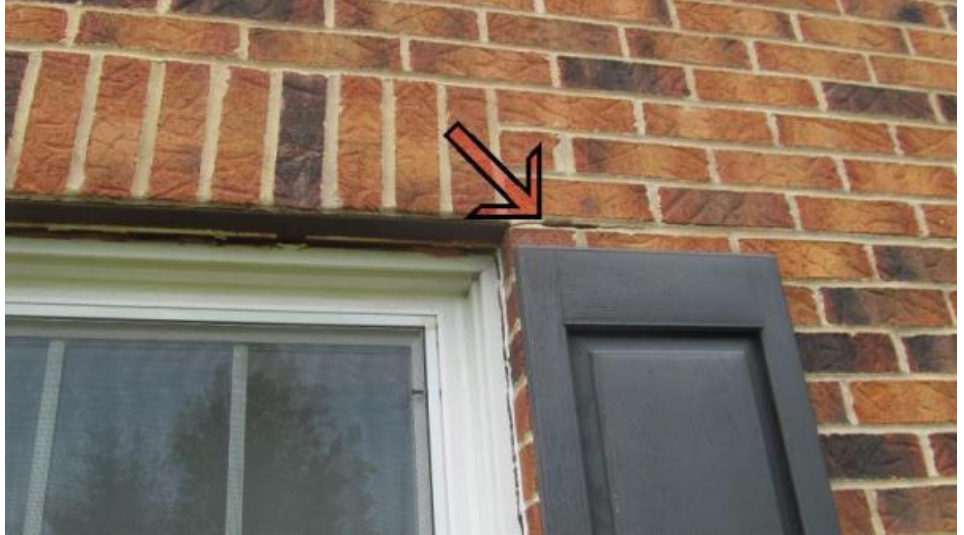
4.3 BRICK CONDITION:

Intact. General condition serviceable. Paint the metal window or garage lintels. Do not caulk above them. This space acts as a natural weep hole for trapped moisture.

Cracking along or around the lintel noted. re-grout with mortar to seal it. Front window.

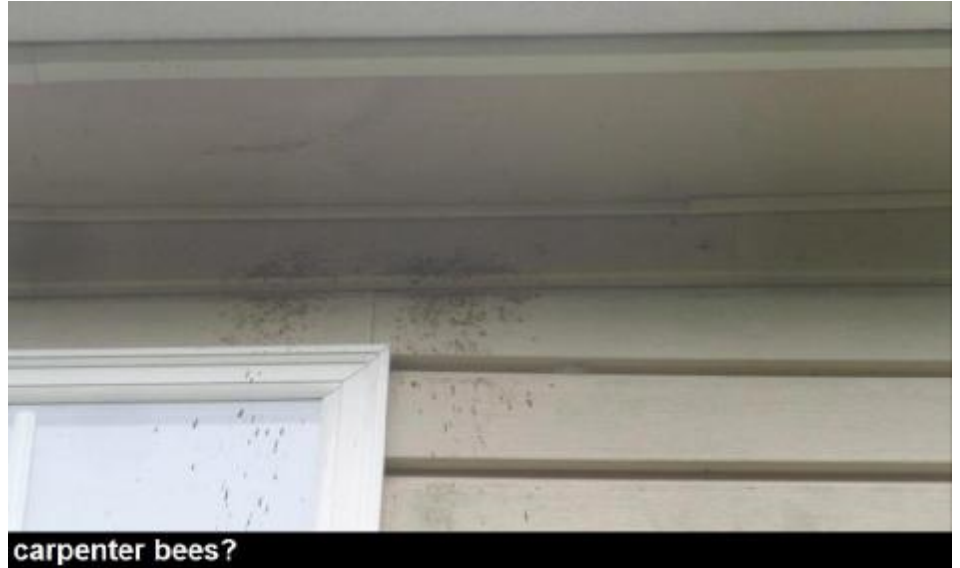
4.4 MOLDINGS & TRIM
CONDITION:

carpenter bees?

Possible carpenter Bee activity noted at: the rear soffit. Not conclusive. Have the Bug professional further review the condition.

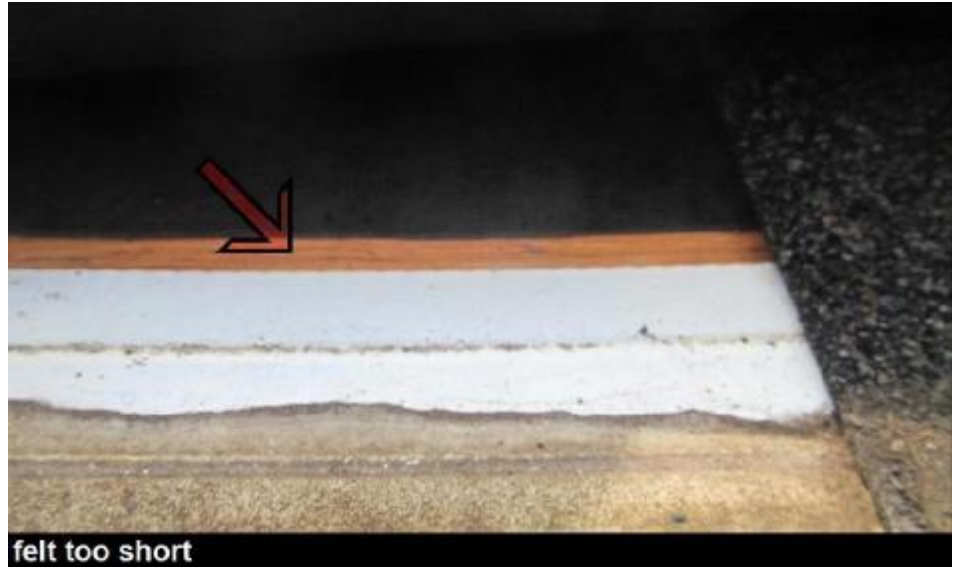
5.1 INSPECTION METHOD:

The drip edge does not fit under the felt and in some areas the felt is too short to go over the edge of the roof sheathing or drip edge. Monitor or repair as needed.

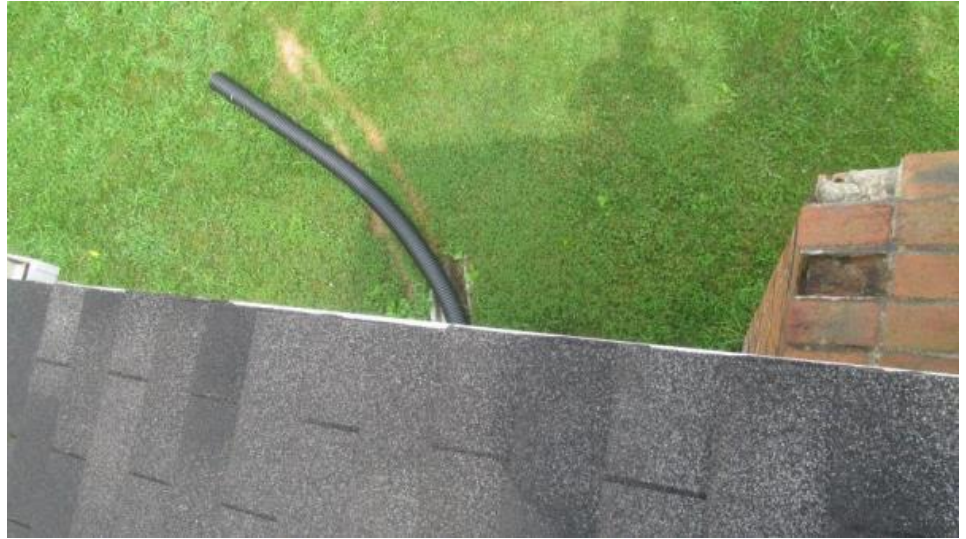
5.9 ROOF COVERING STATUS:

The roof covering does not extend over the gable ends or rake boards at all sides. This will allow water under the roof material and lead to premature deterioration of the wood structure underneath. Possibly the roofing material, metal, wood or vinyl can be secured under the shingles, or new shingle material will be required. We recommend a roofing contractor further review and repair as needed or monitor for water intrusion.

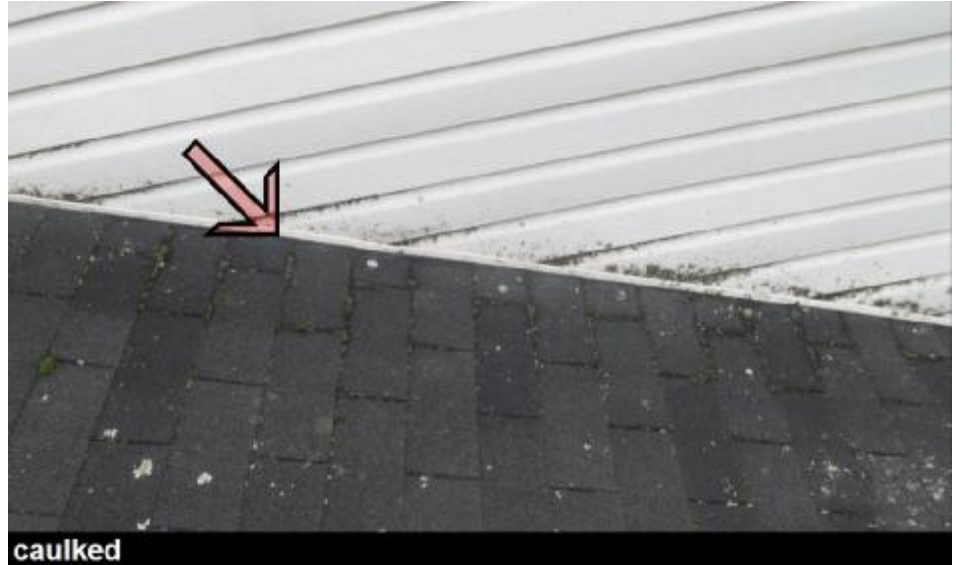
5.13 ROOF METAL/FLASHINGS:

Caulking or sealant is installed along the roof and siding in some areas. If flashed properly you should not need caulk. Inquire with the seller about the need.

Usually a metal flashing is installed where the garage roof attaches to the brick front. Caulk or add flashing to seal the area.

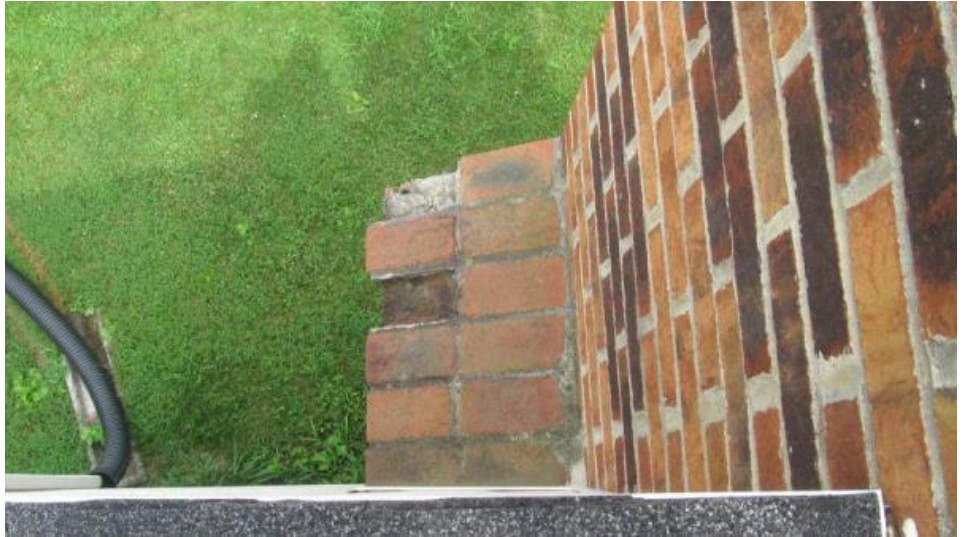
5.18 SPECIFIC CONDITIONS:

Install the missing bricks.

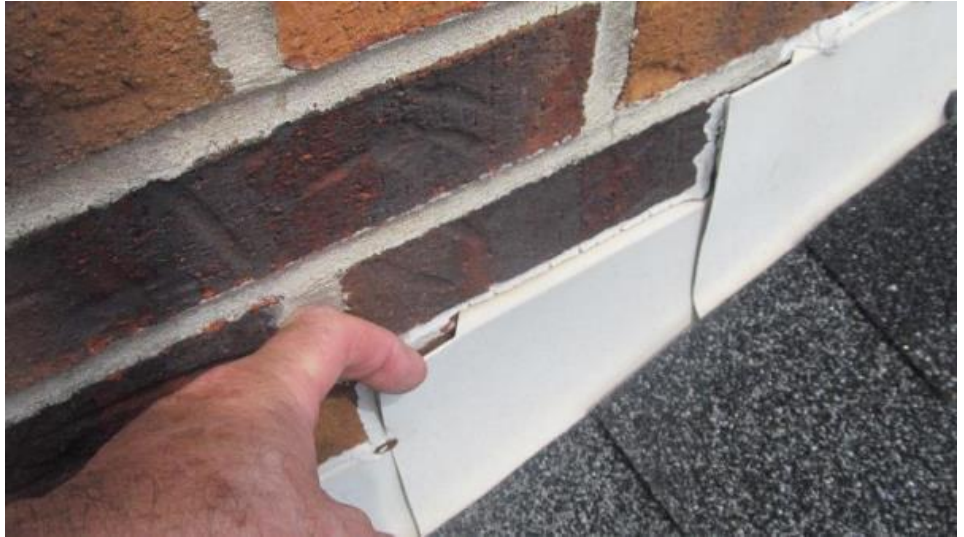
5.23 ROOF JOINT:

The following conditions were noted: **The chimney/roof joint shows deferred maintenance separation cracks. Recommend sealing with the appropriate sealant.**

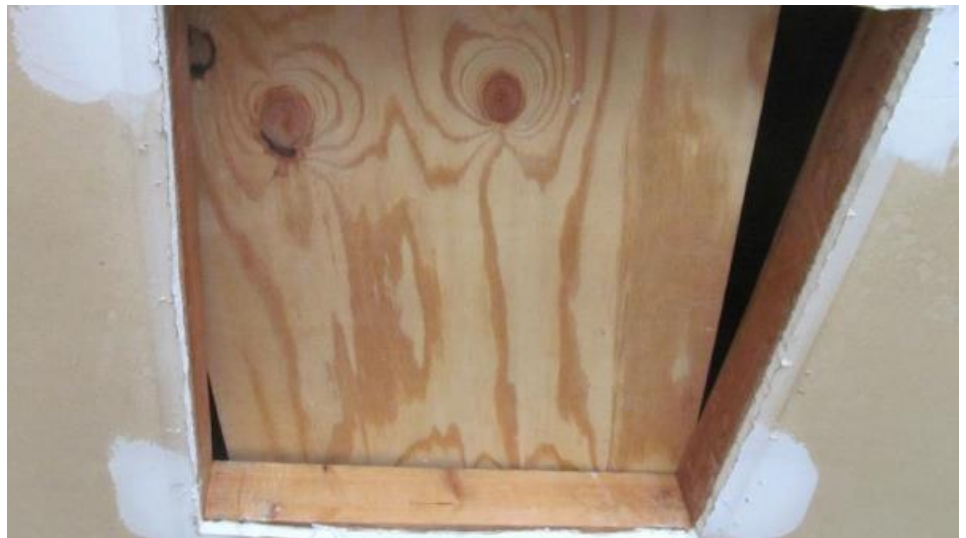
6.5 FIREWALL CONDITION:

The firewall integrity is compromised by, There is a non-fire rated access hatch into the attic.

Drywall seam tape is loose/missing. holes in the sheetrock.

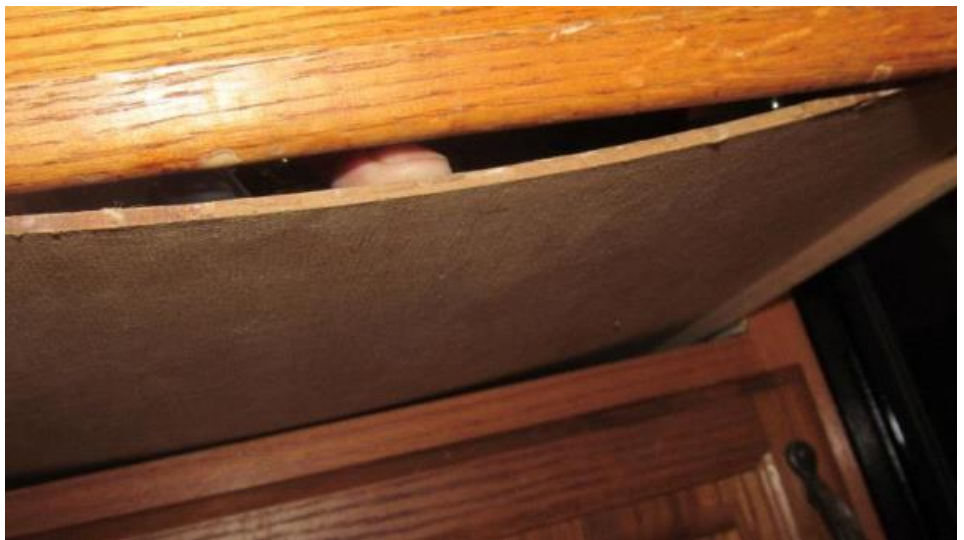
8.5 CABINET HARDWARE:

Serviceable and functional, Some of the door handles are broken or missing.

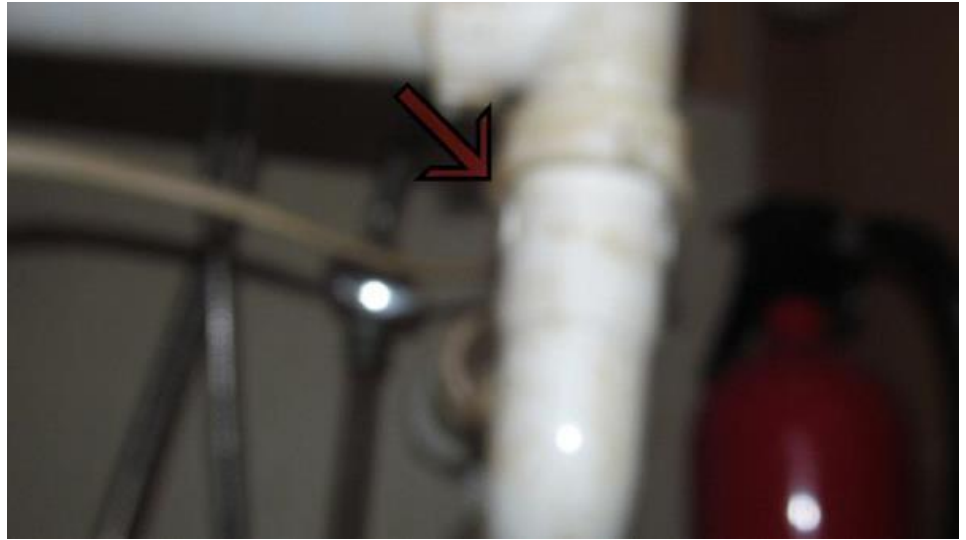
8.10 SINK DRAIN:

The sink drain is currently leaking below the sink. Drip at one of the joints.

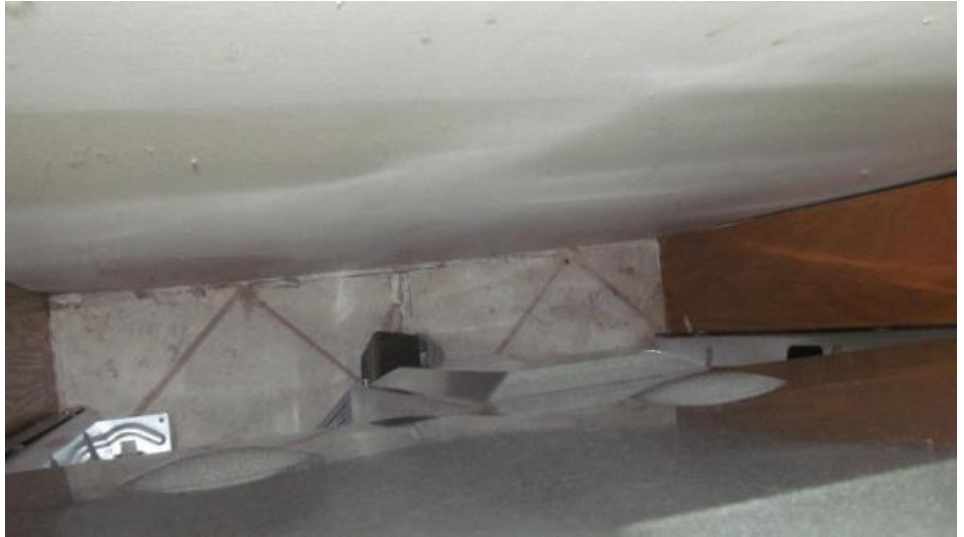
8.13 STOVE (or Cook Top):

Electric, **Properly secure the loose 240 outlet on the floor, or the wall.**

The required anti-tip safety device has not been installed on the freestanding stove. We suggest that this inexpensive device be installed for child safety. Instructions for installing this device were included with the appliance. If not included, these devices are generally available from appliance stores.

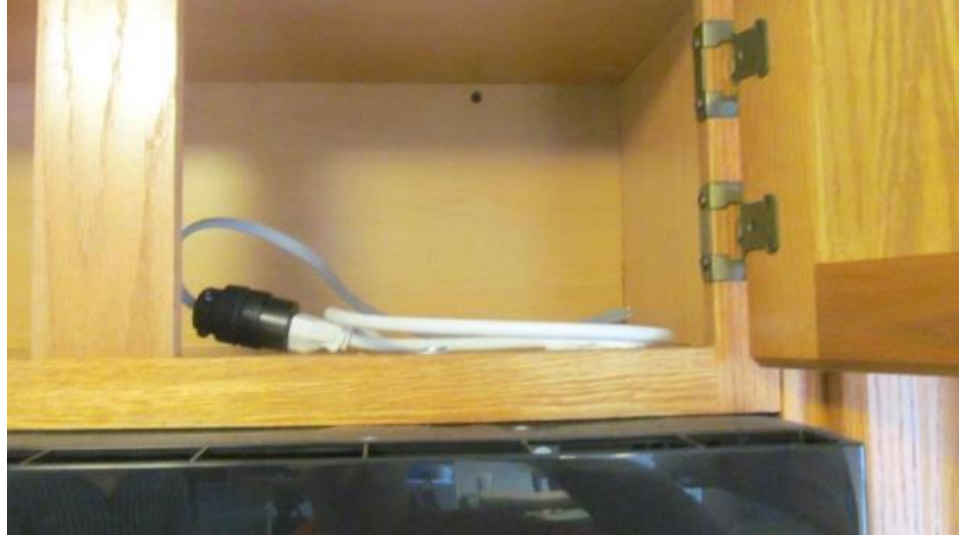
8.15 BUILT-IN MICROWAVE:

Separate circuits required for new installations at or after 2005. The appliance is plugged into an extension cord. Permanent or semi- permanent appliances shall not be powered via extension cords for safety. Run a new outlet for this device.

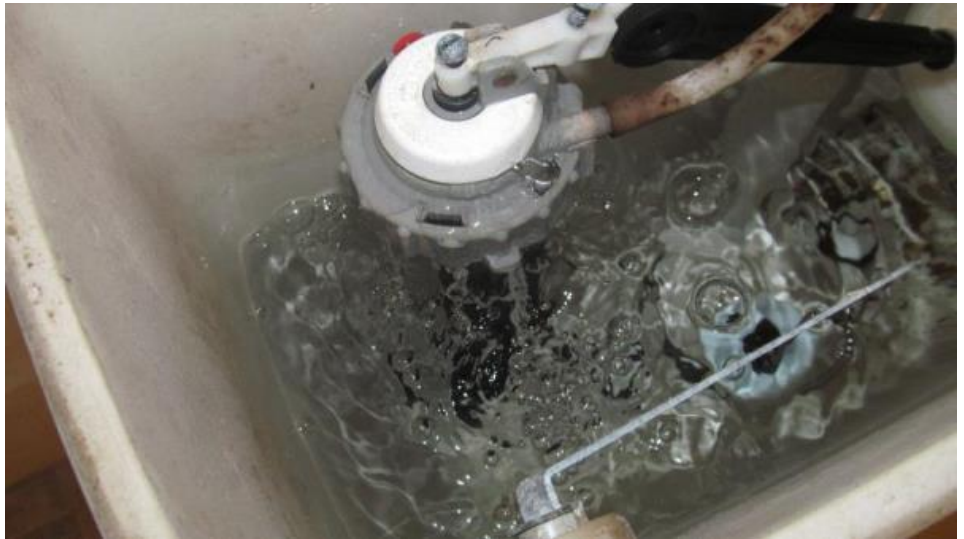
The toilet tank filler device in the tank leaks at the seams. This is a sign of failure and should be replaced now before water leaks out over the lid.

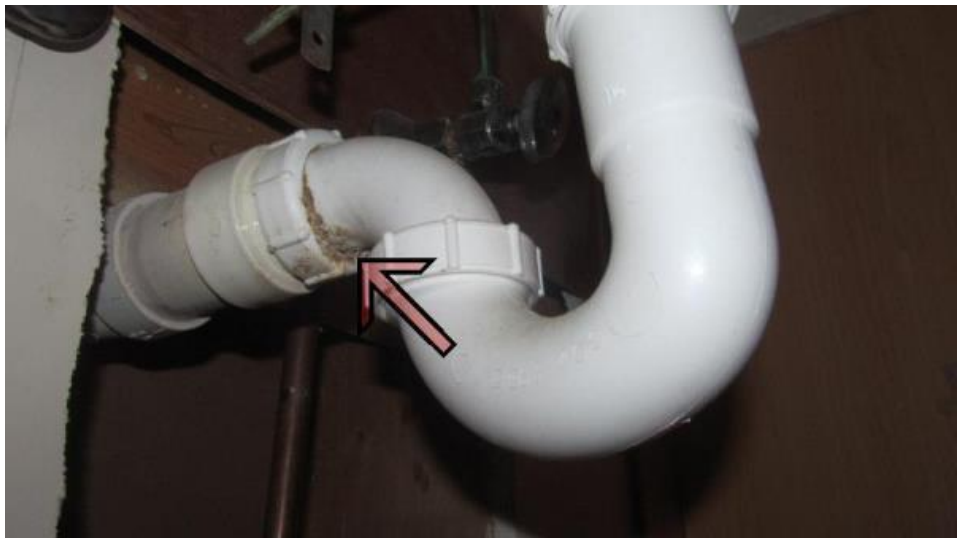
- 9.51 SINK PLUMBING LEAKS:**

There is evidence of a past leak under the sink. Monitor.

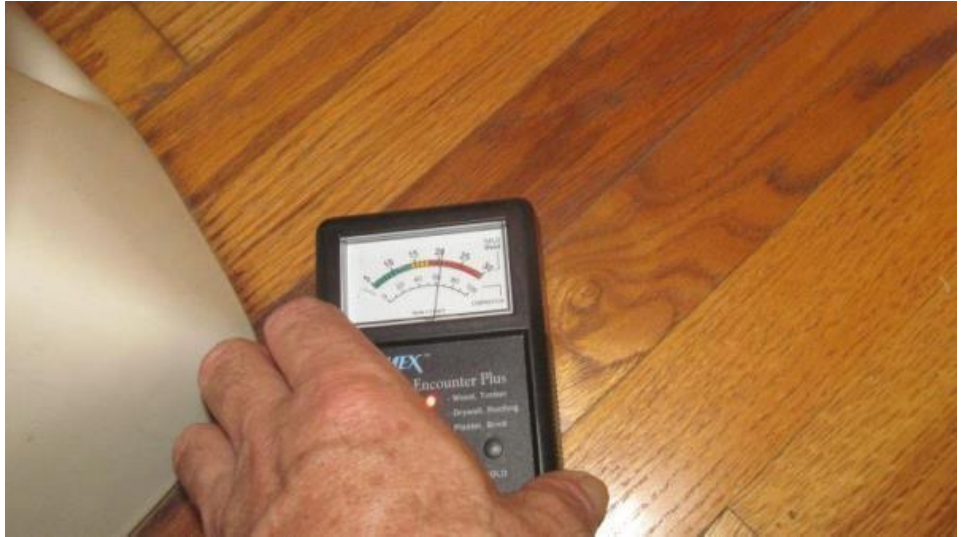
9.56 FLOORING:

Wood floor stained at the toilet. The wood is damaged. Repair the floor. See toilet for more details.

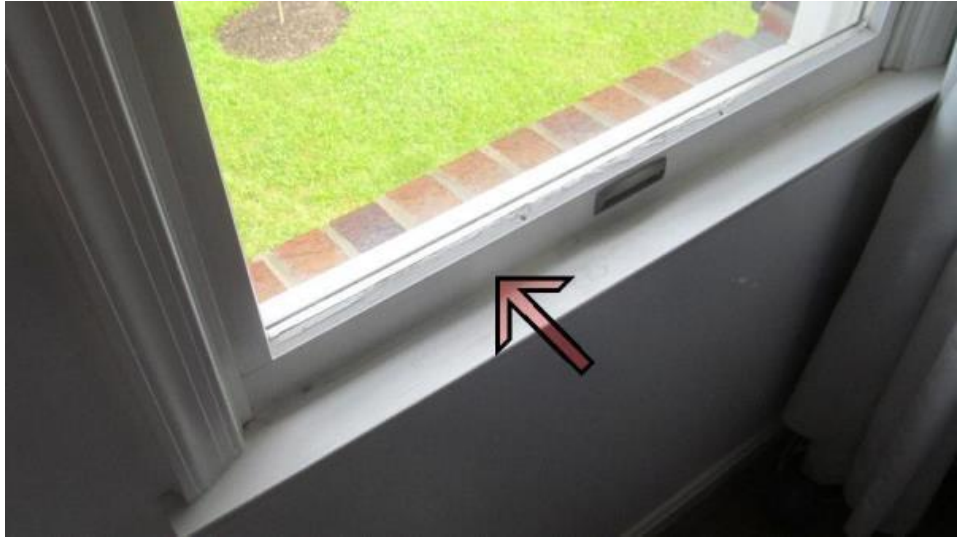
Some emergency exit windows are caulked shut in the bedrooms. This is a safety hazard and should be repaired now. Repair and re-test.

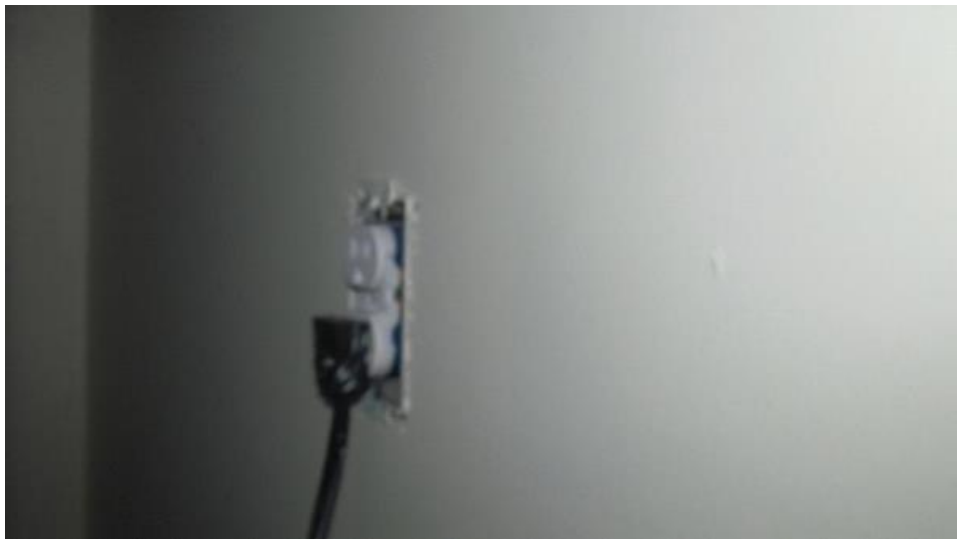
10.4 RECEPTACLES:

Noted missing cover plate. This is a potential safety concern but is easily and inexpensively corrected with a new cover plate. Locations include: Behind the

refrigerator and a couple other locations.

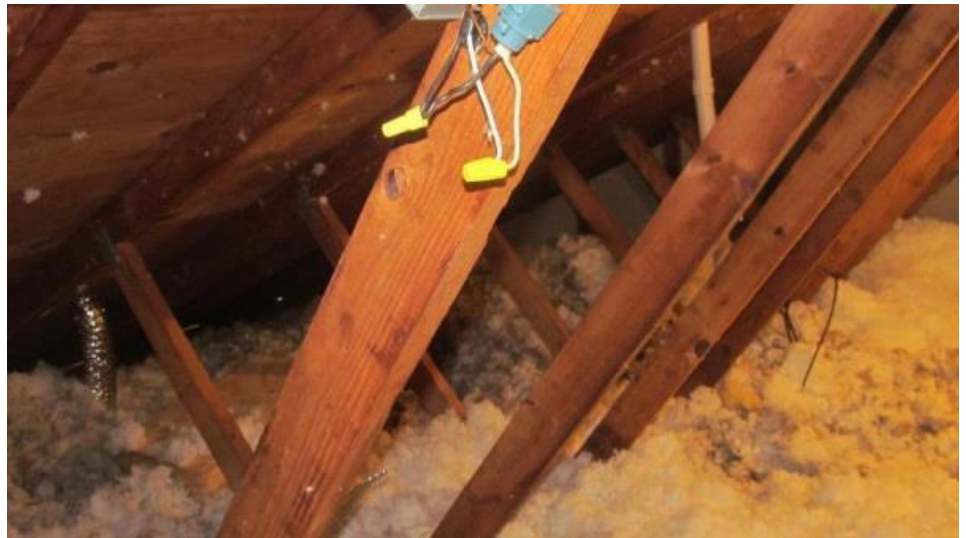
11.10 ATTIC ELECTRICAL:

The electrical junction box does not have a cover and the wires are exposed. This condition may be easily corrected with the installation of an inexpensive cover.

Some of the electrical connections are not properly installed in the safety of the electrical boxes as required. Repair at the attic fan and verify the fan thermostat is working and the fan functions as intended.

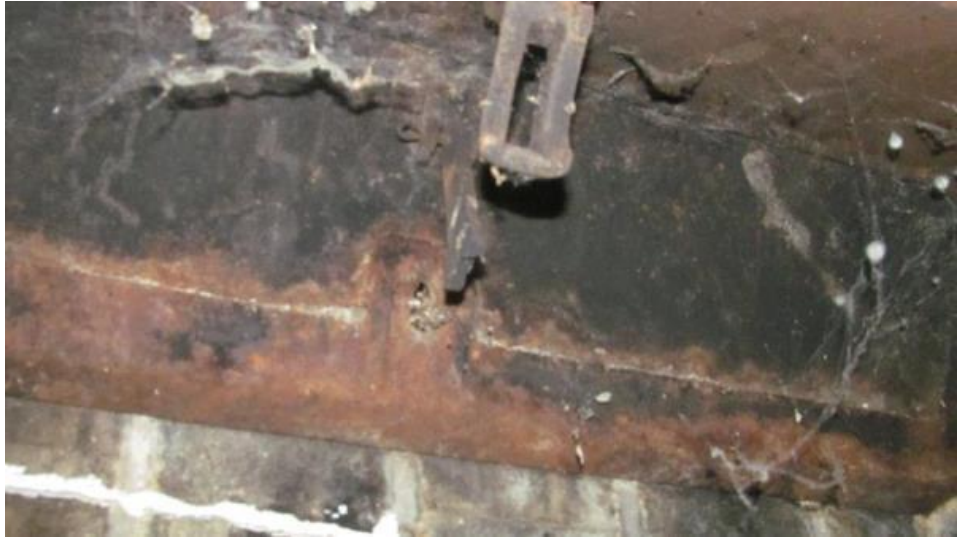
13.20 TYPE OF UNIT:

Standard brick and mortar fireplace. **The handle or damper is broken or not working. Repair needed.**

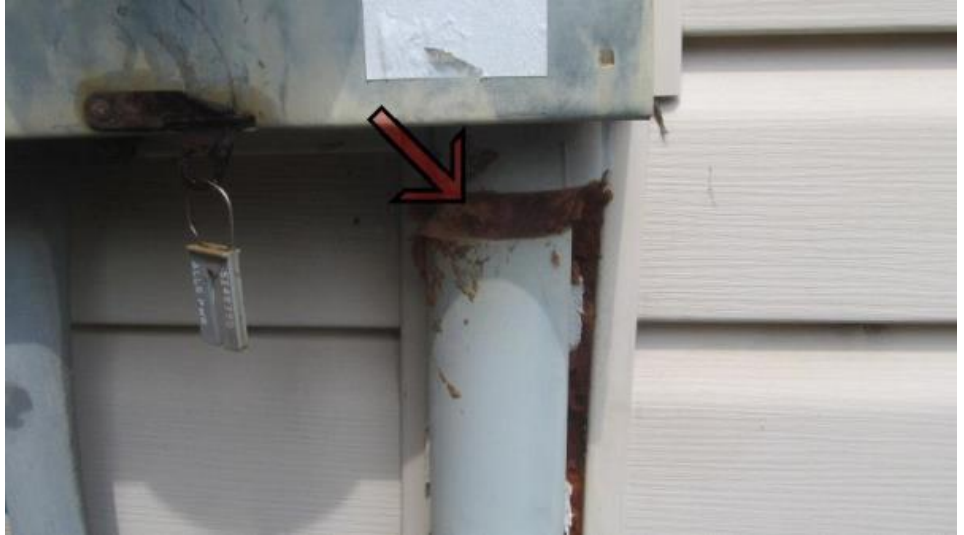
14.1 SERVICE
AREA/CONDITION:

Service Panel Location, There is a gap at the entrance conduit by the meter. The electrical cable is exposed. This is a serious safety hazard that should be corrected. Have the electric company repair the defect.

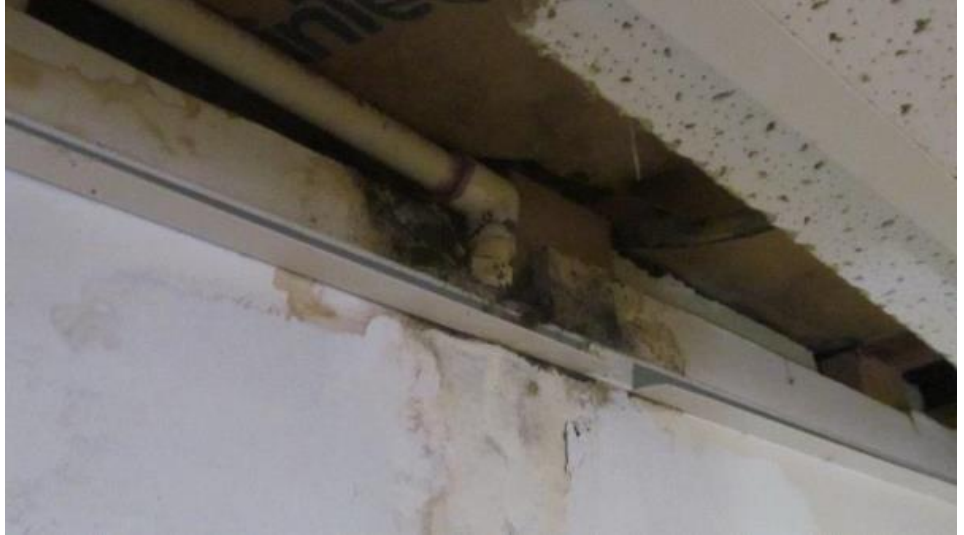
15.9 SUPPLY PIPE LEAKS:

Evidence of supply pipe leaks. Water is leaking from the basement cold water shut off valve for the old washer hook up. Repair the leak and replace the drywall in the cove. it will be moldy on the back side.
