-- PRINDLE LAKE DAM --

PHASE I

INSPECTION / EVALUATION REPORT

Date of Inspection: JUNE 6, 2008

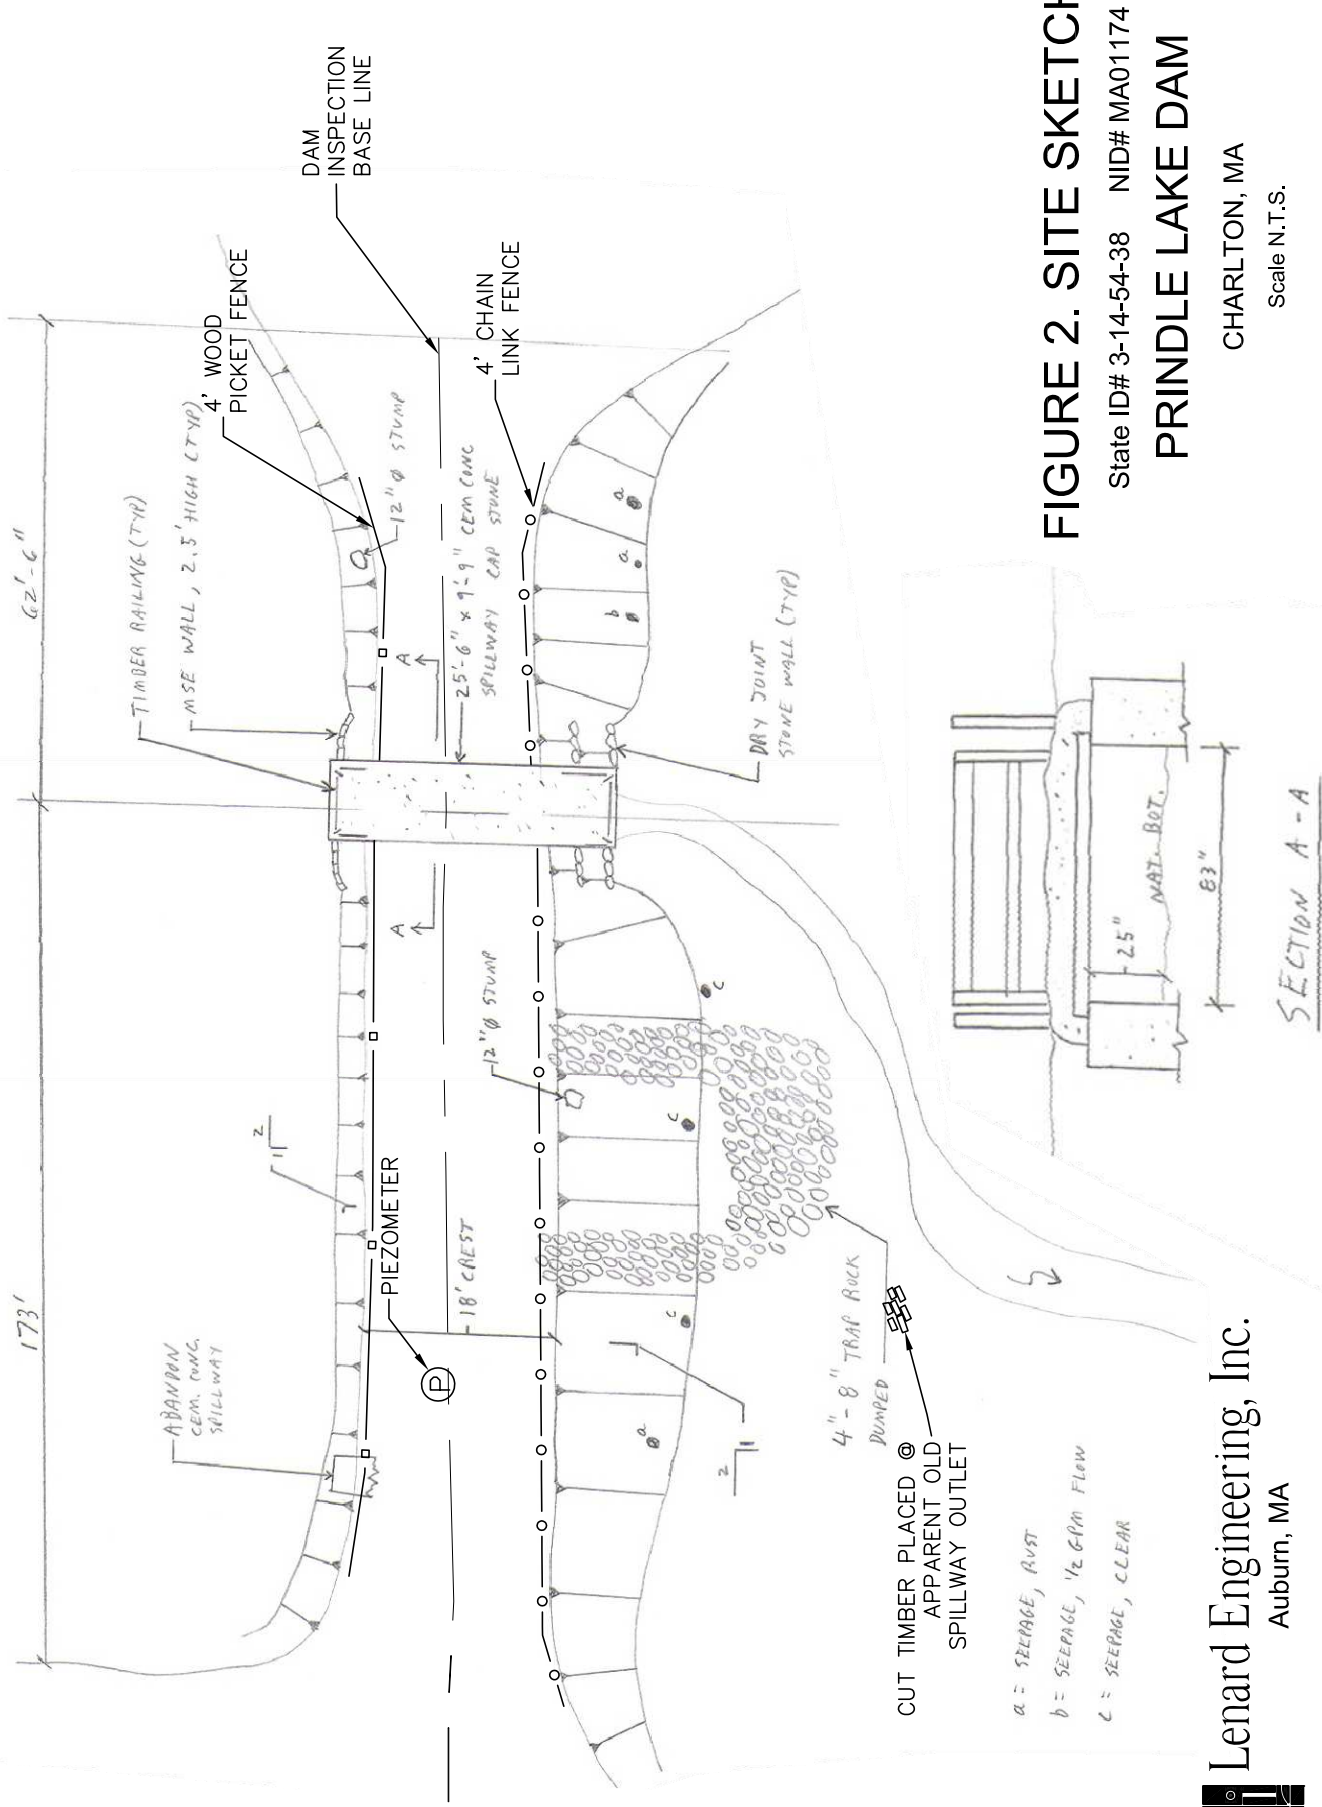
FIGURE 2. SITE SKETCH

CUT TIMBER PLACED @ APPARENT OLD SPILLWAY OUTLET

- a = SEEPAGE, ROUST
- b = SEEPAGE, 1/2 GPM FLOW
- c = SEEPAGE, CLEAR

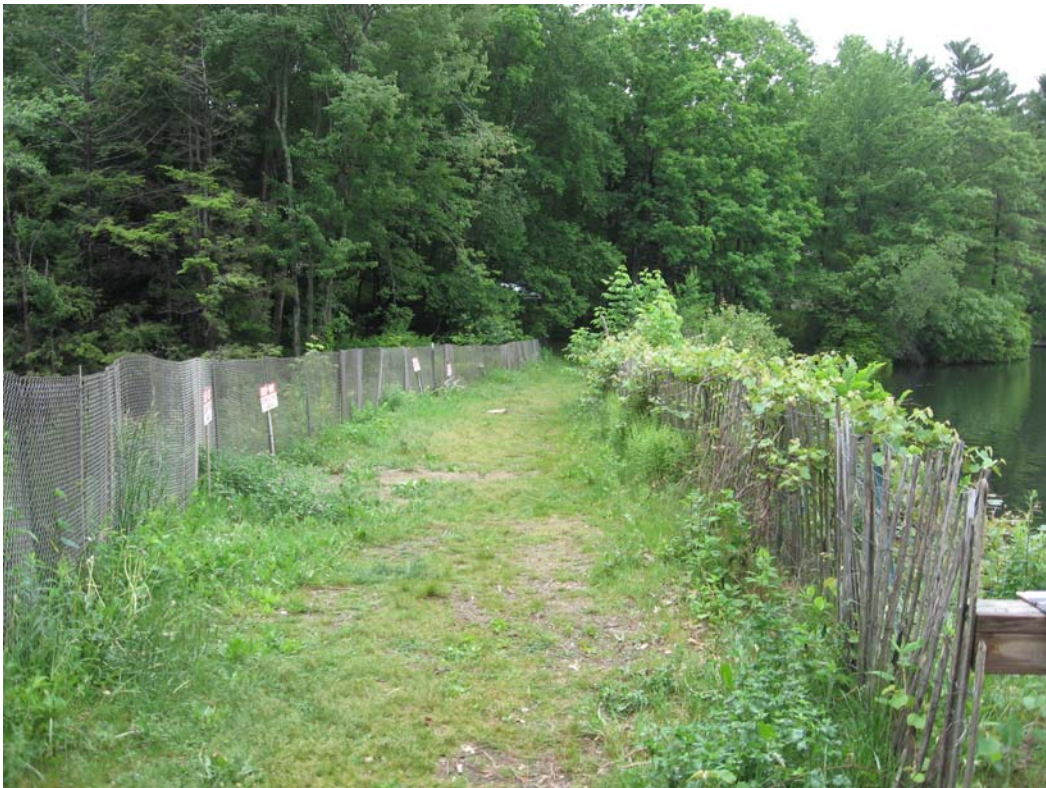
The upstream face is covered with broad leaf vegetation, which made observation difficult (Photo 002). The face is possibly covered with earth and riprap. Some brushy vegetation was observed on the right side with a 12" tree stump located on the left side.

Photo 002. Standing on spillway looking right along crest

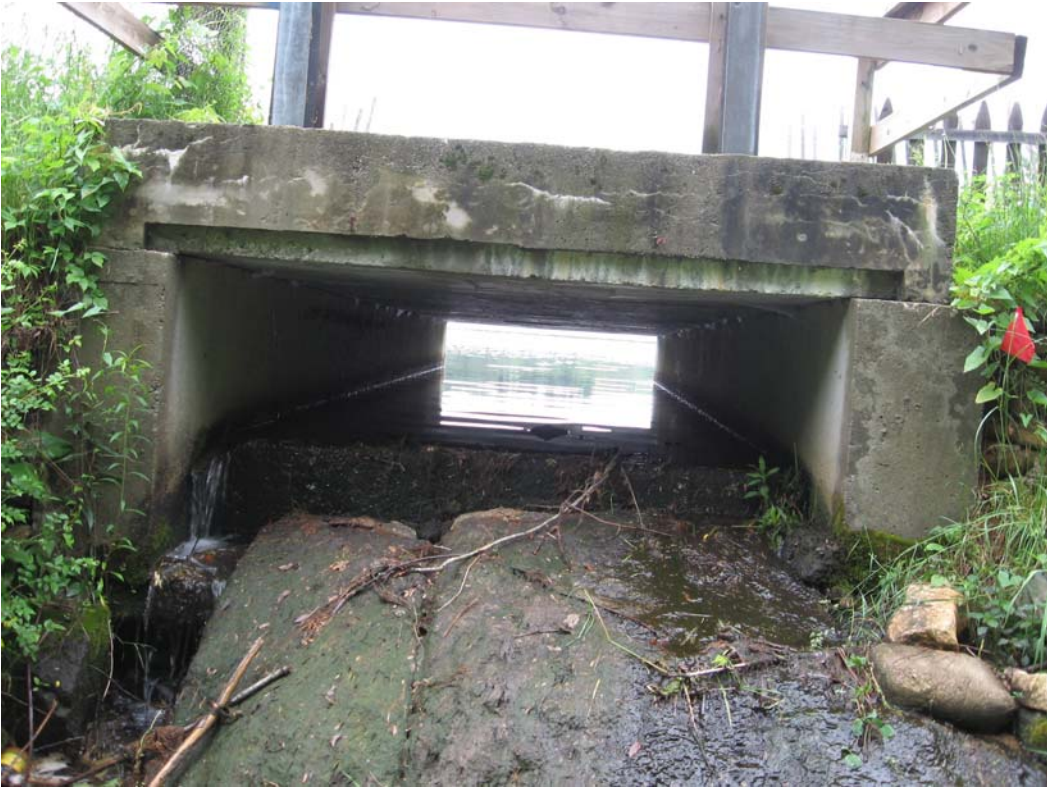
The primary spillway, which is the only defined dam discharge, consists of a cast in place concrete slab supported on 16" wide cast-in-place concrete abutments (Photo 003). The top of the slab is spalled and the condition of the inside of the culvert is satisfactory. No trash rack was observed. However, the culvert appeared to be clear of debris.

Photo 003. Spillway downstream opening

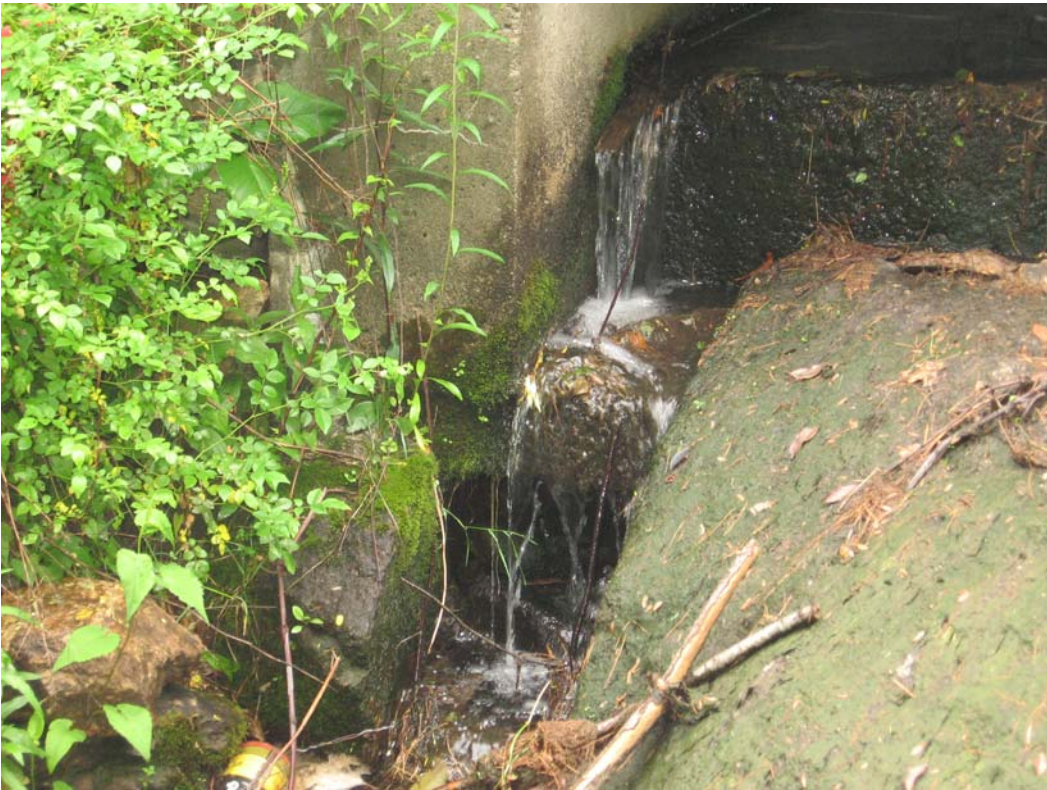
Photo 004. Spillway outlet undermining

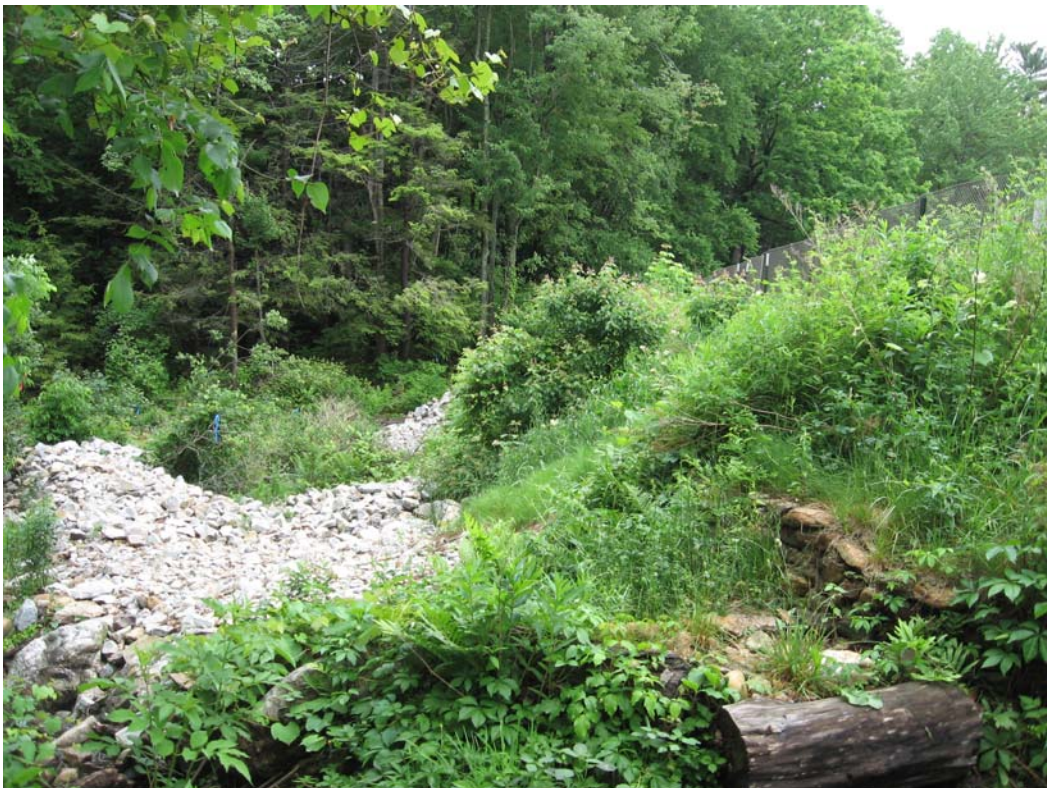
The downstream face is partially covered by broad leaf vegetation (Photos 006 and 010), which made observation difficult. Riprap has been dumped on two areas of the face to the right of the spillway (Photo 010). Some seepage was observed through the riprap on the face. A 12" stump had been left in place to

the right of the spillway. The condition of the earth underneath the riprap was not possible to assess.

Photo 006. Downstream face looking right

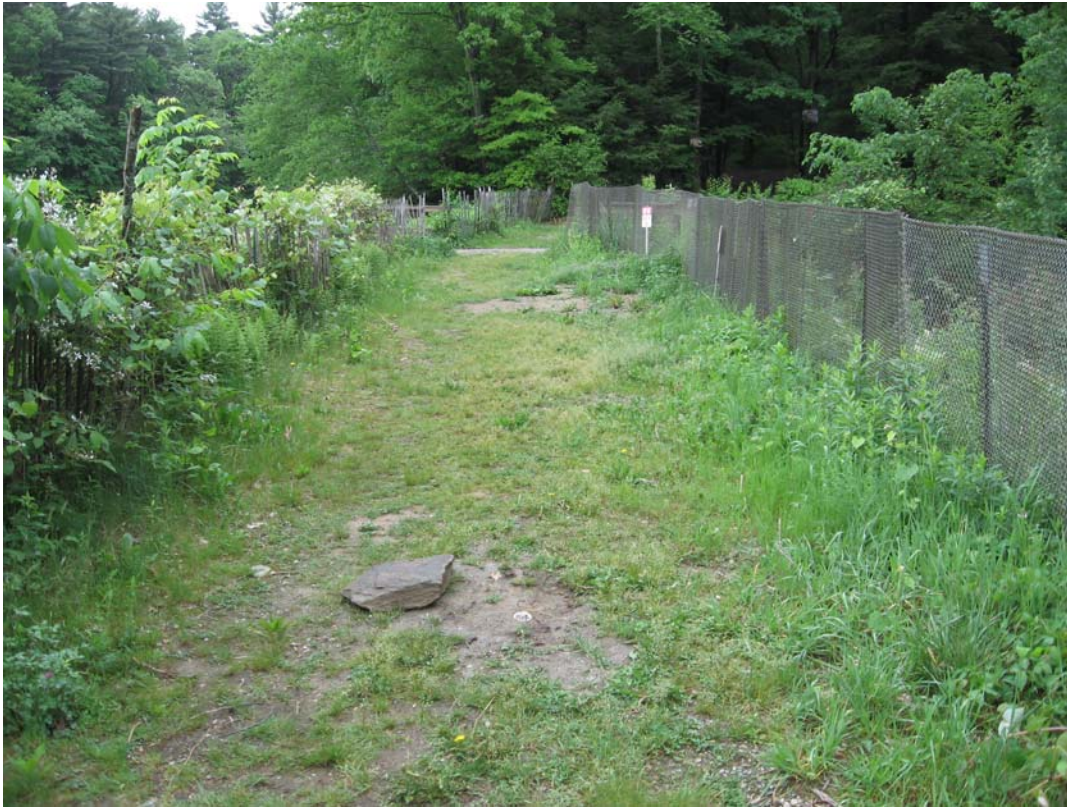
Photo 007. Crest looking right with piezometer location identified by stone

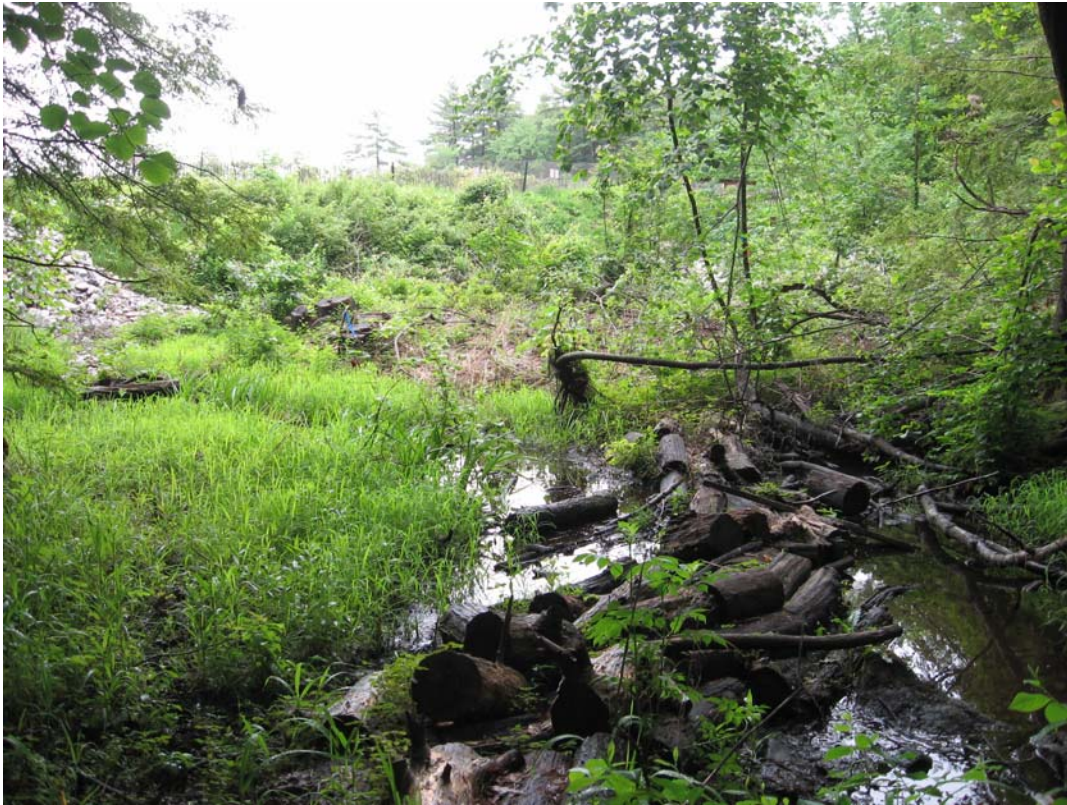
Photo 009. Cut timber placement at apparent old spillway outlet

- 1) Clear and grub the dam and areas within 25 feet of the abutments and downstream toe. Regrade and install slope protection for upstream and downstream slopes.
- 2) Remove apparent abandon spillway and reconstruct that portion of the dam.
- 3) Repair cracked or deteriorated concrete and grout, as necessary, on the spillway and outlet channel.
- 4) Construct a defined waterway (minimum 50 feet downstream of toe) to safely convey discharge away from the toe of the dam. Regrade the immediate downstream area so that the channel under the existing spillway is utilized and the old channel becomes abandoned.
- 5) Install toe drains along the downstream face.
- 6) In-situ compact the dam core material.
- 7) Construct an emergency spillway and a low level outlet.

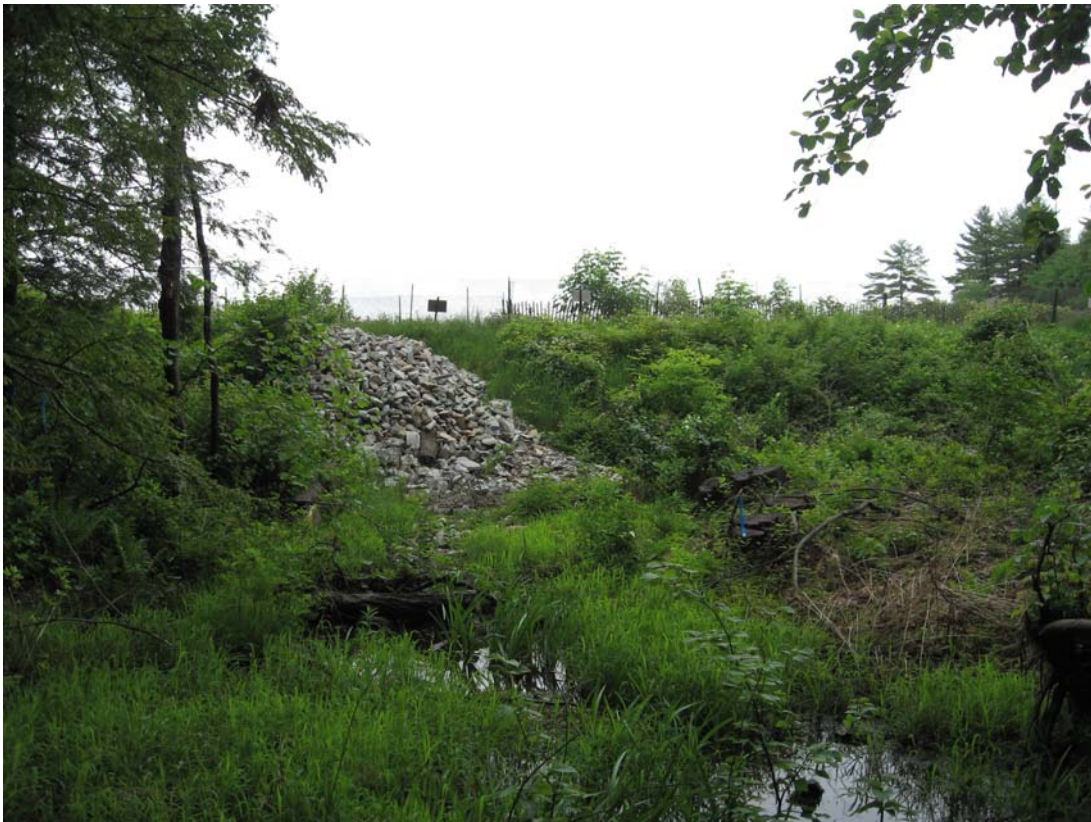
Photo 010. Downstream face with apparent out spillway outlet left of center

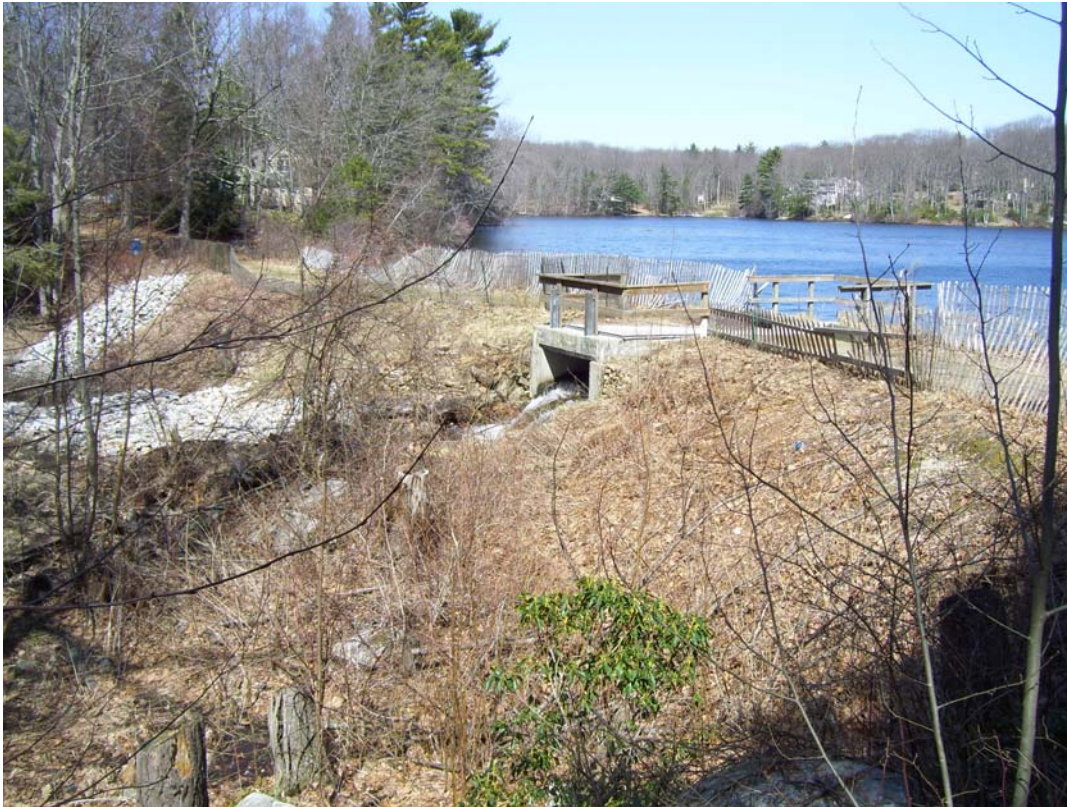
The referenced safety inspection from April 2008 depicts a downstream face condition without broad leaf vegetation (Photo 011-R). This report also depicts an active flow from the apparent abandon spillway (Photo 012-R).

Photo 011-R. Downstream face from April 2008 Inspection

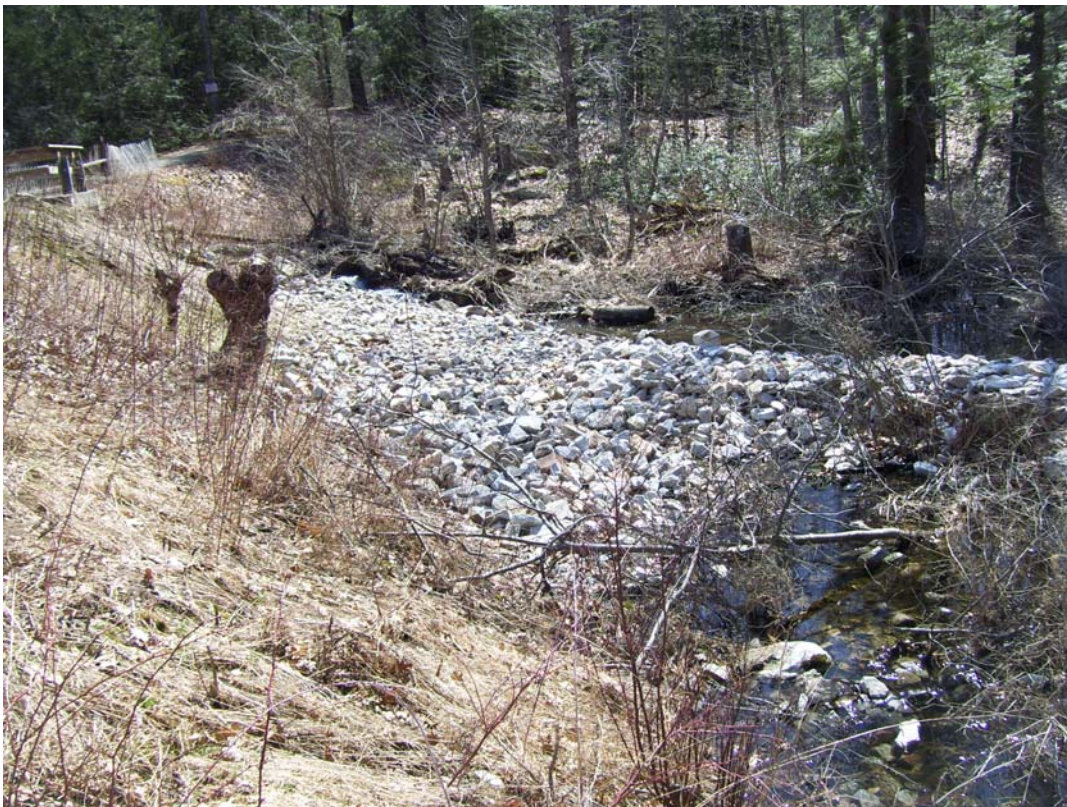
Remnants of an apparent abandon spillway inlet were located 105 ft to the right of the existing spillway on the upstream face. The outlet of the apparent abandon spillway was not observed. However, the old channel was observed on the downstream side of the dam.

Photo 012-R. Apparent abandon spillway seep from April 2008 Inspection (active spillway in left background)
