PROPERTY INSPECTION REPORT

Concerning: 1234 Street Dallas, TX 75219
(Address or Other Identification of Inspected Property)

By: Michael Craycraft TREC License #21088 09/21/2014
(Name and License Number of Inspector) (Date)

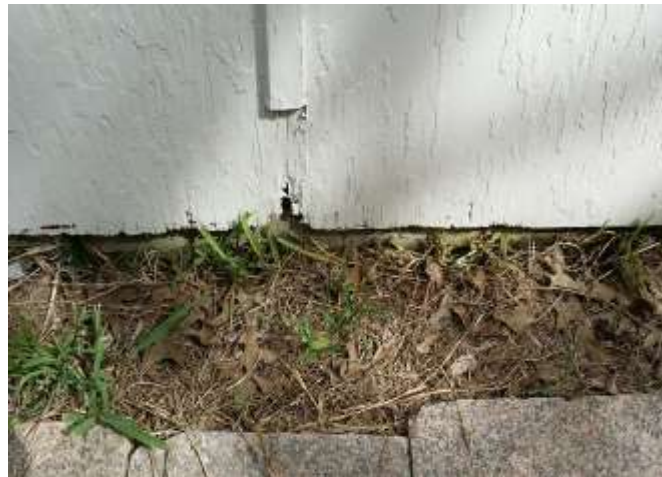
D – There is an area of honeycombing present at the foundation wall. This area should be monitored.

- D – There were areas of insufficient exposure of the foundation wall.
- D – The grade was basically flat with a negative slope and high soil in some areas. There should be a minimum of six inches of exposed foundation edge and a positive slope away from the building on ALL sides.
- D – All surface runoff water should empty to the street and / or alleyway as is practical. There should be a positive slope away from the building on ALL sides.

No gutters on the home at the time of inspection.

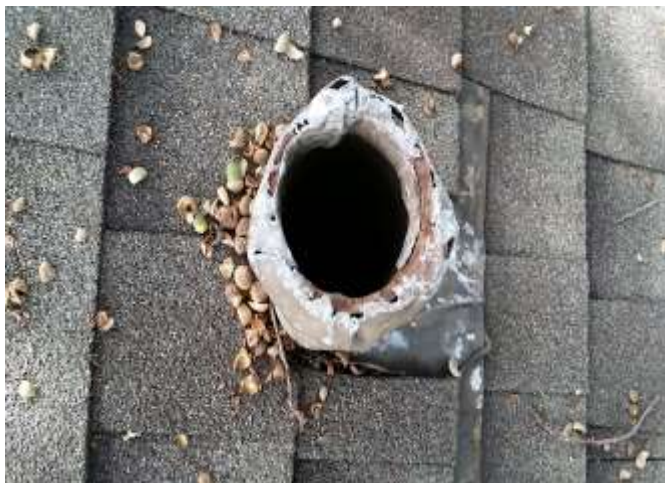
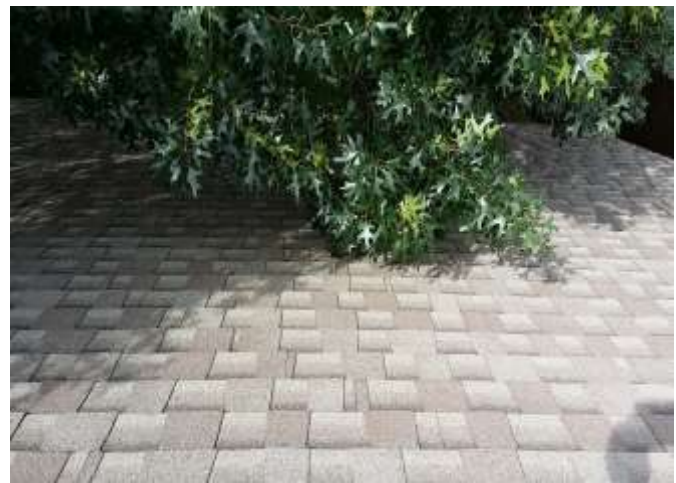
- D – The vent boot seals area damaged and separating.
- D – Exposed fasteners. Fasteners should be sealed to prevent water penetration.
- D – There were areas of uplifted shingle corners at the roof covering. There were unsealed shingles present. Possible wind damage.
- D - Roof rain water falls directly onto the A/C compressor. This will damaged the unit and void any warranty that may exist on the unit. Diverter flashing or gutters should be installed in this area.

There were tree trunks and tree limbs in close proximity to and touching the roof line. Trees should be trimmed to a minimum of 3feet away from the roof. If you have any concerns about the roof covering life expectancy, insurability or the potential for future problems, a roofing specialist should be consulted.

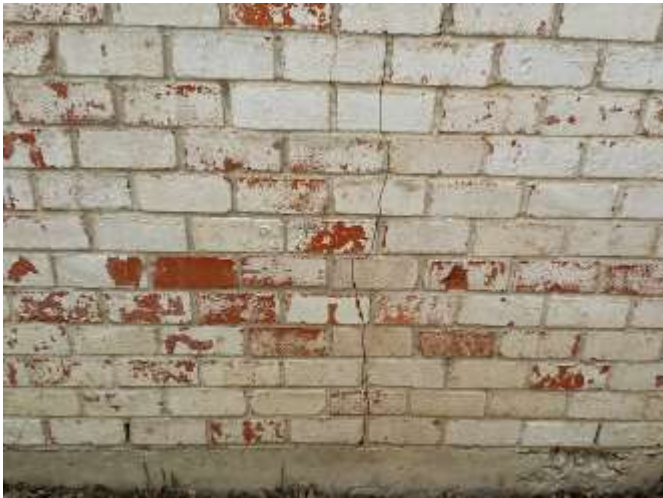
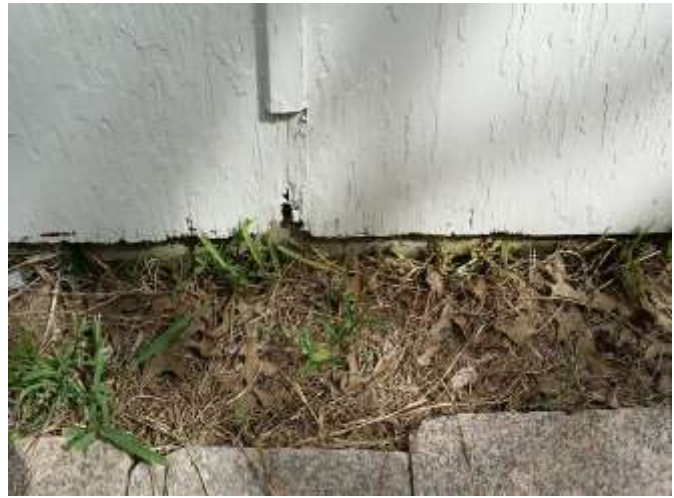
D – There were brick cracks noted at the time of inspection.
 D – There were areas of brick and mortar separation at the exterior walls.
 D - Exposed fasteners were present. Fasteners should be sealed to prevent water penetration.

- D – There were areas of damaged siding.
- D – There was a trim piece in contact with the roof covering.
- D – There was siding installed with insufficient clearance to grade.

There were bushes and shrubs blocking visibility of the exterior wall in areas.

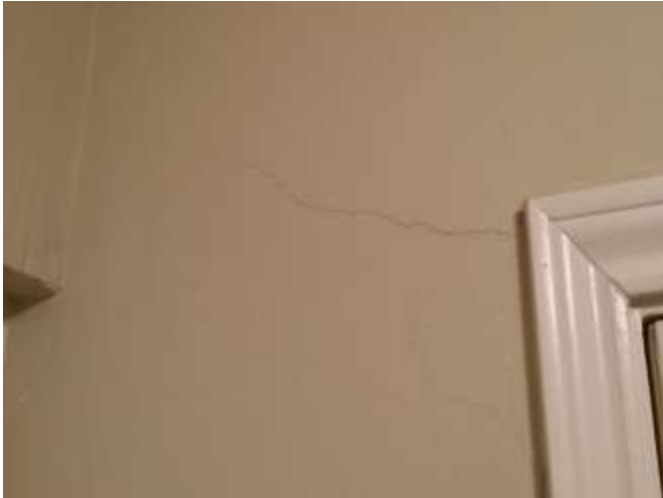
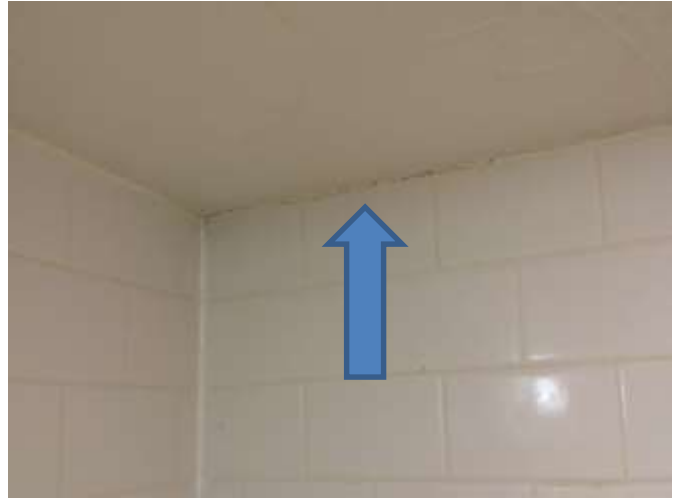
- D – There were cracks and repaired cracks at the interior walls.
- D – There was wall/ceiling separation present.
- D – The escutcheon plates are loose at the master shower wall and should be sealed with silicone caulk to prevent water from entering the wall when the shower is on.

Some of the walls appear to have been recently painted. This may hide some stains, mildew, or other damage that may exist.
There is areas of mildew at the showers.

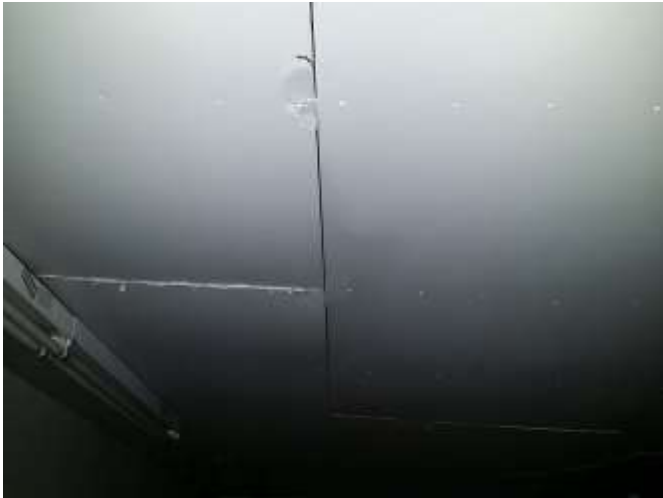
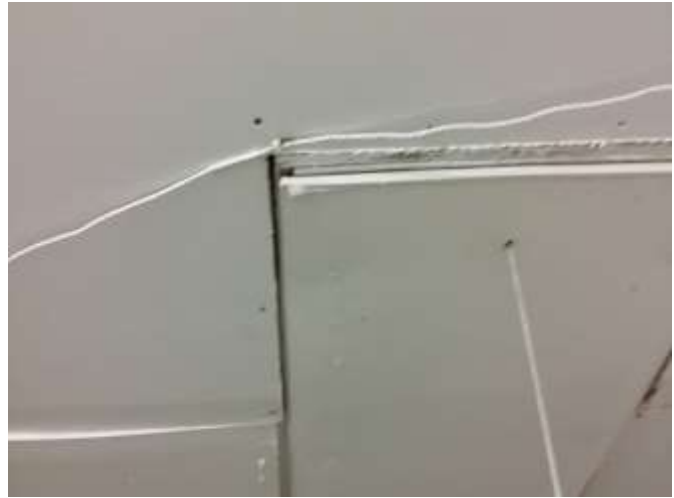
- D – There was wall to ceiling cracking present within the home.
- D – There were gaps/openings at the garage firewall. The garage ceiling is a fire wall, and should not contain any openings to the attic area. Repair is recommended.
- D – There were gaps around the garage attic door. The garage ceiling is a fire wall, and should not contain any openings to the attic area. Repair is recommended.

Some of the ceilings appear to have been recently painted. This may hide some stains, mildew, or other damage that may exist.

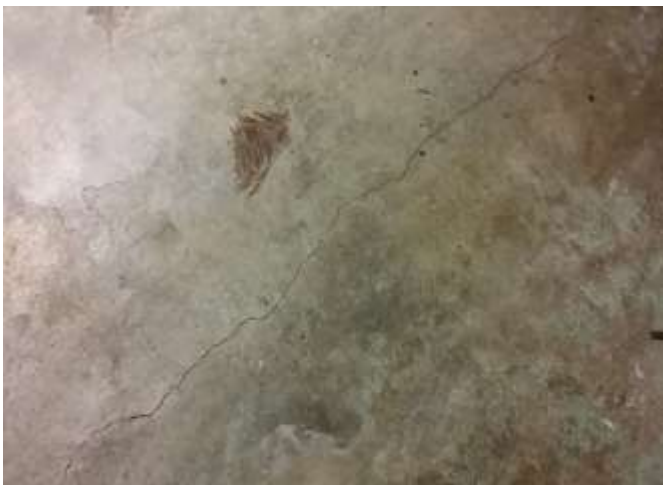
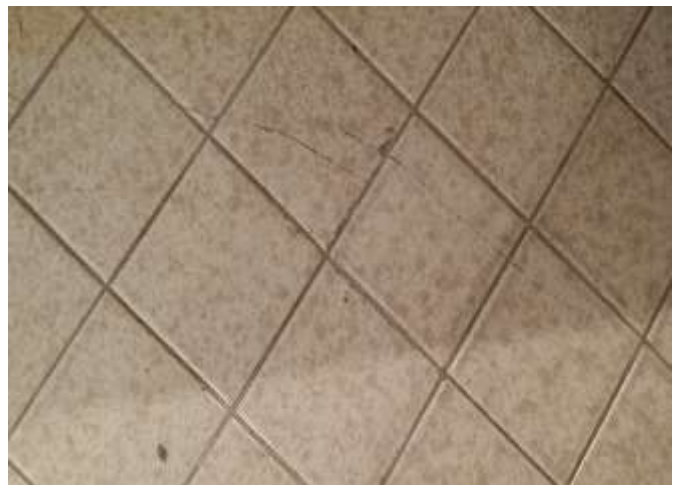
D – There are cracked floor tiles in the master bathroom and the jack and jill bathroom.

D – There were cracks in the garage floor.

There were areas of gapping at the hardwood floor in the living room.

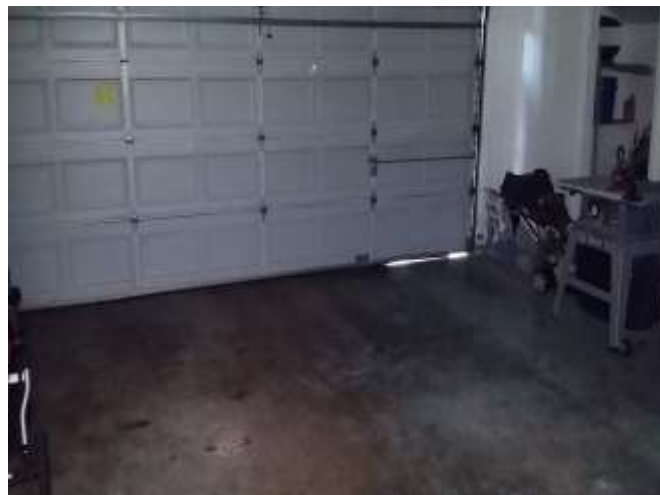
- D – The laundry area door bind at the jamb.
- D – The jack and jill bathroom door opens by itself when left in a fixed position.
- D – The weather stripping at the overhead garage door is damaged, resulting in air and light gaps at the bottom.

The house to garage door does not self-close and latch. A self-closing, house to garage door is recommended for safety and fire protection.

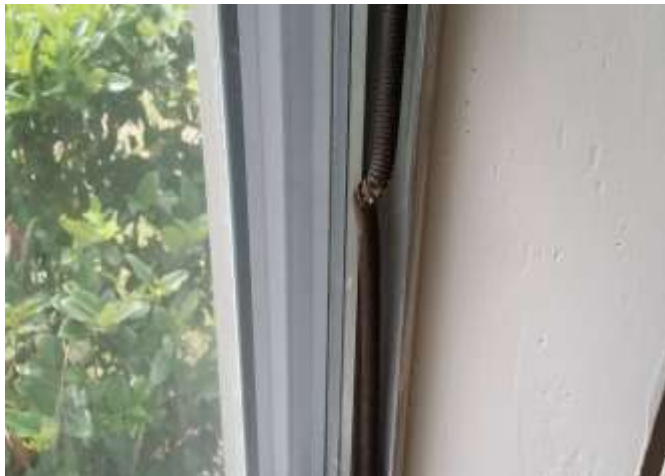
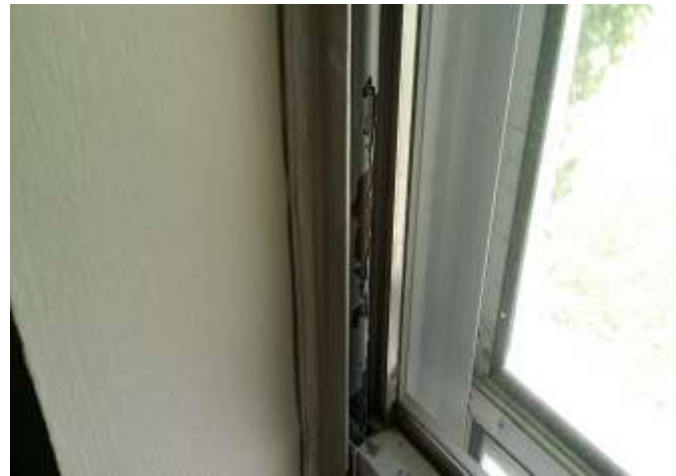
- D – The interior caulk is cracked around the windows in the home.
- D – There were missing window screens.
- D – There is a damaged window spring at the front wall in the dining room area.

There is areas of damage to the window spring plastic covers.
 There was not any observable broken glass. Performing intended function.

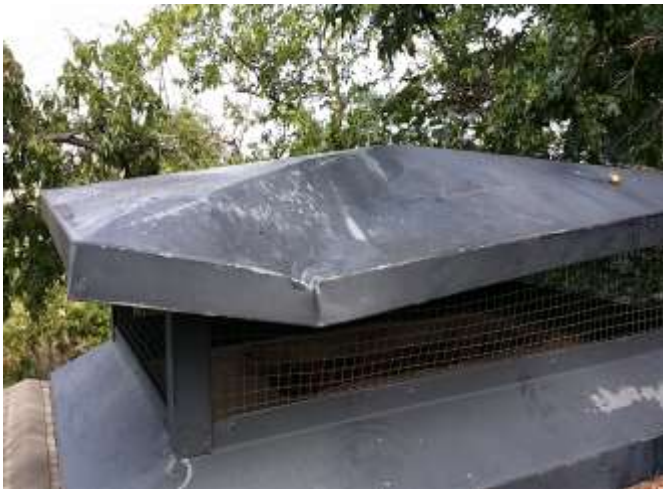
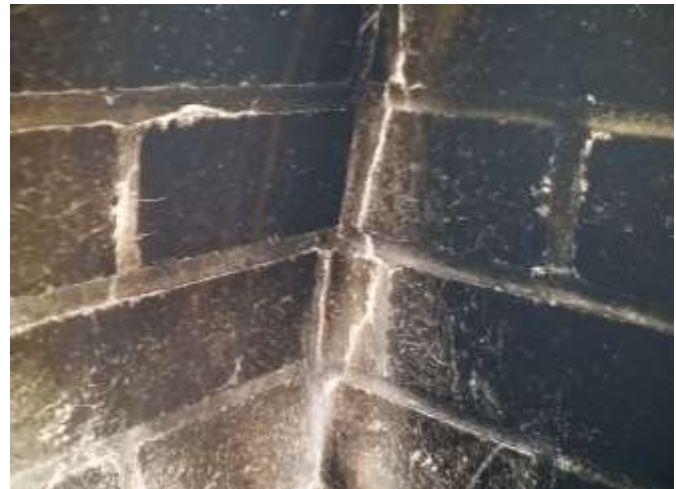
- D - The fireplace chimney is dirty with areas of built up creosote. The chimney should be cleaned and checked for blockage by a Chimney Sweep or other professional.
- D - The chimney cap is cracked and damaged.
- D - The fireplace interior firebrick is cracked and needs mortar repair.
- D - The damper clip is not installed with gas logs in place.

The fireplace is of masonry construction.
 The fireplace chimney flue is brick.
 The fireplace has burned debris on the firebox floor that limits the ability to fully inspect the fireplace.
 The fireplace has gas logs in place and the interior firebox is not fully visible to inspect.

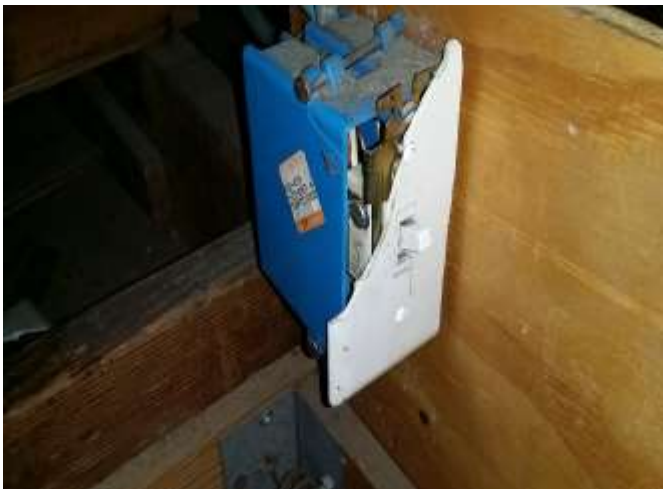
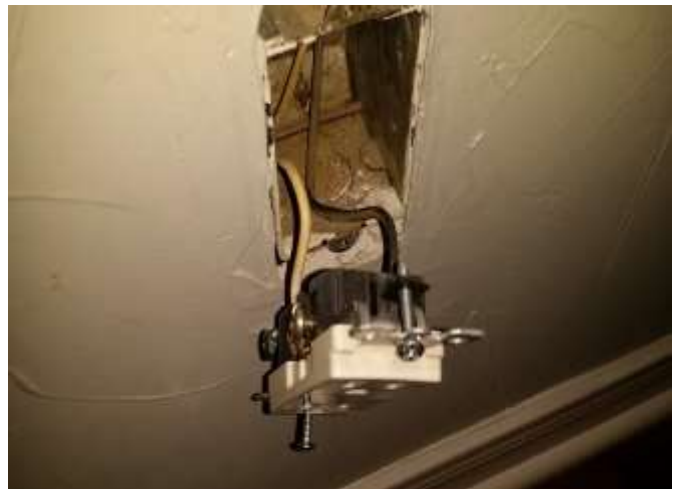
- D –There is not GFCI protection on all of the electrical outlets that serve the kitchen counters.
- D –Hand held tester had open ground readings in the master bedroom, the spare bedroom, the nursery, the living room, and the dining room.
- D –When 2 prong outlets are changed to a 3 prong outlet, this represents the outlet as grounded, without actually being grounded. All of the outlets in the home appear to have this condition.
- D – There were gaps around various outlet covers and switch plates.
- D –Various uncovered light fixtures.
- D – There were pull chain light fixtures present within some of the closets. These fixtures are not considered proper by today’s standards.
- D – Insufficient number of smoke alarms.

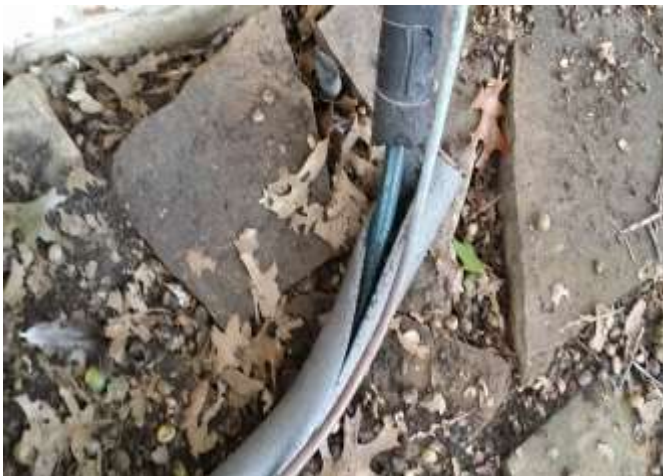
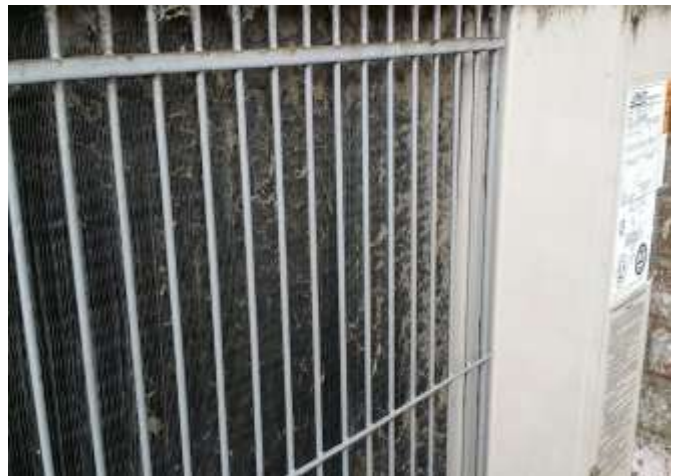
- D –The condensing coils on the air conditioning compressor need to be cleaned.
- D –The condensing coils fins on the air conditioning compressor are damaged.
- D –Insulation is damaged and separating on the large Freon suction line at the air conditioning compressor.

Manufacture date per unit label is 1993.

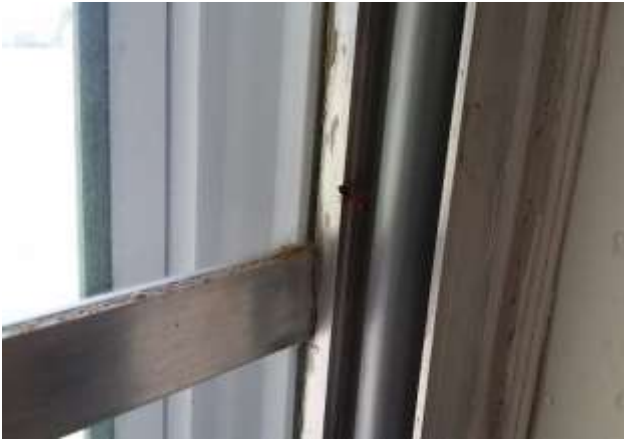
An active carpenter ant was found within the home. Treatment is recommended

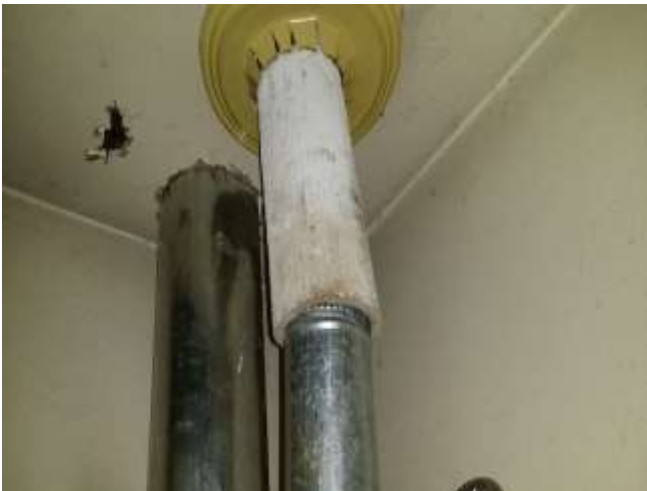
Possible asbestos containing material present at the water heater vent pipe. It is recommended that this area be further sampled, analyzed, and removed/remediated if necessary.
