MARINE ACCIDENT REPORT

SS EDMUND FITZGERALD

SINKING IN LAKE SUPERIOR

REPORT NUMBER: NTSB-MAR-78-3

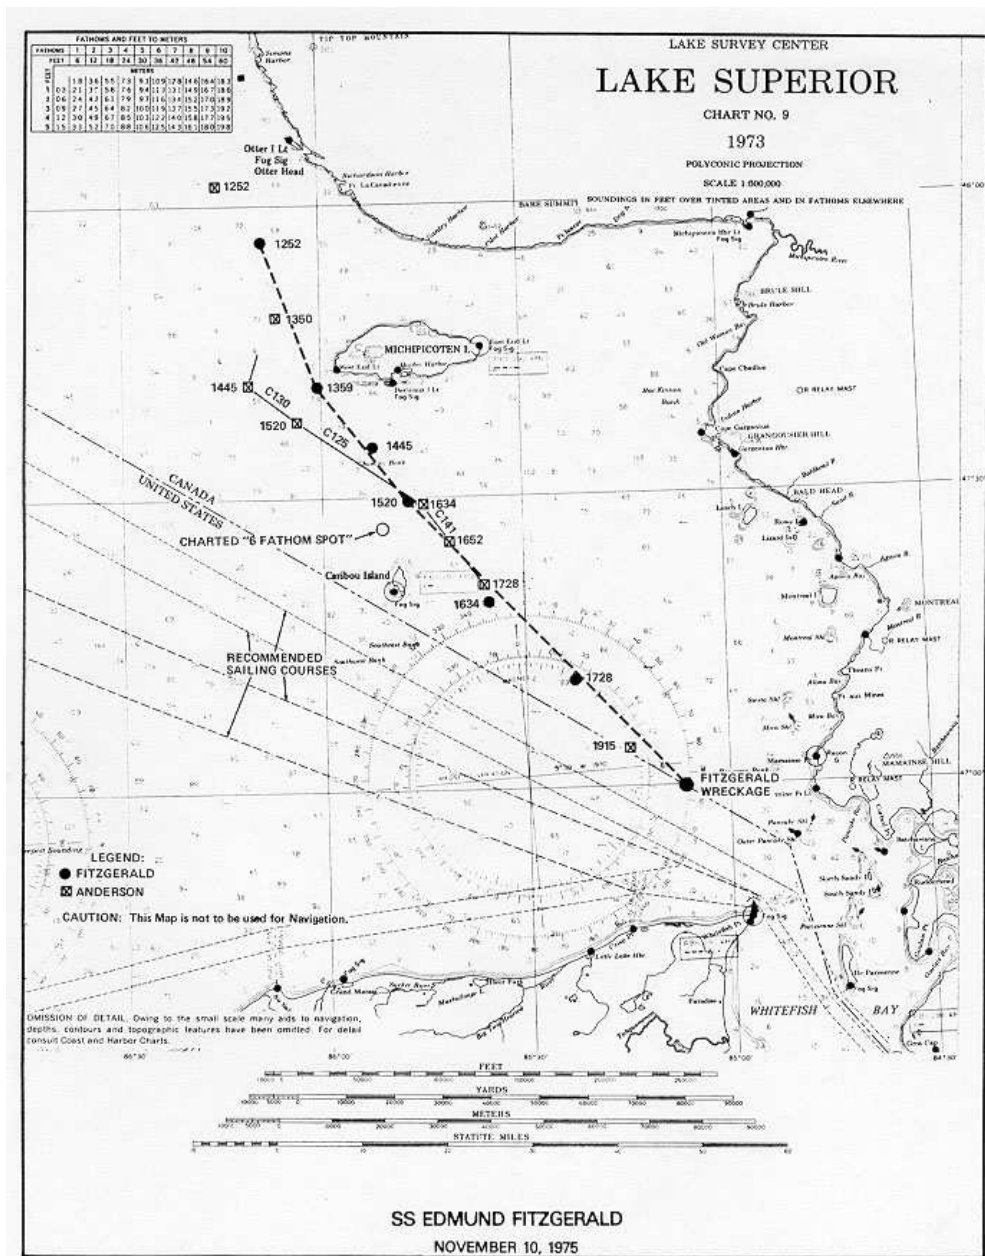
Figure 1: Trackline/Course of the SS EDMUND FITZGERALD

Based on radar data observed by the ANDERSON, the FITZGERALD's position at 1350 (1359), 1445, 1520, 1652 (1634), 1701 (1728), and 1915 correlate with the 141T course reported by the FITZGERALD and the Safety Board's calculated speeds. (See figure 1.)

The trackline of the FITZGERALD lies 2.75 miles east of Chummy Bank and 2.5 miles east of the 10-fathom curve outlining the shoal area north of Caribou Island known as North Bank. Some testimony placed the FITZGERALD closer to North Bank; however, the course of 141 T from West End Light to Whitefish Bay is well known to Great Lakes navigators and this was the intended track of both the ANDERSON and the Fitzgerald. The ANDERSON was navigated to return to this trackline at 1634 for the final leg of her voyage. At this time the FITZGERALD was observed to be almost dead ahead of the ANDERSON when her heading was 142 T.

10. The most probable trackline of the FITZGERALD, from west of Michipicoten Island to the position of her wreckage, lies east of the shoal areas north and east of Caribou Island; therefore, damage from grounding would have been unlikely.

Figure 1. Probable tracklines of SS EDMUND FITZGERALD and SS ARTHUR M. ANDERSON on November 10, 1975.

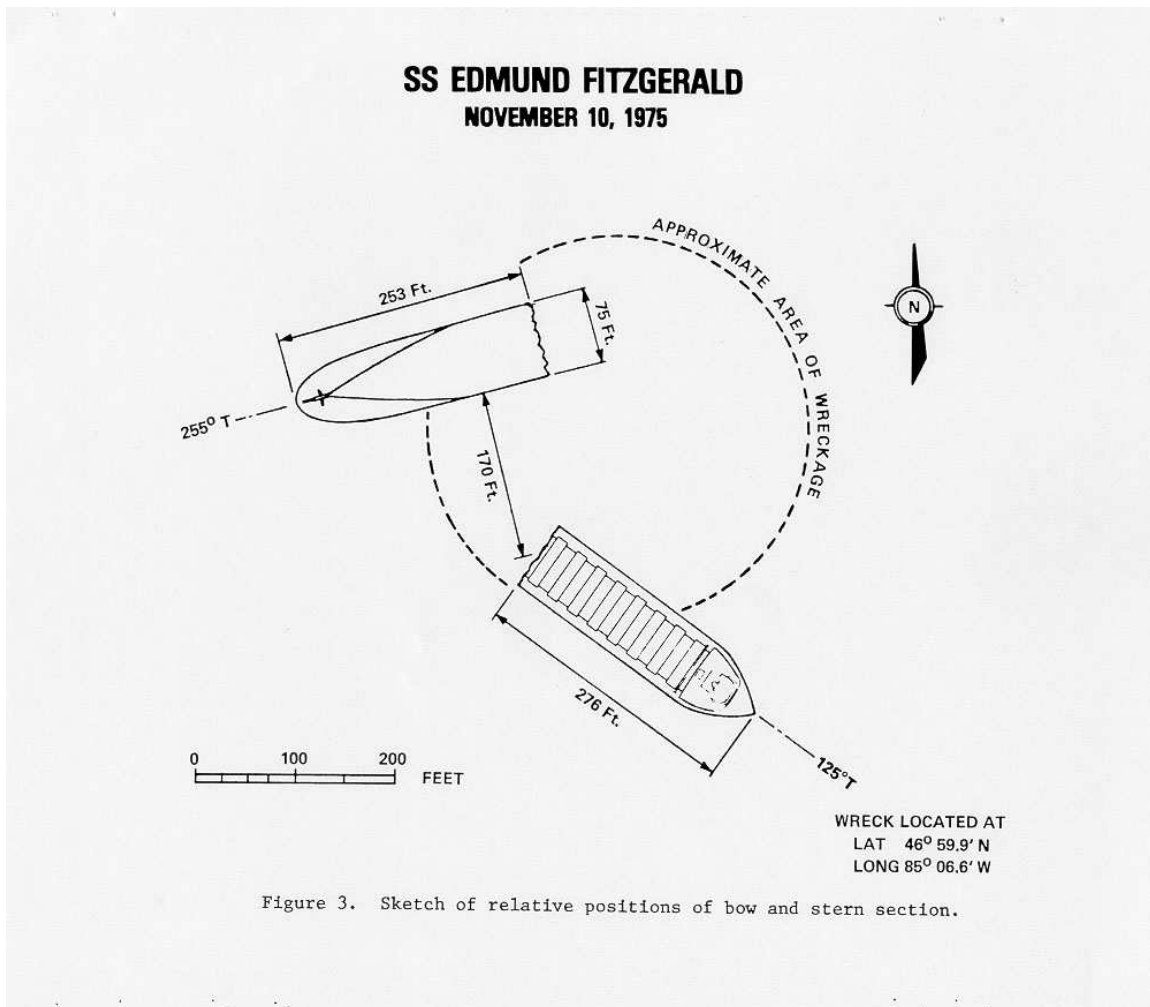
Figure 3: Sketch of the relative positions of the bow to the stern section

The wreckage lies approximately 17 miles northwest of Whitefish Point, Michigan. The wreckage consists of an upright bow section, an inverted stern section, and debris from a missing 200-foot midship portion. The bow section is 276 feet long, inclined 15 degrees to port from the upright,

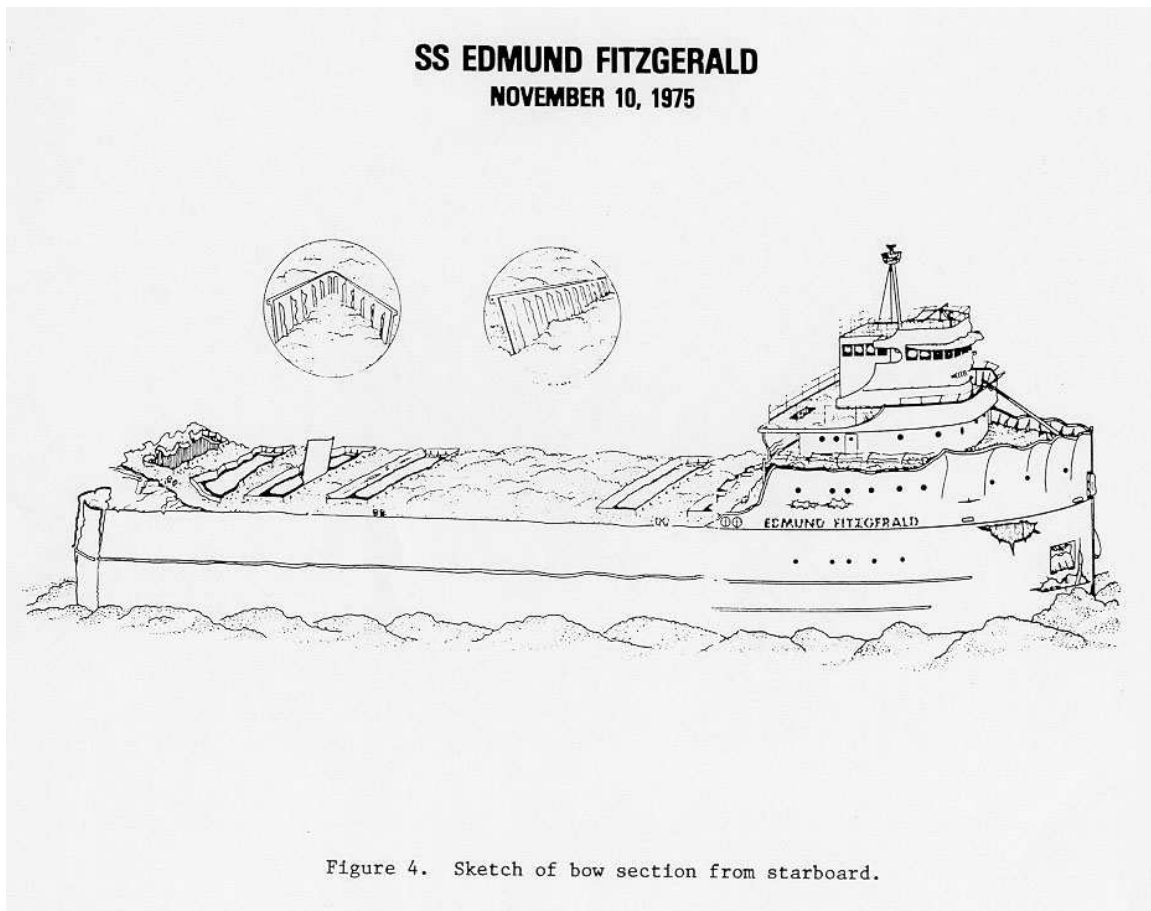
Figure 4: Sketch of bow section from starboard

There was extensive damage to the forward deckhouse and there were several holes in the bow shell plating. The rest of the shell plating extending back to the rupture was intact. The No. 1 hatch cover was entirely inside the No. 1 hatch and showed indications of buckling from external loading. Sections of the coaming in way of the No. 1 hatch were fractured and buckled inward. The No. 2 hatch cover was missing and the coaming on the No. 2 hatch was fractured and buckled. Hatches Nos. 3 and 4 were covered with mud; however, one corner of hatch cover No. 3 could be seen in place. Hatch cover No. 5 was missing. A series of 16 consecutive hatch cover clamps were observed on the No. 5 hatch coaming. Of this series, the first and eighth were distorted or broken. All of the 14 other clamps were undamaged and in the open position. The No. 6 hatch was open and a hatch cover was standing on end vertically in the hatch. The hatch covers were missing from hatches Nos. 7 and 8 and both coamings were fractured and severely distorted. The bow section abruptly ended just aft of hatch No. 8 and the deck plating was ripped up from the separation to the forward end of hatch No. 7.

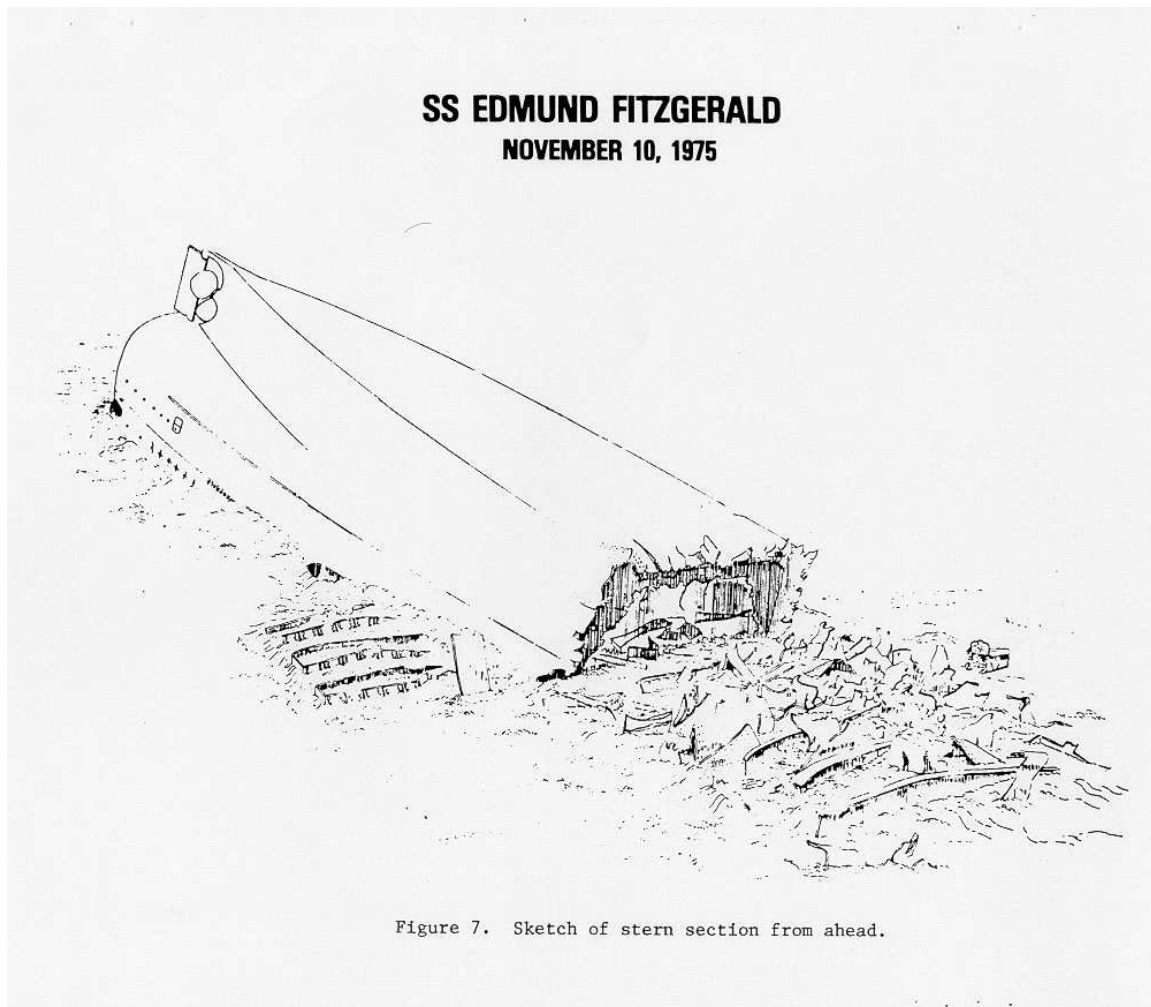
Figure 7: Sketch of stern section from ahead

There was mud—covered wreckage extending out from the ruptured end of the stern section, but no identification of what part of the ship it came from can be determined. Three hatch coamings and a hatch cover were lying next to the stern section. One of the hatch coamings bore the numeral 11.
