# Service Bulletin

## SAFETY RECALL

### 2014 CTX700ND ABS MODULATOR REPLACEMENT

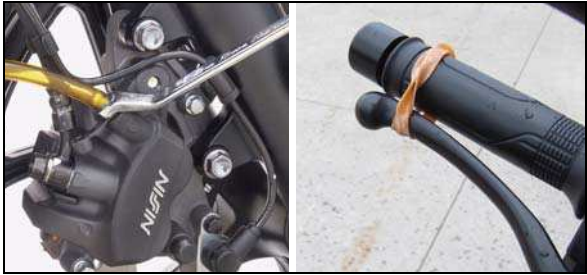
**PREVENTING BRAKE FLUID LEAKAGE (Step 10)**

This will help prevent the brake fluid from leaking out of the reservoir during ABS modulator replacement.

1. Connect a bleed hose to the front caliper bleed valve.
2. Loosen the bleed valve and then pull the front brake lever fully against the handlebar. Secure the lever against the handlebar with a band or zip-tie and close the bleed valve.

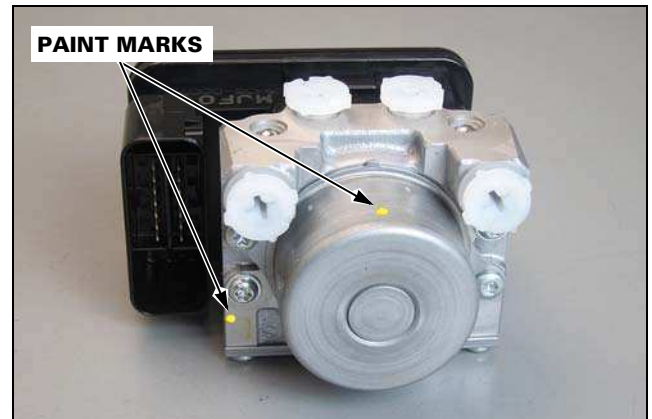
## PARTS IDENTIFICATION

Be careful not to mix up the defective and replacement parts. The as packaged countermeasure part is identified by two yellow paint marks as shown. Use care during unpacking and installation as the the paint marks are easily wiped off.
