Insight Property Inspections

Property Inspection Report

10101 Common Avenue, Las Vegas, NV 89178
Inspection prepared for: All Sampled
Real Estate Agent: Tony Dacloser - Real Estate Agent of Las Vegas

Date of Inspection: 10/22/2014 Time: 9 am
Age of Home: 10 Years Size: 2,020 square feet
Weather: Mostly Sunny 80 degrees
Inspection fee \$275 paid by credit card

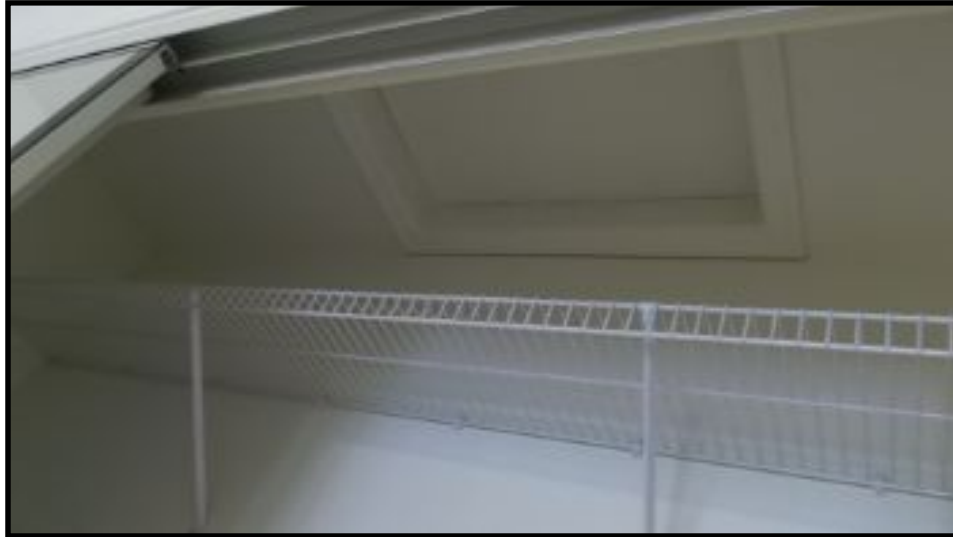
- Location of access
- Bedroom Closet.
- **IMPROVE:** The attic access is not insulated. Expect some energy loss due to this condition. Recommend insulating attic access cover with a batt of fiberglass insulation to reduce energy expenses.

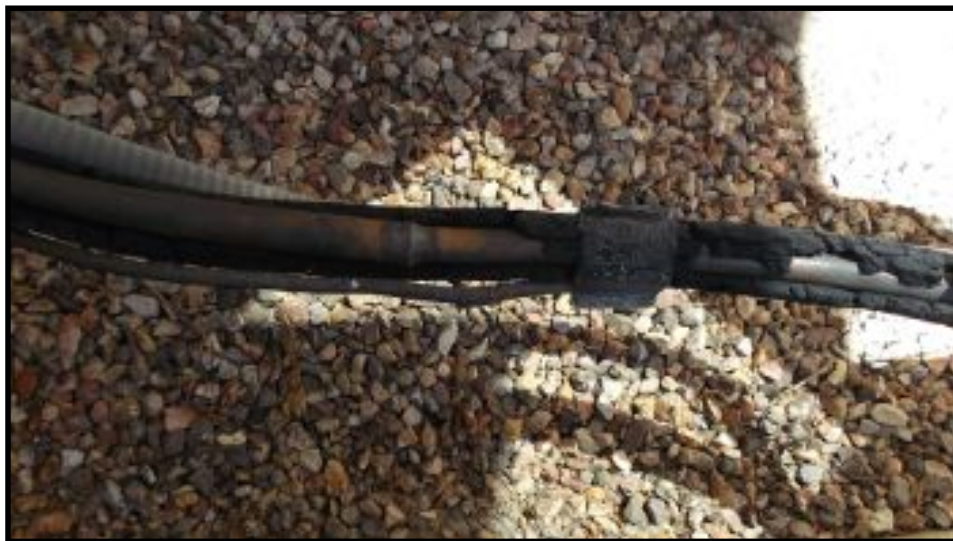
6. Refrigerant Lines

- Deteriorated insulation noted at refrigerant line on air conditioning condenser/compressor unit at the side of the home. Refer to photograph. The proper installation of this tubular foam insulation can have a significant impact on the efficiency of the unit and reduce annual cooling costs. This insulation is readily available at most home improvement stores. Wrapping the insulation with 20 mil electrical tape will help reduce deterioration of the insulation. Corrections are recommended.
- Corrective maintenance should be performed to restore the component to its proper condition.

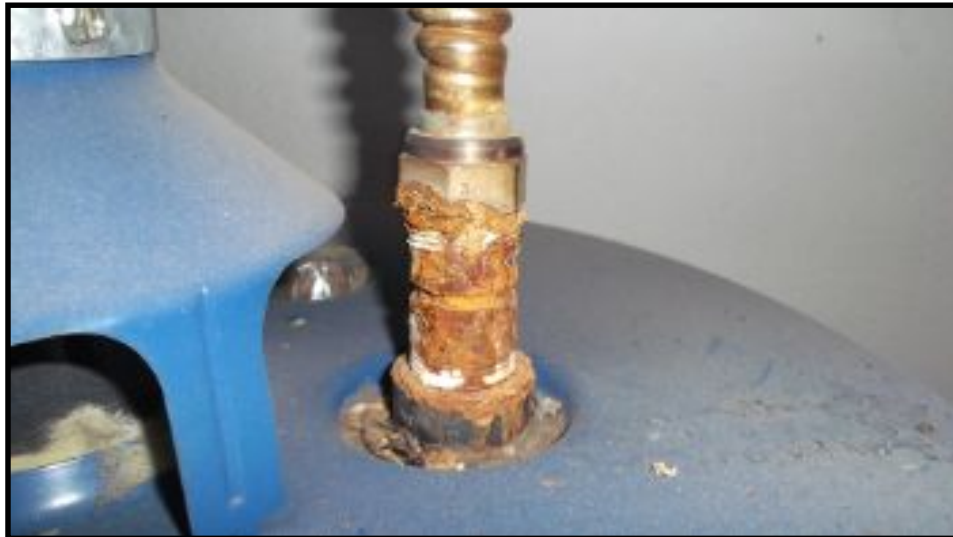
- Corrosion observed at the fittings atop the water heater. No leakage observed during the inspection but this condition can lead to fitting failure. The fitting should be replaced to avoid leakage in the future.
- Refer to the photograph for detailed view.
- It is recommended that a licensed and qualified plumbing contractor review this finding and make repairs as needed.

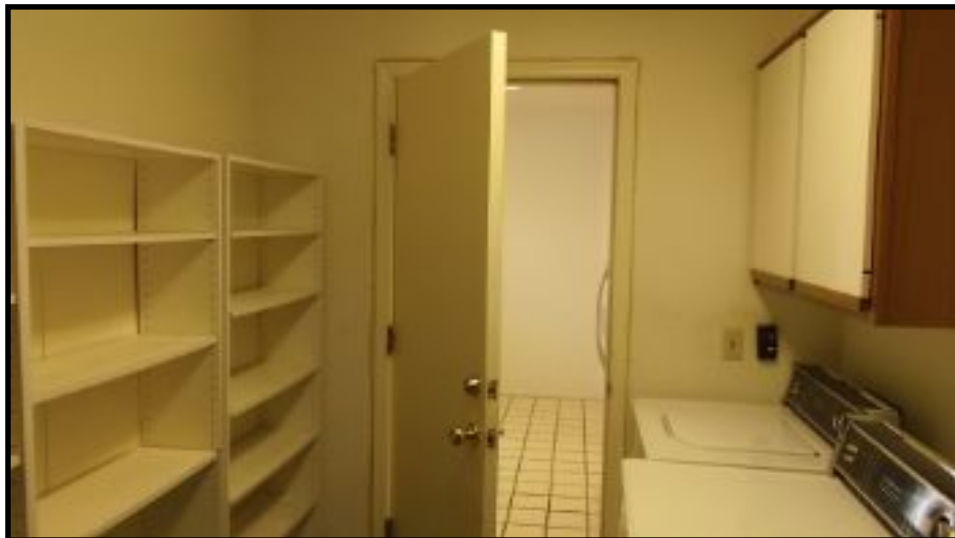
- The flex dryer vent tube is damaged and needs replacement. This condition will discharge moist air and lint into the laundry room and cause lint build up behind the dryer, which is a fire hazard. The area needs to be cleaned of excessive lint and the damaged vent replaced.
- Refer to the photograph for detailed view.
- These products are readily available at most home improvement stores.
