Home Inspection Report

1000 Main St.
AnyTown, Cape Cod, MA

Prepared By: Ken Amelin

03/16/2015.

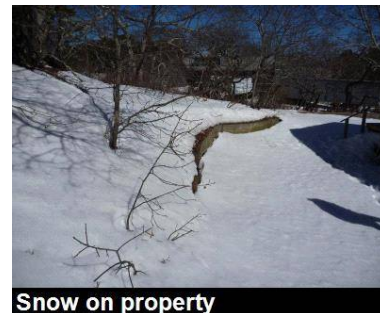
Observation: SNOW cover on the lot at time of inspection prevented a complete evaluation of the grading/drainage along the foundation.

Analysis: True drainage conditions and its impact on the home are concealed by the snow and undetermined.

Snow on property

Recommendation: The grading and drainage along the foundation and its impact on the home should be evaluated during the first available thaw and prior to purchase. You should ask the owner about any adverse conditions that may exist for your record.

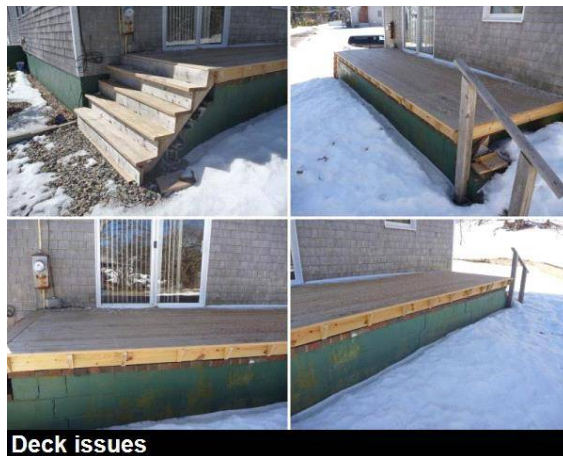
Observation: There are cracks in the foundation blocks supporting the deck flooring that are connected together forming a step appearance.

Analysis: Step type cracks indicate potential footing settlement. Often faulty drainage control and years of roof or surface water drainage along a foundation can erode some of the compacted fill beneath a footing, causing the footing to settle under load. The footing settlement is reflected upward into the foundation and has weakened the support structure.

Observation: The masonry support system (old patio) was built against siding, **Observation:** Guard rail less than 36 inch minimum.

Analysis: **SAFETY WARNING - potential for personal injury.**

Recommendation: These cracks have weakened the structure and will continue to deteriorate and settle. Replacement is recommended. You should have the area of concern reappraised by a foundation contractor or structural engineer prior to commitment.

Recommendation: Elevate railing to 36 inch min. standard for safety. g. The siding extends below the masonry.

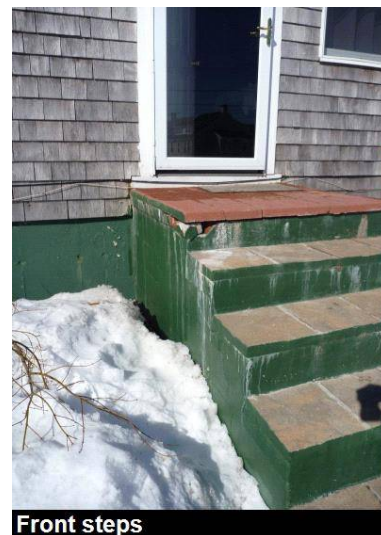
Observation: The brick steps have loose or missing corner bricks and pavers

Observation: Entrance steps are missing bricks.

Analysis: SAFETY WARNING: The brick steps are **UNSAFE** as someone could suffer a personal injury.

Analysis: Either the staircase or walkway has settled or the staircase was incorrectly constructed. Be advised that the high riser could cause a personal injury.

Front steps

Recommendation: Hire a mason to perform safety repairs as required to restore the safe function of the staircase.

Recommendation: Hire a mason to perform safety repairs as required to restore safe function of the entrance.

Recommendation: I advise that you ask a landscape contractor to alter the grade so that the riser heights are even for safety correction.

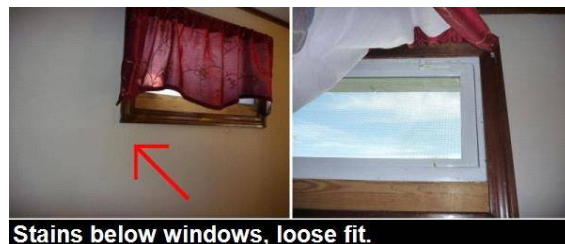
Observation: Stains are visible on the inside of the basement windows.

Analysis: Staining indicates that water infiltration has occurred at basement window(s). I suspect that the windows are level or lower than grade and water has leaked into the basement. Be advised that this condition promotes decay & insect infestation.

Stains below windows, loose fit.

Observation: Basement windows are not installed securely and are loose at opening.

Analysis: Poor workmanship, potential for leakage and a security risk.

Recommendation: I advise that the grade be lowered to provide a reasonable clearance, or that window wells be installed to reduce risk of water entry and prevent decay. Also recommend that roof runoff or gutter overspill be controlled as necessary. Contact a licensed carpenter or landscape contractor for further review and cost estimates for repairs as required.

Recommendation: Repairs are advised.

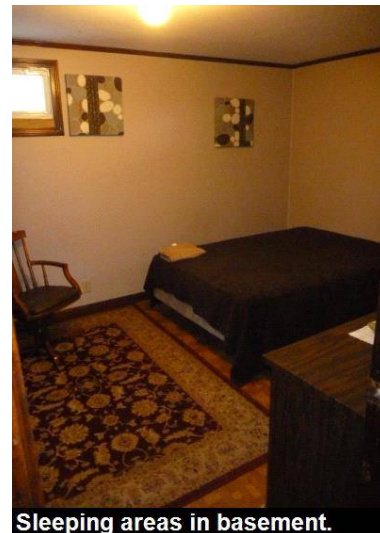
Observation: ESCAPE WINDOW SIZE QUESTIONED - the size of a window may be inadequate for emergency escape.

Analysis: The local building department can provide you with minimum escape window requirements. As a reference, all sleeping rooms and living areas are required to have at least one primary and secondary means of emergency egress - for example, a door and a window. An escape window must be easy to open; it must have a minimum area of 5.7 square feet, a minimum clear width of 20 inches; a minimum height of 24 inches; and a maximum sill height of 44 inches.

Sleeping areas in basement.

Recommendation: If any room within the home is to be used for sleeping or living and does not have a window that conforms to emergency escape dimensions, then I recommend that the room NOT be used for those purposes unless a suitable window is installed.

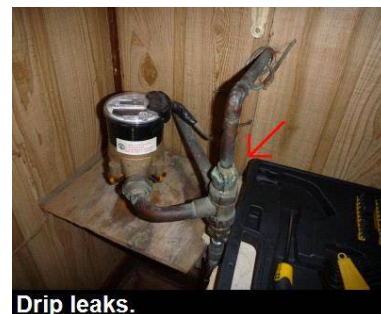
Analysis: Repair is needed.

Drip leaks.

Recommendation: Notify the water department and request further evaluation to determine the jurisdiction of needed repairs.

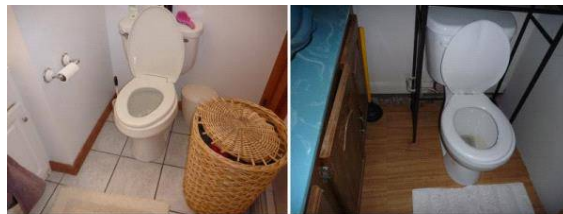
Loose toilet flanges.

Recommendation: Hire a plumber to secure the toilet to the floor and flange as required.

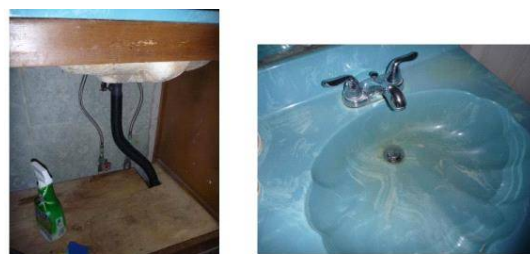
Bath sinks and drain.

Recommendation: Hire a plumber to replace the integrated counter top and sink.
