ABC HOME INSPECTION LLC

**123 Jones Street
Any Town, WI 54321**

Introduction and Overview

This was an actual Inspection completed in 2006. All name & locations have been removed.

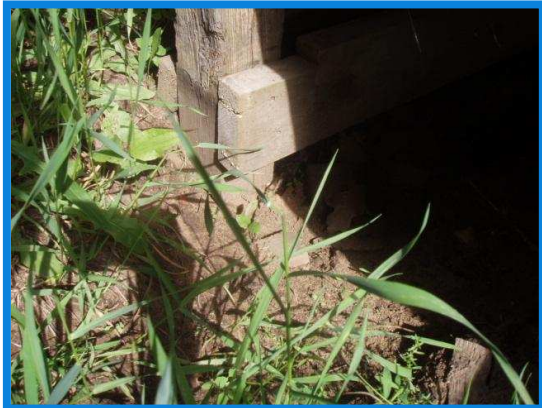
REPAIR NEEDED: In my opinion, the framing of the deck is inadequate as the joist do not properly bear on the main beams, the deck ledgerboard does not appear to be properly attached to the house framing, the deck railings are missing or incomplete, the support columns do not bear on any footings, column post bearing points are washed away, and some beams are not properly configured for proper support.

It is highly recommended having a qualified carpentry contractor evaluate and make any necessary repairs.

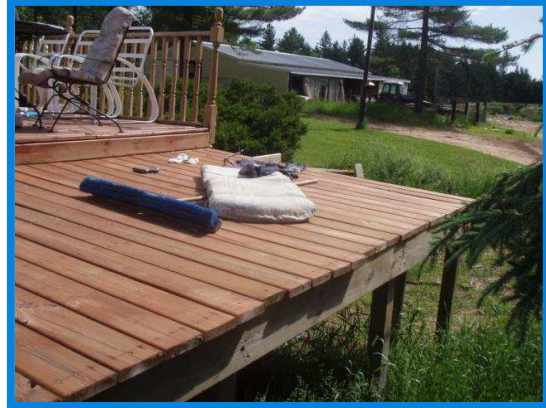
SAFETY ISSUE: The baluster spacing at the perimeter of the elevated deck is too wide. It's possible for a small child to slip through the railing and fall. Current codes specify that baluster spacing can be no more than 4 inches wide. Even though this requirement may not have existed at the time this deck was built, or the local municipality may never have adopted it, I consider this to be a life/safety issue, and feel it would be prudent to bring the baluster spacing up to current code. A competent carpenter that specializes in decks should be consulted to discuss options and cost.

SAFETY ISSUE: The outside stairs/landing don't have a railing or handrail. Any stair with 4 or more steps or decks and landings that are higher than 30 inches above grade should have handrails and perimeter railings. I recommend immediate correction by a competent carpenter.

ATTENTION: Portions of the wood deck are in contact with soil. This will most likely eventually result in rot and insect infiltration, even if the deck has been constructed from treated lumber. I recommend correcting the grading around the deck to achieve at least 3-4 inches clearance between any wood components and soil. Sometimes, this is esthetically impossible due to landscaping. In such circumstances, I recommend creating a border around the deck using pavers and placing river-washed stone or lava beneath the members. This way, the existing grade surface can be retained while providing good drainage beneath the members.

REPAIR NEEDED: The retaining wall is unstable due to poor construction or hydrostatic pressure that is causing the wall to move. This may be the result of a wall without the requisite drainage or retention measures installed behind it to keep it firmly in place. I recommend further evaluation and correction as necessary by a professional landscaping architect or drainage contractor.

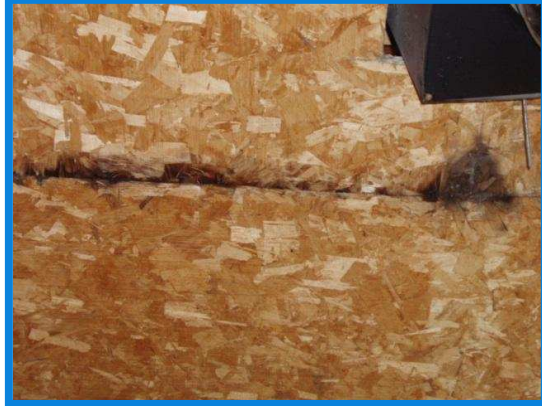
REPAIR NEEDED: Indications of a roof leak were found. It is my opinion that this is an active leak that needs to be immediately attended to. Contact reputable roofers to discuss repair options and related costs.

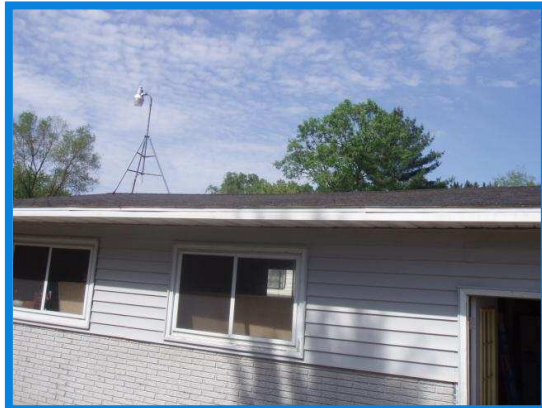
There were more than two different types of shingles installed on the roof over various areas suggesting recent repairs which appeared less than professionally installed.

FURTHER INSPECTION: The inspector noted significant sagging of the roof deck on the garage. No exact cause was noted. Also, the inspector noted while walking the roof several areas where the decking appeared loose.

It is highly recommended having a qualified roofing contractor evaluate the entire roof and determine the necessary areas for repair. It is doubtful that a complete replacement is needed, however some repairs over different areas may need to be made.

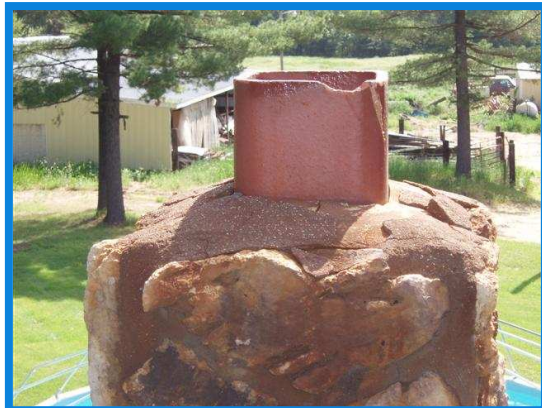
REPAIR NEEDED: The skylight at kitchen exhibits signs of leakage on the interior chase. This could be due to a leaking seal or leaking flashing at the roof sheathing. Recommendation: Evaluation and repair as appropriate by a licensed skylight installer.

REPAIR NEEDED: The mortar cap of this chimney, sometimes known as the 'crown', was cracked, badly weather worn or damaged by the corrosive effects of moss. When this occurs, water seeping past the crack can cause substantial damage to the masonry stack, as well as to the framing, walls and ceilings below. Having this stack and cap repaired by a reputable chimney mason or sweep is recommended.

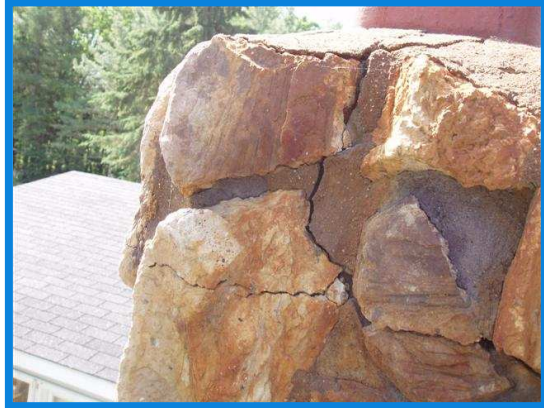
REPAIR NEEDED: The chimney(s) requires repairs, specifically in the form of tuckpointing cracks in the masonry stonework.

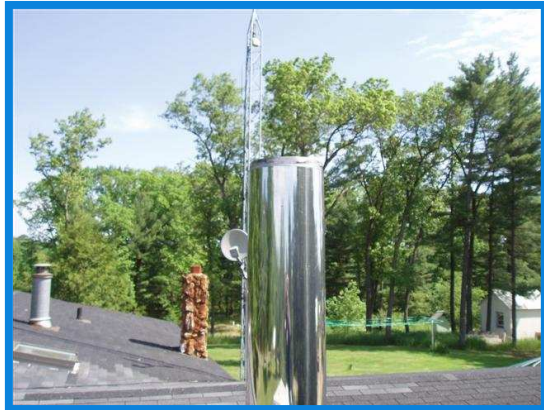
ATTENTION: One chimney stack was noted abandoned. It is recommended to remove this stack if a woodstove is not going to be used in that location.

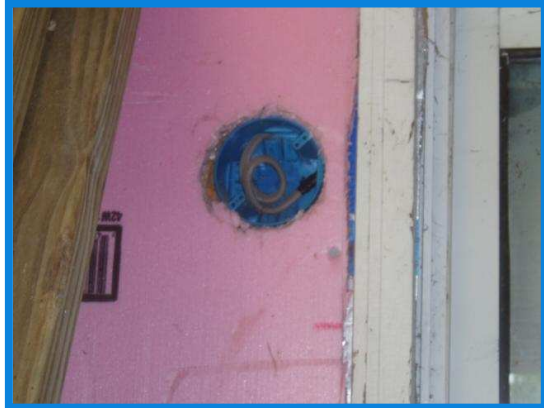
SAFETY ISSUE: I found uncovered electrical junction boxes in the home at the garage/foyer. These boxes must be covered in order to contain any electrical fire within the box and to keep debris, insects and vermin out. Note that the covers may be missing because of too many conductors in the boxes. If this is the case, any overfull boxes will need one or more extension rings added. I recommend having this issue corrected by an experienced handyperson or licensed electrician.

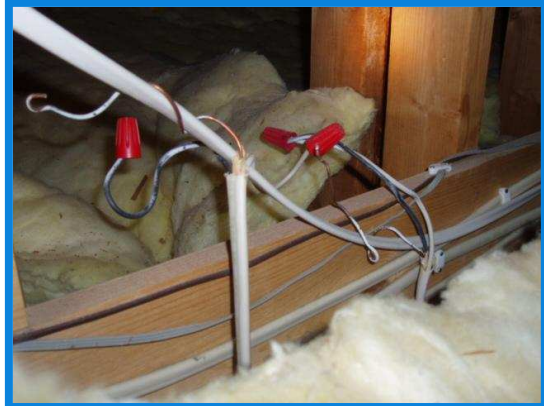
SAFETY ISSUE: There are electrical wires at fixtures or in the attic that have been spliced and not contained in approved junction boxes. Recommendation: Have all splices installed inside required junction boxes by a licensed electrical contractor.

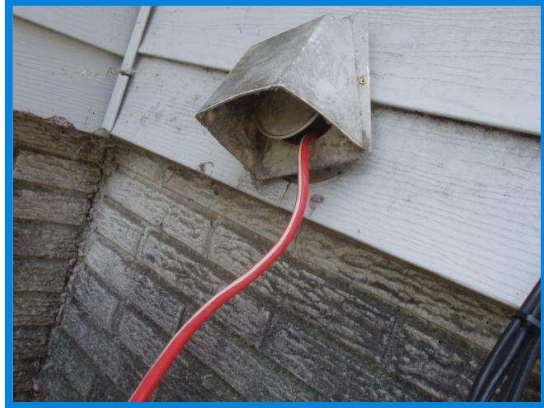
SAFETY ISSUE: Electrical wiring in the form of an extension cord was noted routed thru the dryer duct. This is not recommended practice. Repair as necessary.
