Blue Palmetto Home Inspection

Property Inspection Report

123 Dream Home Lane, Summerville SC, 29483
Inspection prepared for: Julia Sample & Julia Sample
Inspection Date: 1/4/2011 Time: 3:45 pm
Age: 8 years Size: 1500 sf + -
Weather: Partly Sunny 60 degrees
This is just a test report.

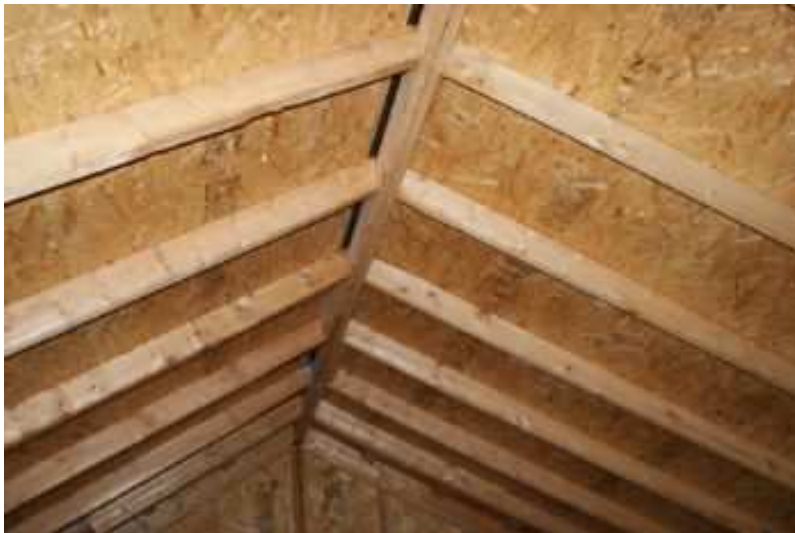
- Recommend adding collar ties at 4' O.C. spacing at ridge of roof structure. A collar tie is a piece of 2x4 or similar material approximate 4' long which are nailed to and connect the rafters on both sides of the ridge board.
- In the absence of engineered drawings we recommend installing collar ties.

Recommend adding collar ties at 4' O.C. spacing at ridge of roof structure. A collar tie is a piece of 2x4 or similar material approximate 4' long which are nailed to and connect the rafters on both sides of the ridge board.

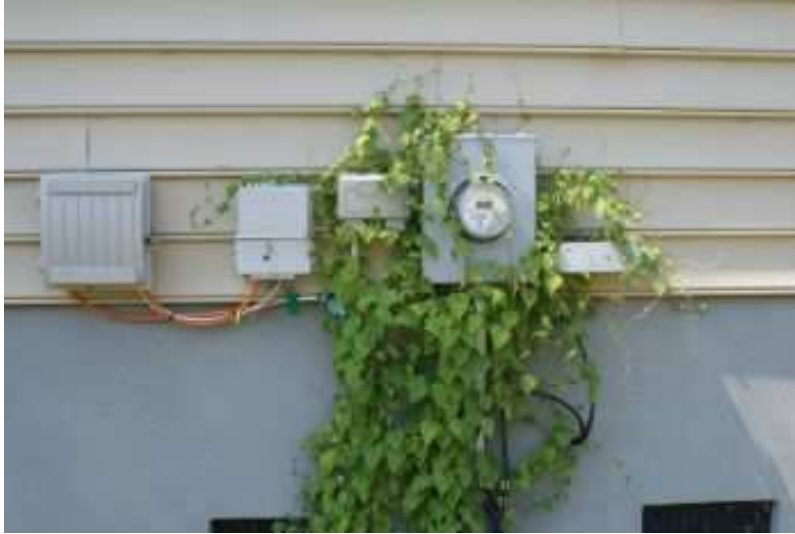
The morning glories growing around the electric meter need no be trimmed back to prevent future problems.

- Recommend removing vines around the electric meter.

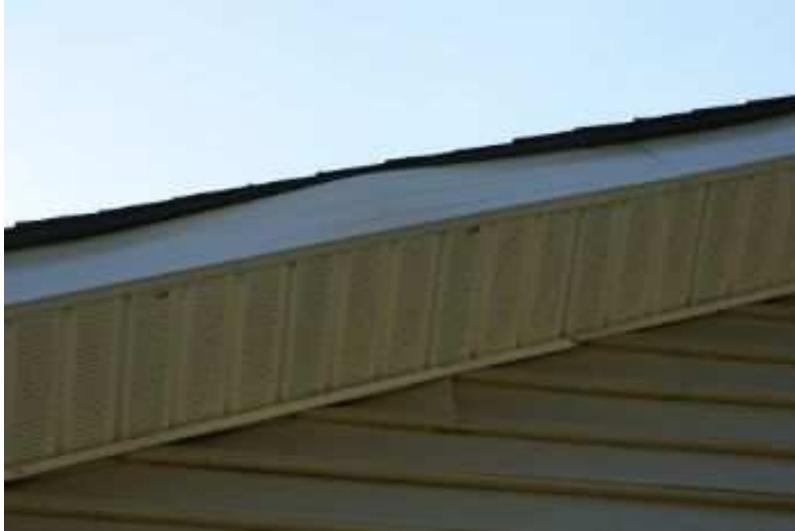
In the rear of house the facial needs to be secured to prevent water intrusion.

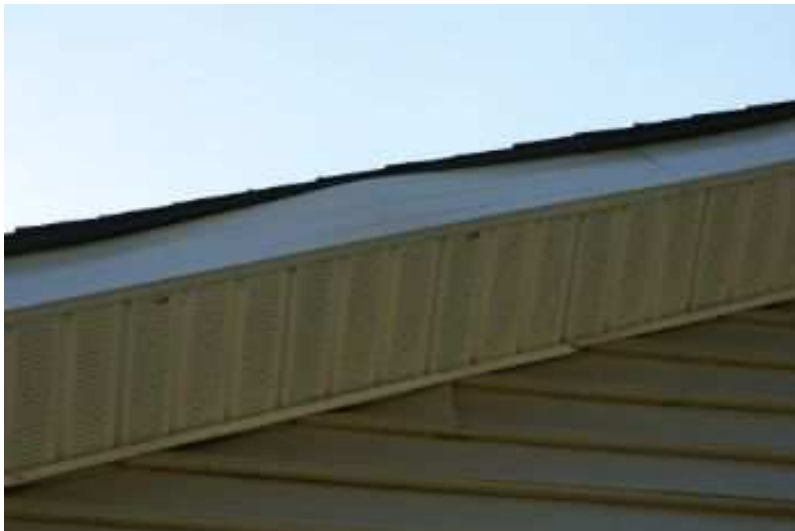
In the rear of house the facial needs to be secured to prevent water intrusion.

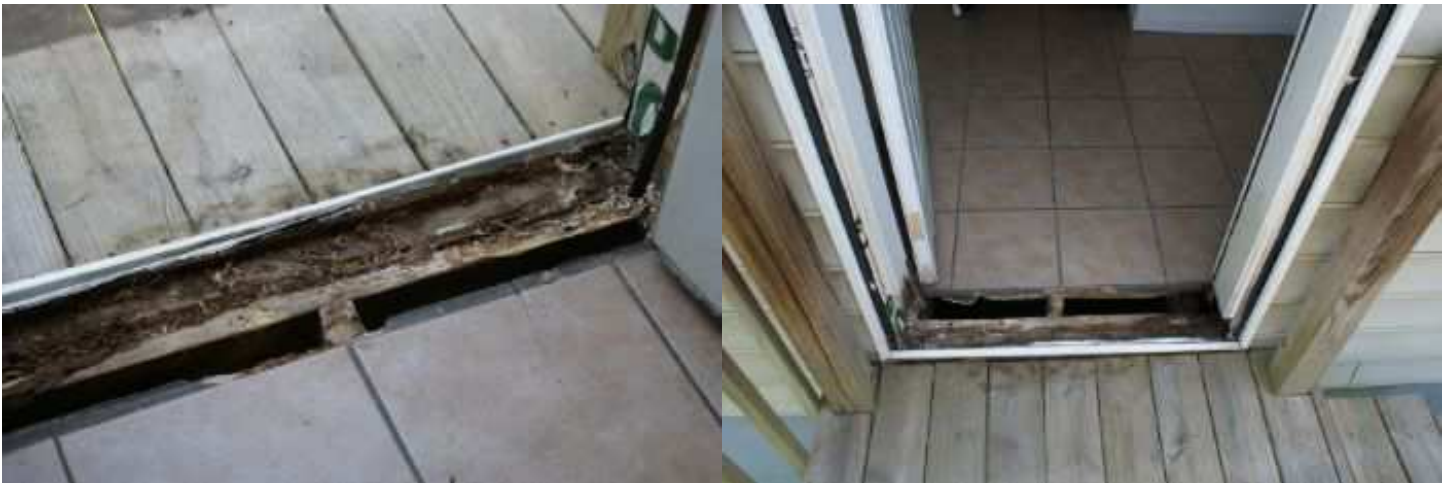
Observations:
• The door on the side of the house needs to be replaced. Water intrusion at this site has also damaged the door sill, sub floor, and has caused some minor joist damage.

Door needs replacement

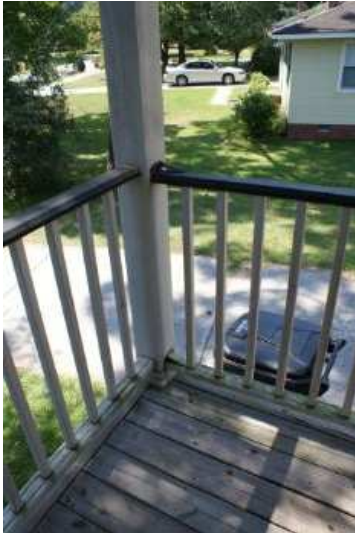
Hand rails are loose or rotted at the attachment points. This is a dangerous situation because someone might lean against them and fall.

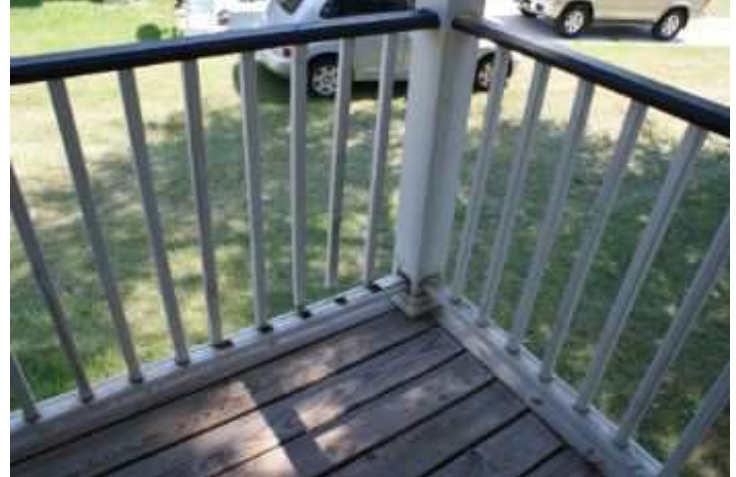
Hand rails are loose or rotted at the attachment points. This is a dangerous situation because someone might lean against them and fall.

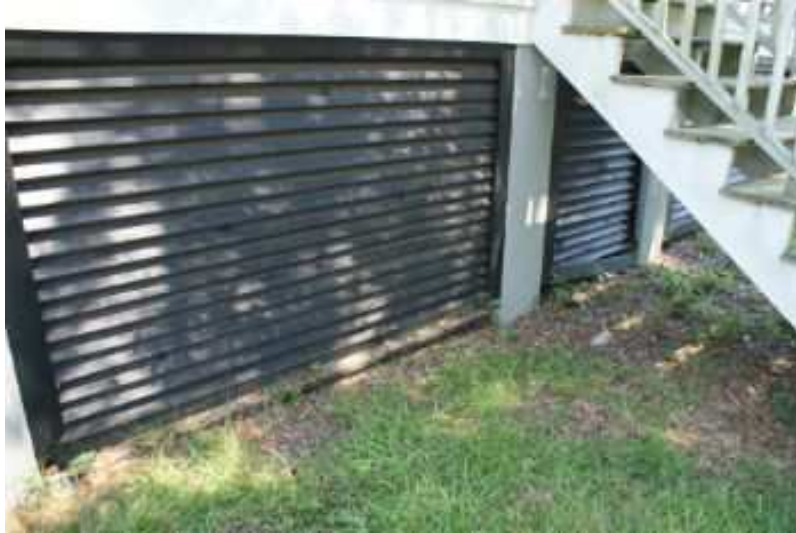
The Lattice under the front porch near the ground has some rotted sections.

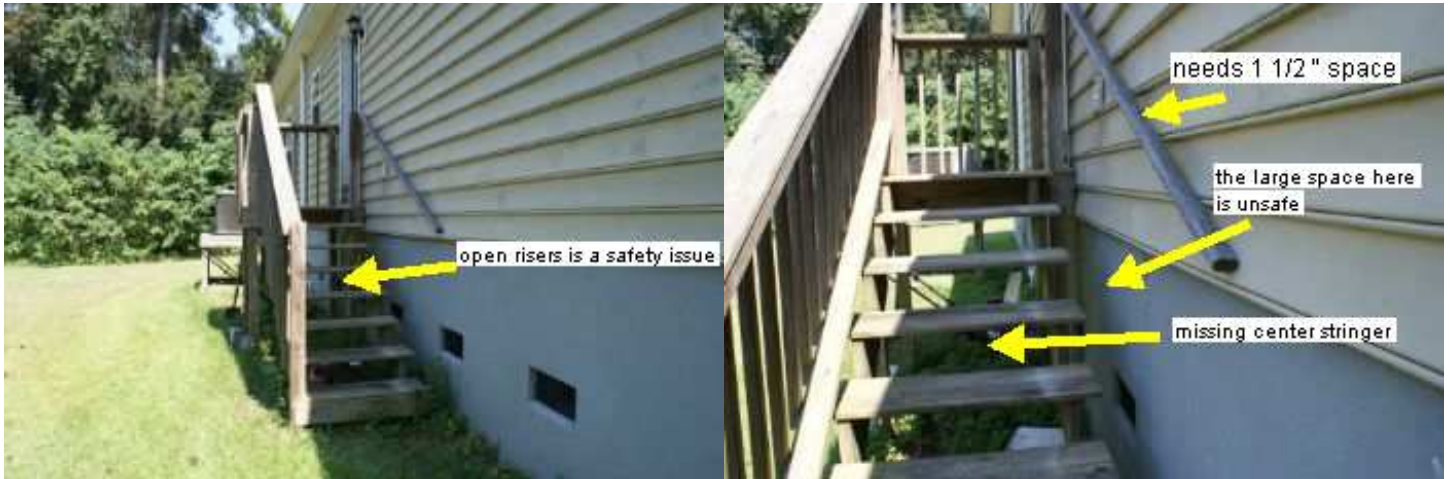
- Handrail should be installed at a height of no less than 34" and no higher than 38".
- There should be an 1 1/2" space between handrail and wall.
- Center stringer is missing.
- Space between the steps and the wall is too great and present a safety hazard.
- Open risers present a safety concern.

Handrail should be installed at a height of no less than 34" and no higher than 38".

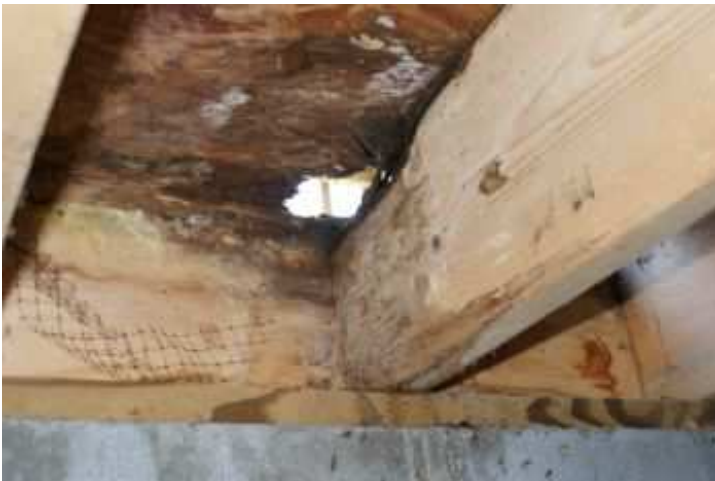
There is a moisture damaged joist under the exterior side door.

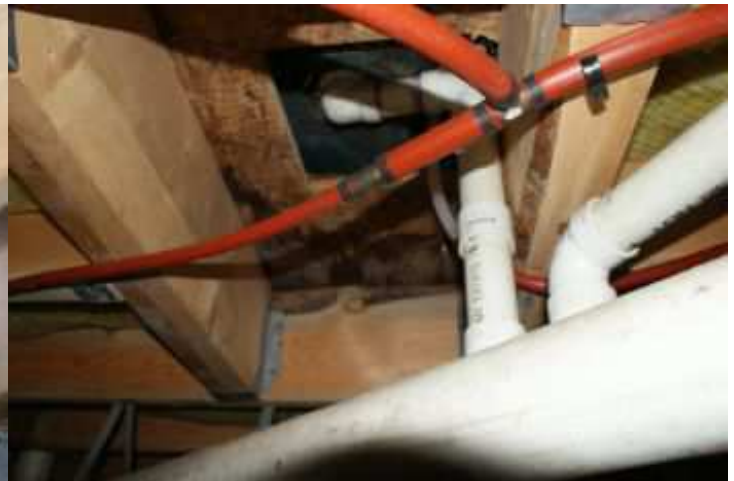
There is evidence of minor sub floor moisture damage under the tub.

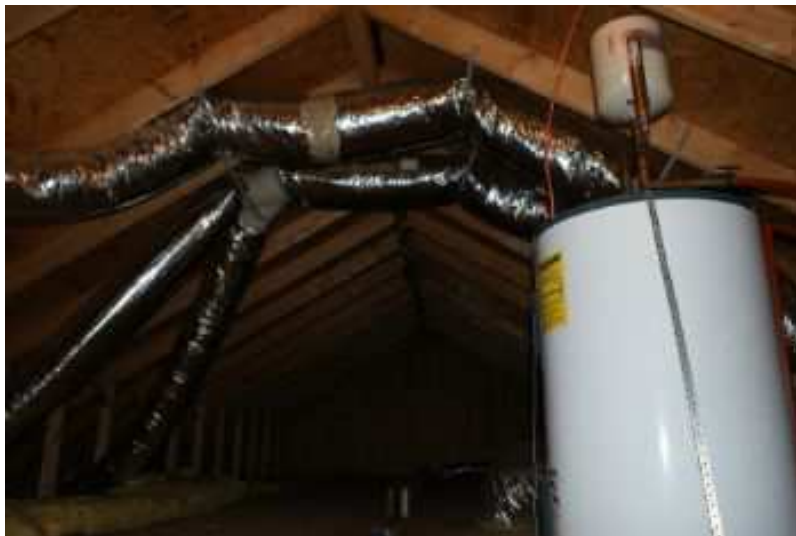
- Strapping although present is not proper by todays standards. A horizontal strap in the upper and lower 1/3 is proper.

straps should be horizontal

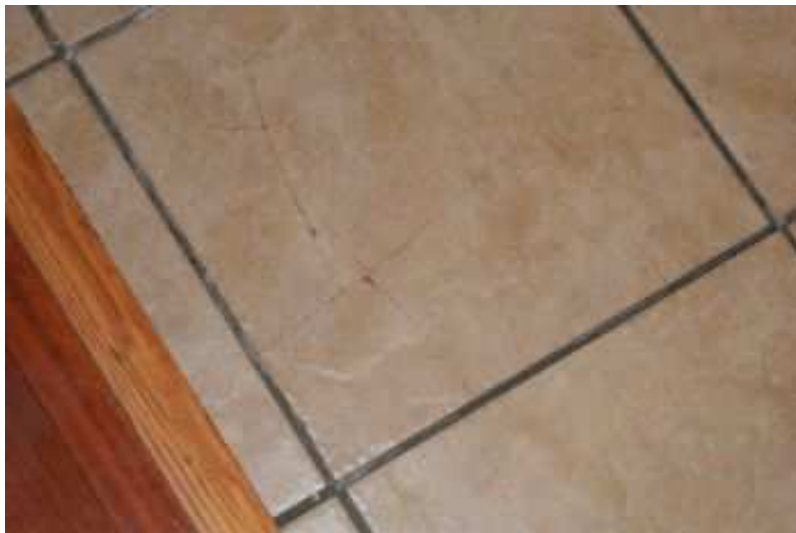
- There is at least one cracked tile on the kitchen floor.

cracked tile

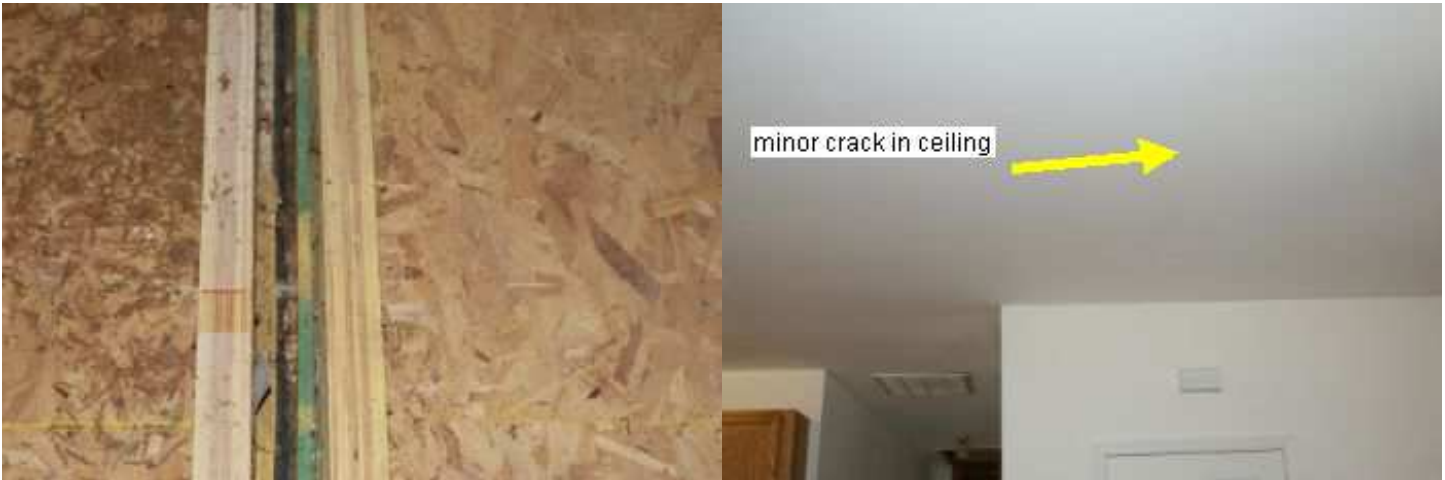
There is a crack in the living room ceiling which we believe to be caused by natural shrinkage of the wood where ceiling joists and a beam are located above. We suggest evaluation by a qualified contractor. We noted that the lvl above has a space at that location. Possibly filling the space and lagging it together would be advisable.
