# Home Inspection Report

2214 Gardner Road  
Hamilton, Ohio 45013

01:48 May 22, 2008

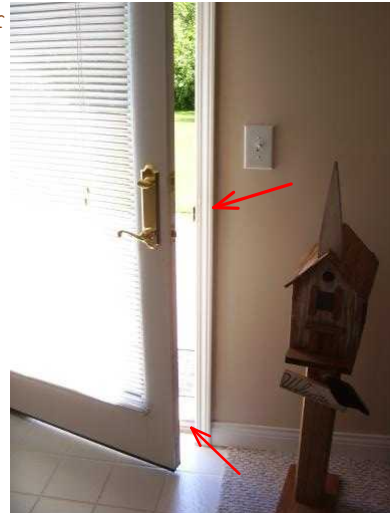
| 1. | <input checked="" type="checkbox"/> | <input type="checkbox"/> | <input type="checkbox"/> | <input type="checkbox"/> | <input type="checkbox"/> | Type: Brick veneer, Vinyl siding, Wood |

1. **Patio Door:** French door, Metal entry door French door to patio needs adjustment to operate properly
2. **Windows:** Double hung vinyl clad Peachtree thermal insulated Hard operation-needs improvements for ease of operation
3. **Window Screens:** Vinyl mesh, Several screens missing, stored in basement

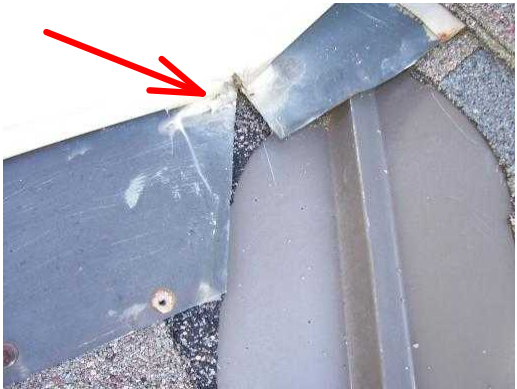
6. ☐ ☐ ☐ ☒ ☐ Flashing: Galvanized, tern metal Prone to possible leaks

4. **Flashing:** Galvanized, tern metal Prone to possible leaks
5. **Plumbing Vents:** PVC Plumbing vent flashing has failed. Replace vent flashing.
6. **South Chimney Chimney Flashing:** Galvanized, tern metal Loose counter flashing- repair

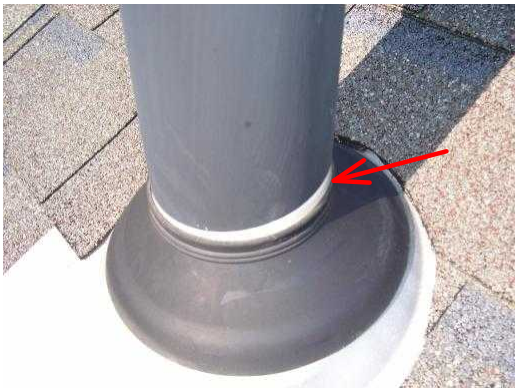
7. ☒ ☐ ☐ ☐ ☐ Valleys: Preformed metal  
8. ☐ ☒ ☐ ☐ ☐ Skylights:  
9. ☐ ☐ ☐ ☒ ☐ Plumbing Vents: PVC Plumbing vent flashing has failed. Replace vent flashing.

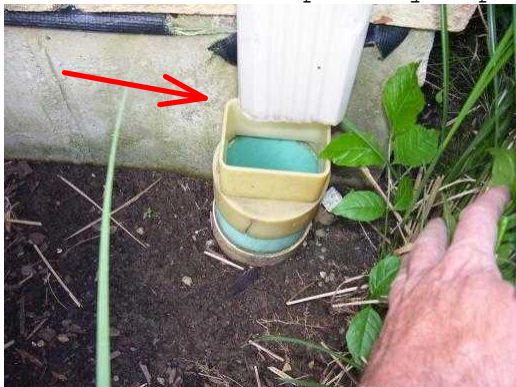
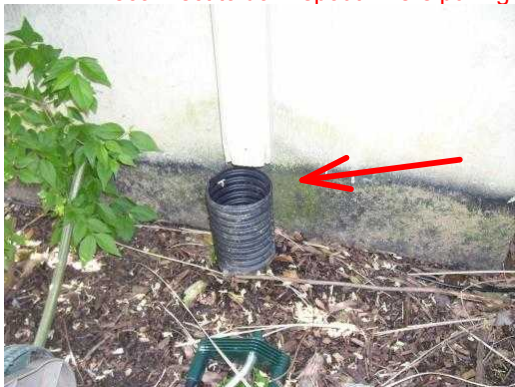
10. ☒ ☐ ☐ ☐ ☐ Electrical Mast: Underground utilities  
11. ☒ ☐ ☐ ☐ ☐ Gutters: Aluminum  
12. ☒ ☐ ☐ ☐ ☐ Downspouts: Aluminum  
13. ☐ ☐ ☐ ☐ ☒ Leader/Extension: Completely seperated Reconnect to downspout where pulling loose

1. Leader/Extension: Completely seperated Reconnect to downspout where pulling loose

Leader/Extension: Replace tile leader connector

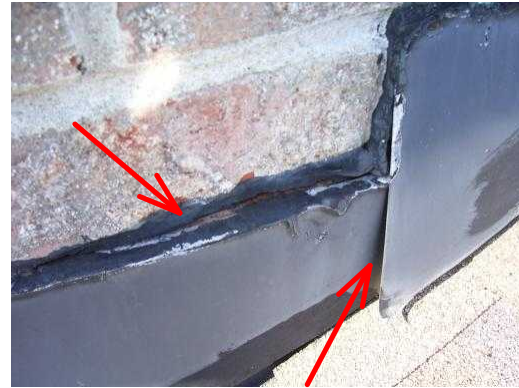
16. ☐ ☐ ☐ ☒ ☐ Chimney Flashing: Galvanized, tern metal Loose  
counter flashing- repair

Chimney Flashing: replace flashing into joint and re-caulk

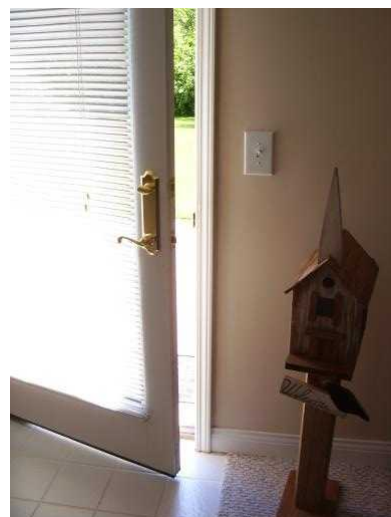
6. ☐ ☐ ☐ ☒ ☐ **Doors:** Multi panel hollow core wood The door is sticking, Sill plate needs to be adjusted, Latch plate needs to be re-aligned

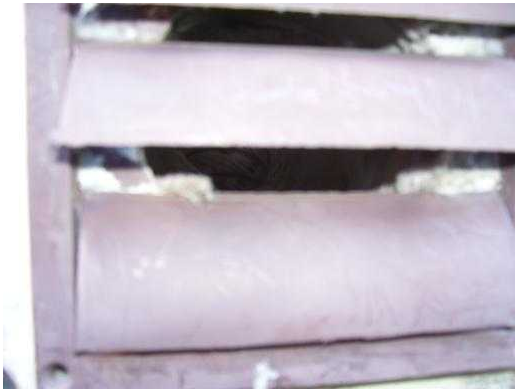
13. ☒ ☐ ☐ ☐ ☐ Dryer Vent: Plastic flex, Rigid metal Needs cleaning
