Rehabilitation of gravity dams

At the example of Neunzehnhain II Dam

**ICOLD Annual Meeting in Dresden
September 2001**

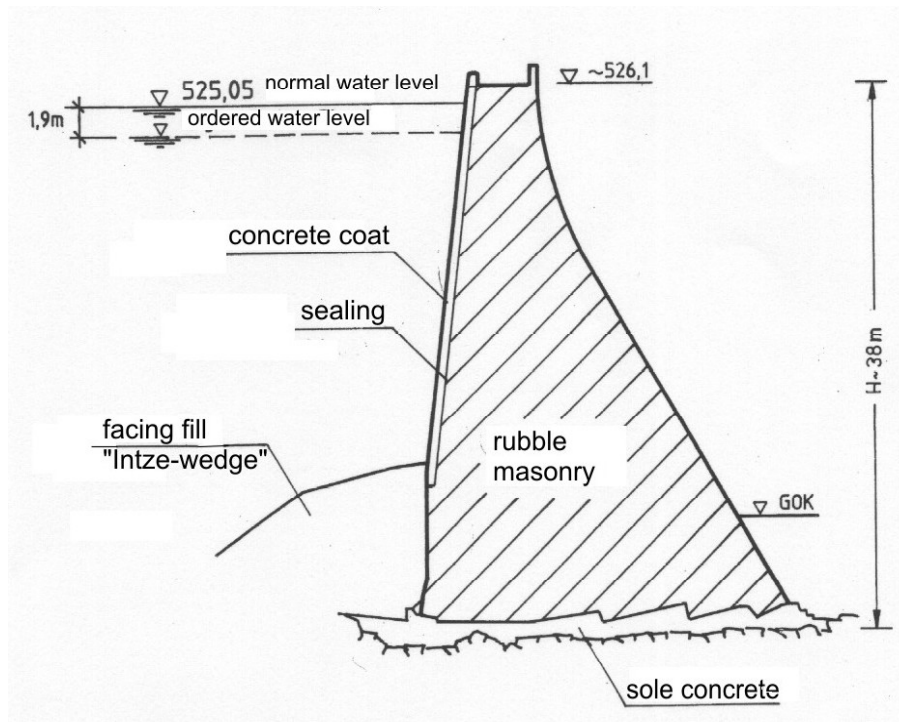
Fig. 1 Wall cross section before the rehabilitation

- The dam has no upstream drainage and no effective sealing any longer.
- Especially in the upper dam area the protective coat is not rehabilitable.
- The spillway including their spillway bridge (crest bridge) are in a extreme bad condition. A reconstruction of the concrete components is not possible due to alkali aggregate reaction (AAR) of the concrete.

- The dam crest and the crest covering are destroyed, so rainwater penetrates into the dam.
- The motion behaviour of the dam is interpretable during a longer period. There are anomalies. These are however interpretable.

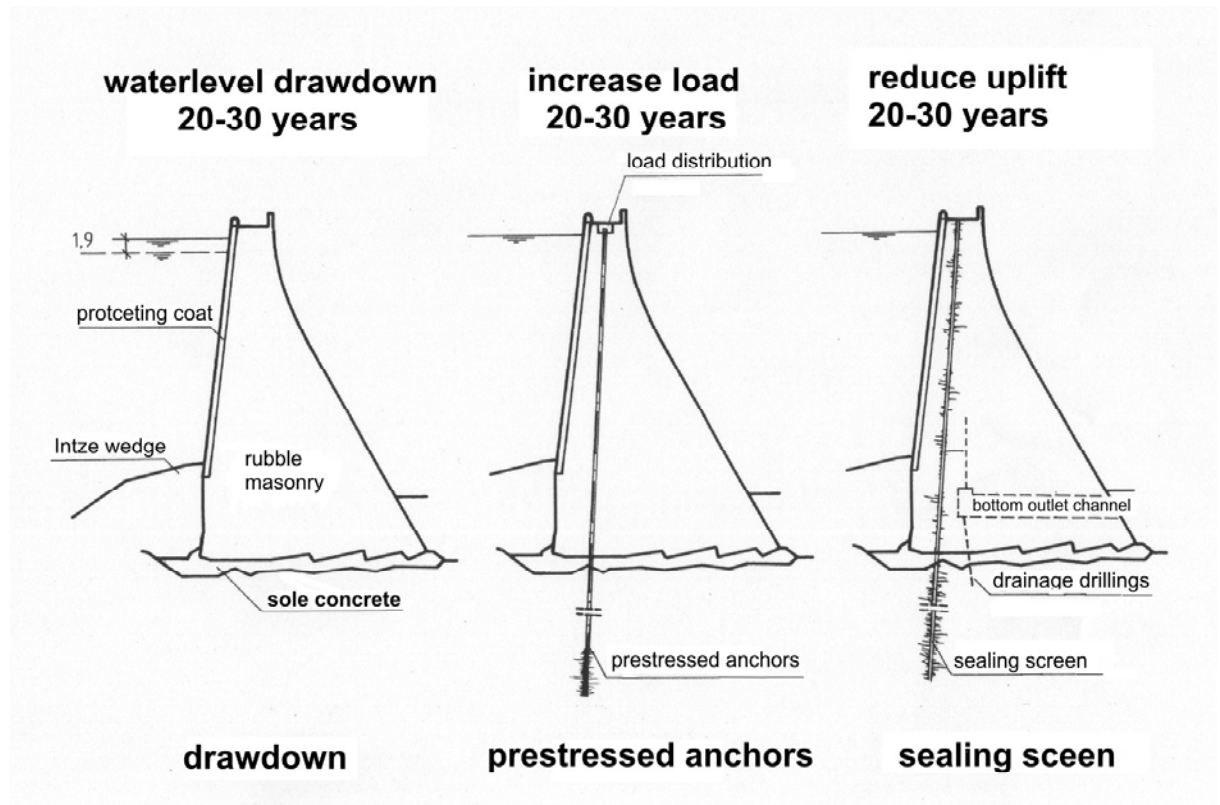
Fig. 2: Variants of rehabilitation

- Possible variants of rehabilitation show fig. 2. These are analysed in an evaluation matrix. The criteria of evaluation are divided into final state and construction status.

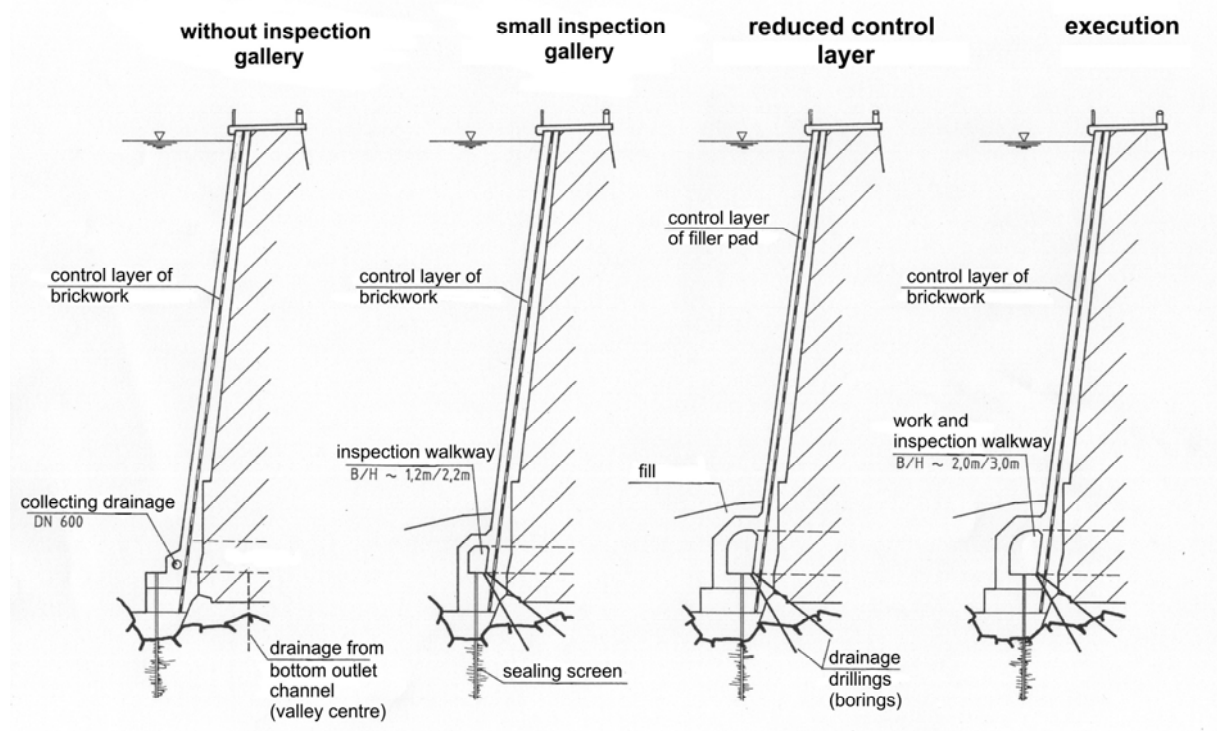
After an evaluation matrix, in which value numbers were assigned to the aforementioned criteria, a rehabilitation with a reinforced concrete sealing resulted as the technically and economically most acceptable solution. Before the final technical execution was determined, also for this solution variants were developed and evaluated cost-related. Fig. 3. shows the variants.

Fig. 3 Variants of reinforced concrete sealings

At the end a variant with a control layer from brickwork and an optimally dimensioned work and inspection gallery was selected.

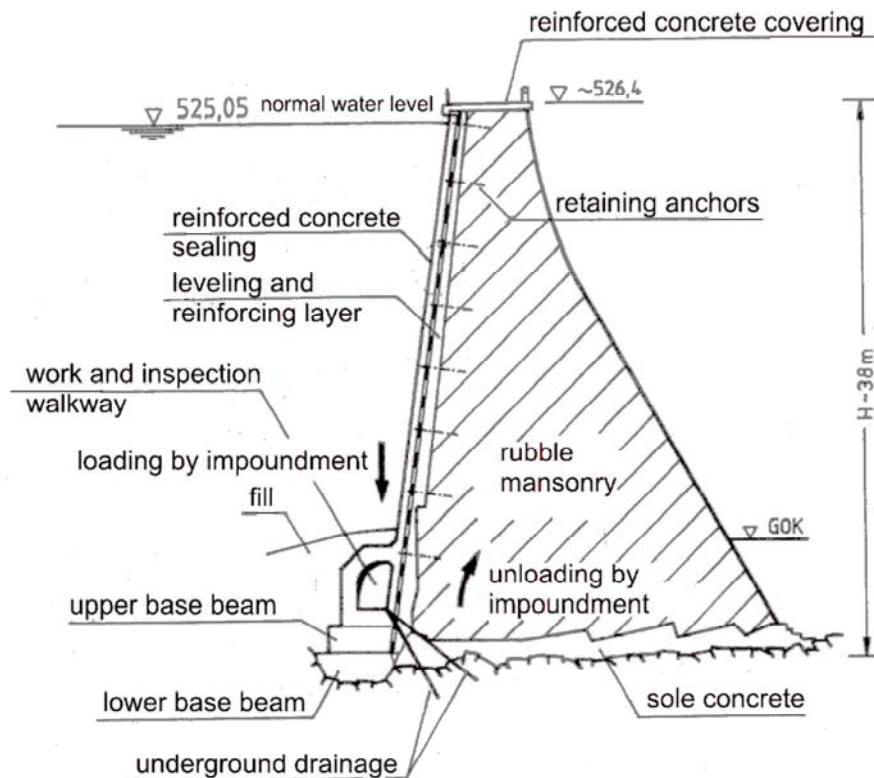
Fig. 4 Wall cross section after the rehabilitation with reinforced concrete sealing

The design features of the reinforced concrete sealing are:

According to the static calculation (FE 2D) the bearing dam cross section at the valley floor had to be strengthened approximately 1.85 m and at the crest of dam approximately 0.2 m. The reinforcement consists of an unreinforced concrete (B 15), which may tear and thus receives a similar elastic modulus as the masonry.

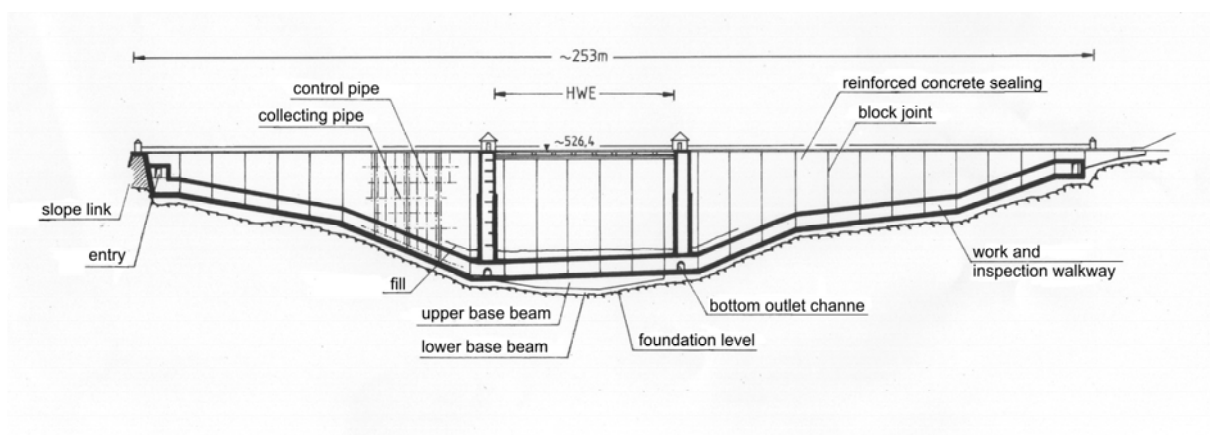
Fig. 5 View of diaphragm wall with section through inspection gallery

Independently of the requirement of a sealing screen the underground behind the sealing level had to be drained, in order to fulfil the static boundary conditions ($l = 0.6$) safely. For that reason drainage borings are drilled from the inspection gallery deeply into the underground rock (2 to 3 m) with a distance of 2 to 3 m, under an angle of 10 to 20°. Under the present geological conditions a danger of cleft flushing does not exist. In the case of leaching or sintering sealing screen and drainage can be manufactured or re-created or strengthened after years of the operation at justifiable expenditure without interruption of the dam operation from the sufficiently dimensioned inspection gallery (Fig 5).

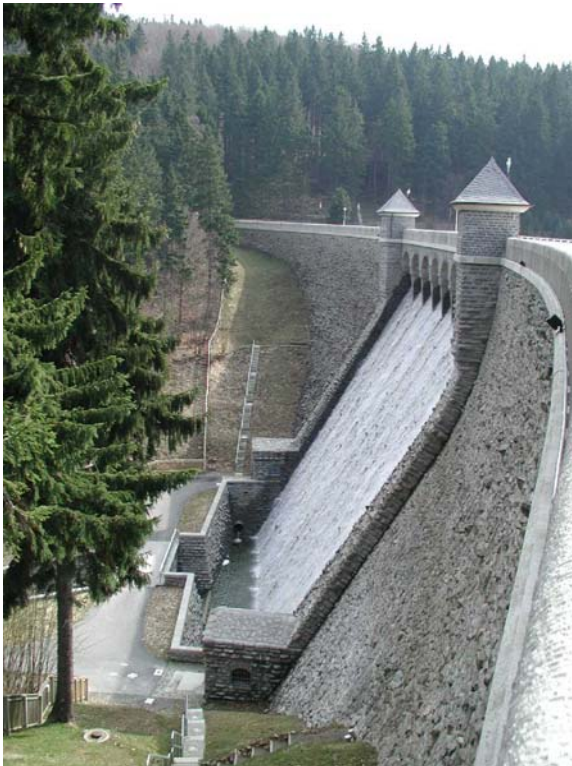
At the beginning of 1996 the reservoir operation was stopped. The construction work began in June 1996. In November 1999 the essential works were finished, so on 23.11.1999 the test impoundment could begin. The maximum water level was achieved on 03.04.2001. Fig. 5 shows a downstream view of dam with the overflowing spillway. All measurements and observations of the dam during test impoundment confirm the success of the rehabilitation works. Both the measured deformations and the drainage performance from the - unsealed - underground are in the range of the prognosticated expectancy values.

Fig. 6 Downstream view with spillway
