PFR-015

Title: Bearing Failure of Release Ring on SPB

Assembly : SPB, S/N 906	SubAssembly : Release Ring Assy
Component : Inner Bearing, Dynaroll Part Number: SR144ZZMC3 3GM6	
Originator: B. Donakowski/ 05 FEB 05	Organization: UCB/SSL/EFI
Phone : 510.642.9050	Email : billd@ssl.berkeley.edu

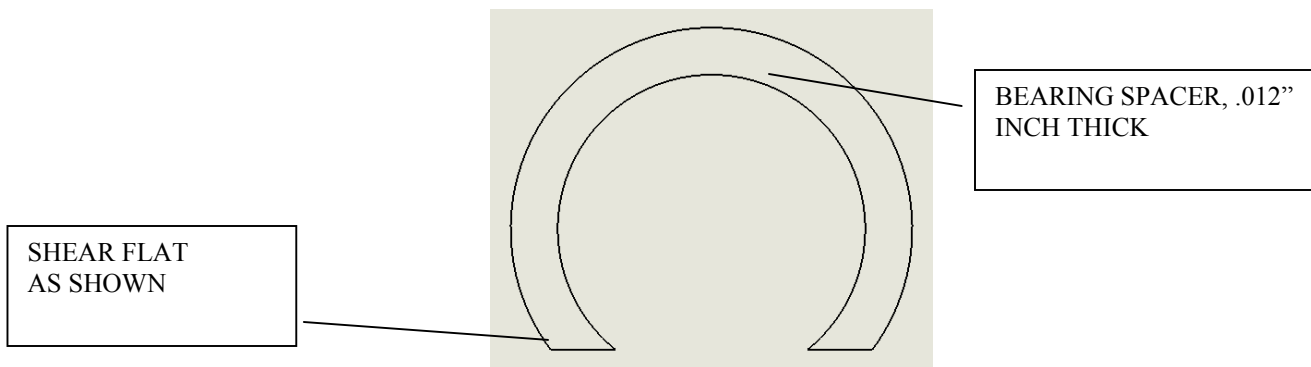
Figure 4: Modification of Bearing Spacer (all units)

5. Press one bearing onto the end of the THM-SPB-MEC-456 shaft, side 'B'. (Bearing Part Number Dynaroll # SR144ZZMC3 3GM6.) End of 'B' side of shaft to be flush with end of bearing. Use custom Arbor Press (with canted surface and cylindrical piece) and proper tool end. See Figure 3.
6. Shear Bearing Spacers as shown in Figure 4.
7. Pre-position a bearing into the opening of the Release Ring, line up the centerlines of bearing and ring. Place three spacers as shown in Figure 5. Place the bearing and ring into the press (see figure 3). Using the Axle and pin (from step 5), press Side 'A' thru the ring, the pre-positioned bearing and spacers, and back into the ring flange.
8. Verify 2 X bearings are free to turn, verify pin is completely installed, verify pin is not exceeding ID of Release Ring, verify outside bearing is flush with pin end, verify pin can not pull out of ring easily.
