Property Inspection Report

2416 Lake Terr
Coral Way, Fl, 12345

General Information

Inspection Date: 08/15/2009

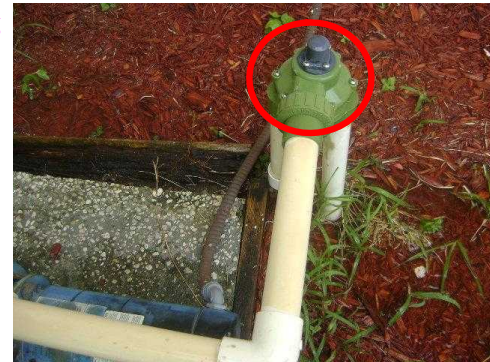
Acceptable: **Driveway:** Concrete
Acceptable: **Walks:** Concrete
Acceptable: **Porch:** Concrete
Acceptable: **Grading:** Moderate slope
Acceptable: **Lawn Sprinklers:** Front and back yard Comments > **Leaking at zone valve, no effect on the system**

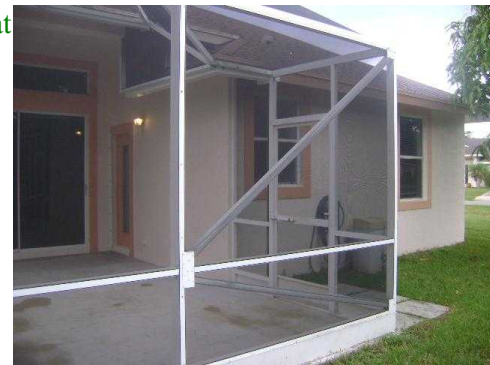
Back elevation Exterior Surface

Marginal **Porch Size:** Large, Screened Comments > **Damaged screens (at least 3 panels)**

Cost to Replace Low: \$ 200 - High: \$ 300

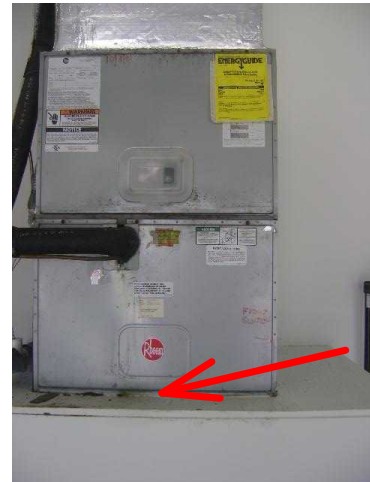
Acceptable: **A/C System Operation:** Appears serviceable
Acceptable: **Condensate Removal:** PVC
Acceptable: **Exterior Unit:** Left of house
Acceptable: **Air handler/Filter:** Garage Area Comments > **Some rust noted at air handler, monitor**

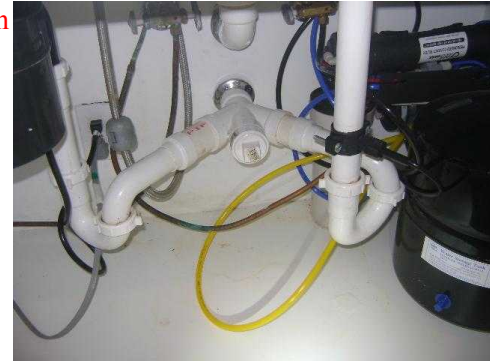
Acceptable: **Dishwasher:** Frigidaire **Approx Age:**
Acceptable: **Refrigerator:** Whirlpool **Approx Age:**
Acceptable: **Microwave:** Frigidaire **Approx Age:** 2002
Ventilator:
Acceptable: **Disposal:** In-Sinkerator
Acceptable: **Sink:** Double - Stainless Steel
Acceptable: **Lighting:**
Acceptable: **Electric Outlets:** 110 VAC GFCI
Defective: **Faucet/Traps:** Faucet with PVC trap Comments > Sink drain is leaking
Cost to Repair Low: \$ 100 - High: \$ 150

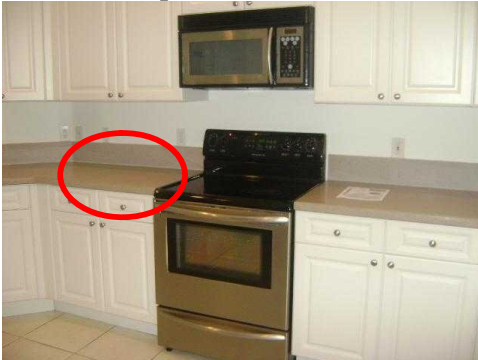
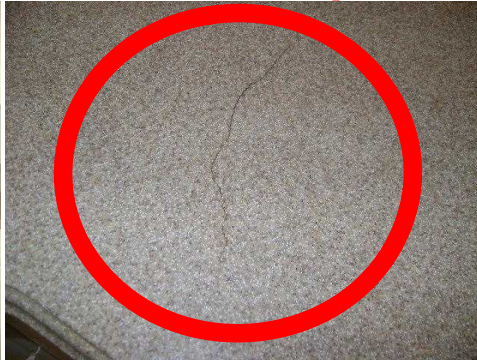
Defective: **Counter Tops:** Granite Comments > Crack noted - obtain repair cost if necessary

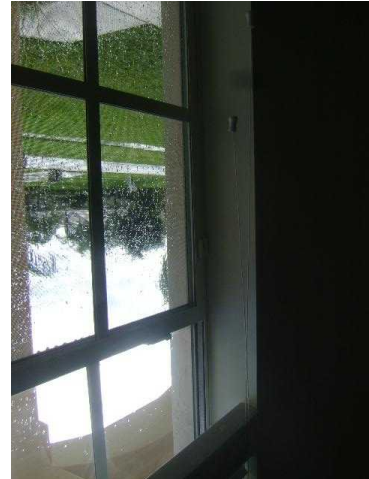
Dining Room/Living Space

Defective: **Window Type:** Single Hung Comments > Evidence of water intrusion,
Replace broken window balances
Cost to Replace Low: \$ 100 - High: \$ 200

Notes: There were signs of water intrusion at the window. This is a moderate to serious issue. Water intrusion into the structure can lead to mold growth and other problems. Removing water-damaged materials for repair or replacement may reveal further damage and microbial growth. Recommend maintenance/repair by a licensed contractor.

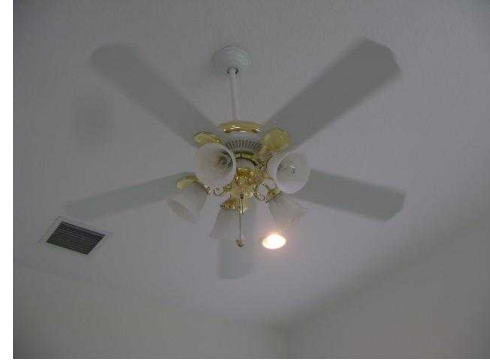
Acceptable: **Ceiling Fan:** Fan wobbles during operation / adjust balances

Notes: There were signs of water intrusion at the window. This is a moderate to serious issue. Water intrusion into the structure can lead to mold growth and other problems. Removing water-damaged materials for repair or replacement may reveal further damage and microbial growth. Recommend maintenance/repair by a licensed contractor.

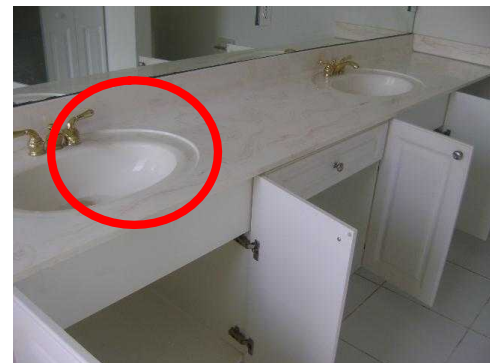
Acceptable: **Closet:** Linnen closet
Acceptable: **Ceiling Type:** Drywall
Acceptable: **Wall Type:** Drywall
Marginal **Floor Covering:** Ceramic tile Comments > Loose / uplified floor tiles noted
Acceptable: **Entry Doors:** Hollow wood Comments > Adjust / repair lock set
Acceptable: **Window Type:** Single Hung
Acceptable: **Lighting:**
Acceptable: **Electric Outlets:** 110 VAC GFCI
Marginal **Counter/Cabinet:** Marble, Laminate and composite material Comments > Counter top appears too short for the cabinet, and water is running off the top on to the cabinet and is causing deterioration
Defective: **Sink/Basin:** Two single sinks Comments > Left sink not draining properly - further review/repair
Cost to Repair Low: \$ 75 - High: \$ 100

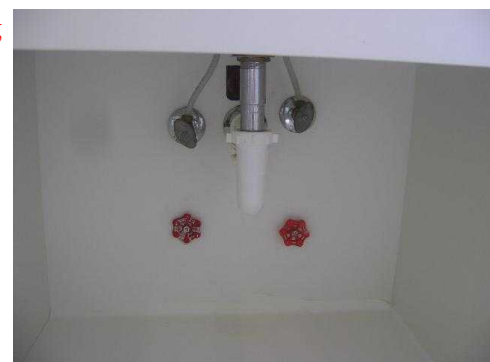
Defective: **Faucets/Traps:** Faucet with PVC Trap Comments > Leaking drain line under left sink
Cost to Repair Low: \$ 75 - High: \$ 100

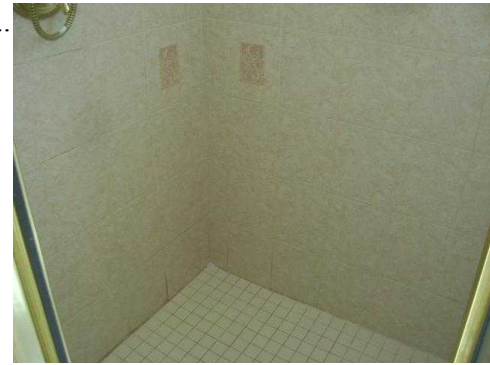
Not Present: **Spa Tub/Surround:**
Acceptable: **Shower/Surround:** Ceramic tile pan and ceramic tile surround
Comments > **Maintenance: Re-grout tile joints as needed**

Notes: The grout is deteriorated / missing at shower wall. This is a maintenance issue. Deteriorated or incorrectly applied grout and caulking can allow water to penetrate the structure, resulting in water damage or mold growth. Water damage or microbial growth occurring may be hidden from view. Recommend maintenance by a licensed contractor.

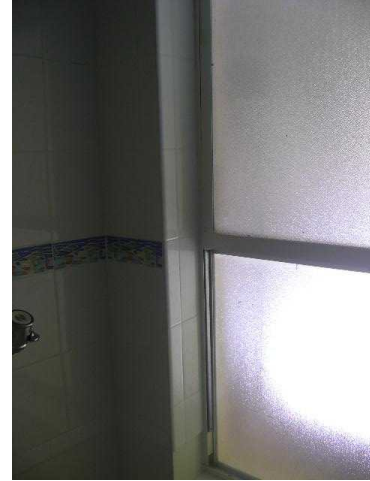
Defective: **Window Type:** Single Hung Comments > **Replace broken window balances**
Cost to Replace Low: \$ 100 - High: \$ 150

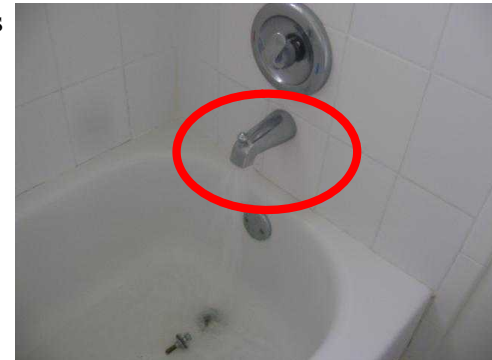
Defective: **Tub/Surround:** Steel tub and ceramic tile surround Comments > **Leaking at tub spout**
Cost to Repair Low: \$ 50 - High: \$ 75
