RESIDENTIAL BUILDING SURVEY

Biggleswade
Bedfordshire
SG18 XXX

Firstly, may we thank you for using our services once again and your kind instruction of XXXX; we have now undertaken a Building Survey (formerly known as a Structural Survey) of the aforementioned property. This Survey was carried out on XXXX.

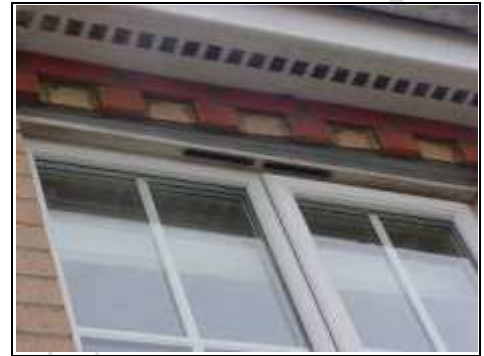
The property has been built at an angle which we mean is that we can see this by looking at the lintels which show the property is not square which is unusual for this to be this pronounced.

Property not square – twist in lintel

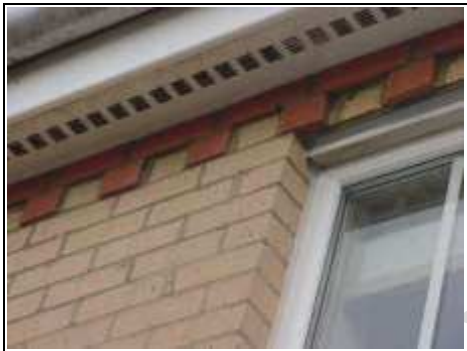
Left hand side of window

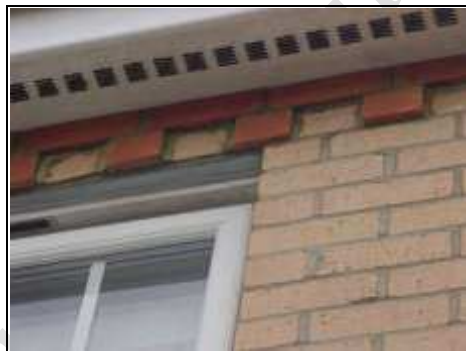
Right hand side of window

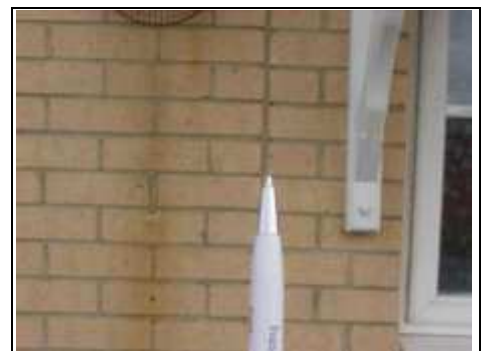
Mastic joint between two buildings

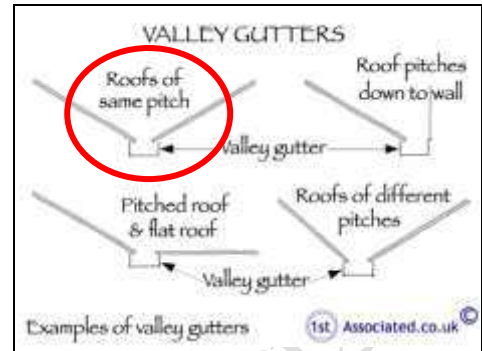
The property has a valley gutter which we noted the cement mortar has come away which in turn means you will get leaks into the roof.

Valley gutter to pitched roof

ACTION REQUIRED: Check all valley gutters and verge details and remove the cement mortar and replace.

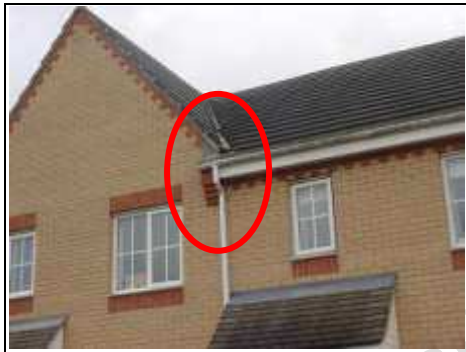
Valley gutter

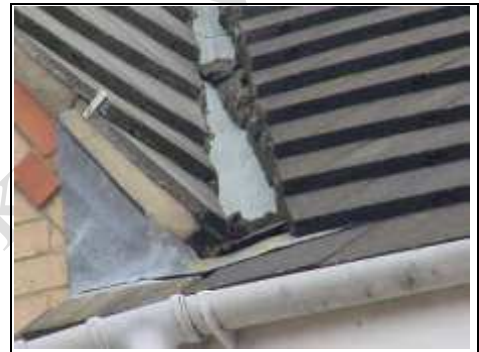
Cement mortar has come away

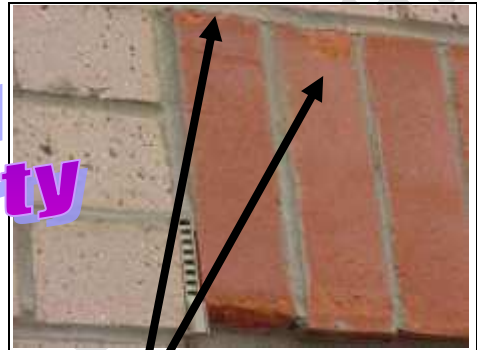
Spalling starting to occur to red brickwork at the front of the property

For example: to the soldier course of bricks over the windows.

Whilst the spalling is minor this really should not be occurring on such a modern property.

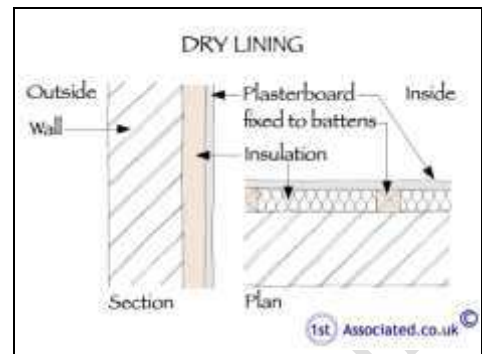
The cracking is relatively straight which tends to mean that it is a plasterboard crack (the property is lined with a gypsum plaster) and is what is known as dry lined or false wall construction please see our sketch. This type of hairline cracking is relatively common in this type of modern property particularly where there are problems with humidity/condensation.

The walls have been dry lined

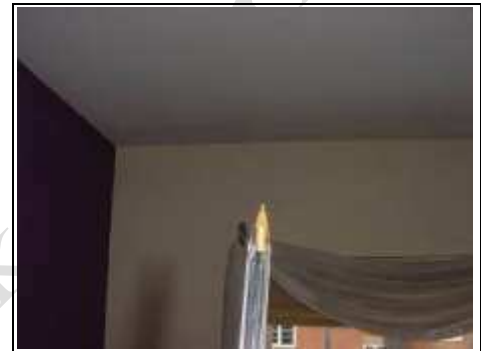
We noted hairline cracking throughout the property

Cracking in master bedroom

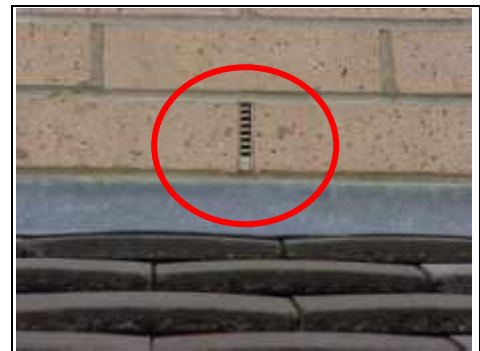
Another feature of this type of dry lined construction is the trickle vents on the outside of the property.

Trickle vent

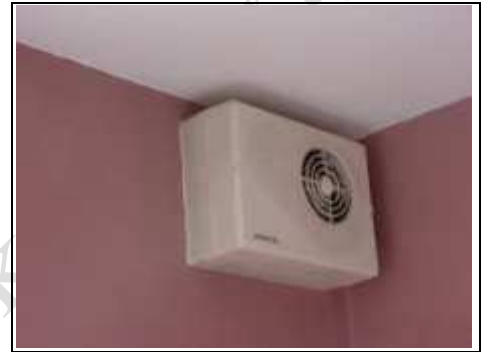
Extract in kitchen never used

Interestingly when we spoke to the present owner they advised that they have never used the extract fan in the kitchen and did not know where the switch was located. We could not get the extract fan to work and recommend you replace this extract fan.

ACTION REQUIRED: Again, we would recommend replacement of the fan with a large humidity controlled extract fan.

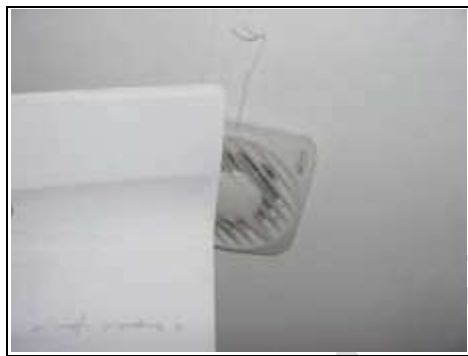
We would just like to reiterate the internal bathroom problems. We noted that the extract fan was not drawing the air from the bathroom which ultimately results in condensation occurring in the property.

Extract system not working
- Testing suction of extract fan by putting some paper against it

ACTION REQUIRED: Please see our previous comments regarding replacing the extract fan with a humidity controlled large extract fan but still internal bathrooms can struggle.

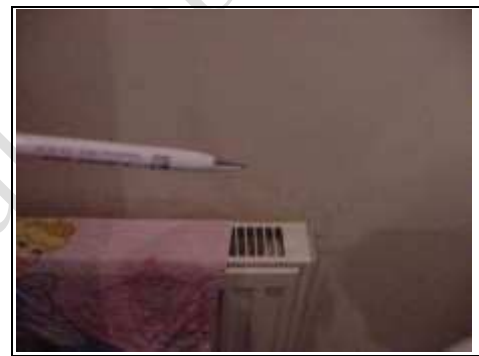
Quite unusually we noticed some staining around the radiators which may relate to drying of clothes internally.

Staining around radiator

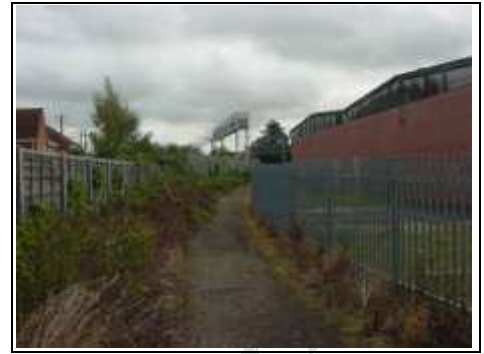
The property is located quite near to industrial buildings and train line. Throughout the time we were carrying out our survey we could hear a beeping noise which sounded like a truck reversing which may relate to an industrial premises. In the end the noise was carrying on for so long we did not believe it was a truck reversing but a noise made by one of the industrial buildings.

Nearby industrial buildings with bridge in the background over train line

ACTION REQUIRED: Is the area noisy? We believe the area is noisier than we would expect. This is a personal choice you need to revisit the property to ensure you are happy with the location prior to committing to purchase the property.

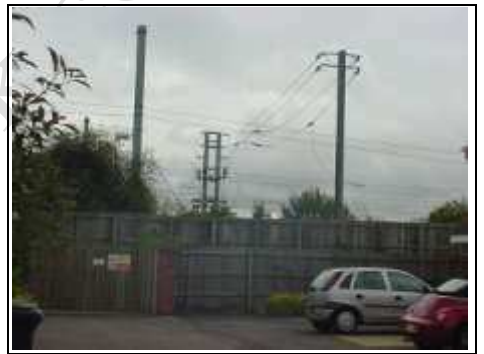
We also noted that the railway line is fairly close by and that you will probably be able to here noise from the railway whilst in the garden although we did not experience this on the day of our survey.

Railway line at the end of the road

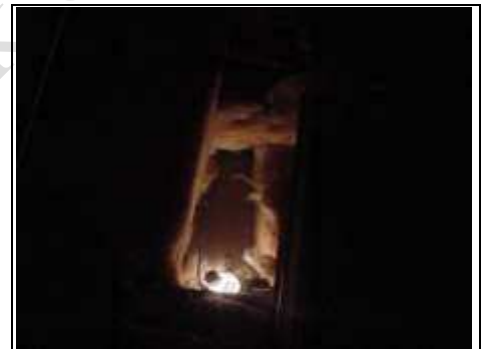
Heat and light being given off by the ceiling lights

ACTION REQUIRED: Check when putting stored items into the roof that you do not cover the lights.

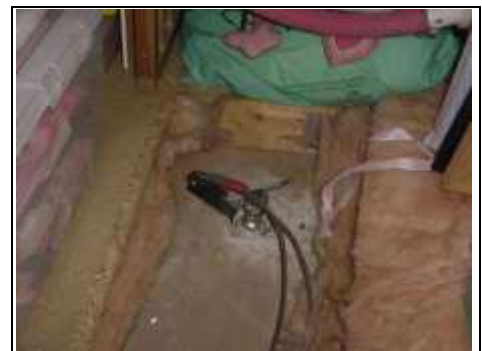
Ceiling lights cannot be covered

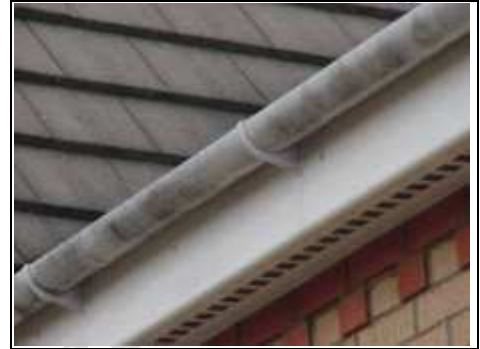
This type of property is relatively modern (i.e., less than one hundred years old) but nevertheless still requires ongoing maintenance and repair. A budget for such work must be allowed to ensure it is maintained in a good condition. This will prevent undue and unnecessary deterioration. For example we noted that your gutters are covered with a moss which does indicate that they may be overflowing and need cleaning.

Moss covered gutters

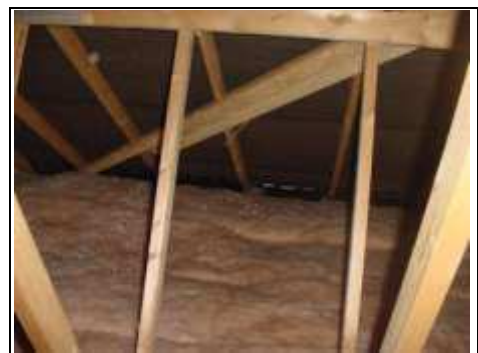
- 1.0) as we did not have full view of the roof space due to the mass of insulation and stored items.

Mass of insulation

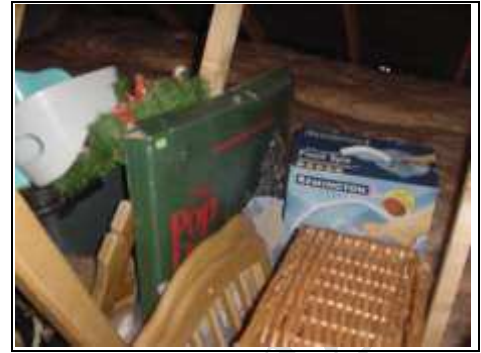
Stored items in the roof space
